OPERATOR:	F3 Gold, LLC.
PERMIT NUMBER:	EXNI-436
INSPECTION TYPE:	Pre-Inspection
DATE:	September 23, 2020
TIME IN:	9:00 am MDT
TIME OUT:	2:00 pm MDT
INSPECTORS:	Roberta Hudson, Eric Holm, and Mark Keenihan
ACCOMPANIED BY:	Brandon Isakson (F3 Gold), Stan Michals (GFP), and Dave Williams and Dustin Lloyd (ARC)
WEATHER:	Sunny, 70's

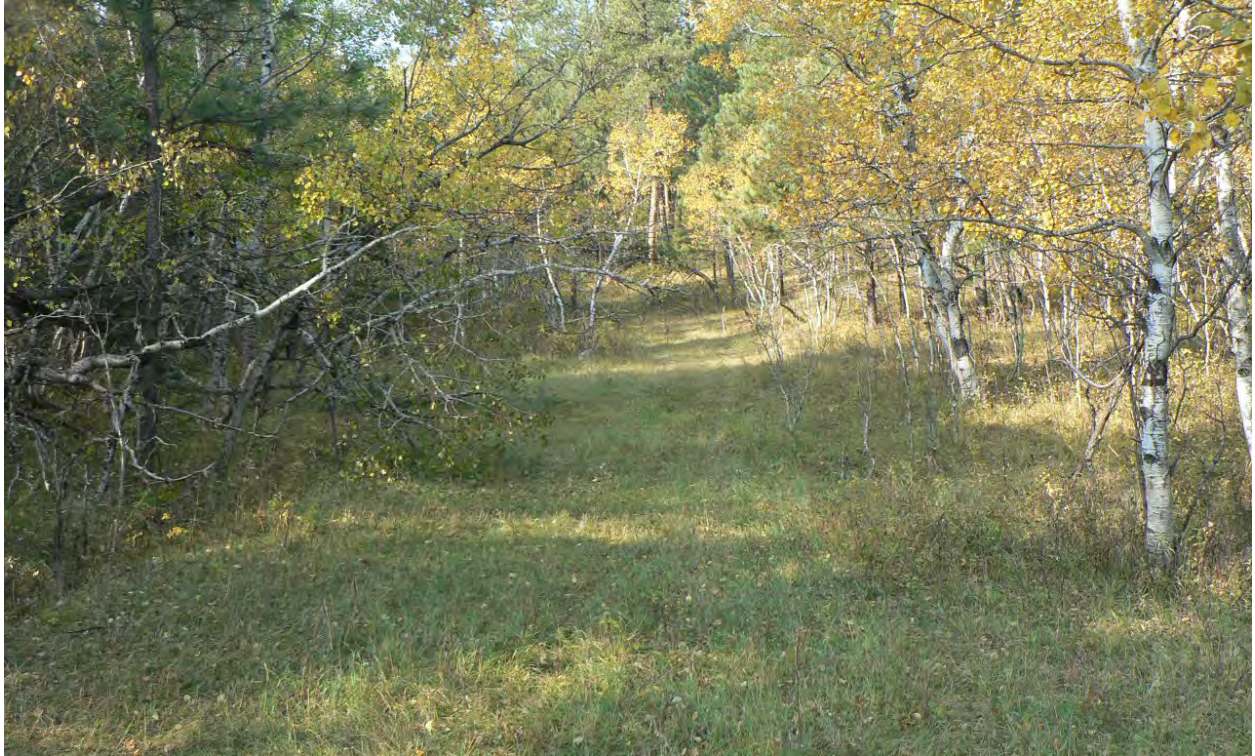
Photo 1. Approximate location of first drill site inspected.

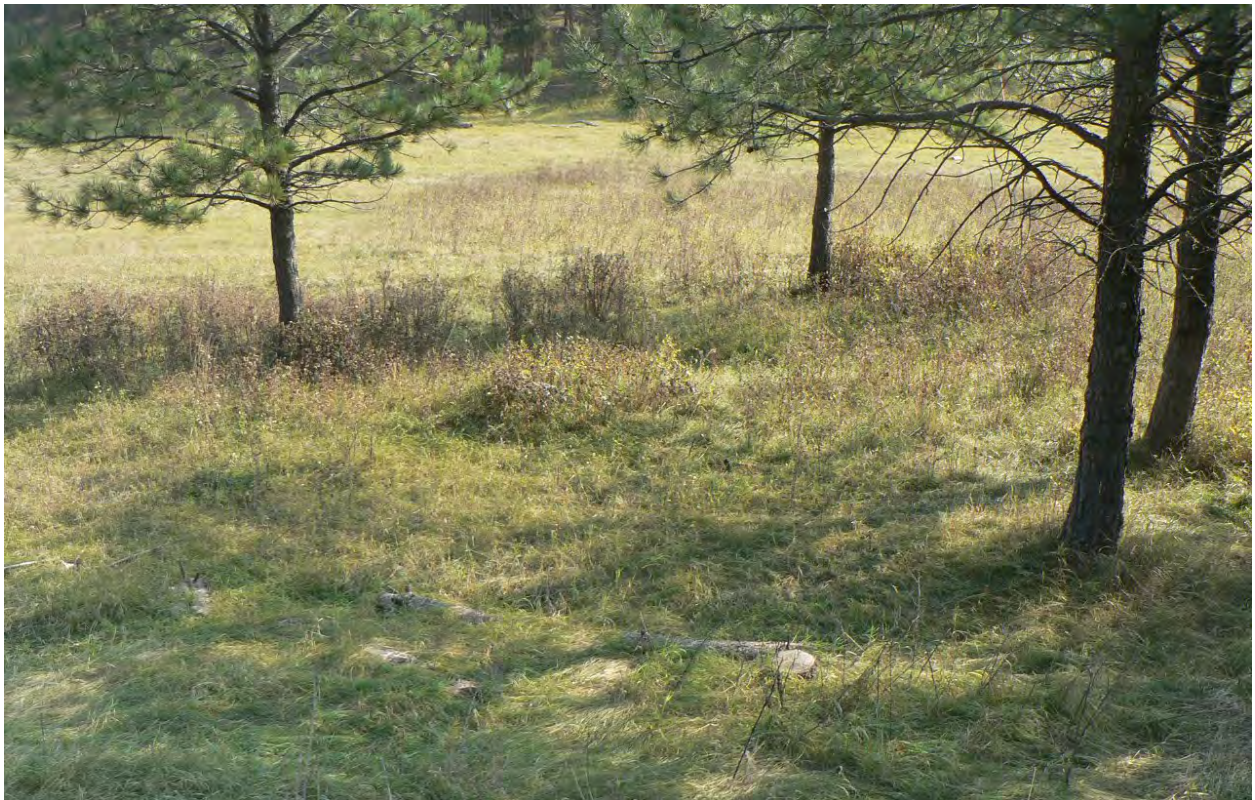
Photo 2. Proposed location of second drill site from inspection.

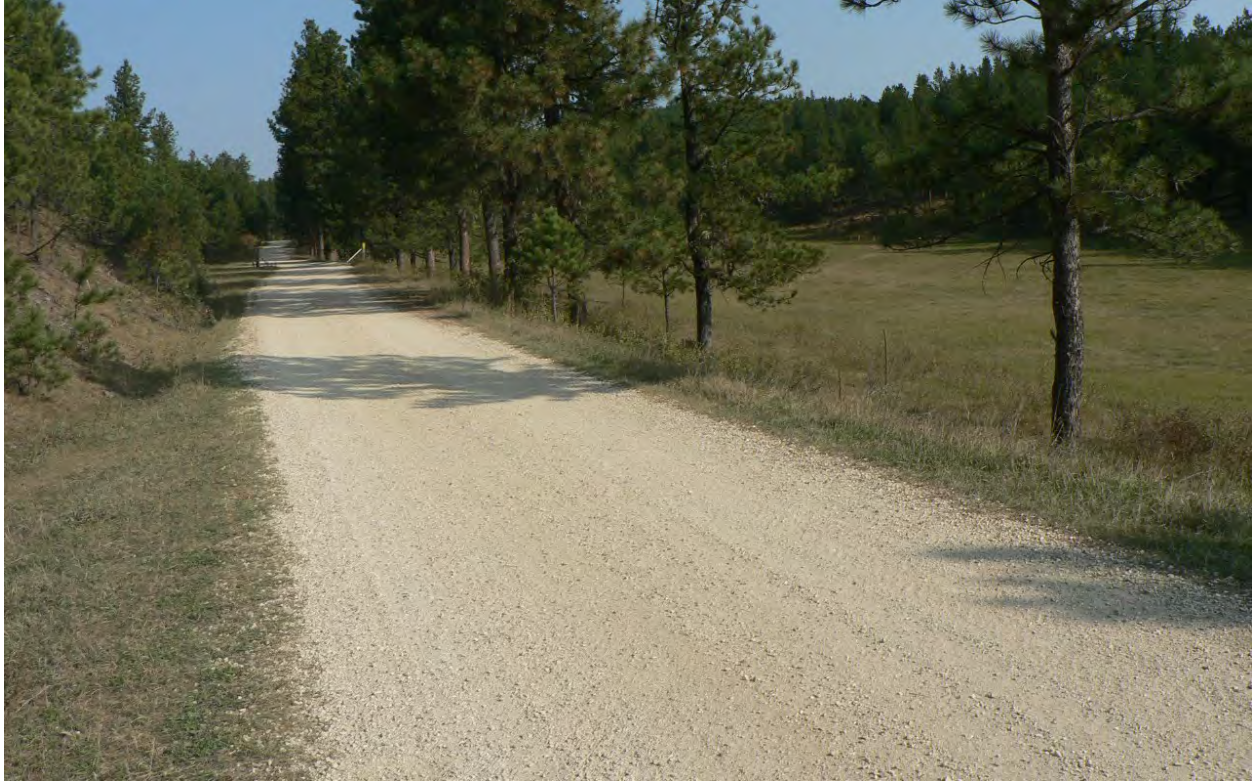
Photo 3. Proposed location of next hole near cattle guard located further down the road.

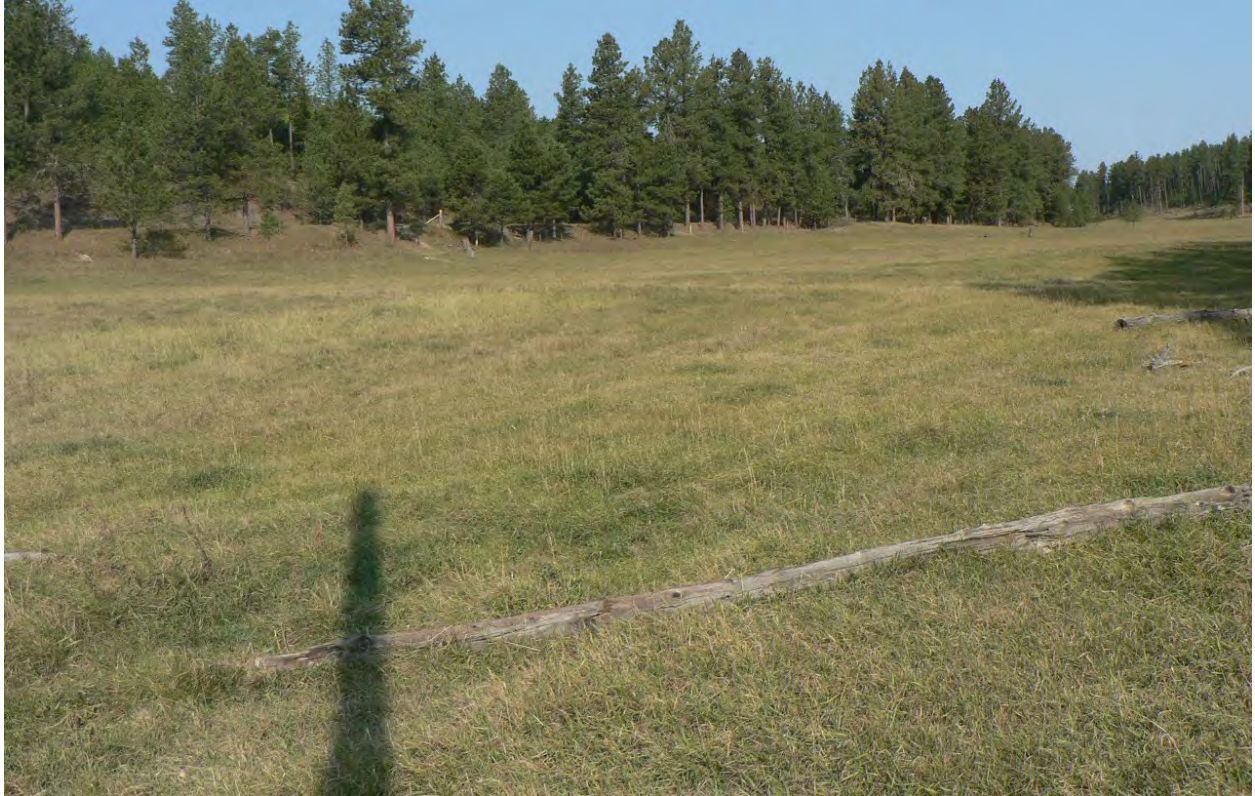
Photo 4. Jenny Gulch Creek Valley.

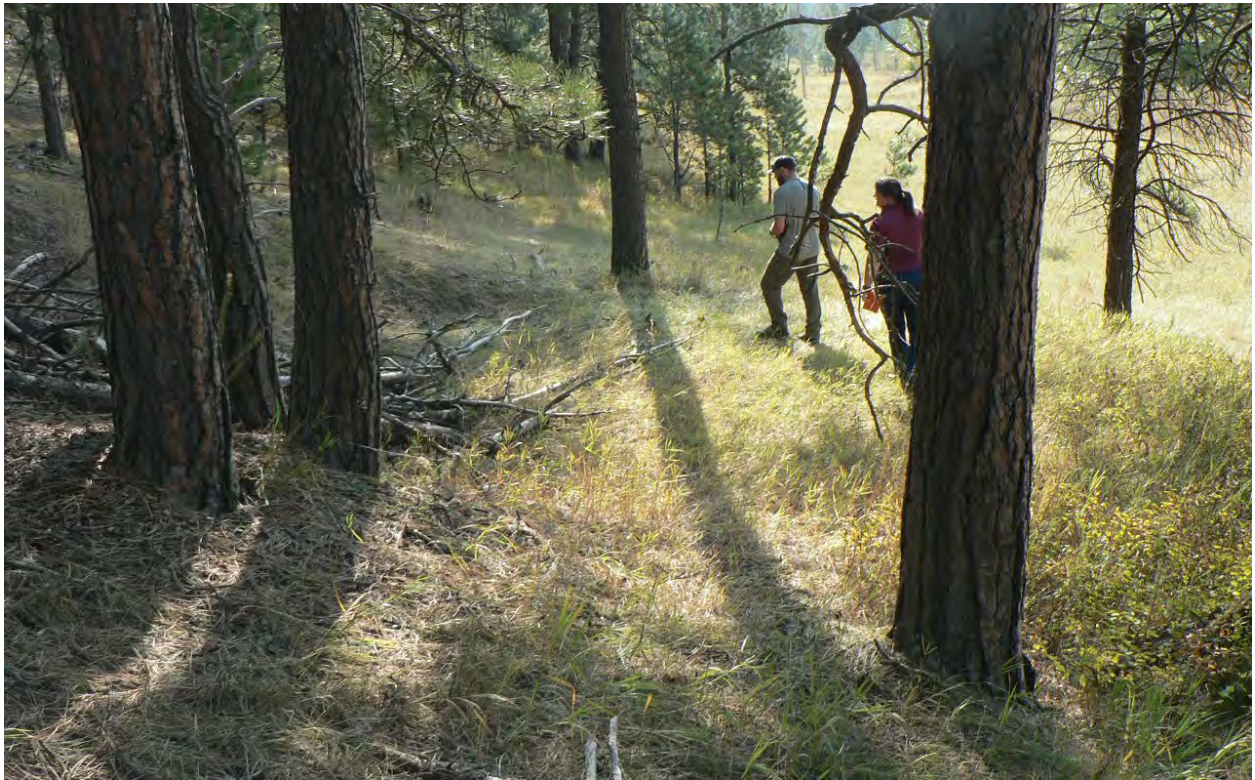
Photo 5. Proposed drill site in landing of old prospect pit.

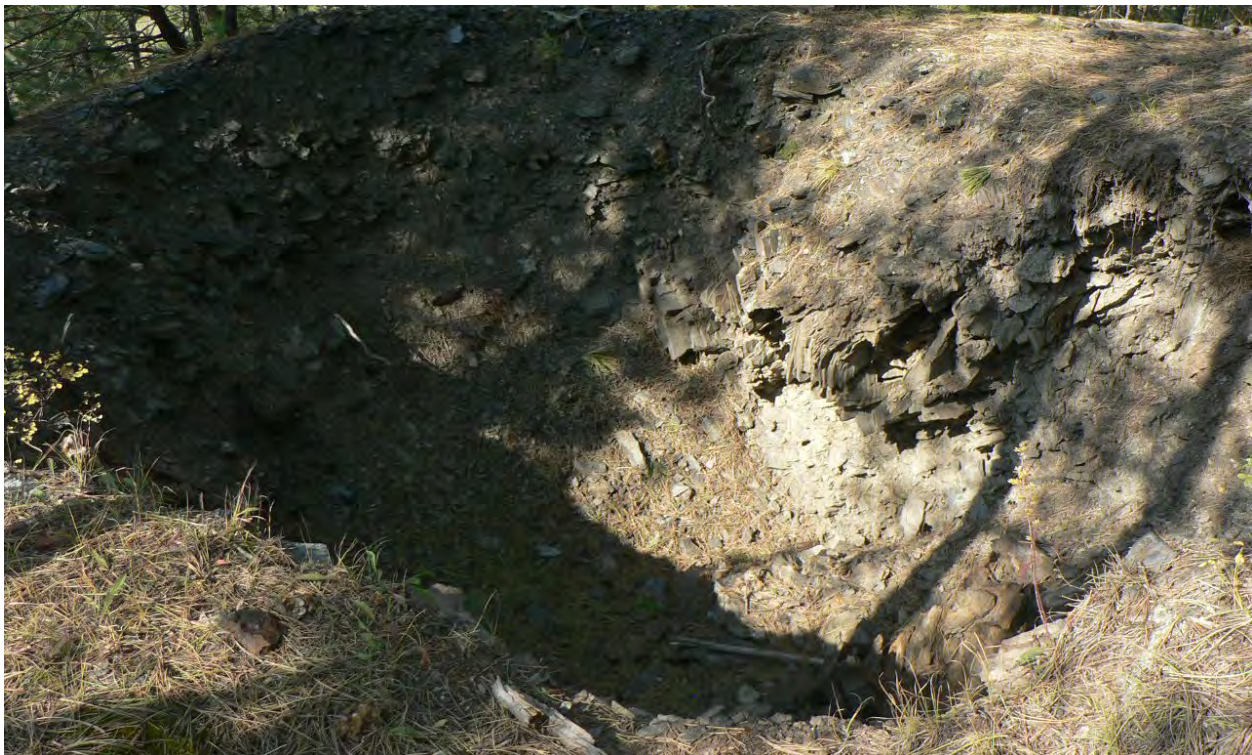
Another site, near the end of our walk, had been moved out of a secondary dry gulch that fed into Jenny Gulch. Some of the historic prospect pits and mine shaft areas had been marked within an area noted to be eligible for the National Registry (photo 6). Proposed drill sites and a road that had originally been marked as coming from the south were now extended on to the route coming from the north. This area had appeared to have been moved so as not to disturb any areas within the boundaries of the eligible lands.

Photo 6. Historic mine workings near location of proposed road and drill site.

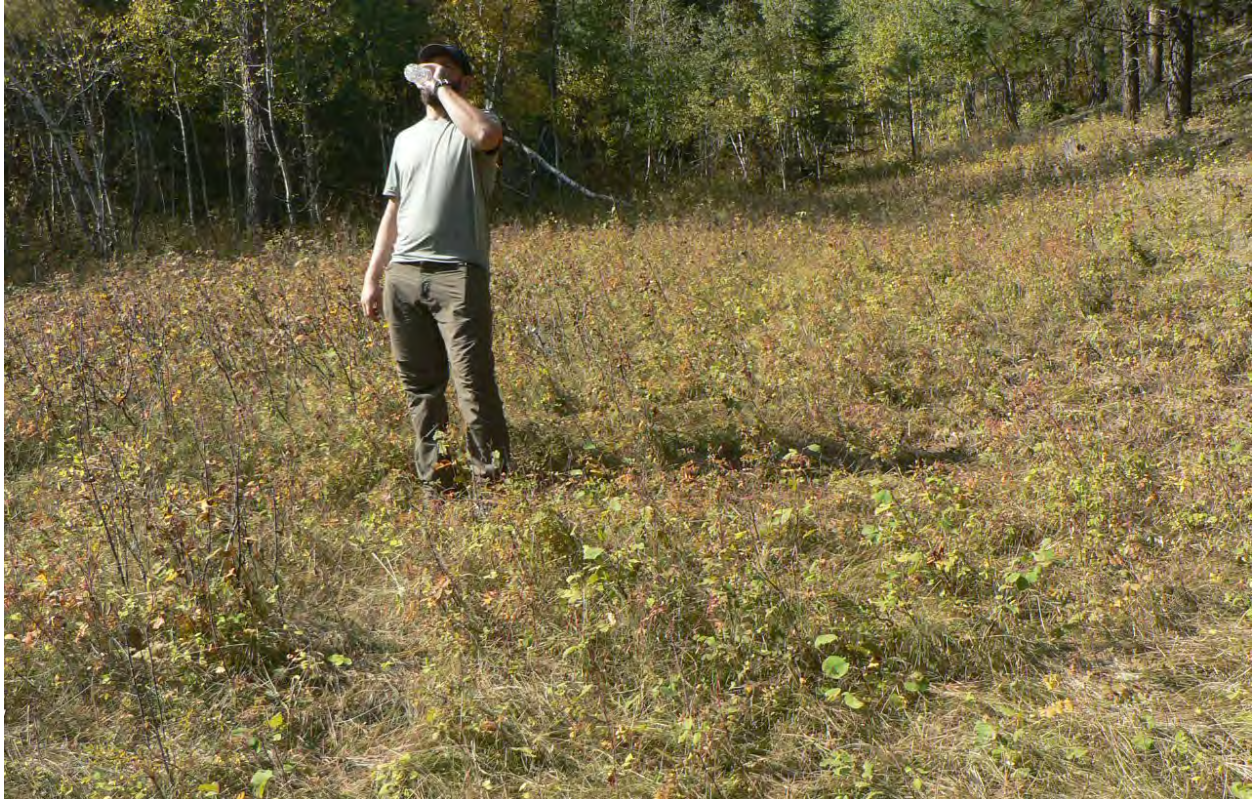
Once we completed the walk along the eastern side of the upper Jenny Gulch, we returned to the vehicles and drove a short distance to the south to look at another proposed drill site. This site was near another area that was eligible for the National Register of Historic Places. This site was near some power lines and was well away from the historic site. There was a slight incline in the proposed area (photo 7). An access road came nearly to the site along a portion of the powerlines, though it was noted that the road being constructed for the site was not following this access route and was coming through the forest to the north. Mr. Isakson was not certain why the road had not been marked to follow the easier access route along the powerlines but was going to investigate the reasons behind this to see if there was a way to minimize disturbance.

Photo 7. Proposed drill location near powerline access route.

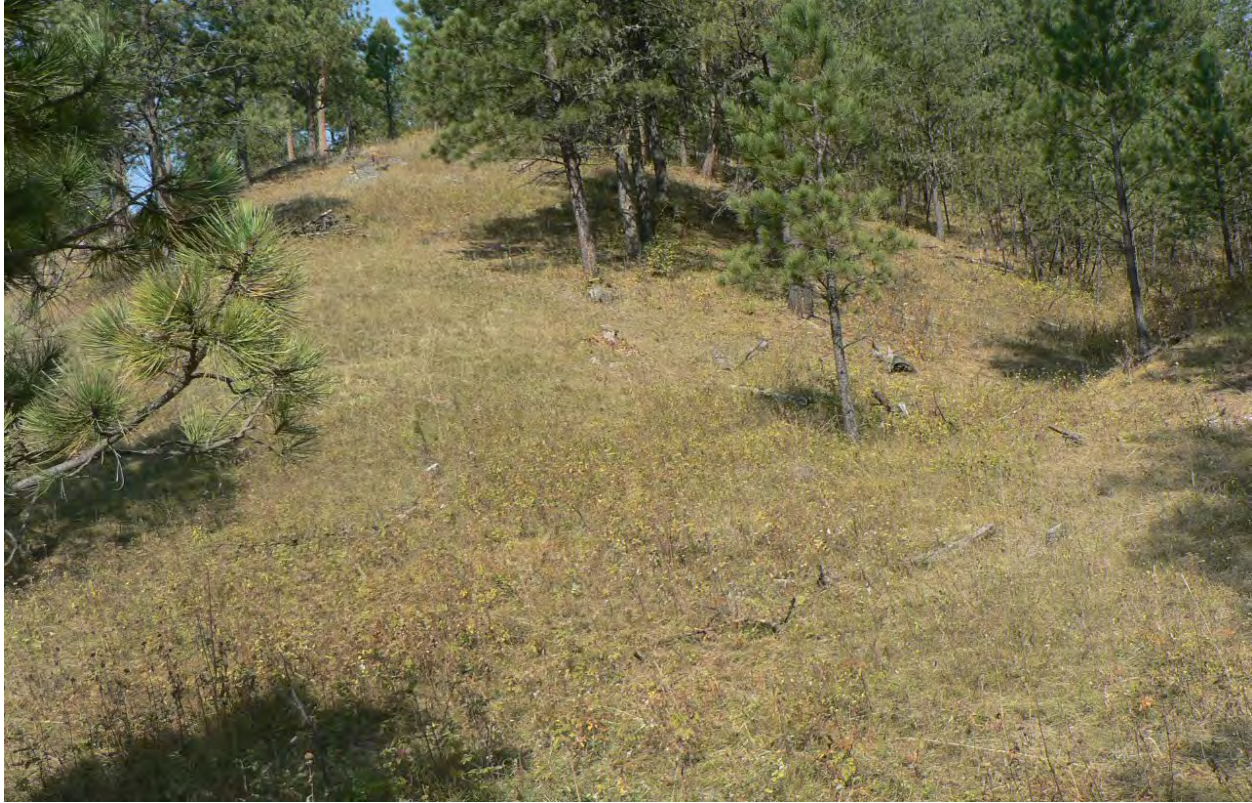
The group returned to their vehicles and drove to the next site. This was near the intersection of Sunnyside Gulch Road and Jenny Gulch Rd. There are a couple of proposed drill sites in the vicinity of this intersection. One site was located at the point of a nearby ridgeline (photo 8) while the other was located to the south approximately halfway up a steep slope. Ms. Hudson then requested more information on construction of sumps for some of these sites that may be constructed on steep slopes. Mr. Isakson indicated the sumps would most likely be constructed on the downhill side of a drill pad. Ms. Hudson then mentioned there had been some concern in the past about seepage from a sump on the downhill side of a drill pad creating an overland flow situation of drill fluids away from a site. She mentioned if it was not possible to place the sumps along the upgradient side of the drill pad, F3 Gold may need to consider lining the sump in order to prevent seepage.

Photo 8. Proposed drill site near top of ridgeline.

Mr. Isakson said access to the holes would be along the top of the ridge. Stan Michals also noted the group was standing in a narrow drainage and that there was proposed road construction within the reaches of the drainage. He wanted to know what would be done to protect the drainage in the instance of a flow event. Ms. Hudson noted the group was standing at the entrance of a steep gully that did not appear to even maintain ephemeral flow except perhaps in the most extreme rain events. However, there was some discussion on providing appropriate sediment and erosion controls while operating or constructing within these narrow gullies. Mr. Michals suggested we utilize the Best Mineral Management Practices as a reference for guidance on appropriate sediment and erosion controls.

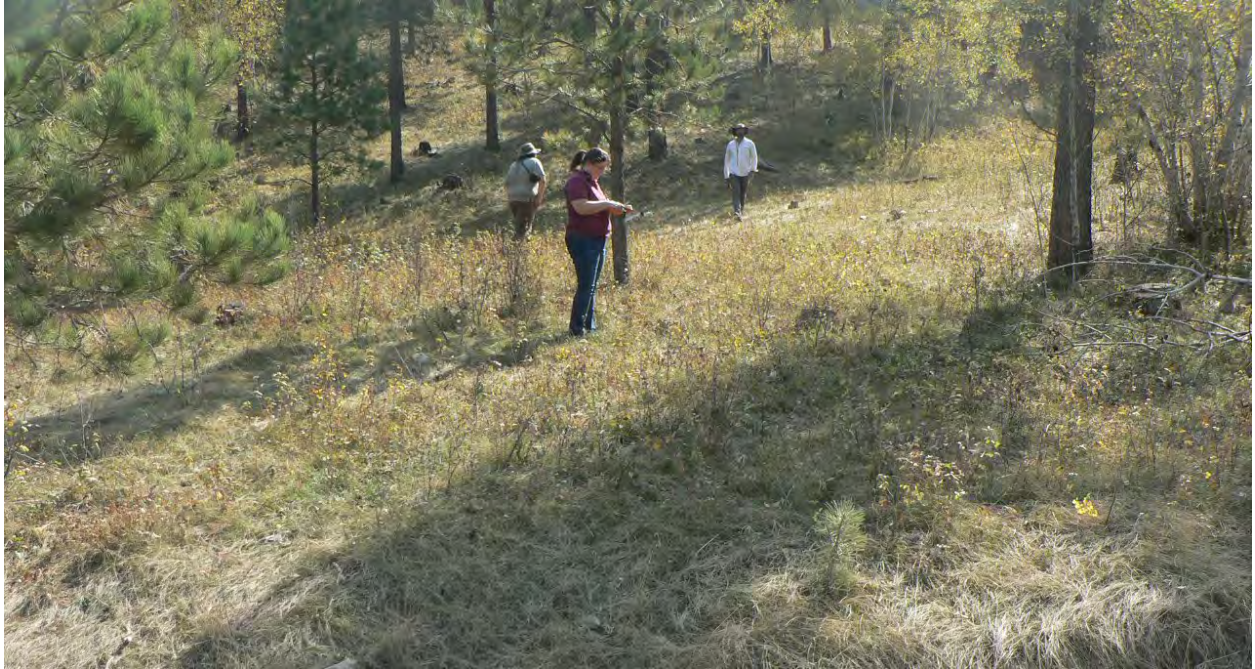
The inspection then continued as the group drove down Sunnyside Gulch Road. They stopped at one proposed drill site that had been flagged adjacent to the road (photo 9). The site was up in the delta of a small gully approximately eight feet above the road. The slope in the area was shallow and Mr. Michals again mentioned concern with controlling flows in a rain event. Ms. Hudson assured that the state would require sediment and erosion controls be in place during operations to ensure proper erosion controls.

Photo 9. Site flagged adjacent to the Sunnyside Gulch road.

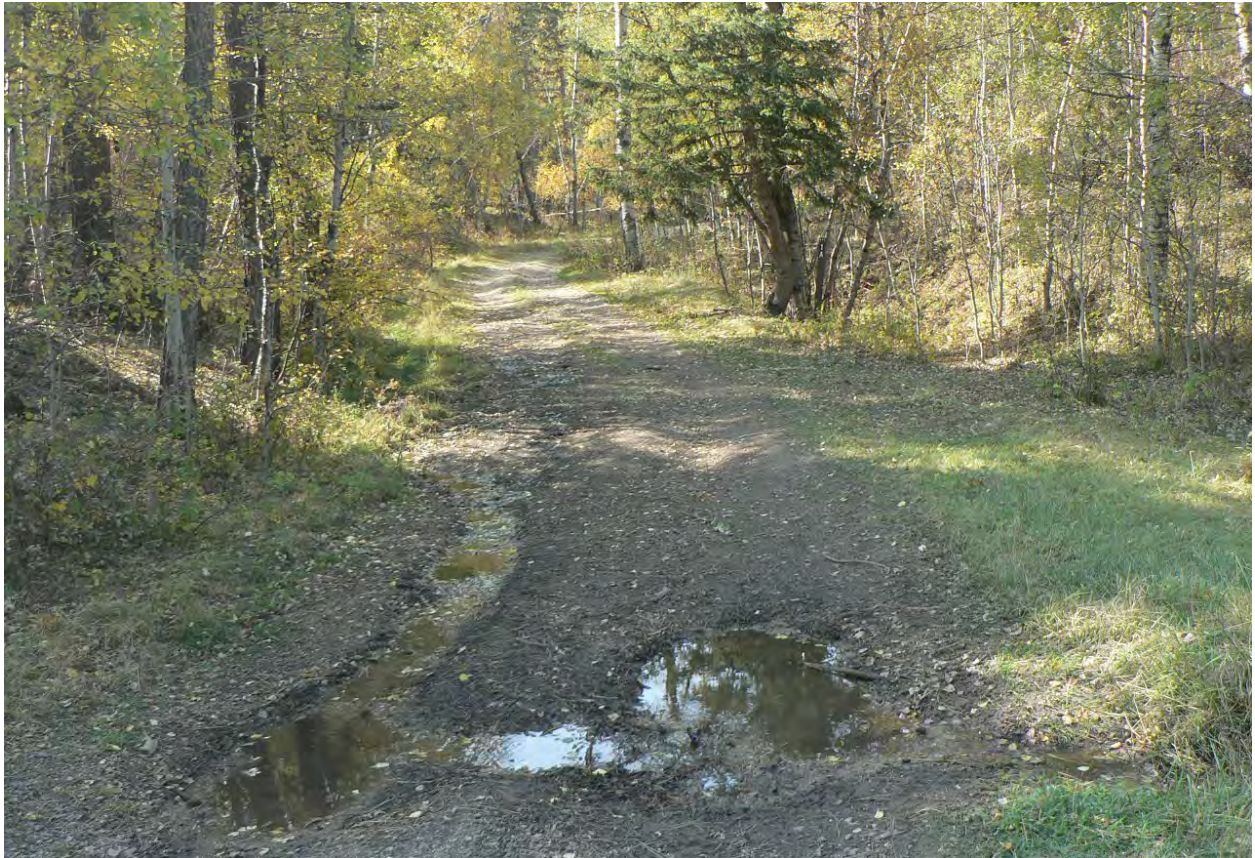
Continuing down Sunnyside Gulch Road, the group stopped at an intersection with a small two-track trail the extended to the west (photo 10). Another proposed drill site was located near this intersection and another was located further down the road. The map showed a new trail was being constructed to about halfway down the two-track road before following the road the remainder of the way to the site. Again Ms. Hudson expressed confusion over the extra disturbance acreage when there was already an existing road back to the site. Mr. Isakson again indicated he would investigate it.

Photo 10. Existing two track trail. Proposed drill site further down the road.

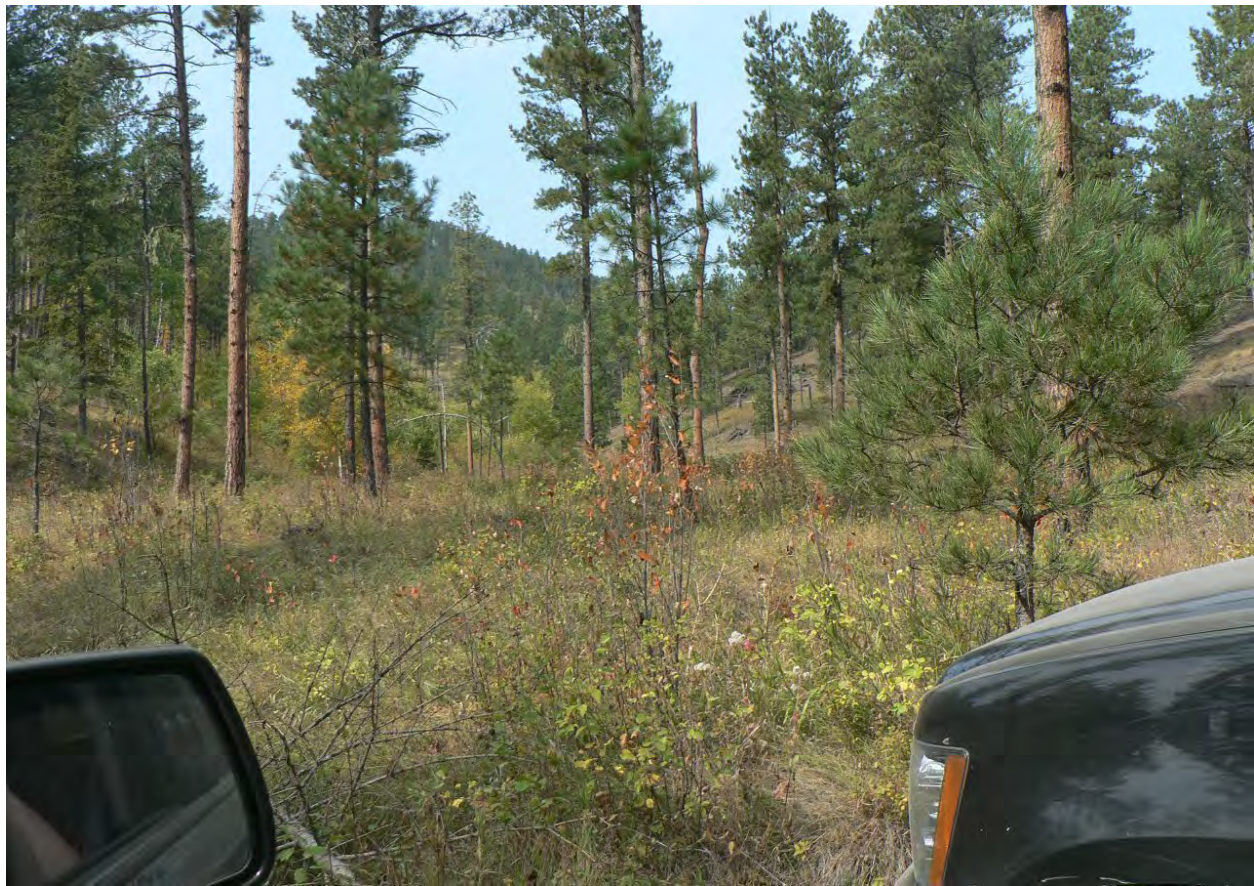
The group drove further on Sunnyside Gulch down to an intersection with an existing two track. The road itself was blocked. The proposed drill site was located at a distance from the vehicle but was ultimately visible on the edge of a large meadow area a little way down the track (photo 11). Due to time constraints and a greater interest to see the final two sites on this portion of the inspection trip, it was ultimately decided not to walk back to the proposed drill area. The terrain was noted to be gentle and there were minimal concerns in this area.

Photo 11. Proposed drill site located back near tree line.

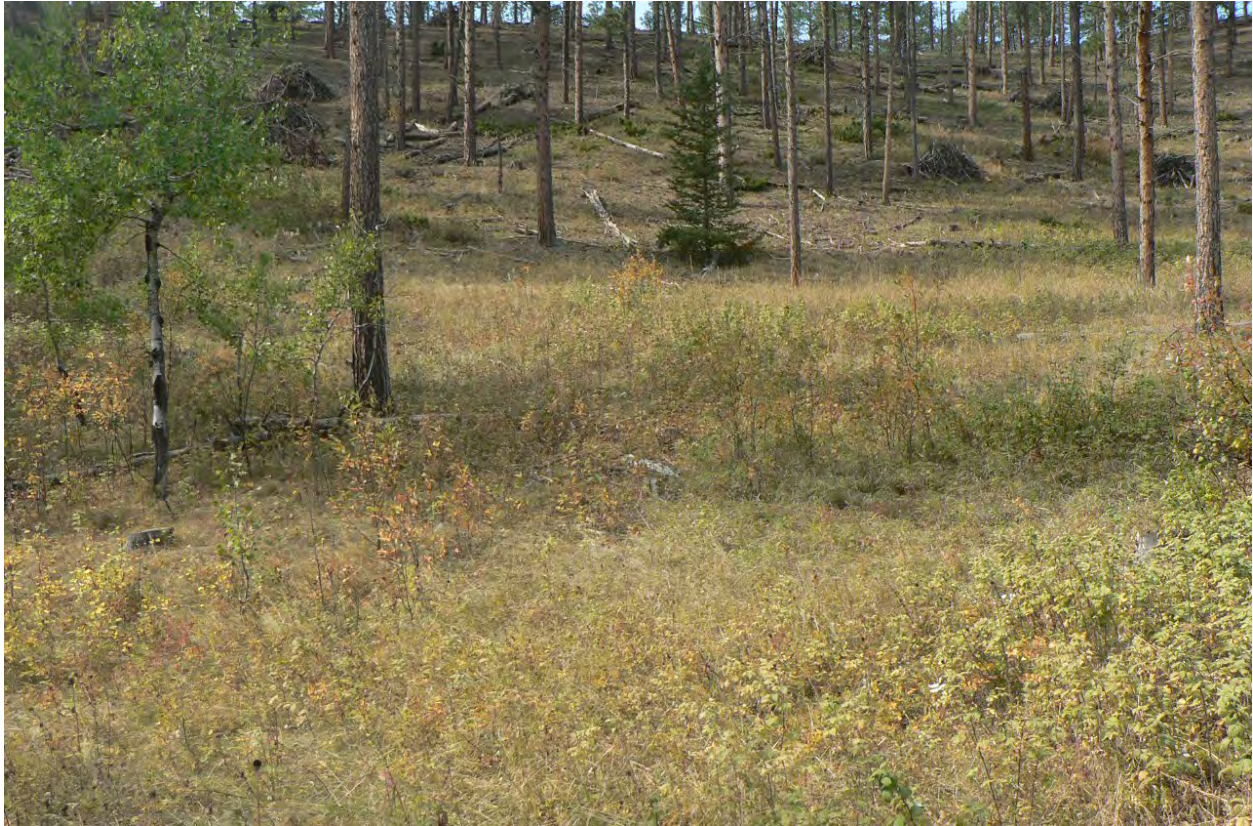
The next site was also located very near the road. It was located approximately halfway up the hill at the point where the shallower slope at the lower part of the hill then changed to a steeper grade (photo 12). No other concerns were noted with this site.

Photo 12. Proposed drill site about halfway up the hill.

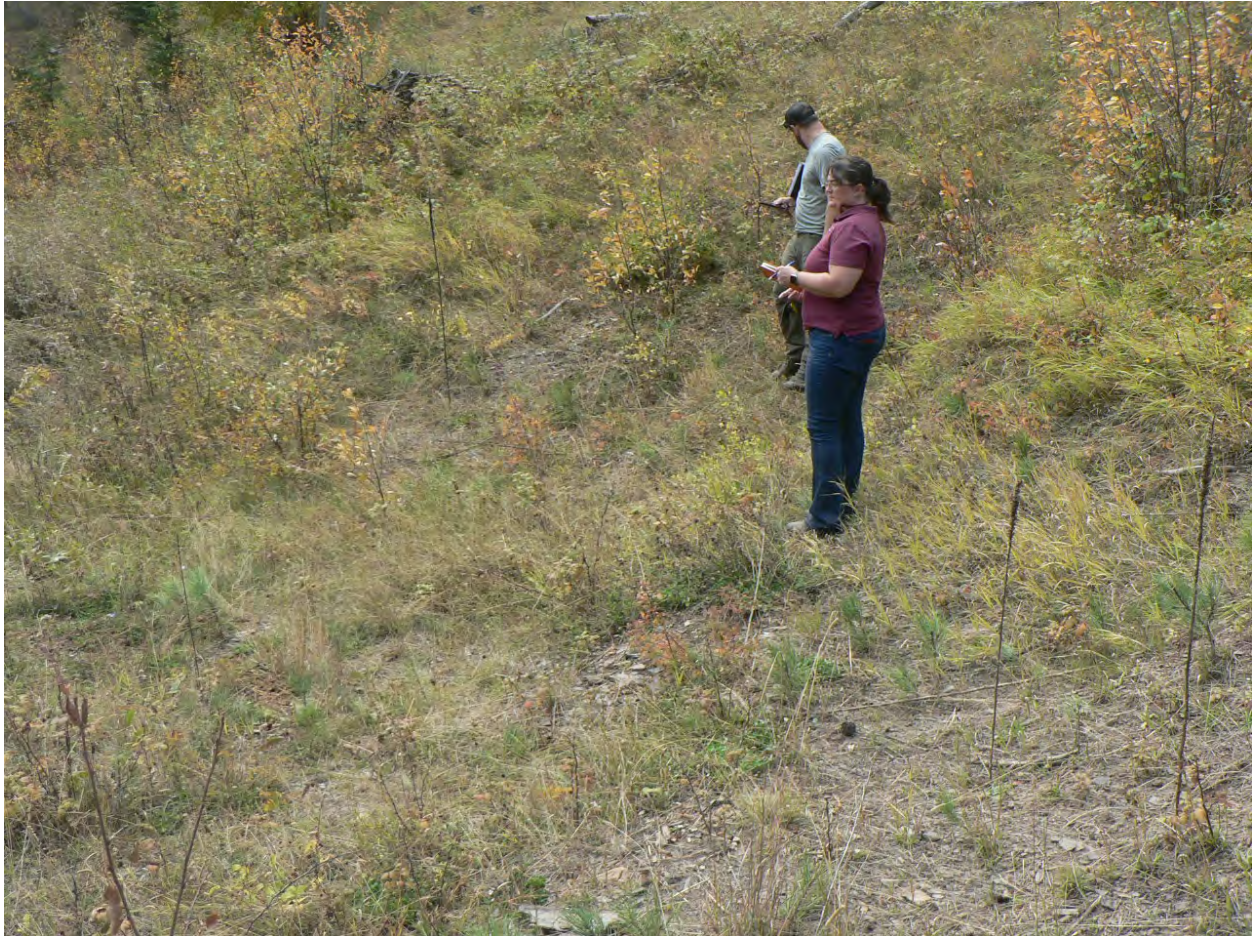
A road is to be constructed up over the top of the ridgeline and then roughly follow topography to the other side of a steep drainage. Concern was primarily associated with the proposed road and the second hole. At the top of the ridgeline, in the approximate location of the proposed roadway, the group came across a historic foundation or collared shaft. If it had been a shaft, it appeared to have been collapsed to within a few feet of the surface. A thin plywood board had been nailed over the top of the foundation area along with a thin black plastic layer. Boards, plywood and plastic were littered in the area immediately surrounding the foundation (photo 14). Upon inspection, this did not appear to be a site that had been previously recorded by other archeological assessments in the area. Ms. Hudson noted a narrow path coming up the hill side towards the foundation. The group then continued on the path another short distance. Mr. Williams and Mr. Lloyd recorded a couple more previously undocumented areas along the path, including a rock structure. Afterwards, we returned to the top of the hill and were looking at the

Photo 13. Proposed drill site.

proposed road construction area. We recommended the site and pathway discovered at the top of the hill be avoided by adjusting the road a respectable distance to the north to avoid disturbing the area.

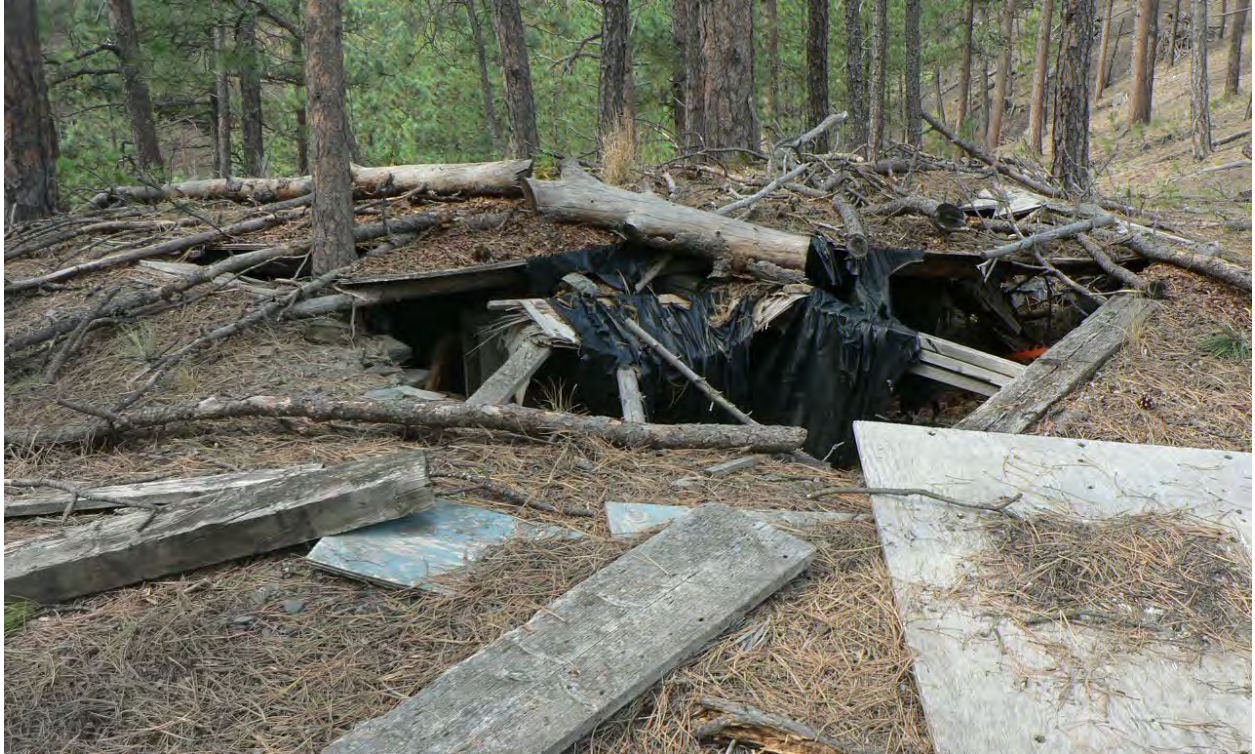
Photo 14. Historic foundation near proposed trail construction

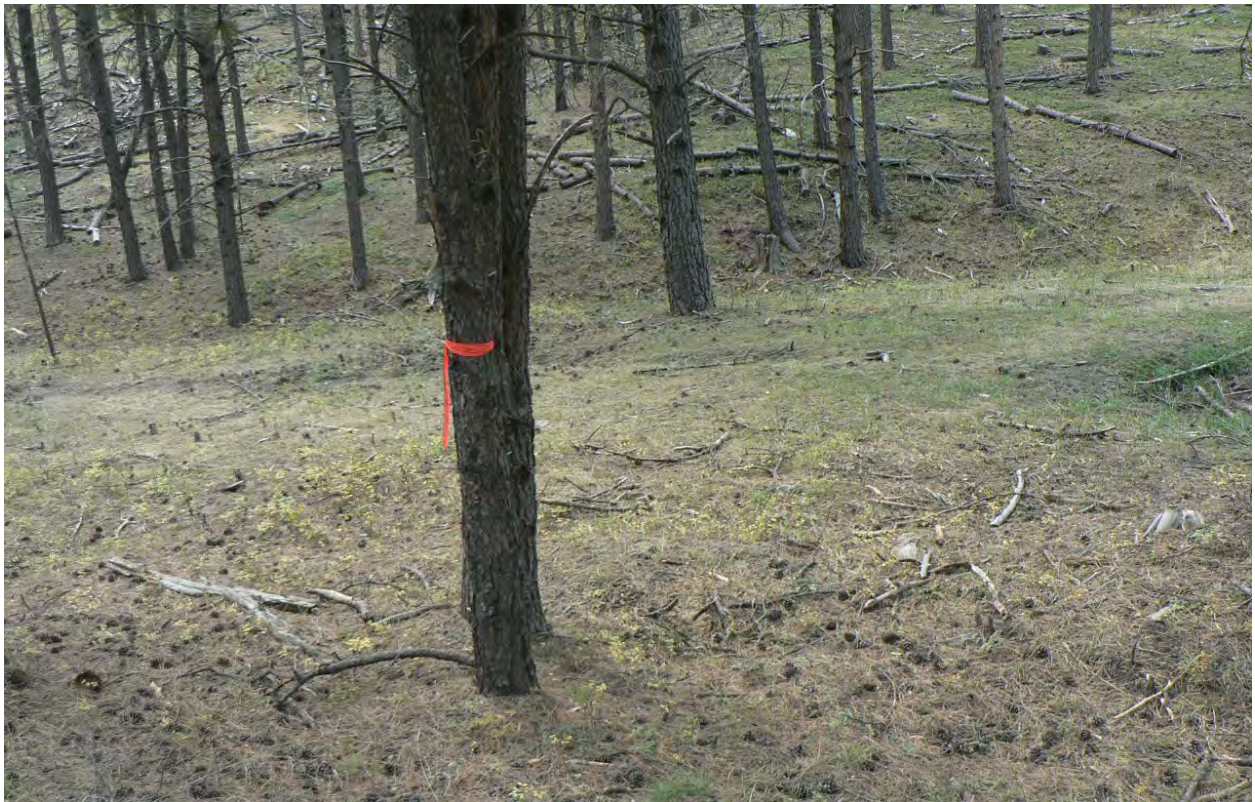
Photo 15. Flagged tree near proposed drill site.

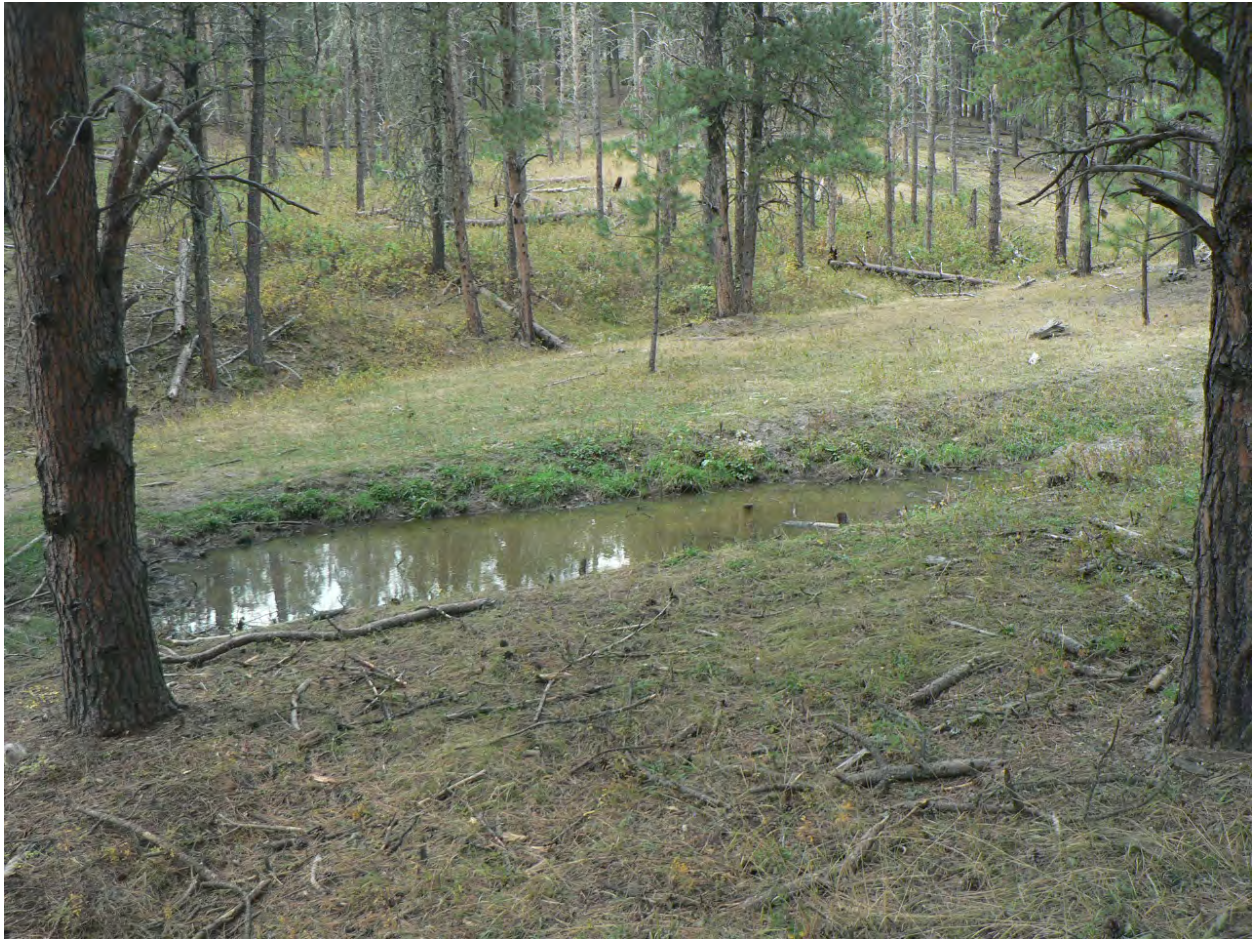
Photo 16. Small ponded area adjacent to proposed drill area.

This marked the end of the inspection for much of the group. Mr. Isakson was needed at another meeting and it was necessary for him to leave. As a result, the group separated upon returning to the vehicles. The final two sites were inspected by Eric Holm and Roberta Hudson. These sites were located to the north of the extent the group had already inspected along Jenny Gulch. The two sites were close to each other along the road. Both sites were found relatively easily, as they were marked by pink flags wrapped around trees. Both sites were located immediately adjacent to the road in a relatively flat drainage area (photo 15). One site was located adjacent to a small ponded area (photo 16). There should be minimal concern with erosion and sediment controls in these areas, though effort should be made to maintain any sumps away from the depressions noted in the area where there may be or is normal ponding of water.
