**PRELIMINARY ENGINEERING REPORT**  
**FOR THE**  
**DRINKING WATER SYSTEM**  
**IN**  
**BUFFALO GAP, SOUTH DAKOTA**

**Project Number: A-7515**

**September 2021**  
**February 2022**

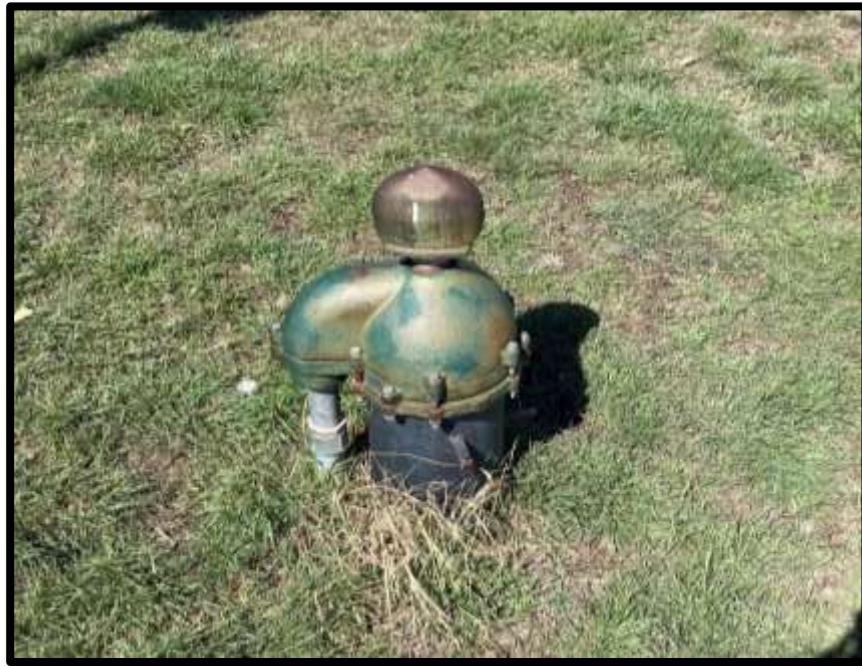
Well #1 and Well #2 has not been returned to use since. Both wells draw water from the Inyan Kara formation. The well water is disinfected before being pumped into the ground storage tanks and then distributed to town. The water is tested and meets the requirements set forth by the SDDANR. A copy of the 2019 and 2020 drinking water reports are included in Appendix B of this report. Currently the water from the well meets all requirements to be considered safe for public consumption. However, the amount of Uranium present in the water is dangerously close to the limits allowable. If in the future the Uranium levels continue to climb, the Town may have to consider other possible water sources.

**Figure 3.4.1-1: Well #2 (Not in Use)**

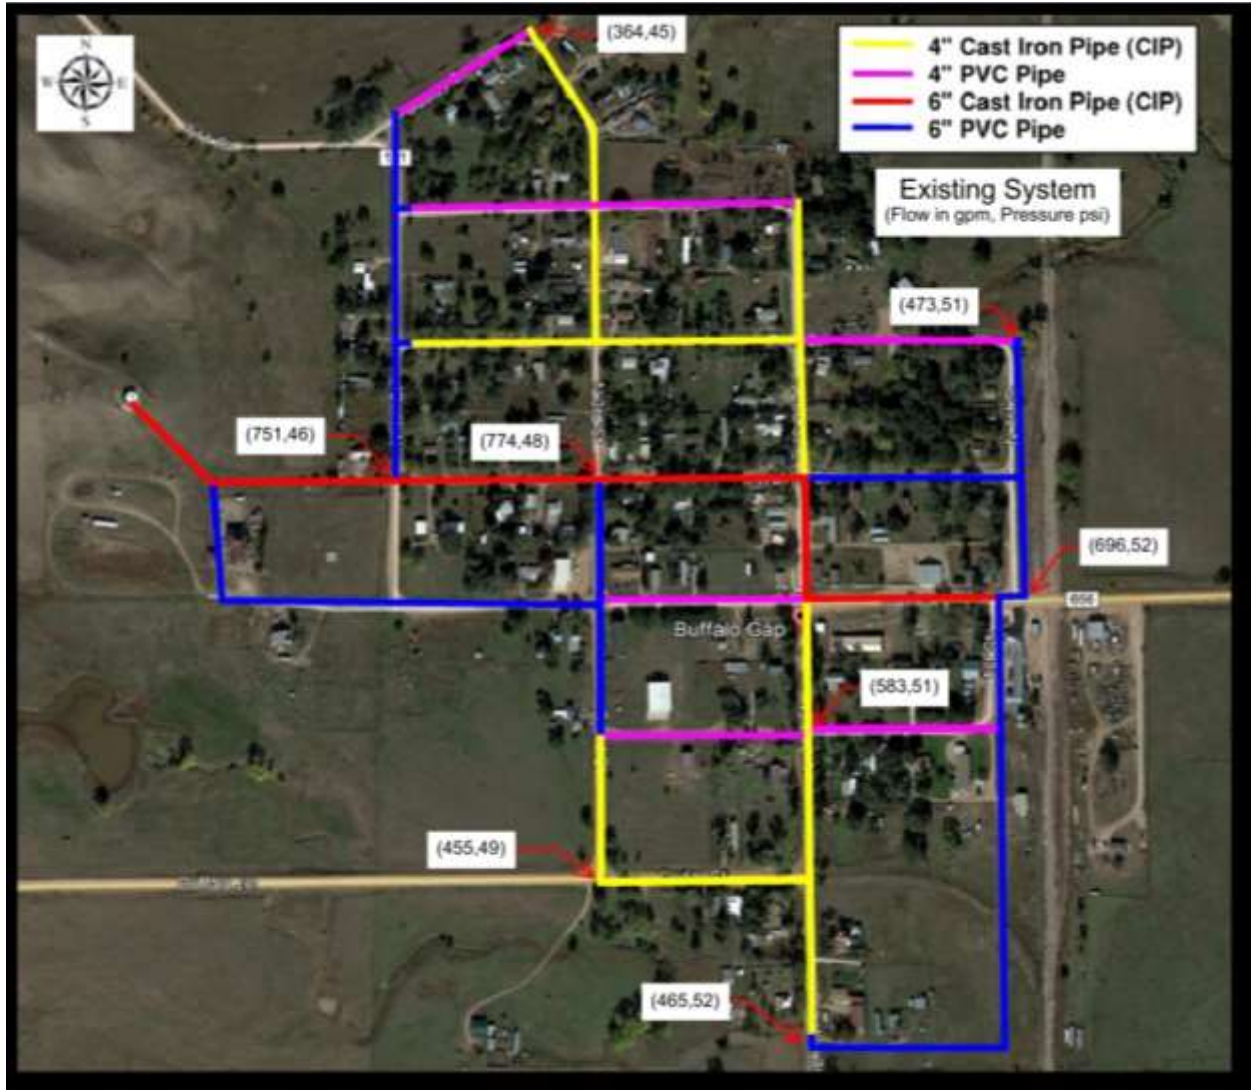
**Figure 3.6.4-1: Existing System Model**

Using data from both field testing and the maps, the system was modeled using the KYPipe 2020 program. Figure 3.6.4-1 shows the existing system model with calculated flows and pressures at different hydrants locations. Parameters of the system were altered to model the system to match the field conditions as best as possible. This model will be used to re-analyze the system with proposed improvement alternatives added.

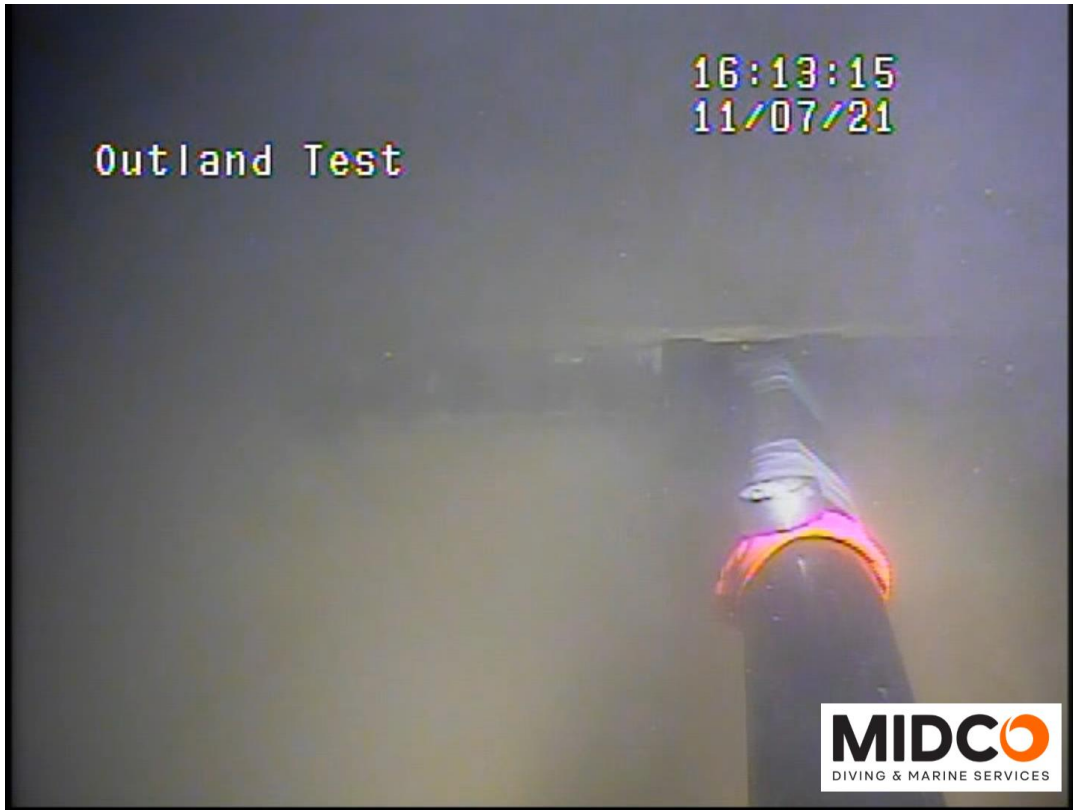
1. Up to 3" of sediment noted.
2. High turbidity noted upon tank entry.
3. Areas of corrosion noted.

**Cleaning Reservoir – High Turbidity Noted Upon Entry**

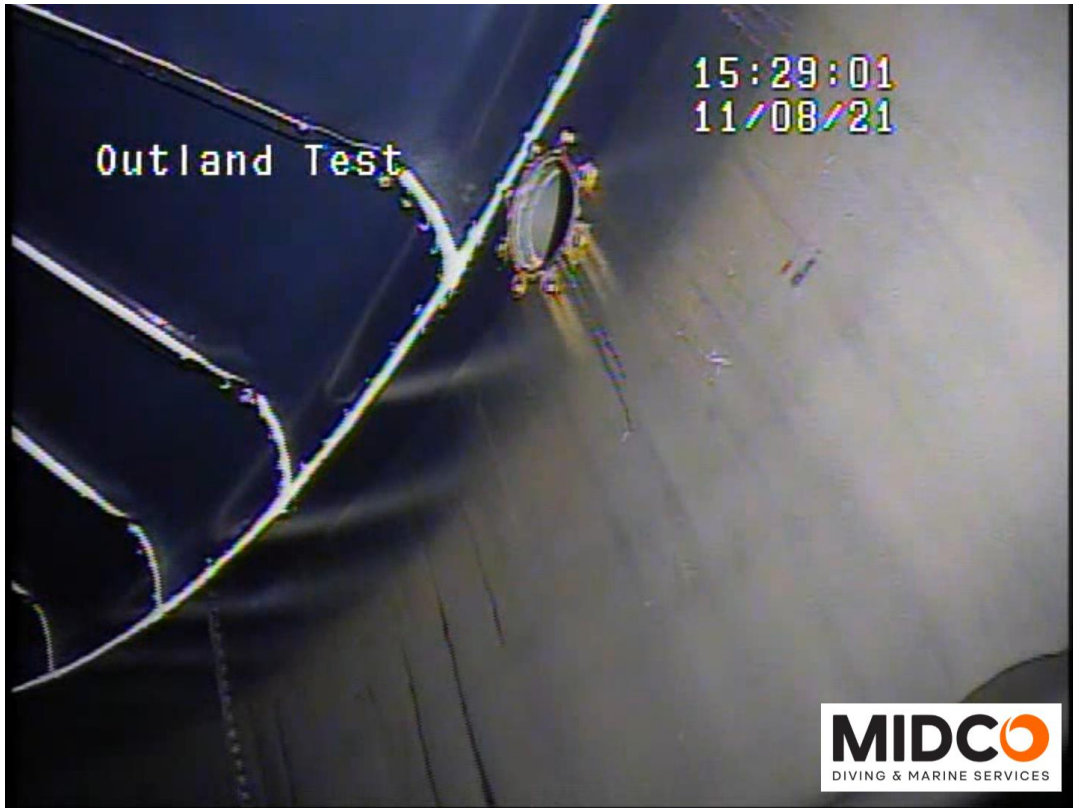
**Wall to Roof Seam and Overflow – Corrosion Noted**

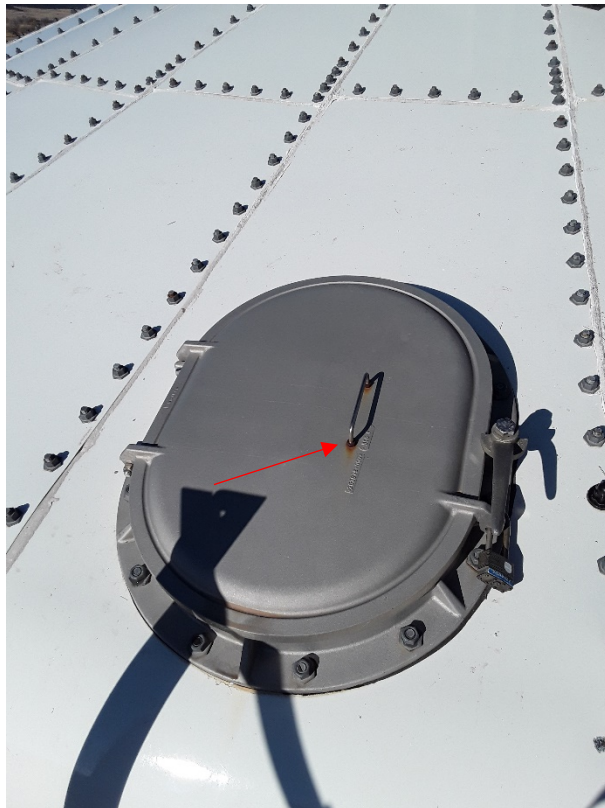
1. The overflow screen is not #24 corrosion resistant mesh.
2. The overflow does not discharge at least 12"-24" above the splash plate.
3. Hardware corrosion noted on the access hatch.
4. Roof vent deterioration noted.

**Access Hatch – Hardware Corrosion Noted**

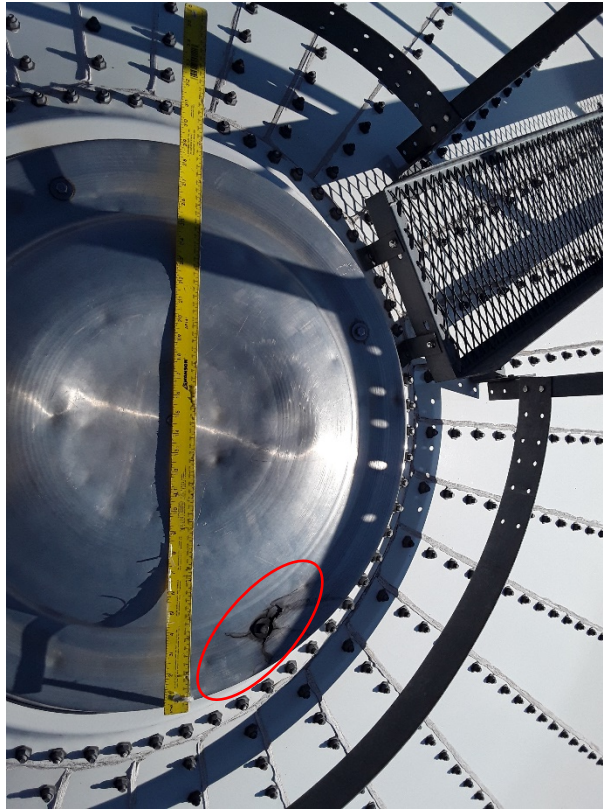
**Roof Vent – Deterioration Noted**

1. Install #24 corrosion resistant mesh on the overflow.
2. Correct the overflow to discharge at least 12"-24" above the splash plate.
3. Monitor/repair the roof vent due to noted deterioration.
4. Monitor/repair noted corrosion.
5. Consider having Midco Diving & Marine Services, Inc., install a PAX Water Mixer.
6. Have Midco Diving & Marine Services, Inc. clean & inspect every 3 years or less.

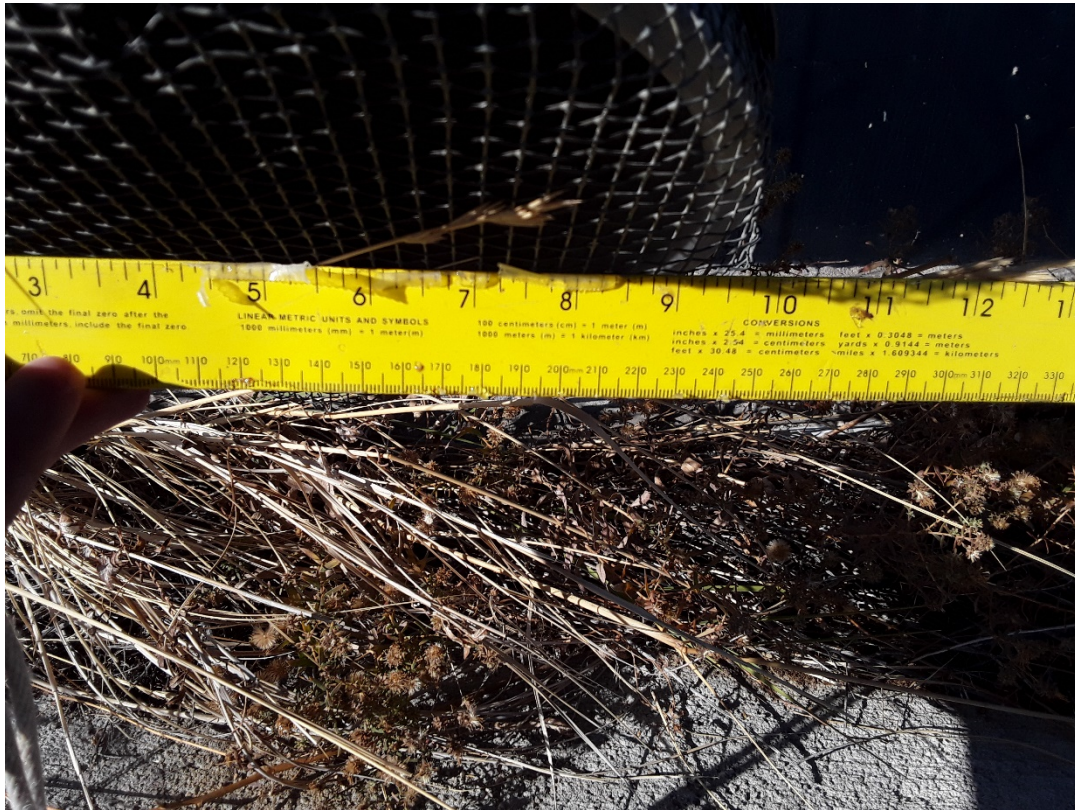
**Overflow Screen – Not #24 Mesh**

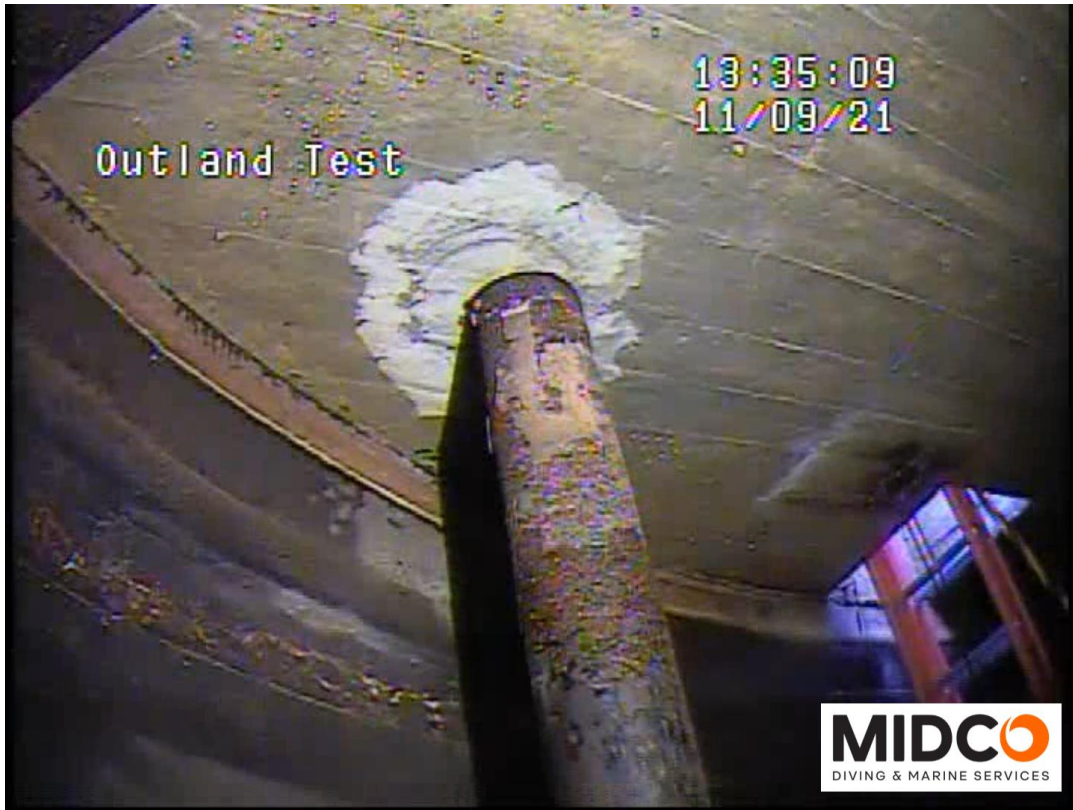
**Overflow Plumbing – Corrosion Noted**

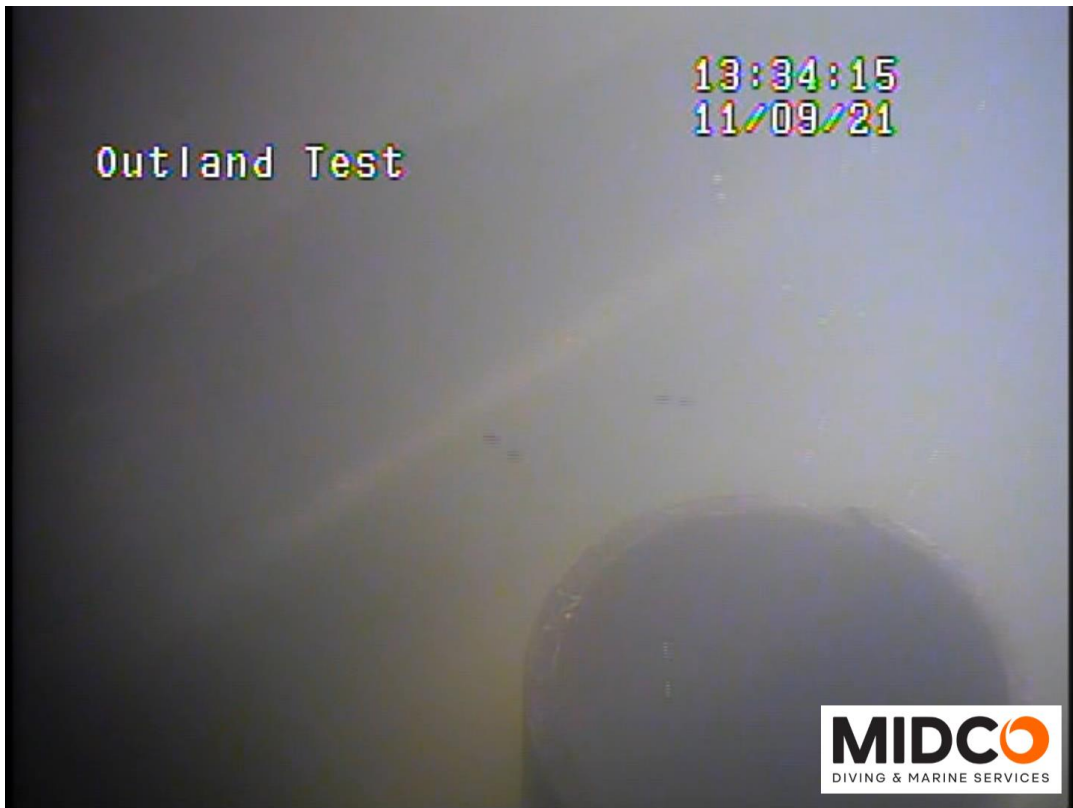
**Common Inlet/Outlet – Corrosion Noted**

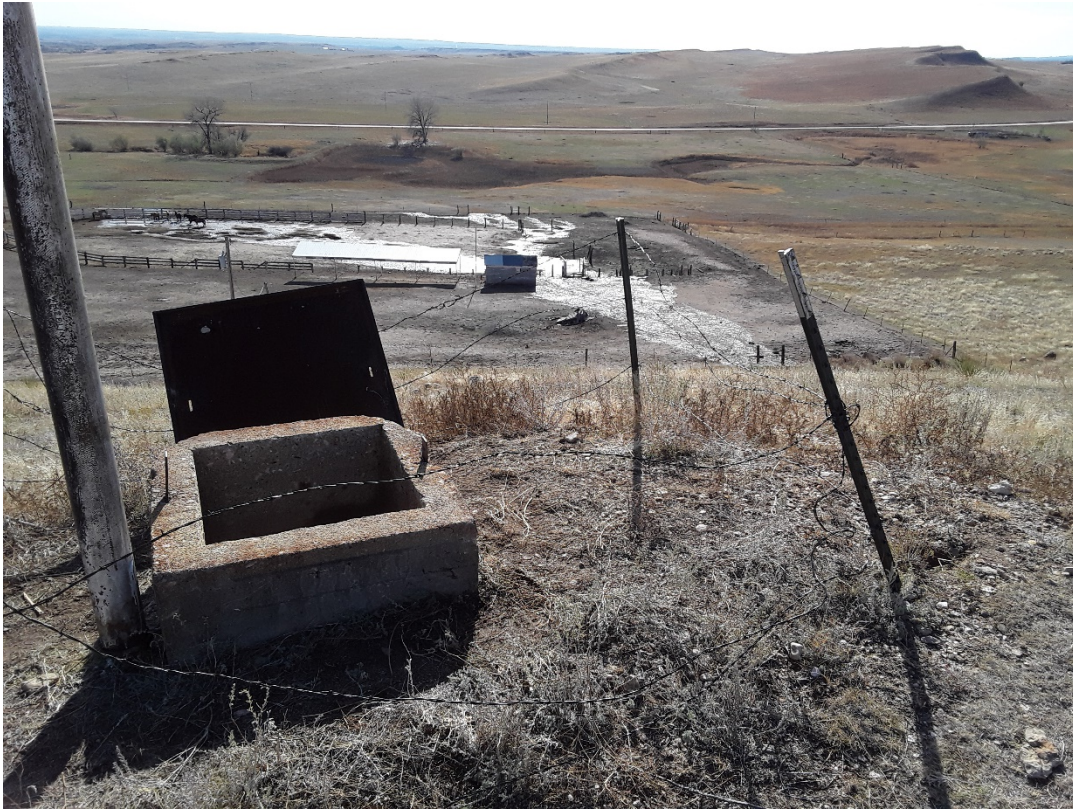
**Access Hatch – No Weather Stripping Noted**

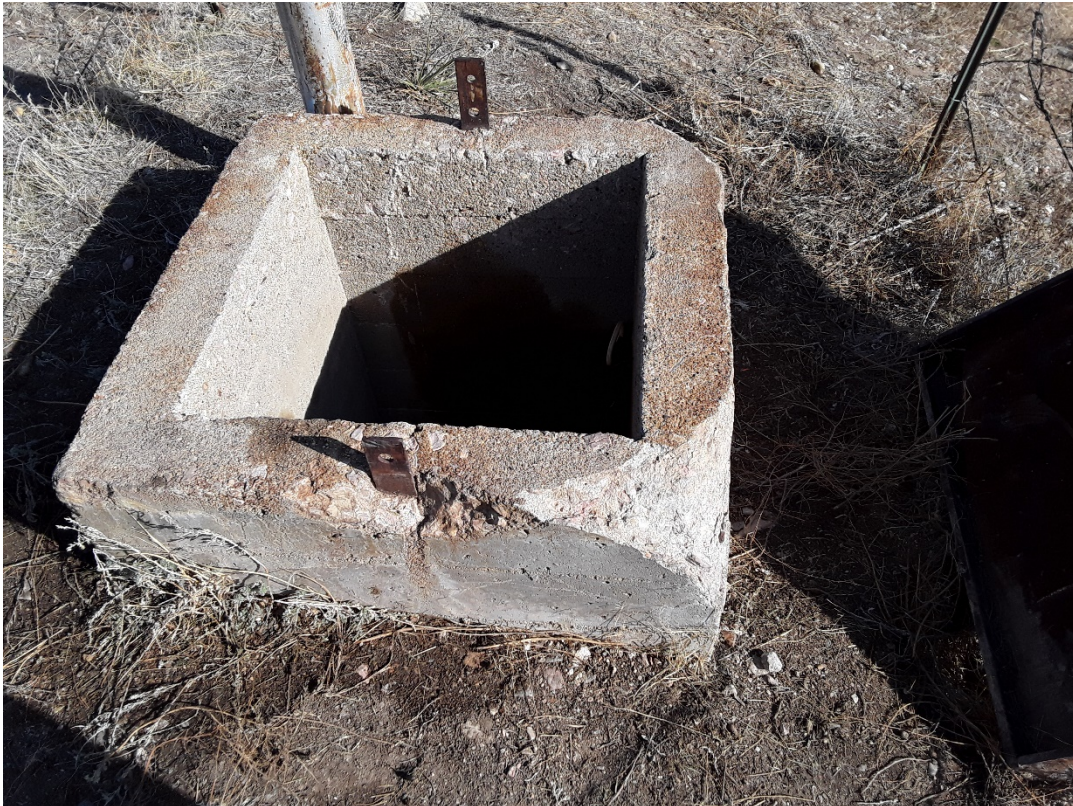
1. Roof Vent deterioration noted.
2. The overflow screen is not #24 corrosion resistant mesh.
3. The overflow does not discharge 12"-24" above the rip-rap.
4. Debris noted around the overflow.
5. No weather stripping noted on the access hatch.
6. The access hatch does not sit at least 24" above the ground surface.
7. The access hatch does not have a shoe box lid.
8. Areas of corrosion noted.
9. Spalling noted in the access hatch.

**Access Hatch – Spalling Noted**

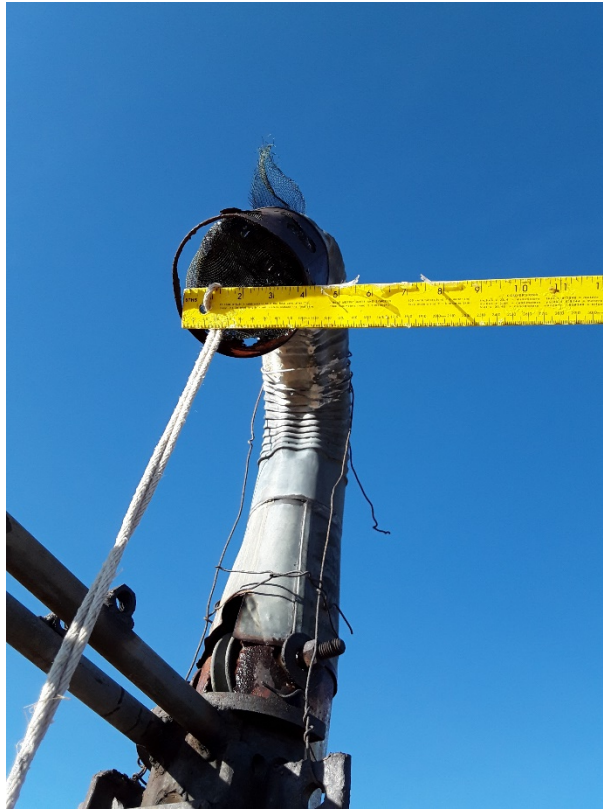
**Roof Vent – Deterioration Noted**

1. Repair/replace the roof vent.
2. Install #24 corrosion resistant mesh on the overflow.
3. Correct the overflow to discharge 12"-24" above the rip-rap.
4. Clear out the debris from around the overflow.
5. Correct the access hatch to sit at least 24" above the ground with a shoe box lid.
6. Install weather stripping on the access hatch.
7. Monitor/repair noted spalling.
8. Monitor/repair noted corrosion.
9. Consider having Midco Diving & Marine Services, Inc., install a PAX Water Mixer.
10. Have Midco Diving & Marine Services, Inc. clean & inspect every 3 years or less.

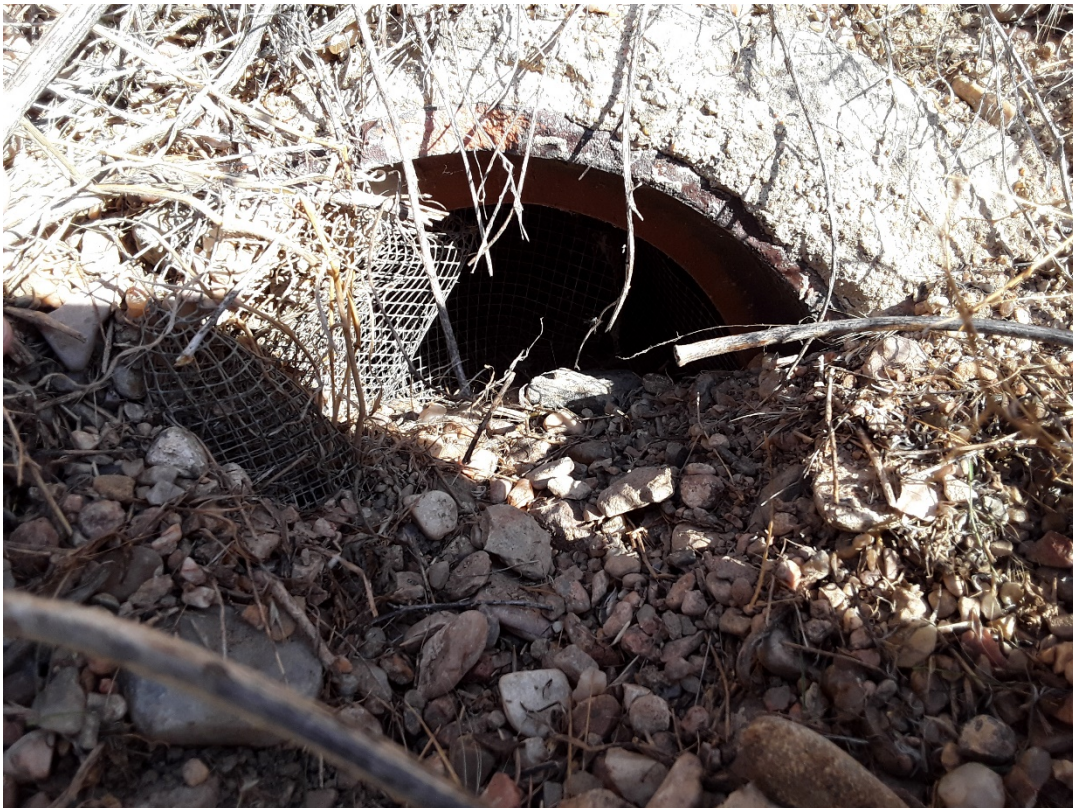
**Overflow Plumbing and Screen – Screen Deterioration & Debris Noted**
