**Removal of Certain
Classified Impoundments
From
Administrative Rules of South Dakota
Chapter 74:51:02**

October 2022

**South Dakota
Department of Agriculture and Natural Resources
Office of Water
Pierre, South Dakota**

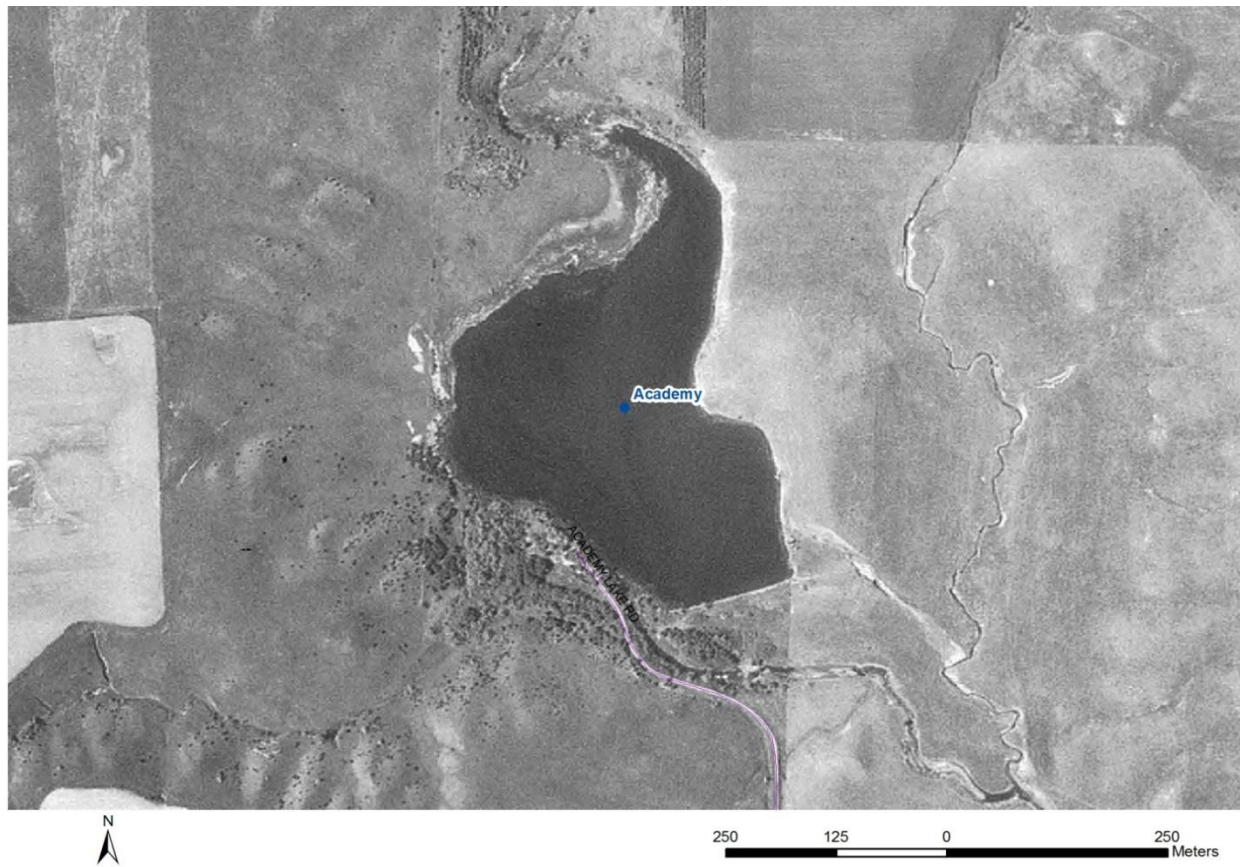
Figure 2. DOQ image of Academy Dam in 1996 shows lake at full pool prior to breach formation.

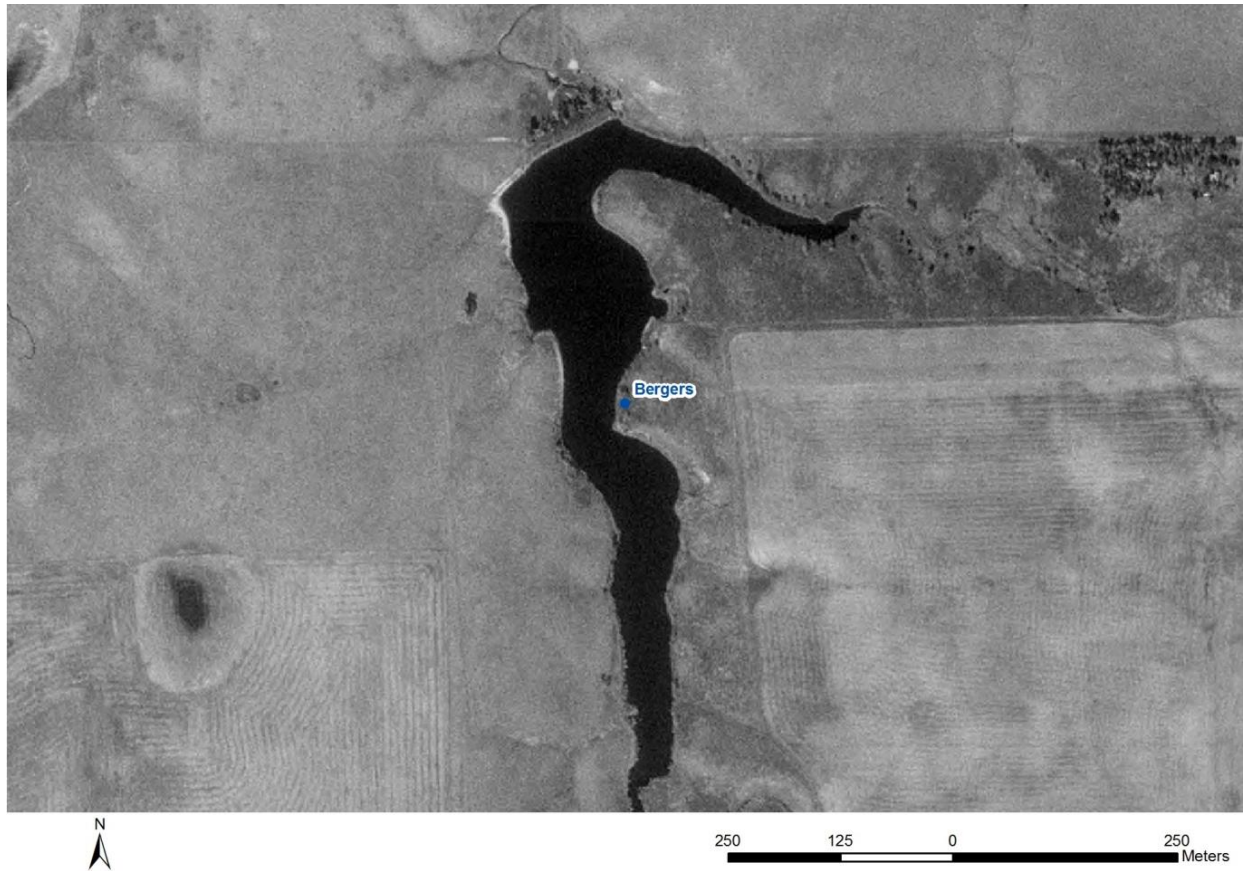
Figure 6. DOQ of Bergers Dam in 1996 shows lake at full pool prior to breach.

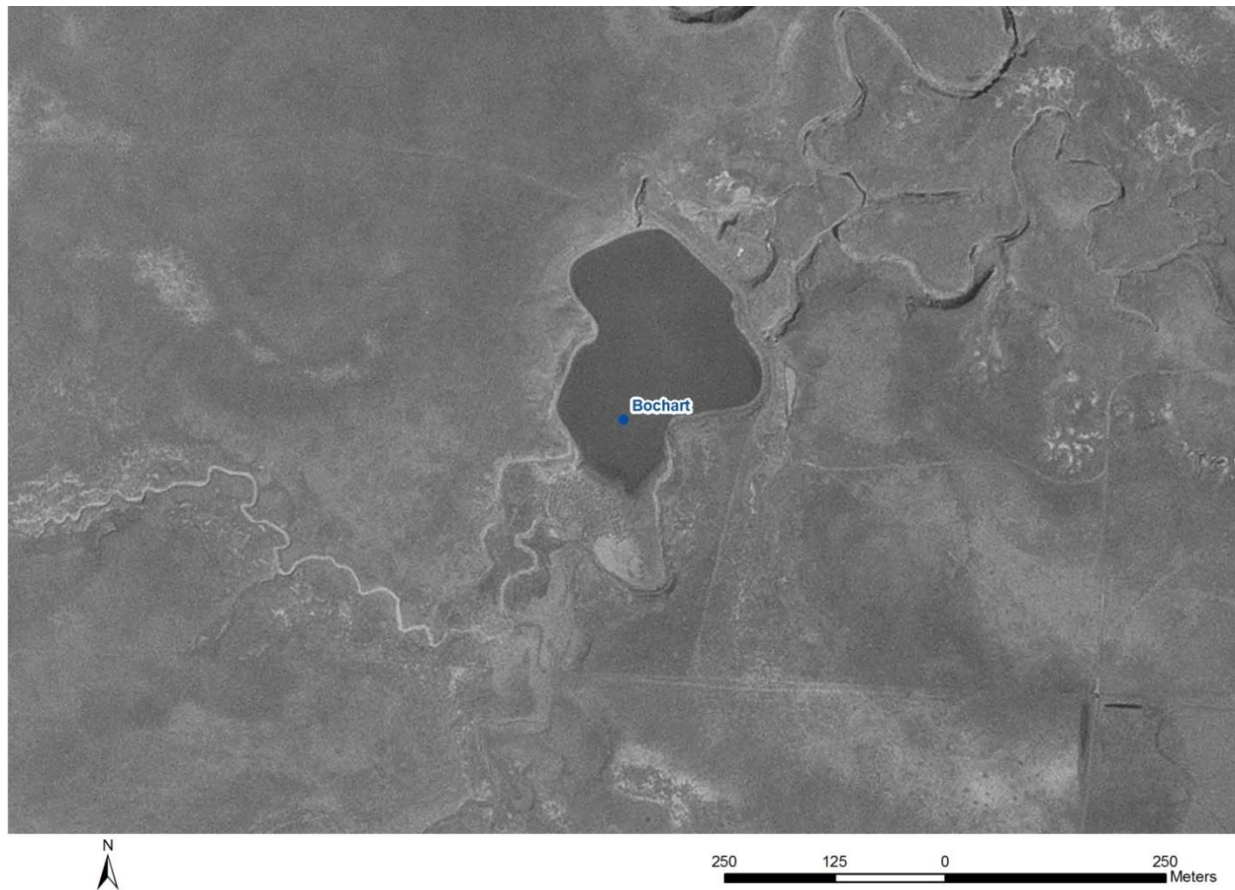
Figure 10. DOQ image of Bochart Dam in 1997 shows lake with partial pool and developing breach.

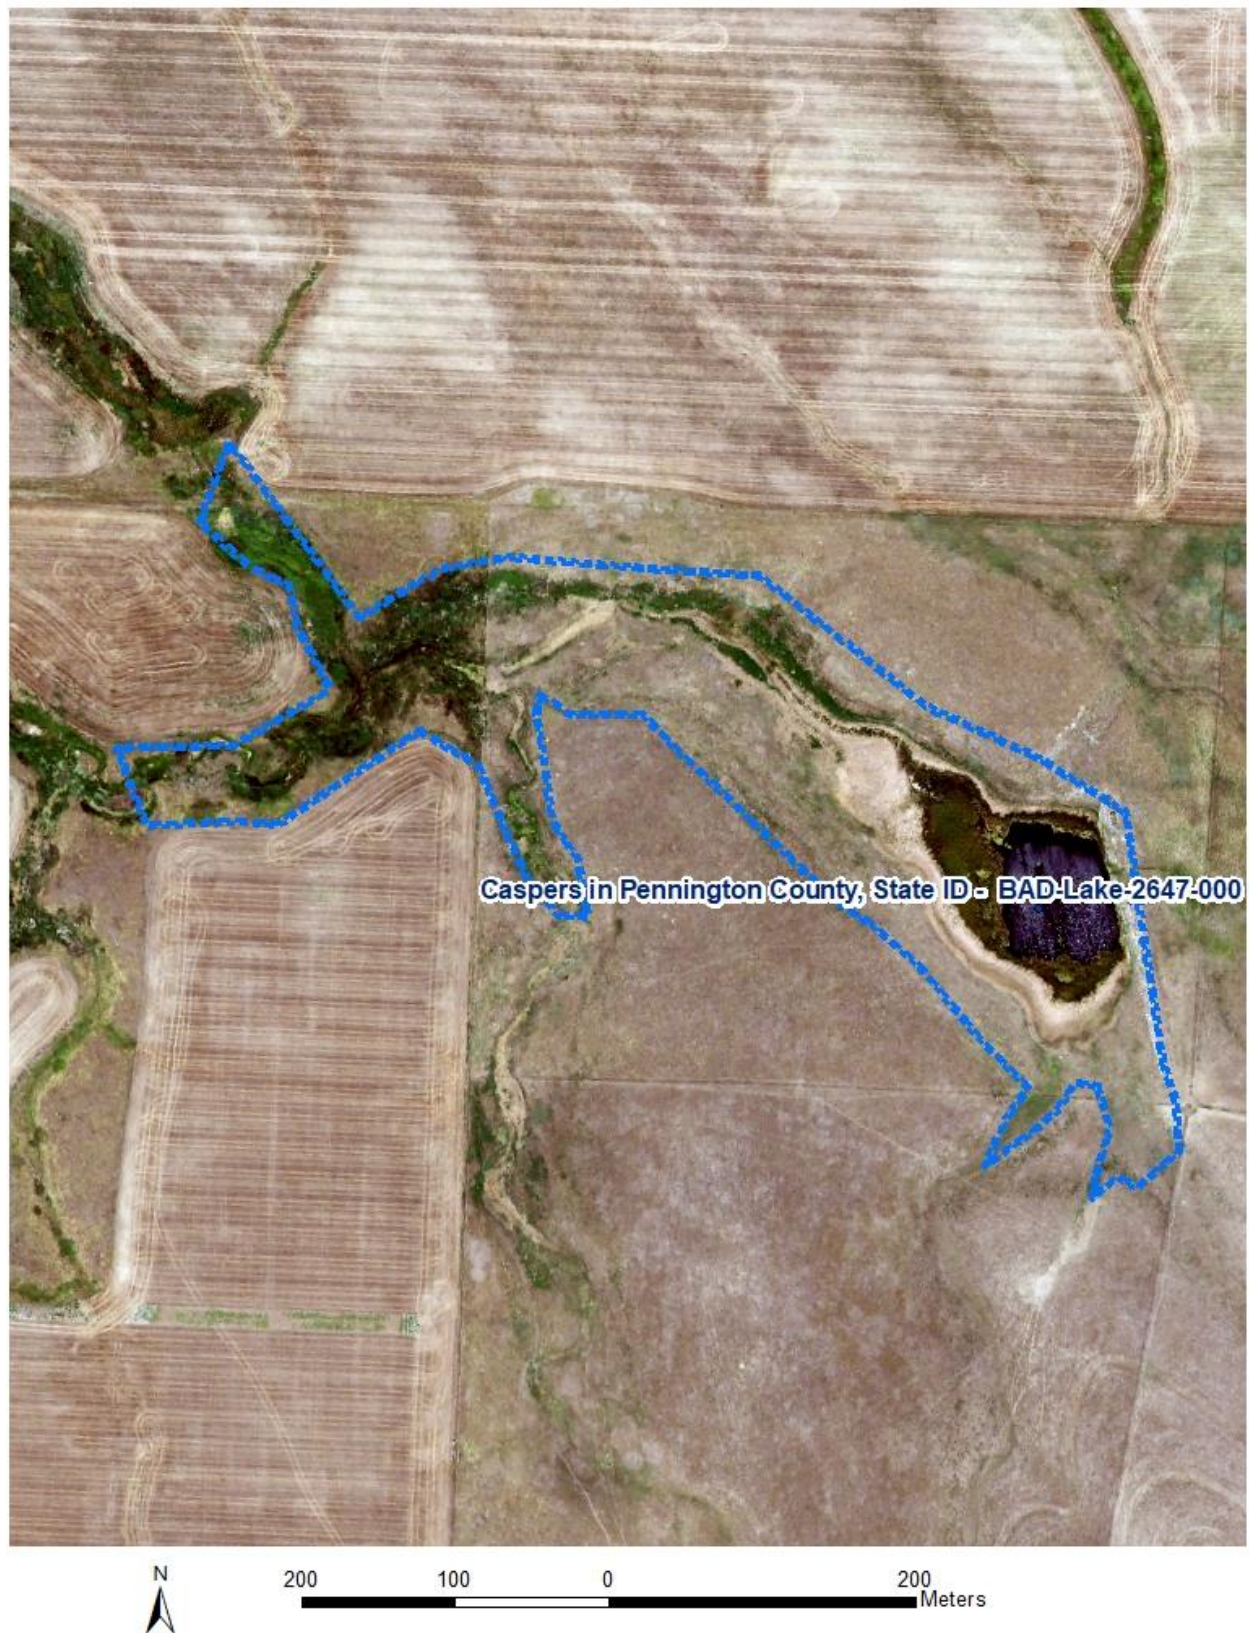
2020 NAIP Imagery with outline of basin and remnant pool 150 feet in width.

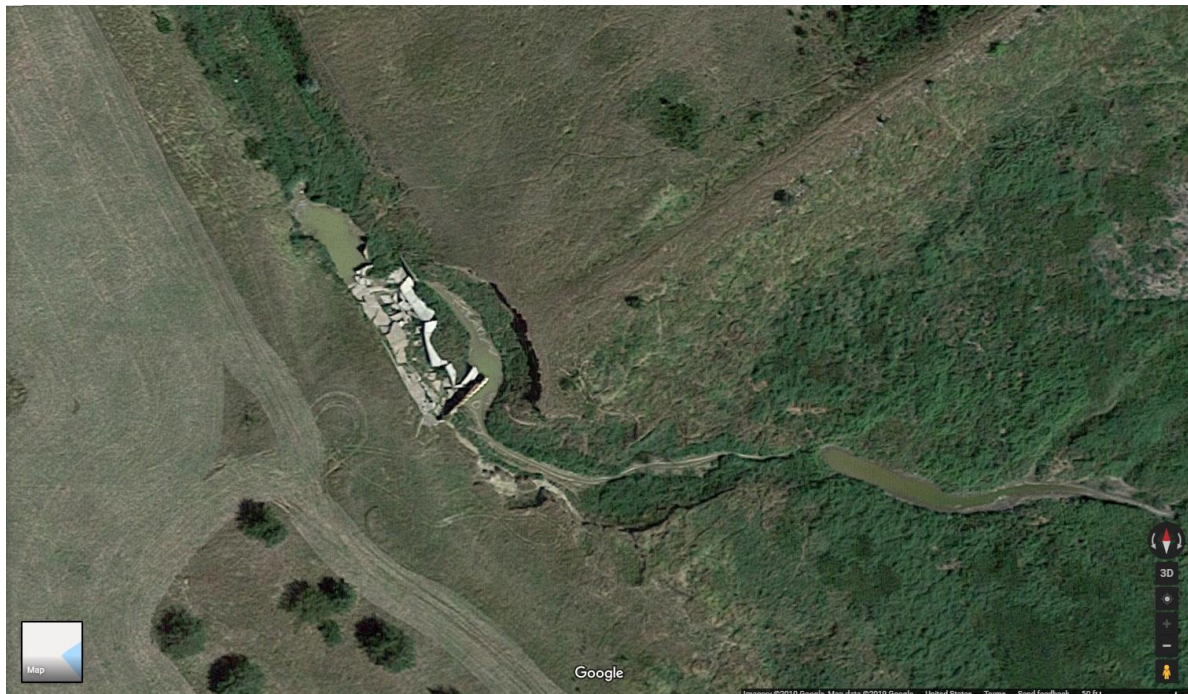
Figure 27. Google image of failed concrete spillway on Burch Dam (Google, 2015)

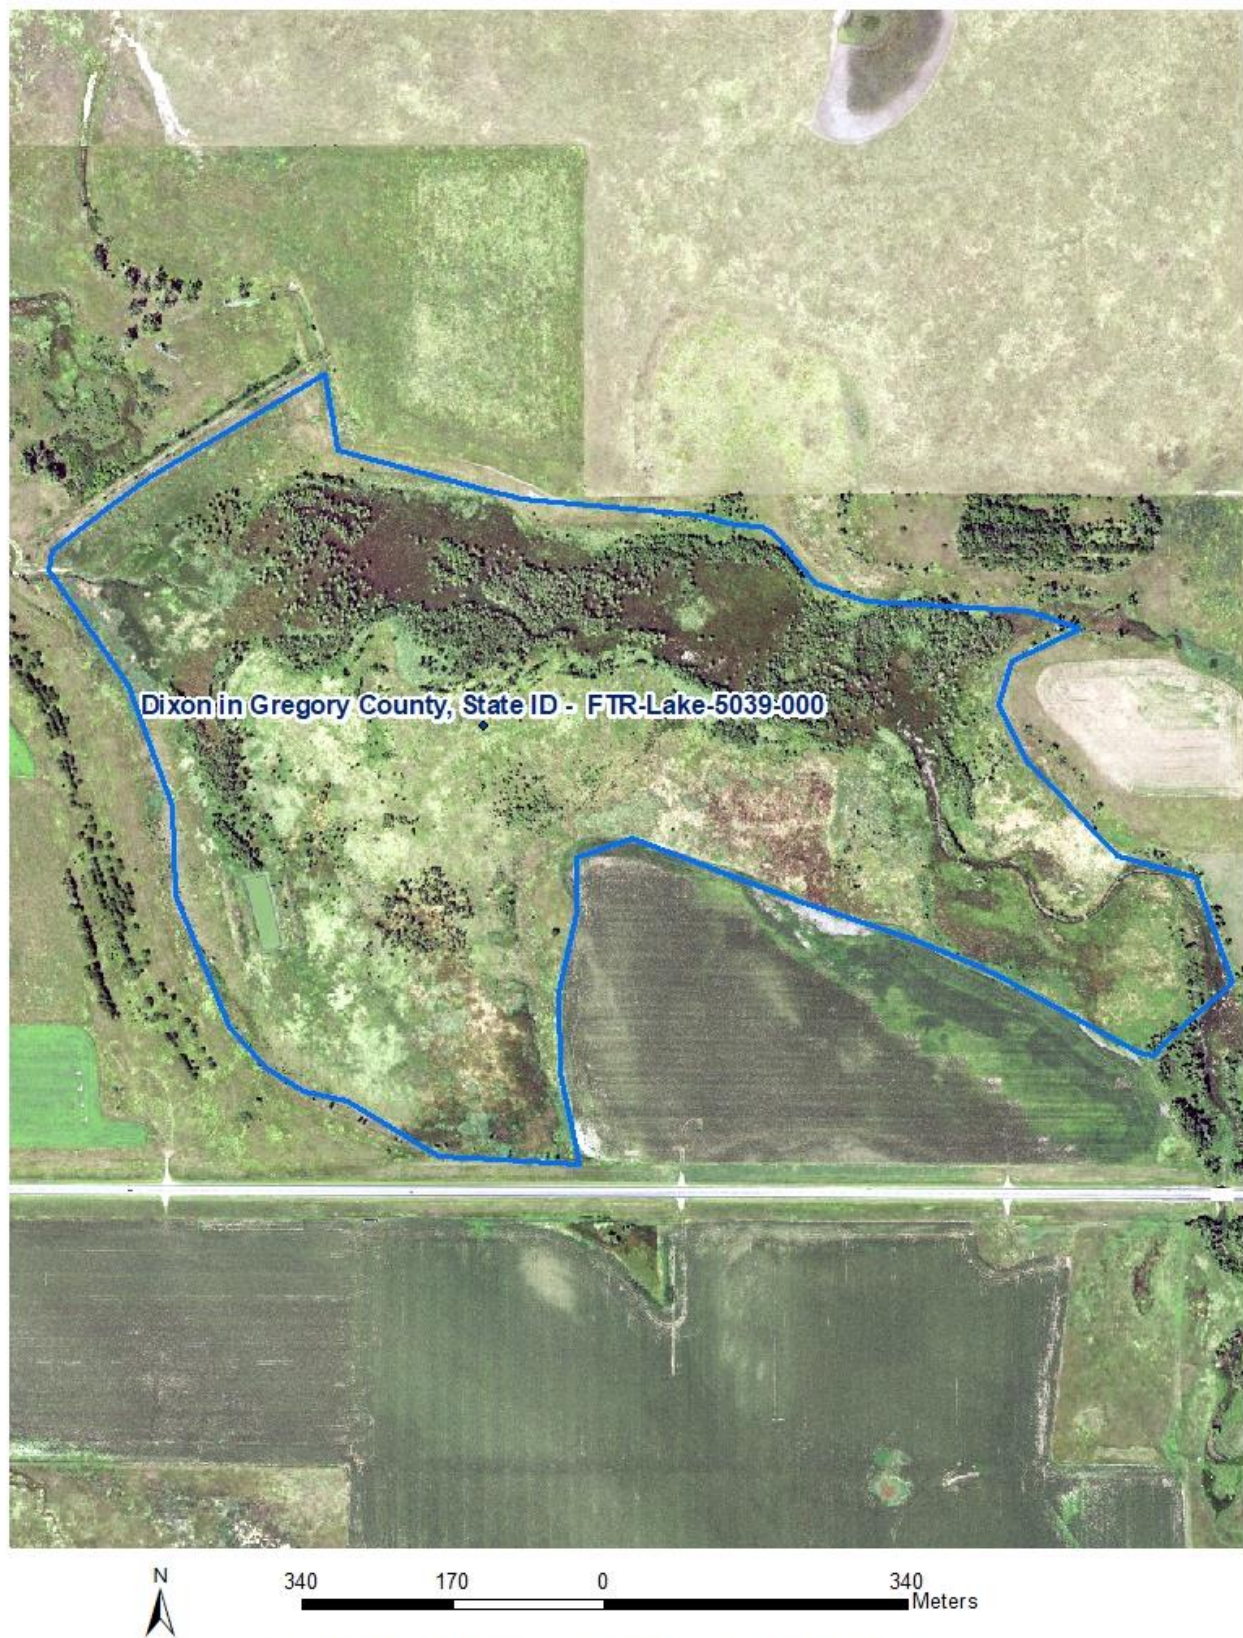
Figure 29. 2020 NAIP imagery of Dixon Lake in Gregory County. Blue outline represents the extent that water was present prior to the dam breach and lake draining.

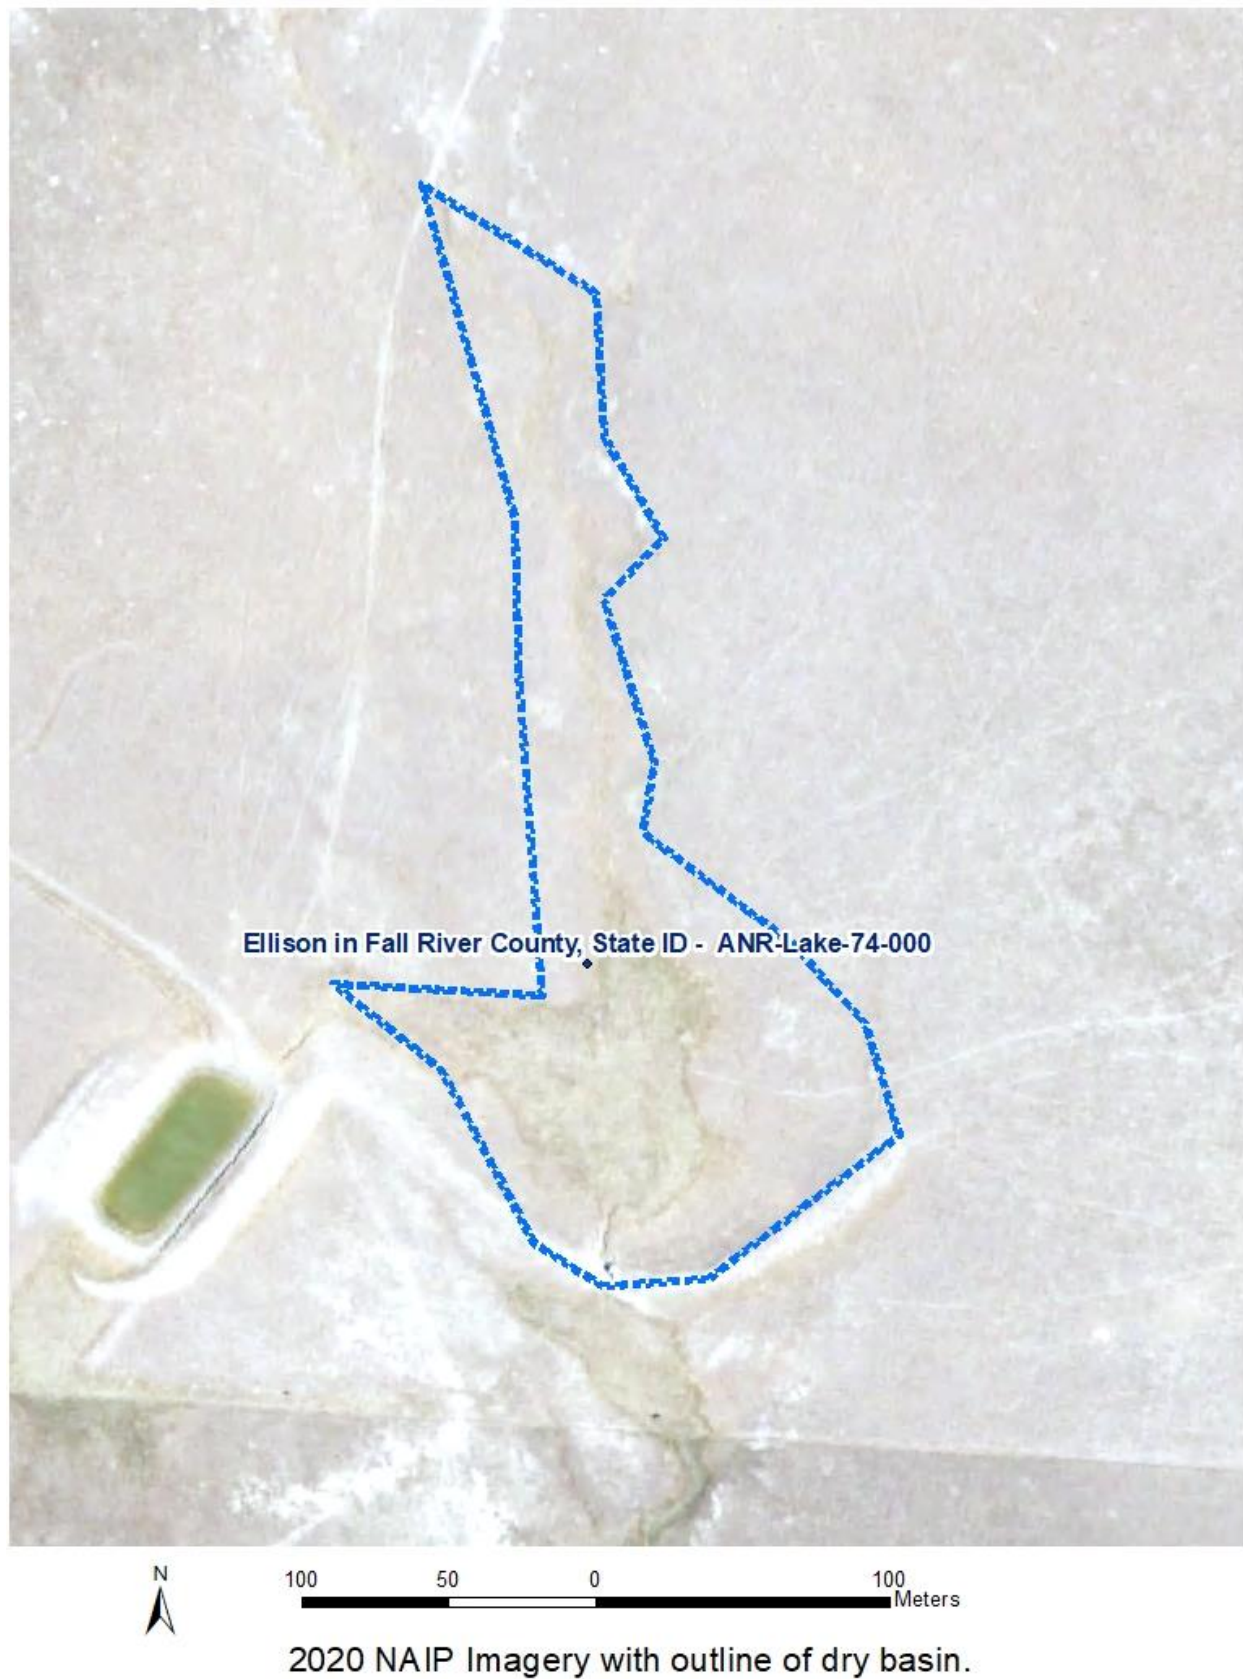
Figure 33. 2020 NAIP imagery of Ellison Lake in Fall River County. Blue outline represents the extent that water was present prior to the dam breach and lake draining.

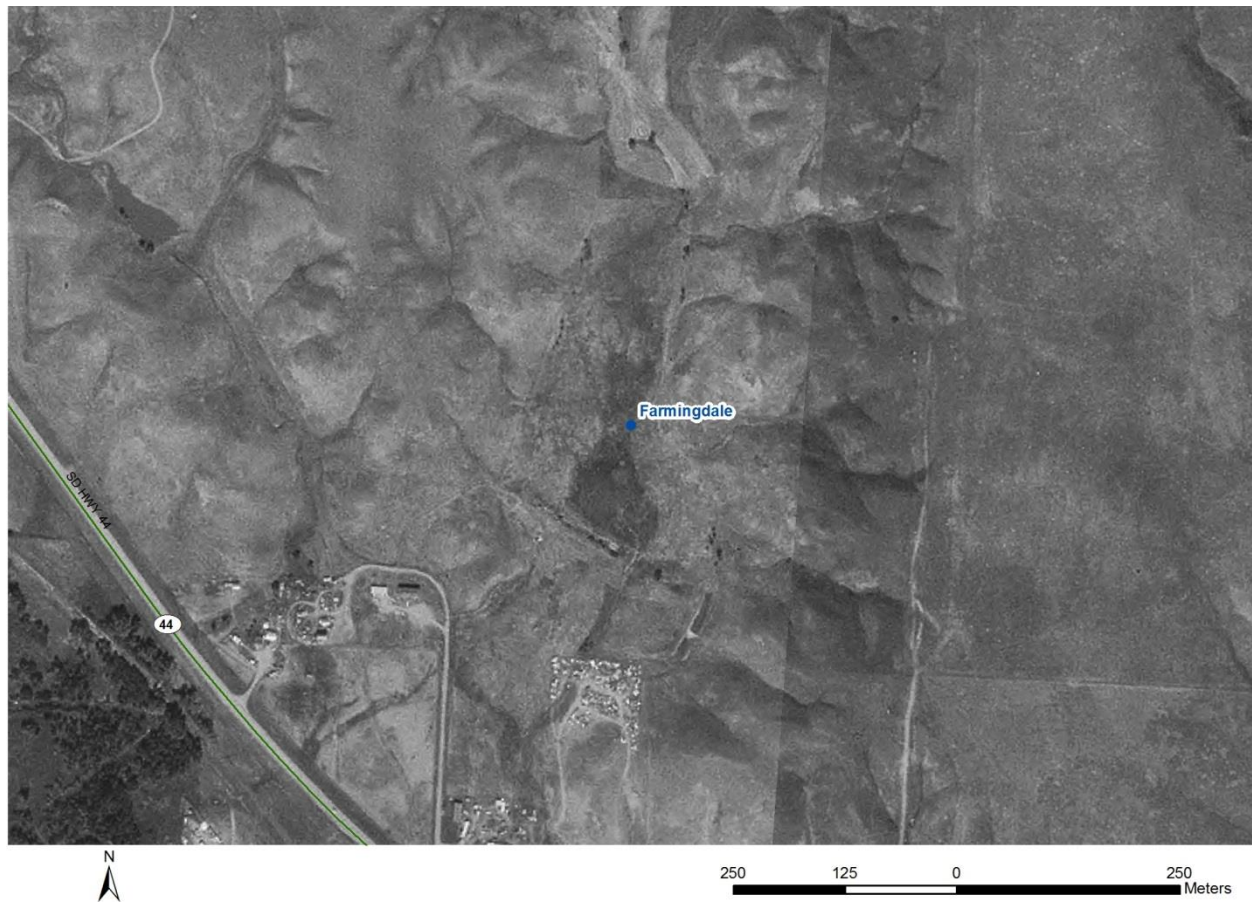
Figure 34. DOQ image of Farmingdale Dam already breached in 1997

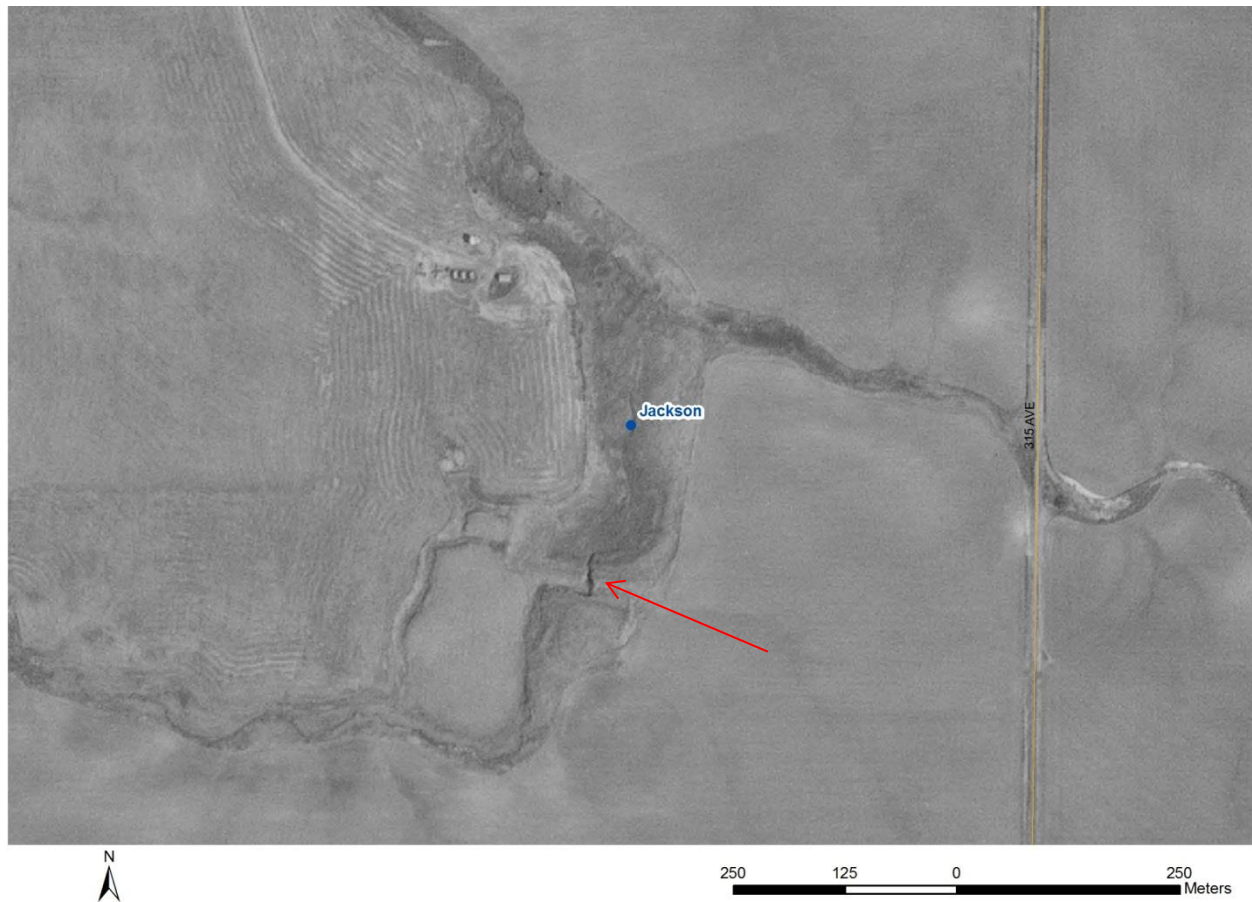
Figure 50. DOQ image of Jackson Dam from 1991 with the dam already breached.

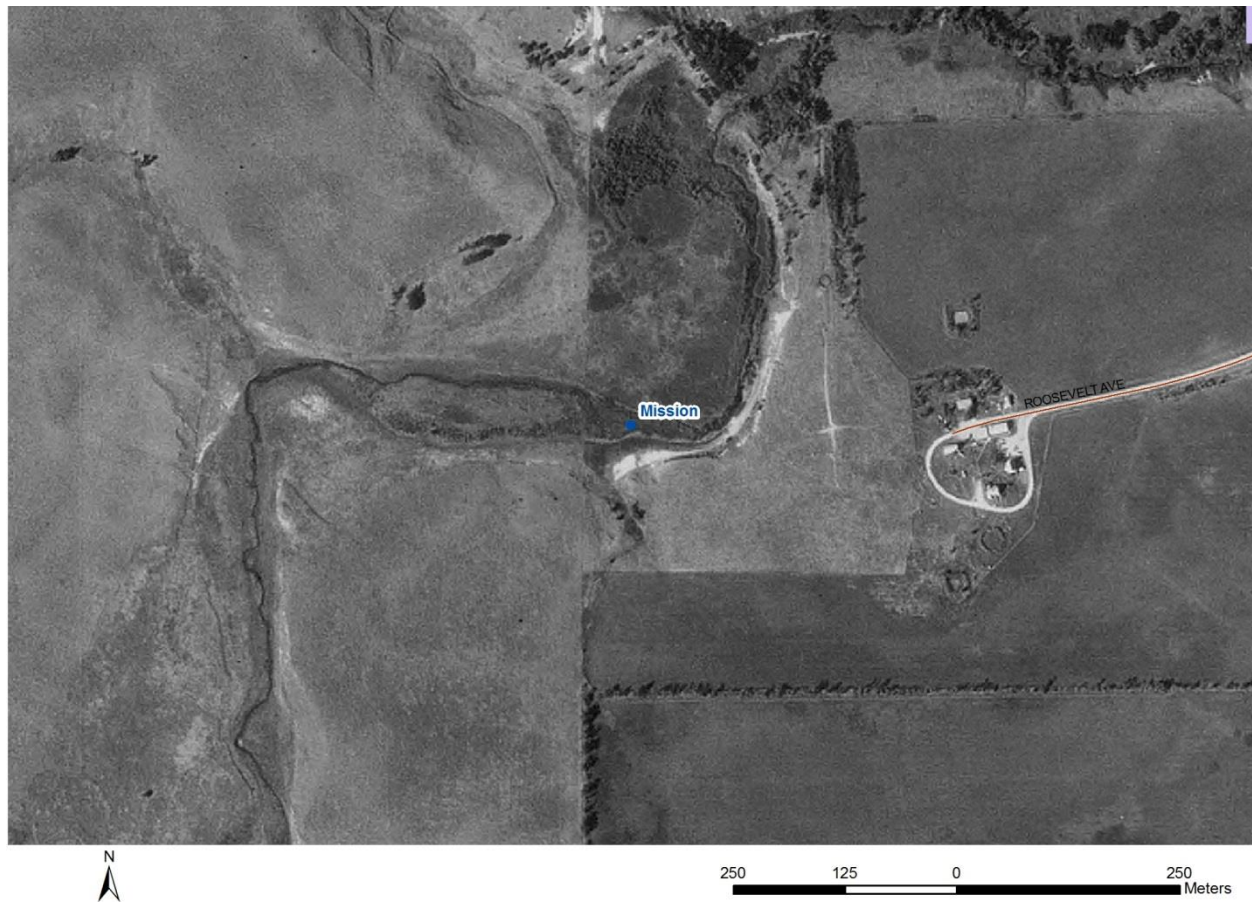
Figure 58. DOQ image of Mission Dam from 1997, breach and trees in lakebed are already present.

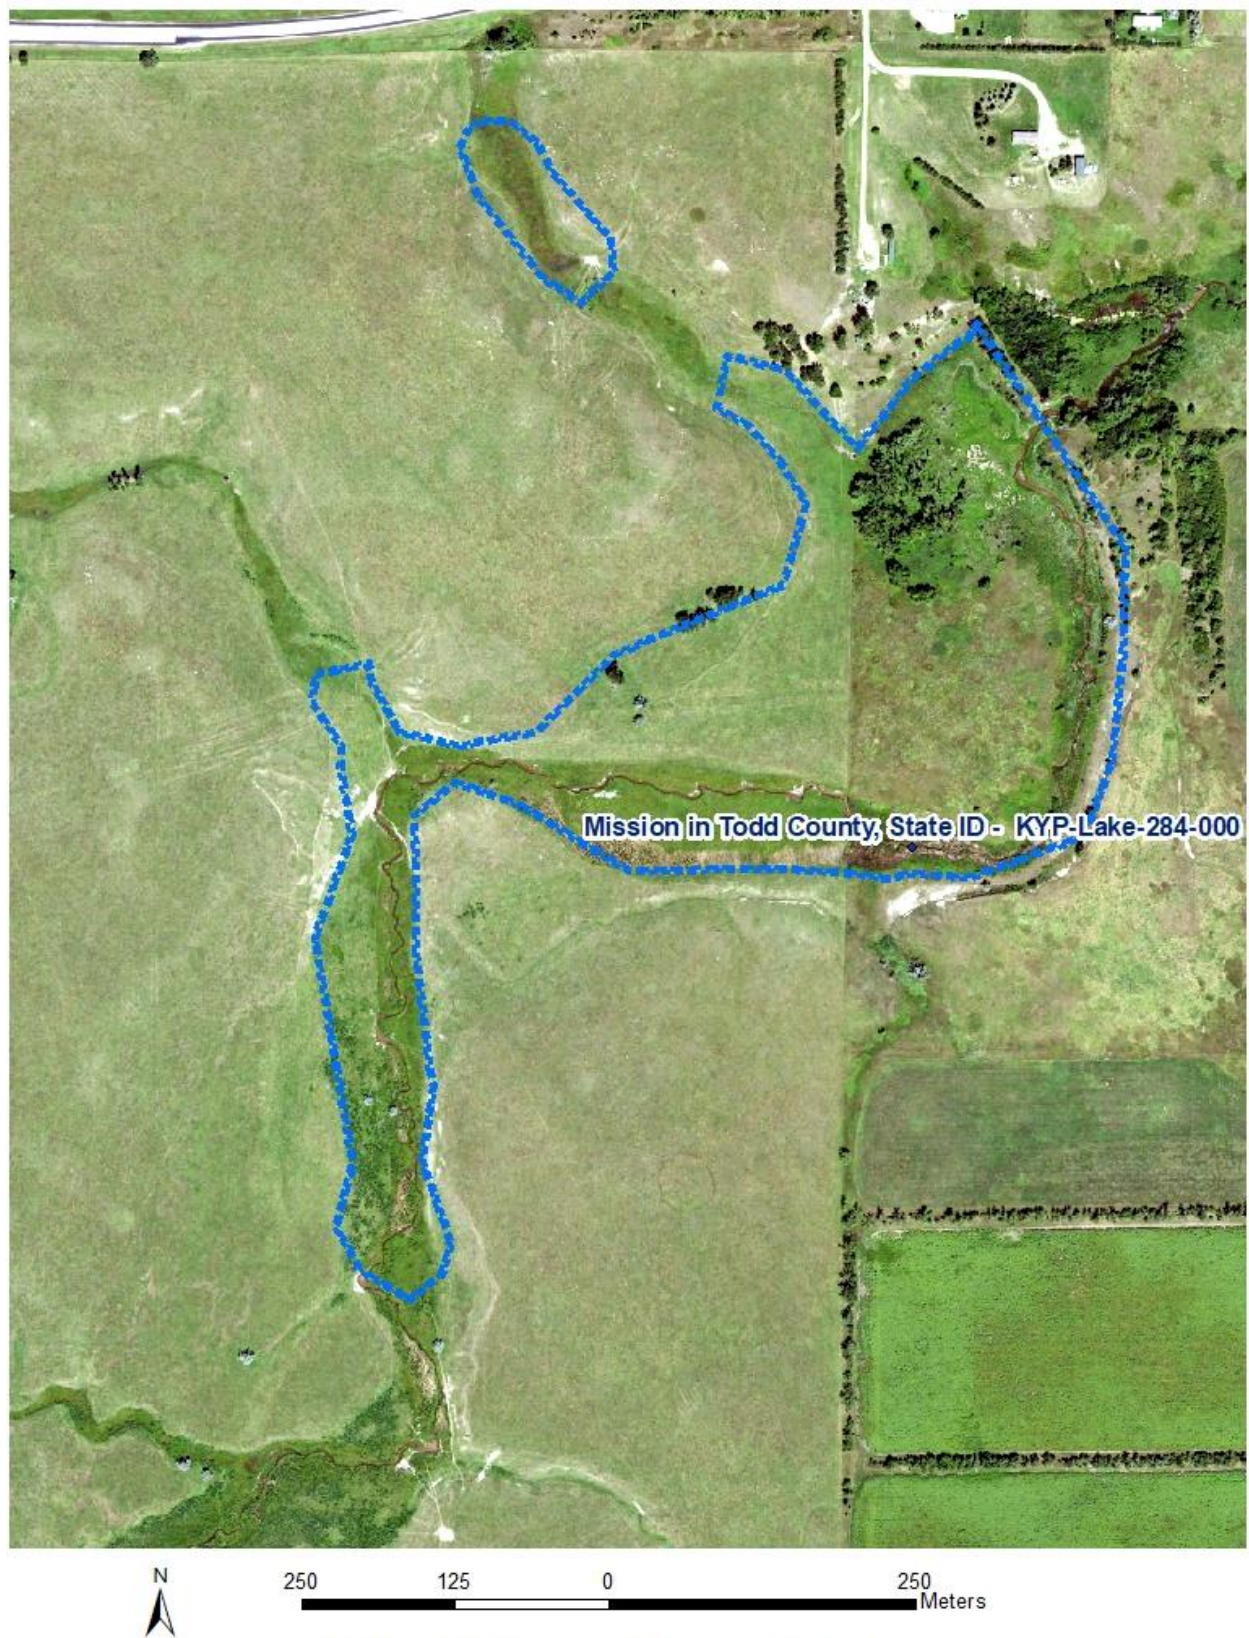
Figure 61 2020 NAIP imagery of Mission Lake in Todd County. Blue outline represents the extent that water was present prior to the dam breach and lake draining.

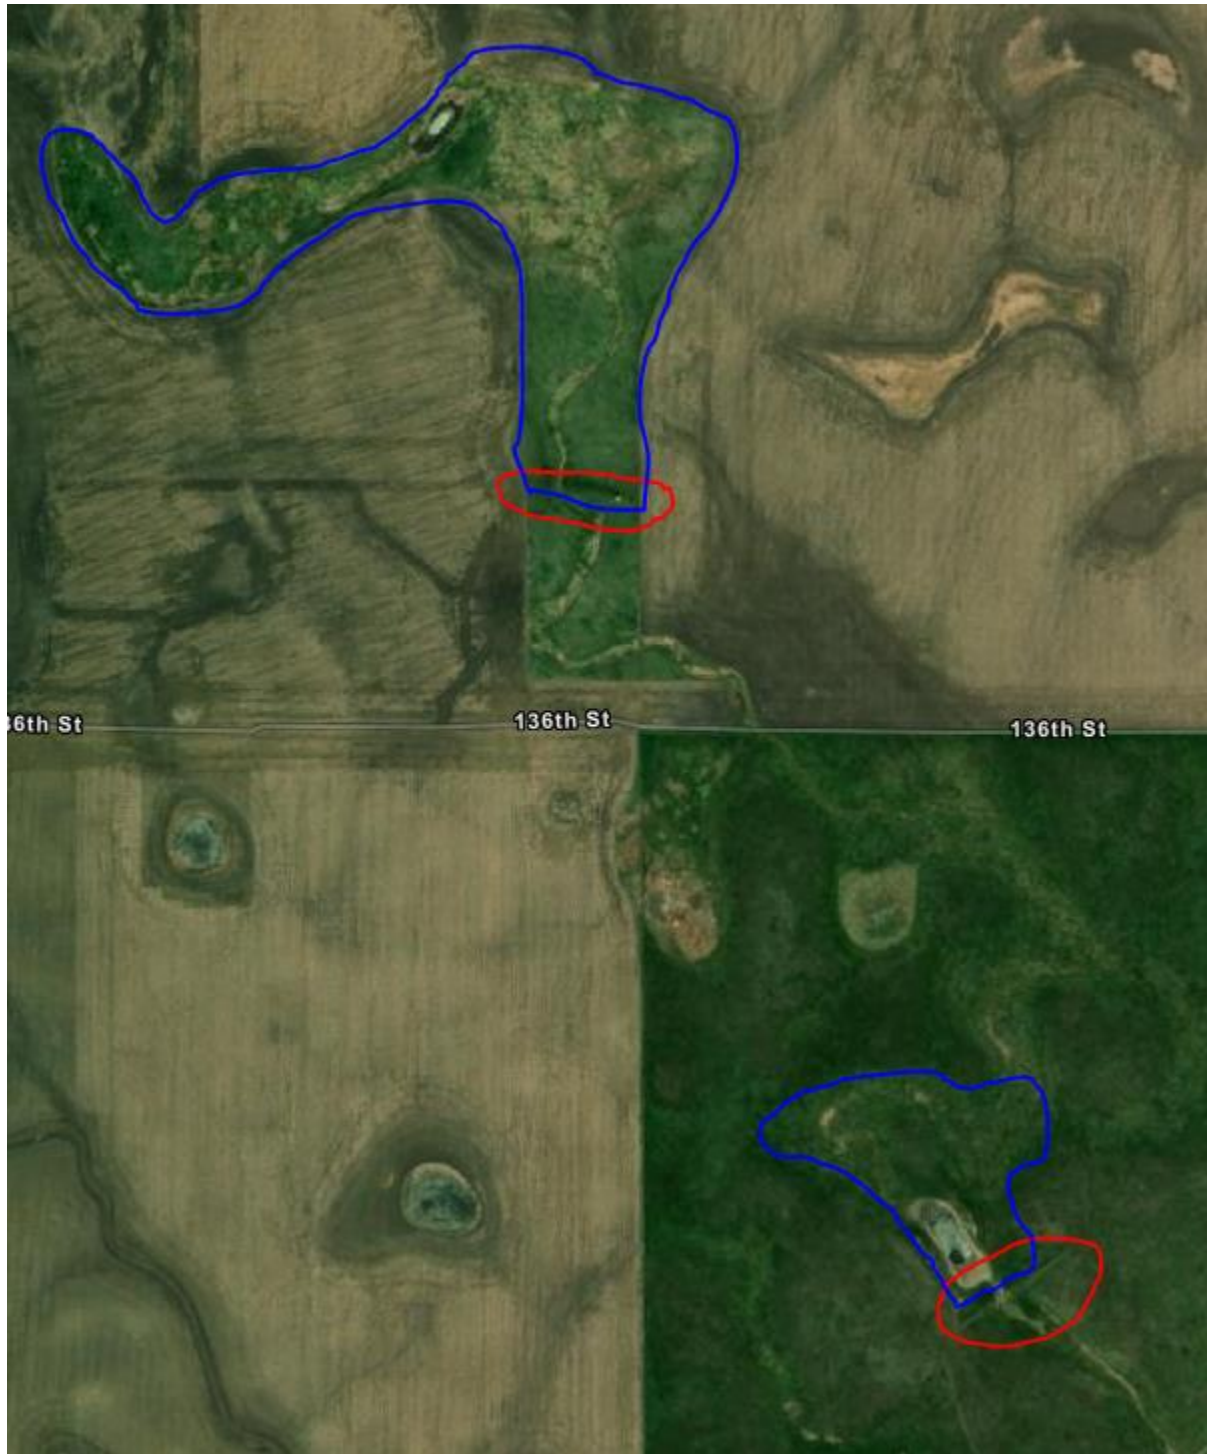
Figure 66. Two possible locations for Lake Picton in Edmunds County. The red circles outline the two breached dams while the blue outlines depict the extent of the former lake beds.

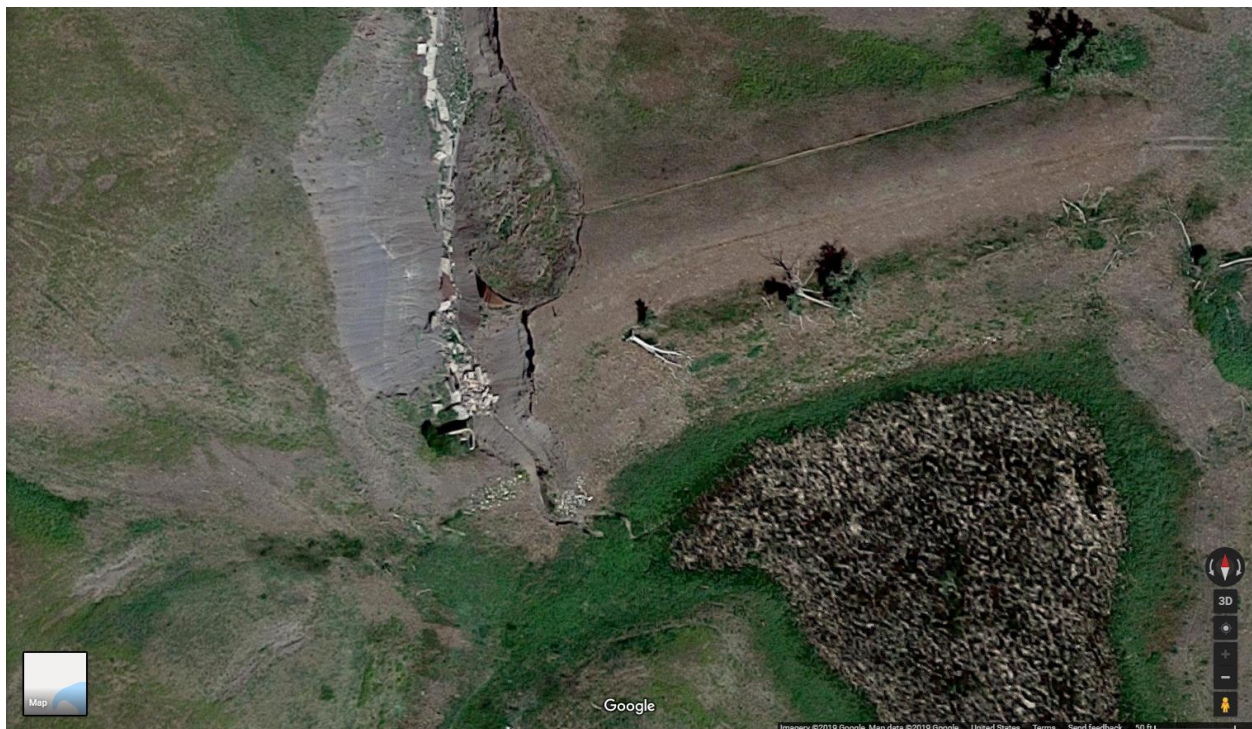
Figure 81. Google image of breached spillway on Red Plum Dam (Google, 2014)

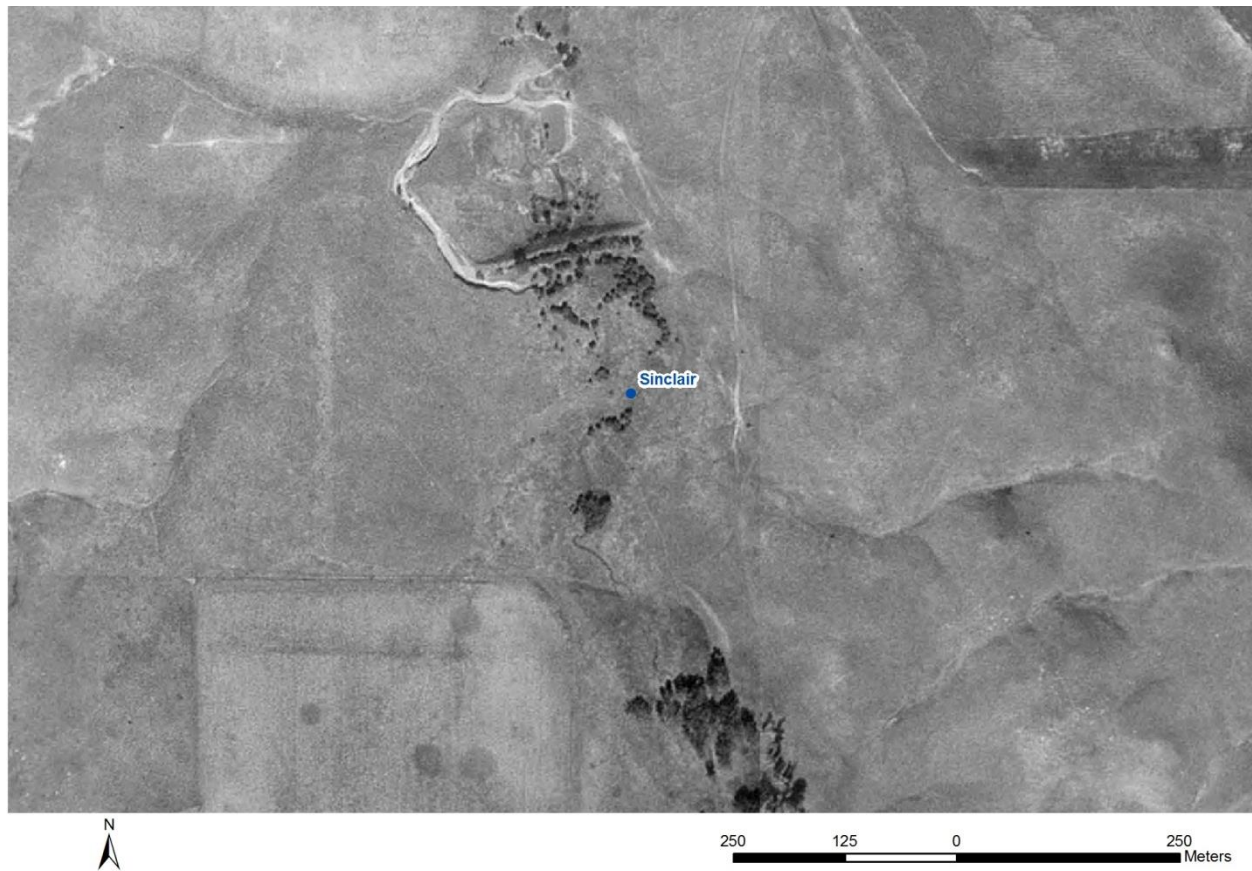
Figure 88. DOQ of Sinclair Dam from 1997 shows a well-developed channel and mature trees in the lakebed.

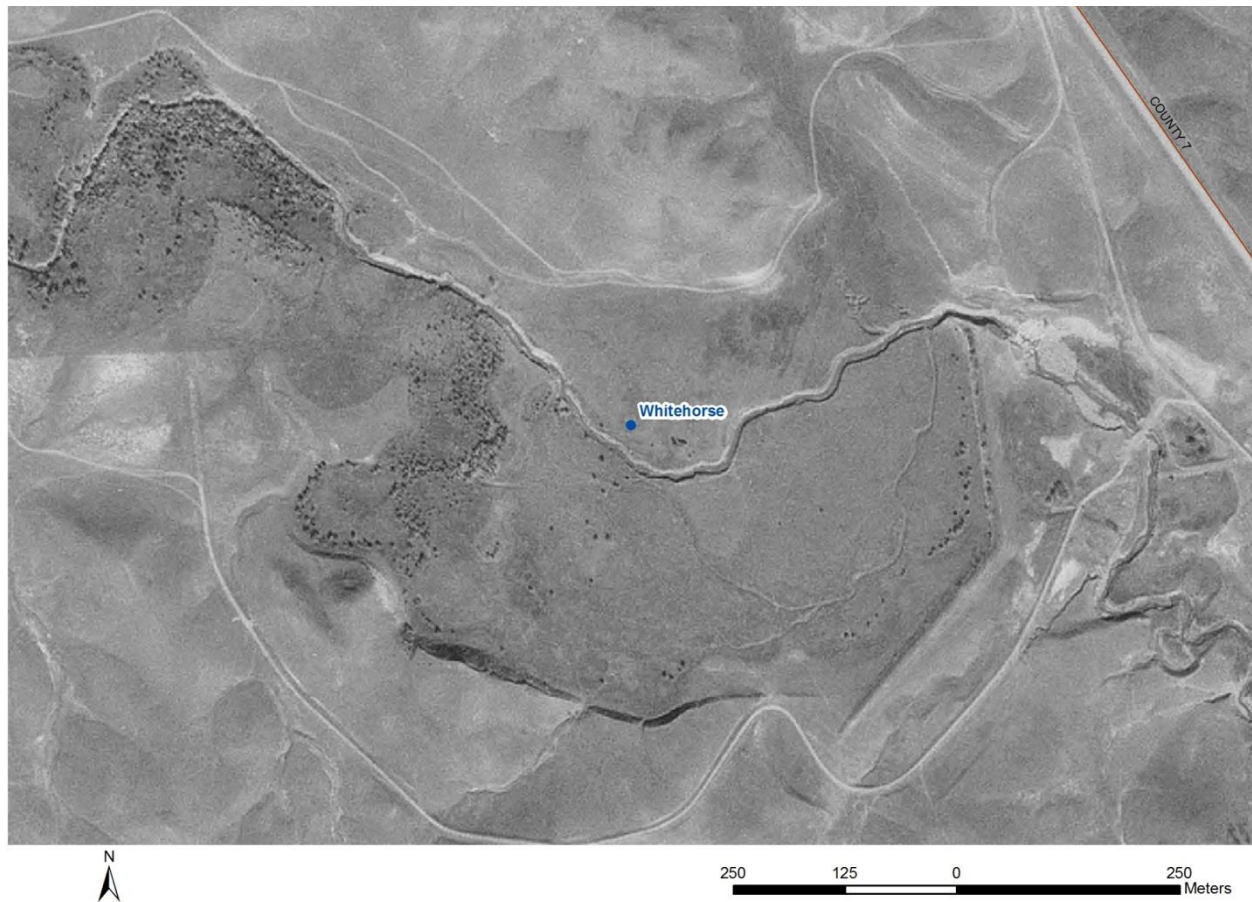
Figure 96. DOQ of Whitehorse Lake in 1997. Trees and a well-developed channel are present in the lakebed.

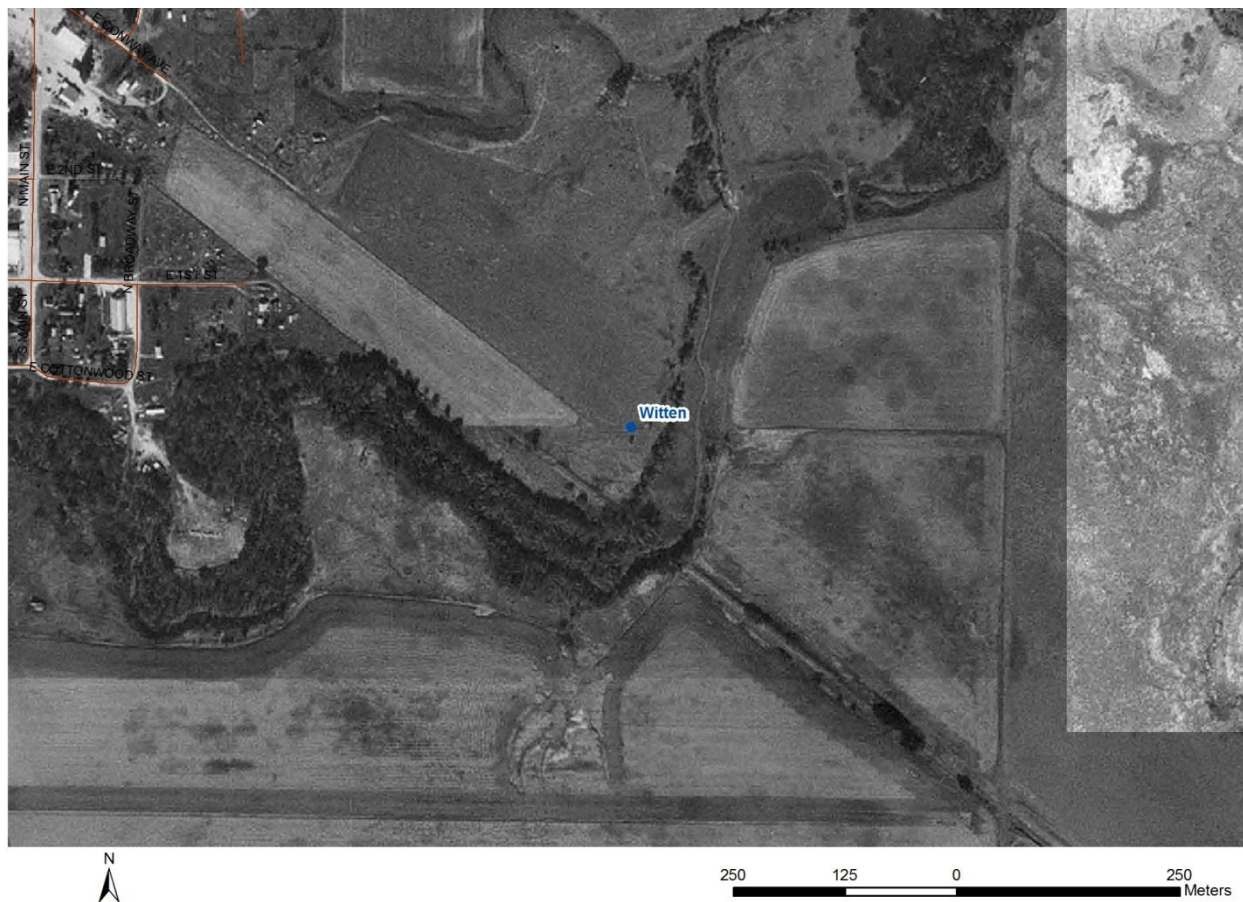
Figure 100. DOQ of Witten dam from 1997. Mature trees and a well-developed channel are visible in the lakebed.

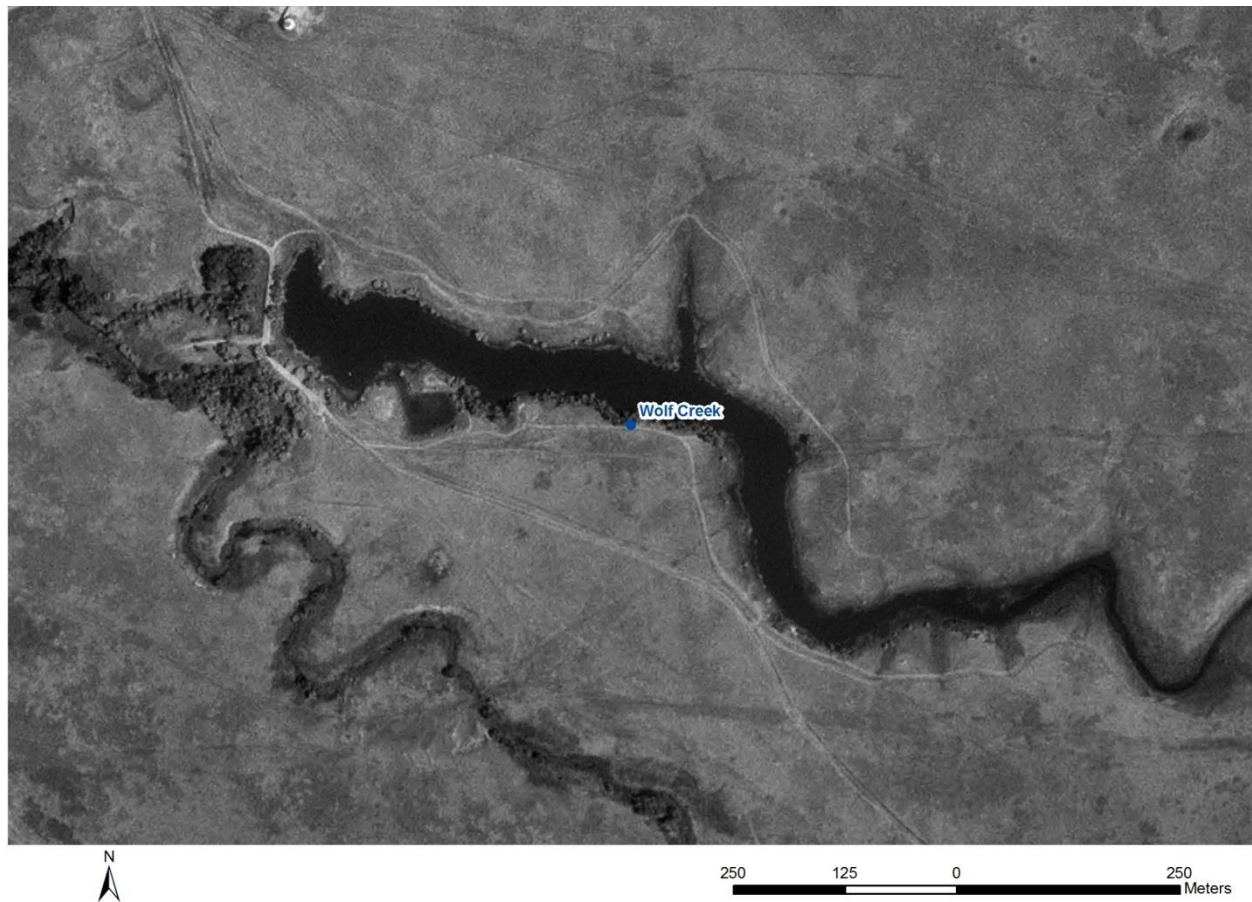
Figure 104. DOQ of Wolf Creek Lake prior to breach in 1991, well used roadway across dam is visible.
