BELLE FOURCHE RIVER WATERSHED MANAGEMENT AND PROJECT IMPLEMENTATION PLAN SEGMENT 9 WATERSHED PROJECT FINAL REPORT SECTION 319 NONPOINT SOURCE POLLUTION CONTROL PROGRAM

RESPEC 3824 Jet Drive Rapid City, South Dakota 57703

Project Title: Belle Fourche River Watershed Management and

Project Implementation Plan Segment 9

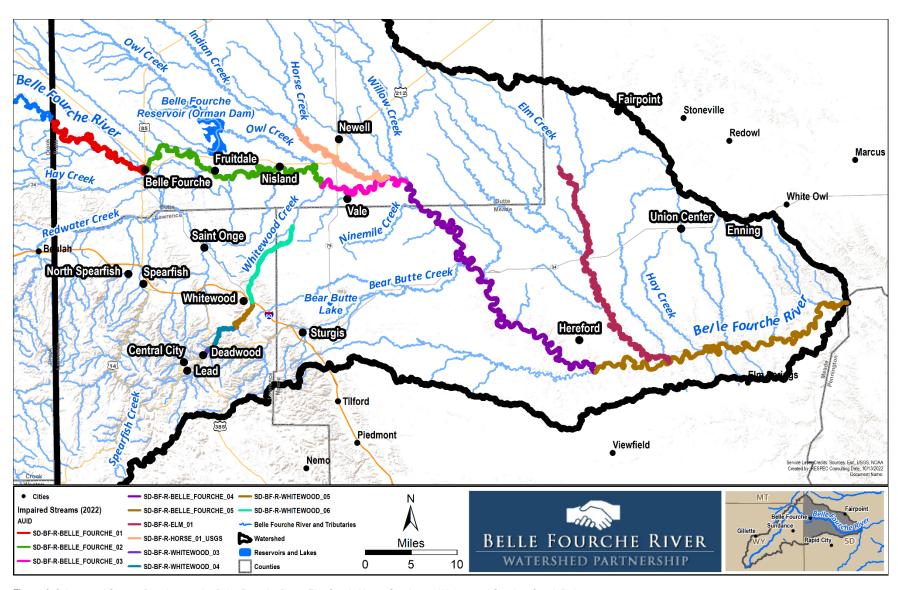
Figure 2-2. Impaired Stream Reaches on the Belle Fourche River, Elm Creek, Horse Creek, and Whitewood Creek in South Dakota.

The Belle Fourche River from the Wyoming-South Dakota state line to the Cheyenne River is determined as impaired in South Dakota's 2022 Integrated Report (2022 IR) because of elevated total suspended solids (TSS) and *Escherichia coli* (*E. coli*) concentrations. However, the Belle Fourche River from the Redwater River to Alkali Creek is currently only listed for *E. coli*. In the 2022 IR, Horse Creek was listed for TSS and delisted for *E. coli*. A reach on Elm Creek was listed for TSS, specific conductivity, and *E. coli*. Also in the 2022 IR, two reaches on Whitewood Creek were listed for pH and two reaches were listed for *E. coli*. Table 2-1 is a summary of the 2022 IR's TMDLs in the watershed. The table also lists the stream reach, impaired beneficial use, impairment parameter, and water-quality criteria. The impaired segments within the watershed are shown on Figure 2-2.

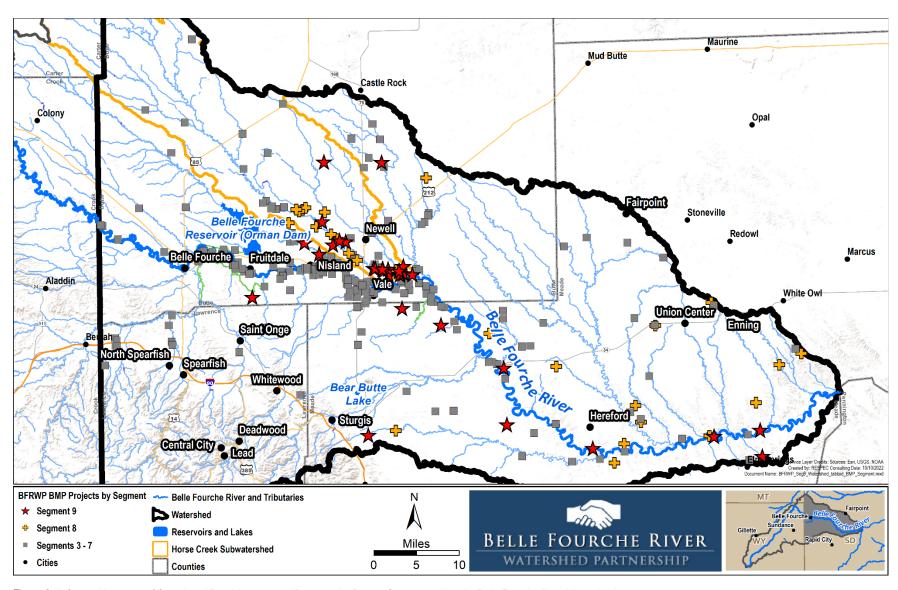
Figure 3-1. General Location of Completed Best Management Practices by Project Segment within the Belle Fourche River Watershed.

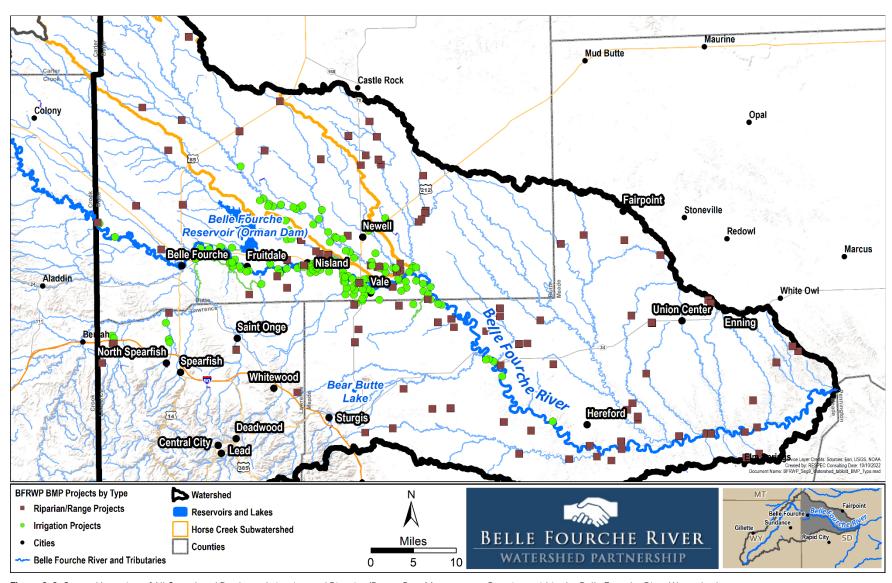
Figure 3-2. General Location of All Completed Producer-Irrigation and Riparian/Range Best Management Practices within the Belle Fourche River Watershed.

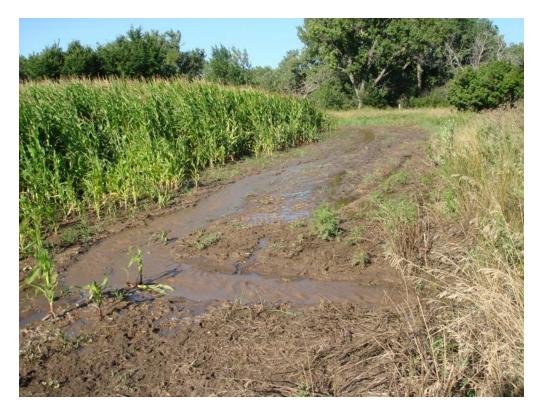
Figure 3-3. Flood-Irrigated Field Demonstrating Inefficient Water Use That Leads to Sediment Runoff.

Twelve center-pivot sprinklers were installed to replace flood irrigation on 460 acres during Segment 9. Figure 3-3 shows a flood-irrigated field and inefficient water use that leads to increased sediment runoff. Figure 3-4 shows a cost-share funded center-pivot irrigation system that reduces soil and water runoff from the field. Figure 3-5 shows a typical on-farm earthen irrigation ditch before conversion to buried underground pipe to prevent sediment and water runoff. Figure 3-6 shows a cost-share funded irrigation pipeline conversion from earthen ditch that reduces soil and water runoff from the field. There have been 254 center-pivot sprinklers on 20,390 acres installed in the watershed. The BFRWP has partnered on 145 of 254 sprinklers with the other systems funded by NRCS or by individual producers.

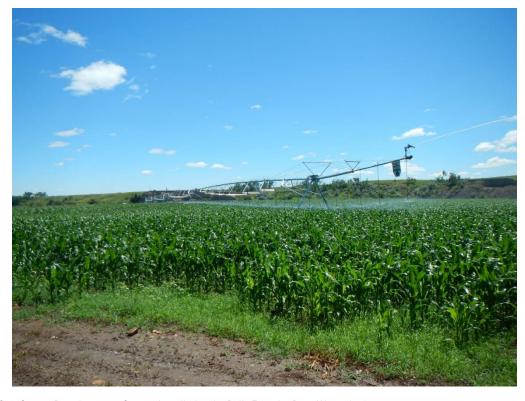
Figure 3-4. Center-Pivot Irrigation System Installed in the Belle Fourche River Watershed.

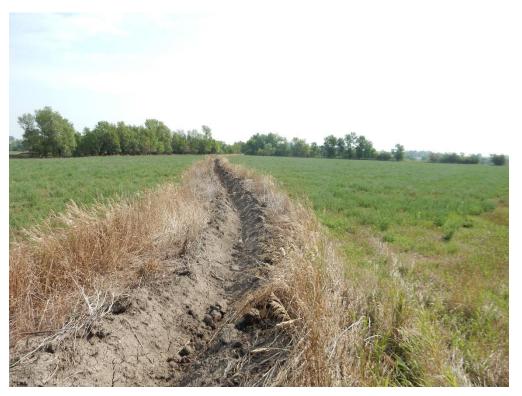
Figure 3-5. Typical On-Farm Earthen Irrigation Ditch Before Conversion to Underground Pipeline to Prevent Sediment Runoff.

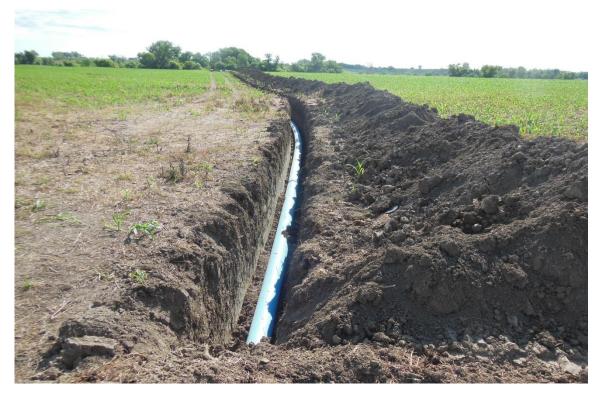
Figure 3-6. On-Farm Earthen Irrigation Ditch Conversion to Underground Pipeline to Prevent Sediment and Water Loss.

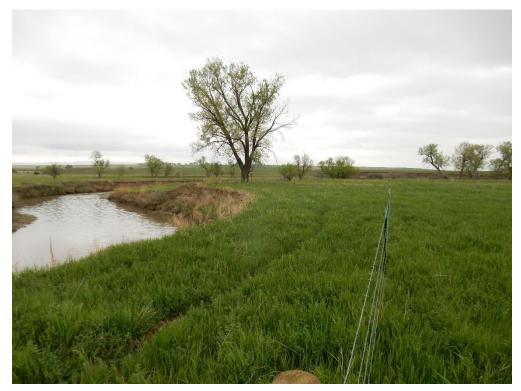
Figure 3-7. Riparian Fence Installed to Improve Riparian Grazing along Horse Creek in the Belle Fourche River Watershed.

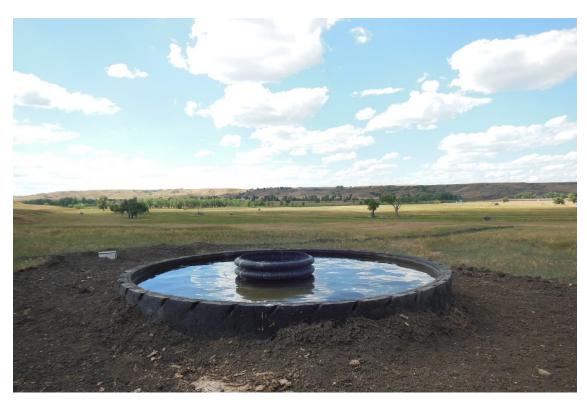
Figure 3-8. Livestock Watering Facility Installed in the Riparian/Upland Area to Replace Watering on the Belle Fourche River.

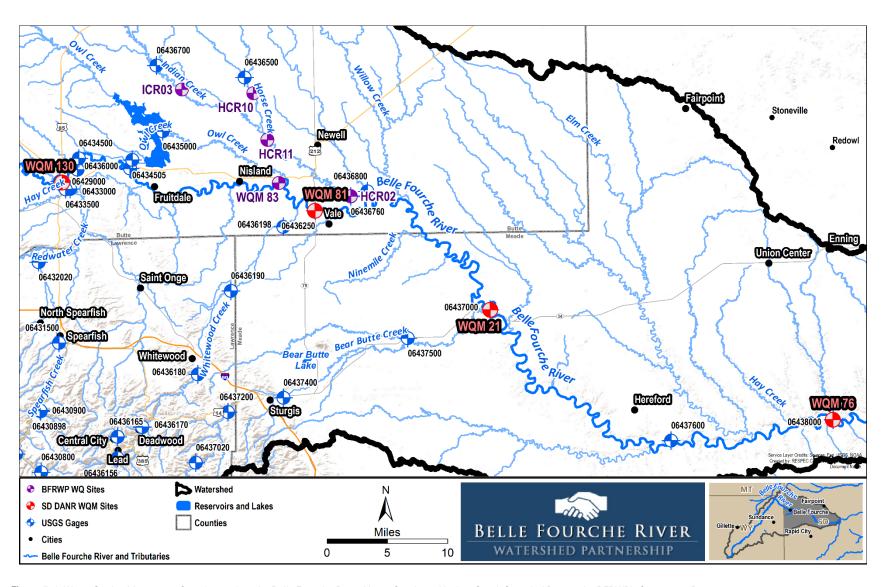
Figure 5-1. Water Quality Monitoring Sites located on the Belle Fourche River, Horse Creek, and Indian Creek Sampled During the BFRWP's Segment 9 Project.

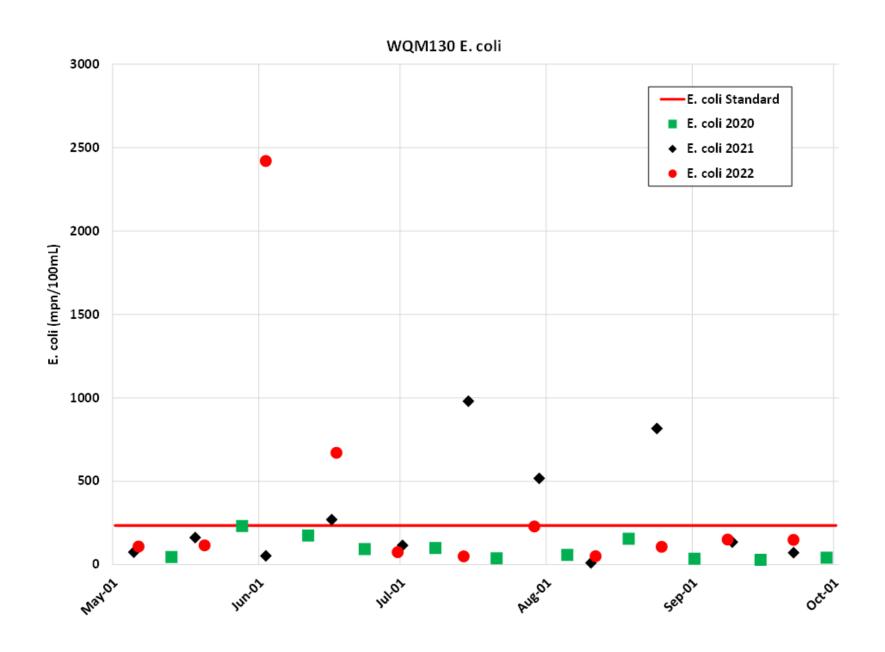
Figure 5-2. BFRWP *E. coli* Water Quality Sampling Results at Site WQM130 (460130) on the Belle Fourche River from May–September during 2020, 2021, and 2022.

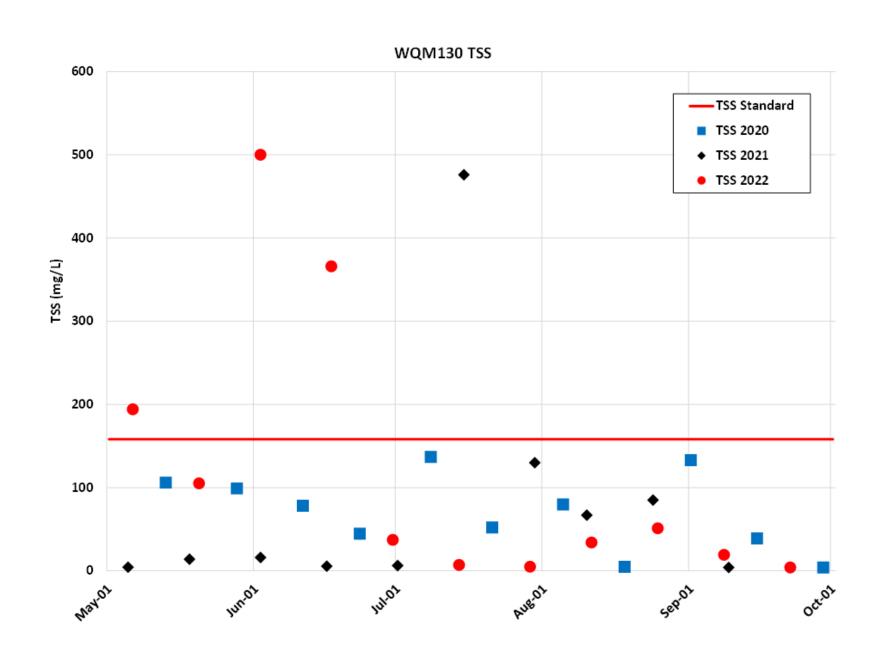
Figure 5-3. BFRWP Total Suspended Sediment (TSS) Sampling Results at Monitoring Site WQM130 (460130) on the Belle Fourche River from May–September during 2020, 2021, and 2022.

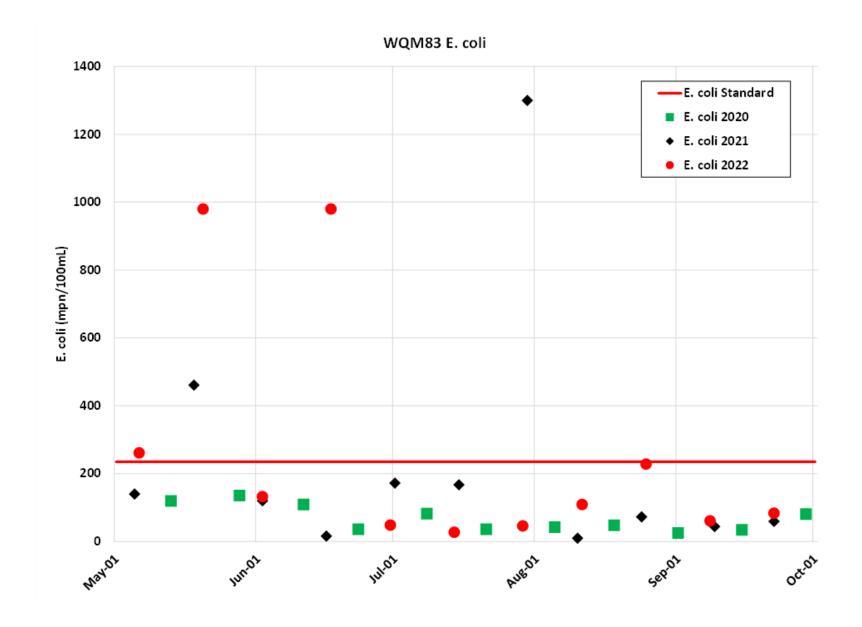
Figure 5-4. BFRWP *E. coli* Sampling Results at Monitoring Site WQM83 (460683) on the Belle Fourche River from May–September during 2020, 2021, and 2022.

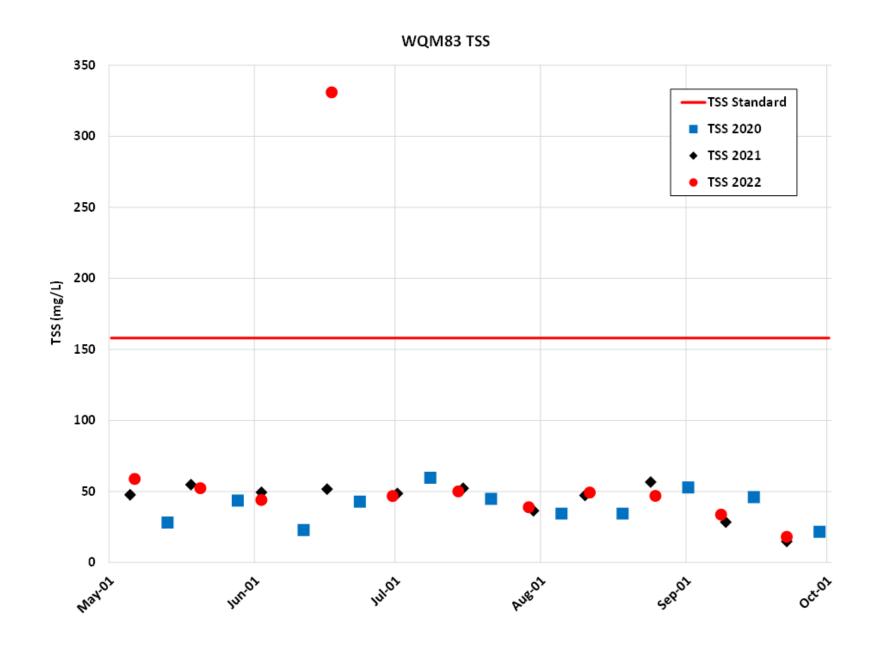
Figure 5-5. BFRWP Total Suspended Sediment (TSS) Sampling Results at Monitoring Site WQM83 (460683) on the Belle Fourche River from May–September during 2020, 2021, and 2022.

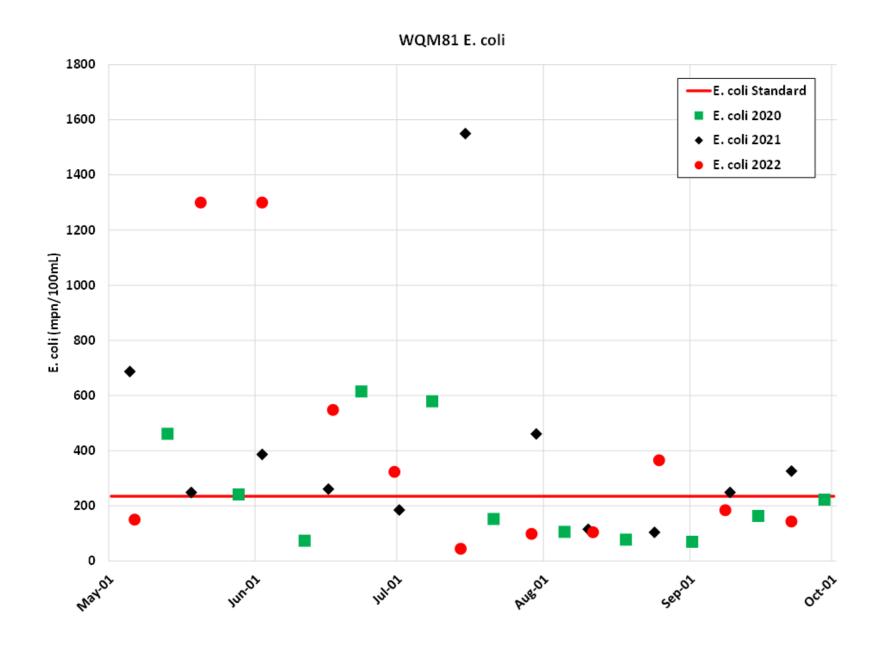
Figure 5-6. BFRWP *E. coli* Sampling Results at Monitoring Site WQM81 (460681) on the Belle Fourche River from May–September during 2020, 2021, and 2022.

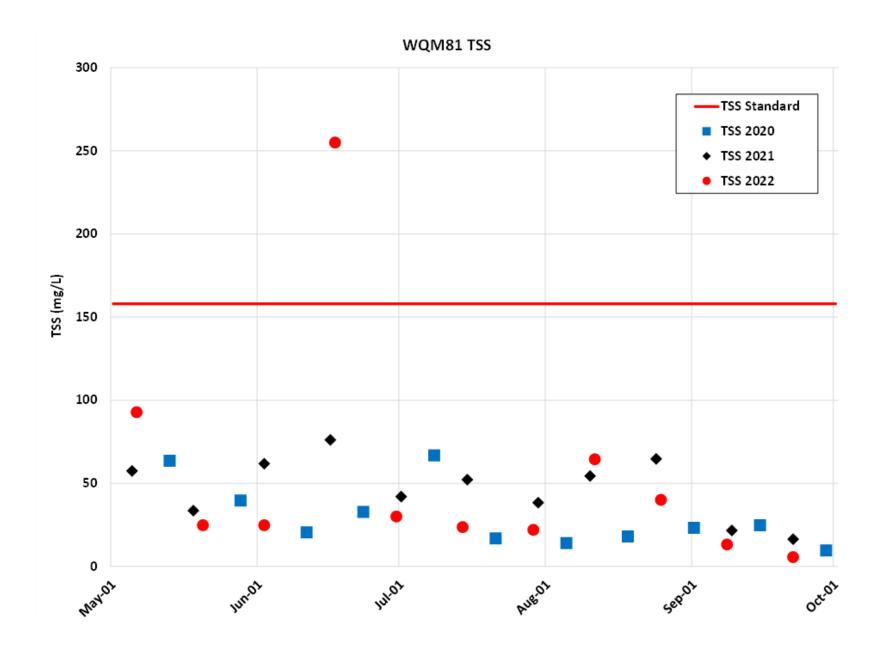
Figure 5-7. BFRWP Total Suspended Sediment (TSS) Sampling Results at Monitoring Site WQM81 (460681) on the Belle Fourche River from May–September during 2020, 2021, and 2022.

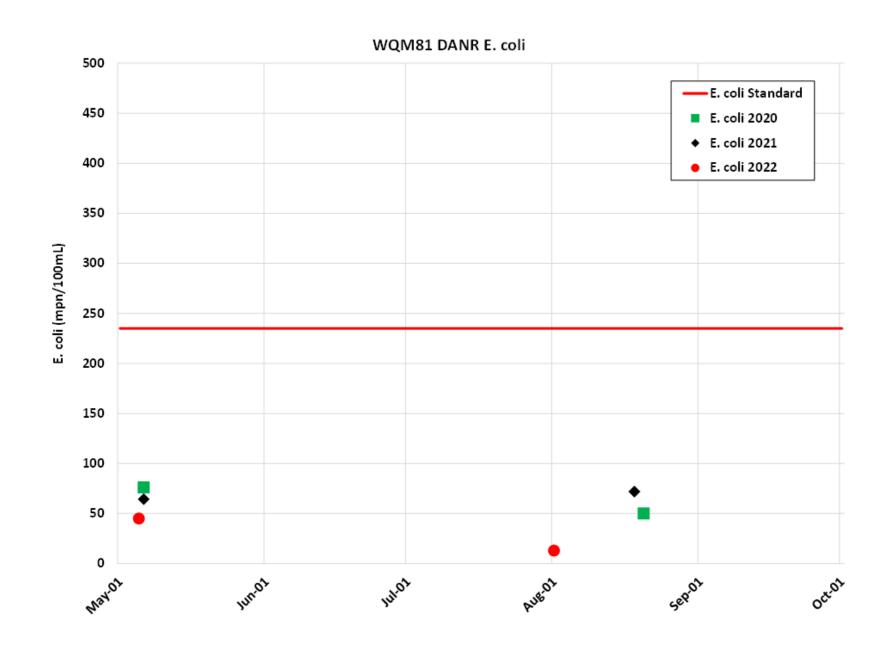
Figure 5-8. SD DANR *E. coli* Sampling Results at Monitoring Site WQM81 (460681) on the Belle Fourche River from May–September during 2020, 2021, and 2022.

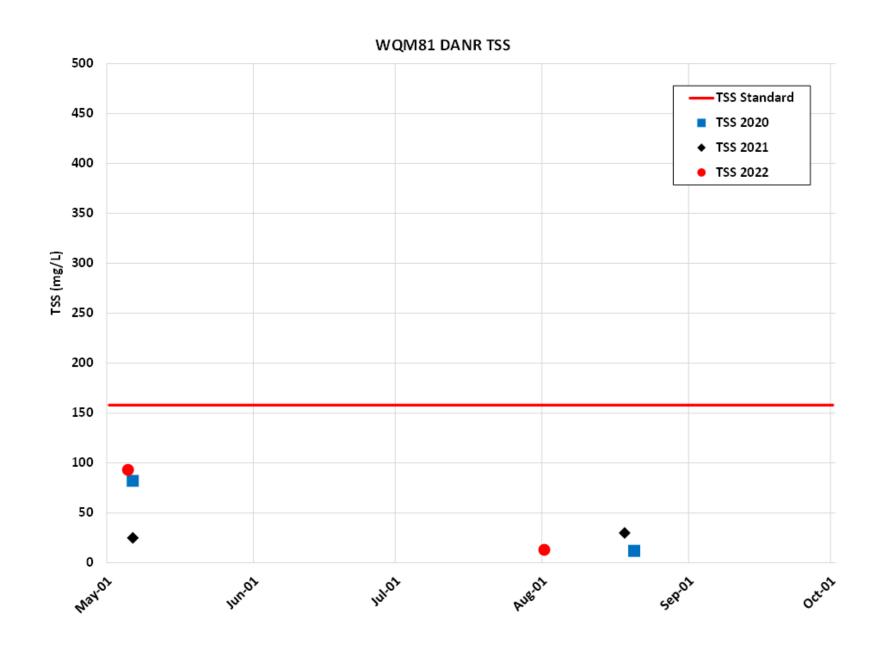
Figure 5-9. SD DANR Total Suspended Sediment (TSS) Sampling Results at Monitoring Site WQM81 (460681) on the Belle Fourche River from May–September during 2020, 2021, and 2022.

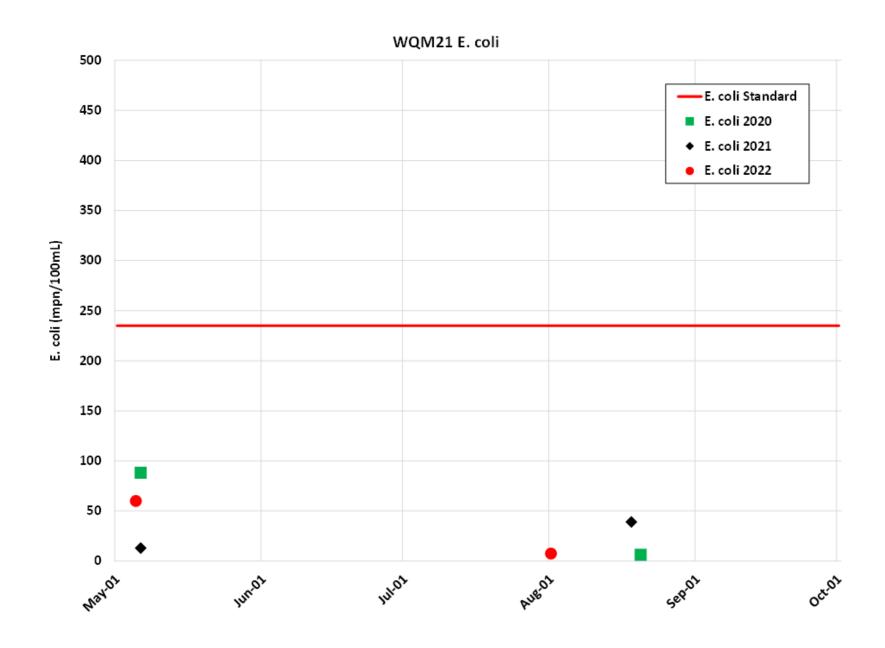
Figure 5-10. SD DANR *E. coli* Sampling Results at Monitoring Site WQM21 (460880) on the Belle Fourche River from May–September during 2020, 2021, and 2022.

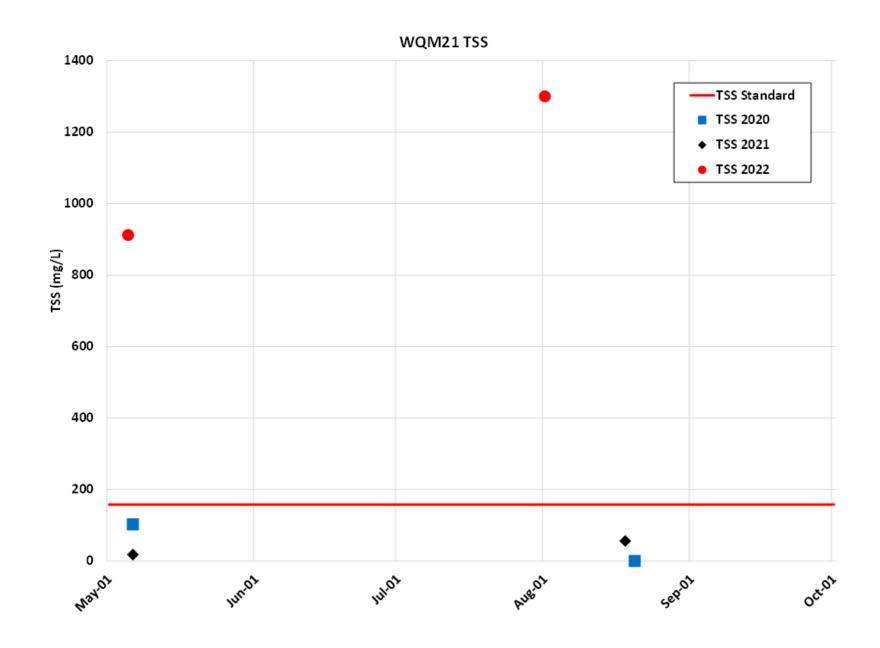
Figure 5-11. SD DANR Total Suspended Sediment (TSS) Sampling Results at Site WQM21 (460880) on the Belle Fourche River from May–September during 2020, 2021, and 2022.

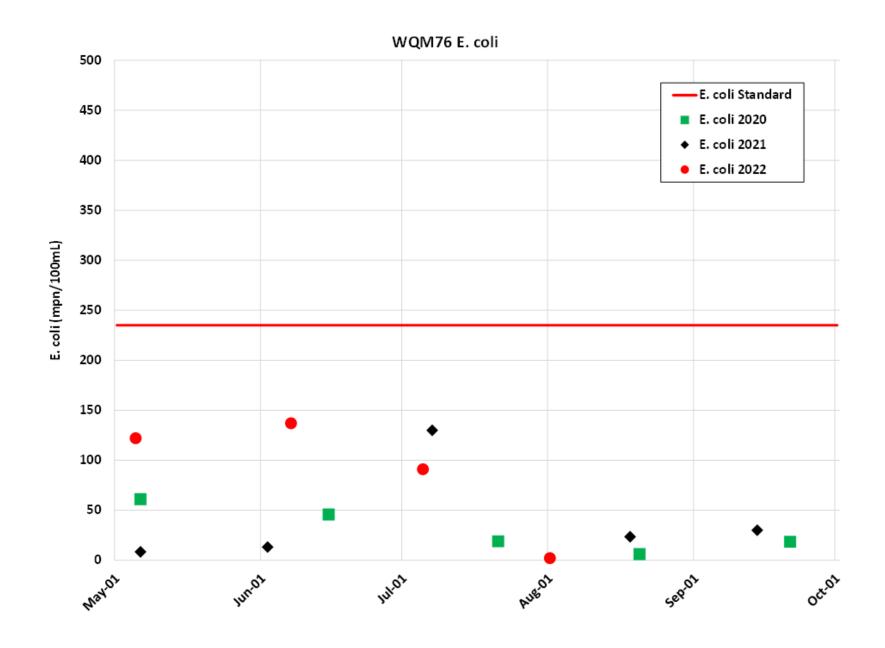
Figure 5-12. SD DANR *E. coli* Sampling Results at Monitoring Site WQM76 (460676) on the Belle Fourche River from May–September during 2020, 2021, and 2022.

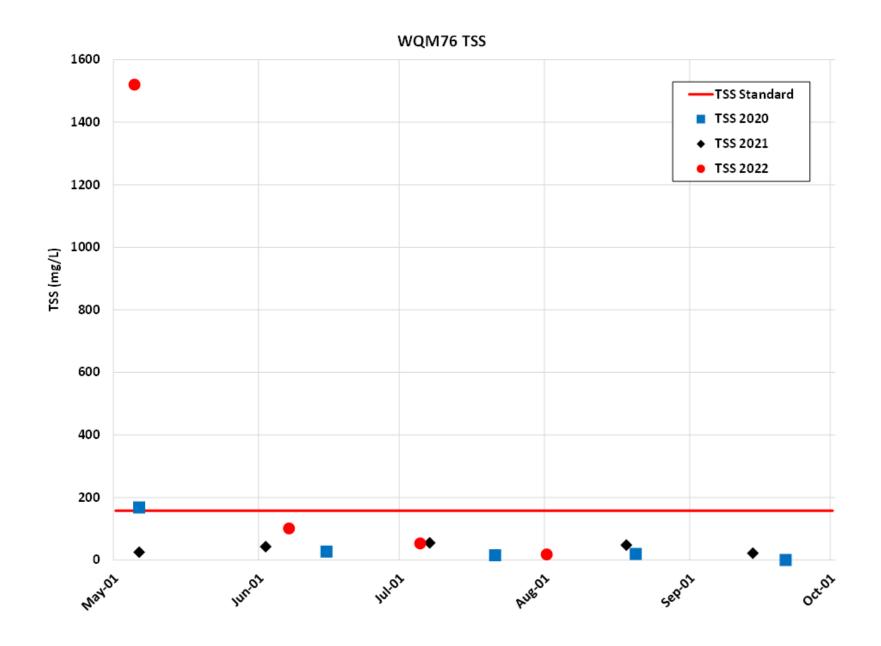
Figure 5-13. SD DANR Total Suspended Sediment (TSS) Sampling Results at Site WQM76 (460676) on the Belle Fourche River from May–September during 2020, 2021, and 2022.

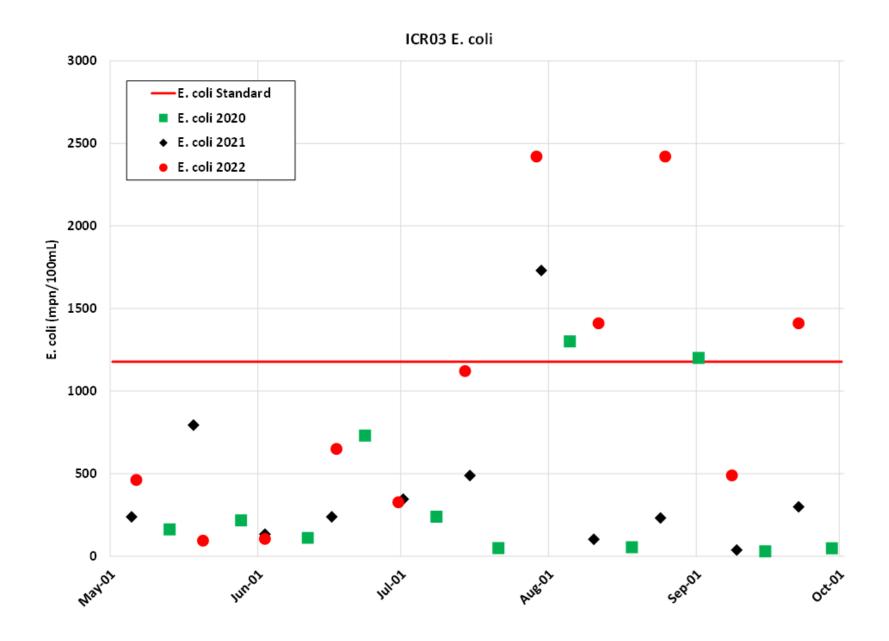
Figure 5-14. BFRWP E. coli Sampling Results at Monitoring Site ICRO3 on Indian Creek from May–September during 2020, 2021, and 2022.

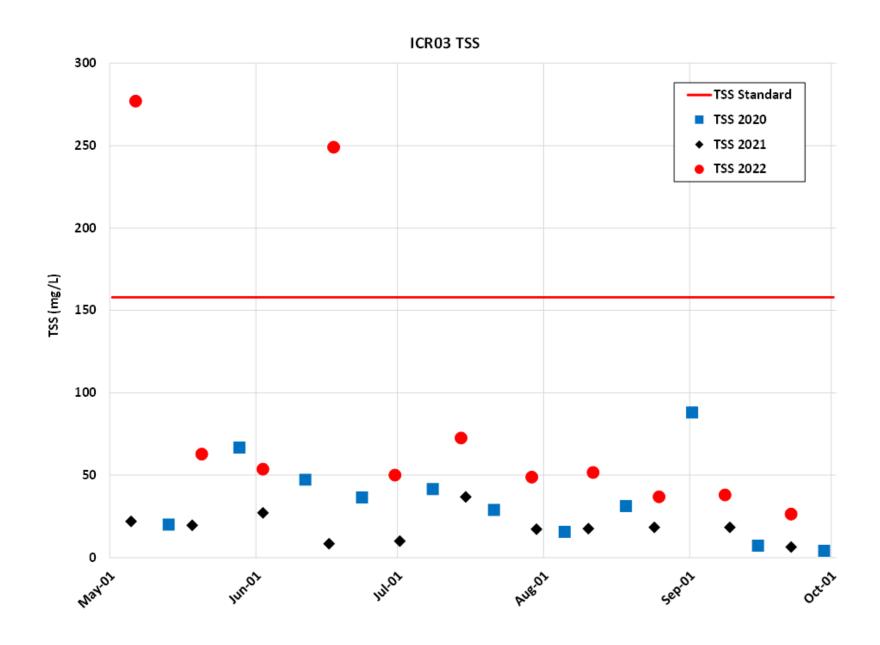
Figure 5-15. BFRWP Total Suspended Sediment (TSS) Sampling Results at Monitoring Site ICR03 on Indian Creek from May–September during 2020, 2021, and 2022.

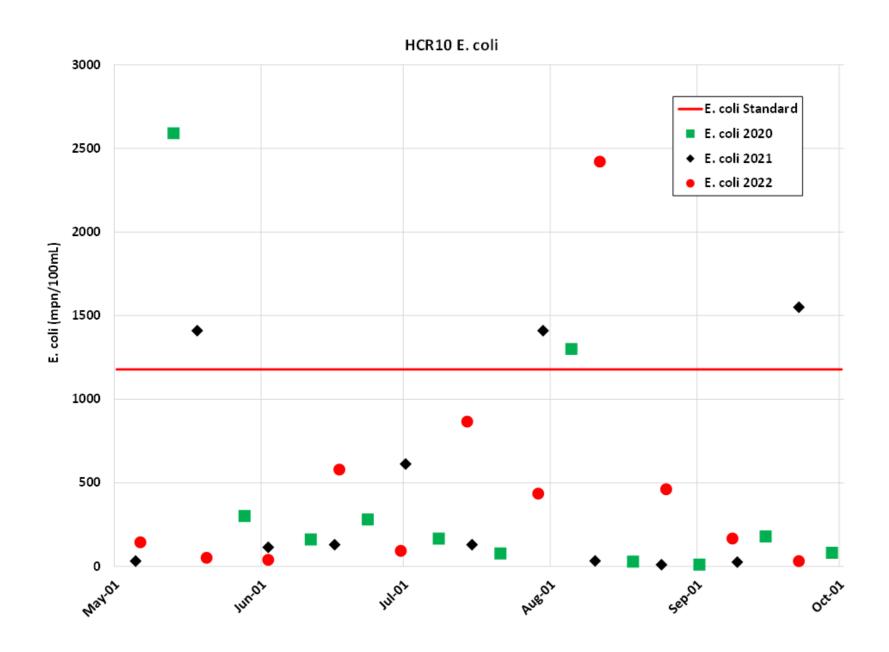
Figure 5-16. BFRWP *E. coli* Sampling Results at Monitoring Site HCR10 on Horse Creek from May–September during 2020, 2021, and 2022.

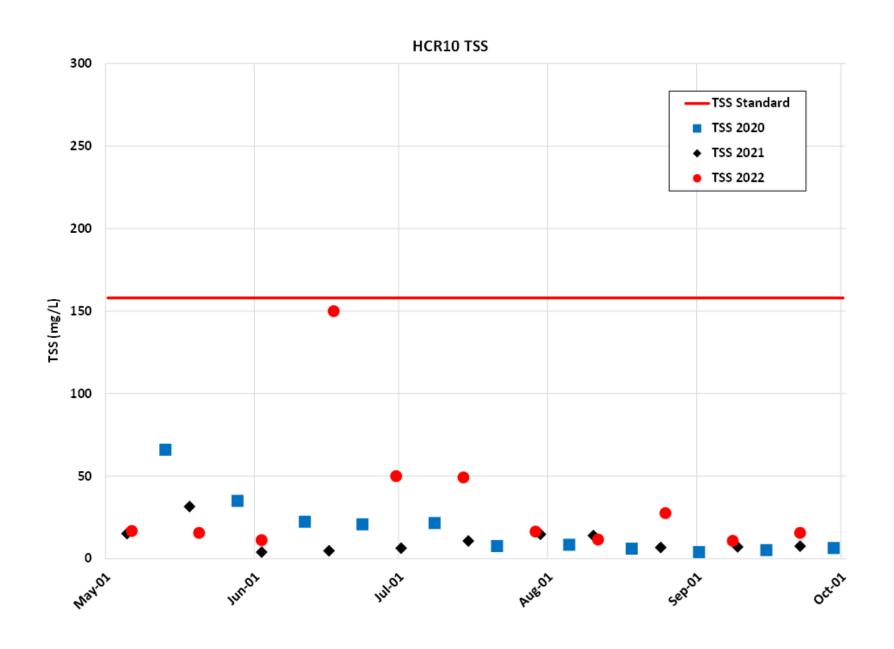
Figure 5-17. BFRWP Total Suspended Sediment (TSS) Sampling Results at Monitoring Site HCR10 on Horse Creek from May–September during 2020, 2021, and 2022.

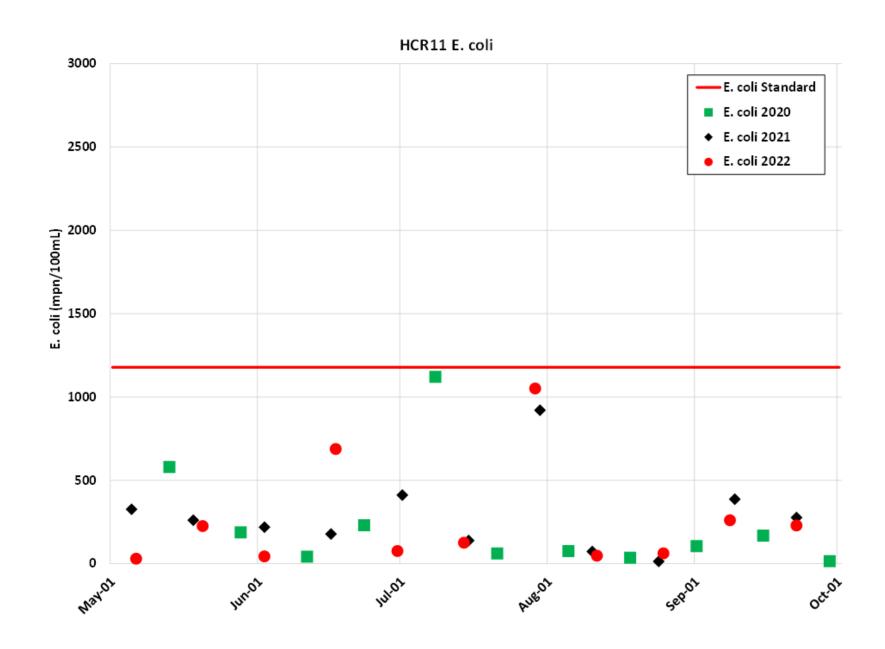
Figure 5-18. BFRWP *E. coli* Sampling Results at Monitoring Site HCR11 on Horse Creek from May–September during 2020, 2021, and 2022.

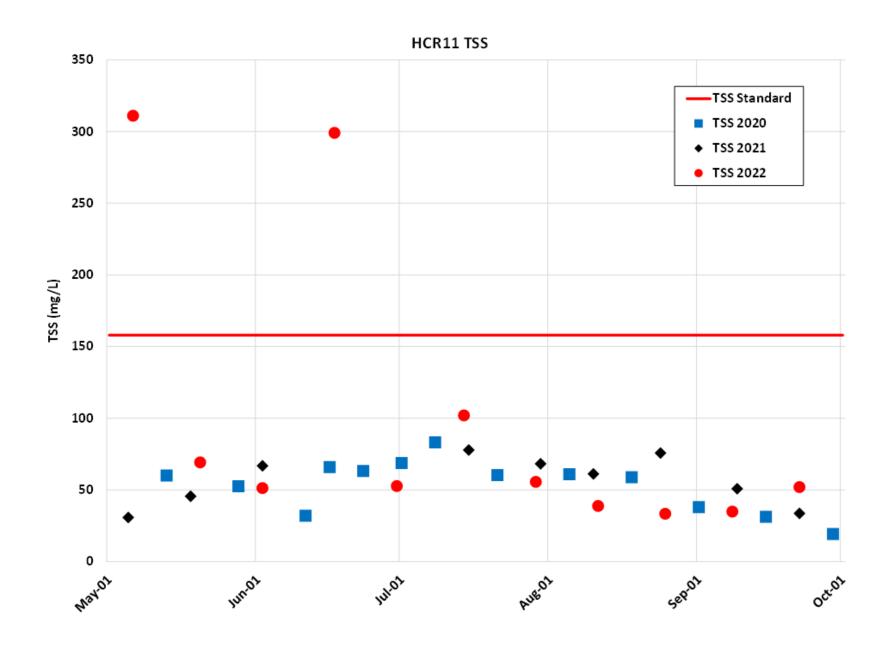
Figure 5-19. BFRWP Total Suspended Sediment (TSS) Sampling Results at Monitoring Site HCR11 on Horse Creek from May–September during 2020, 2021, and 2022.

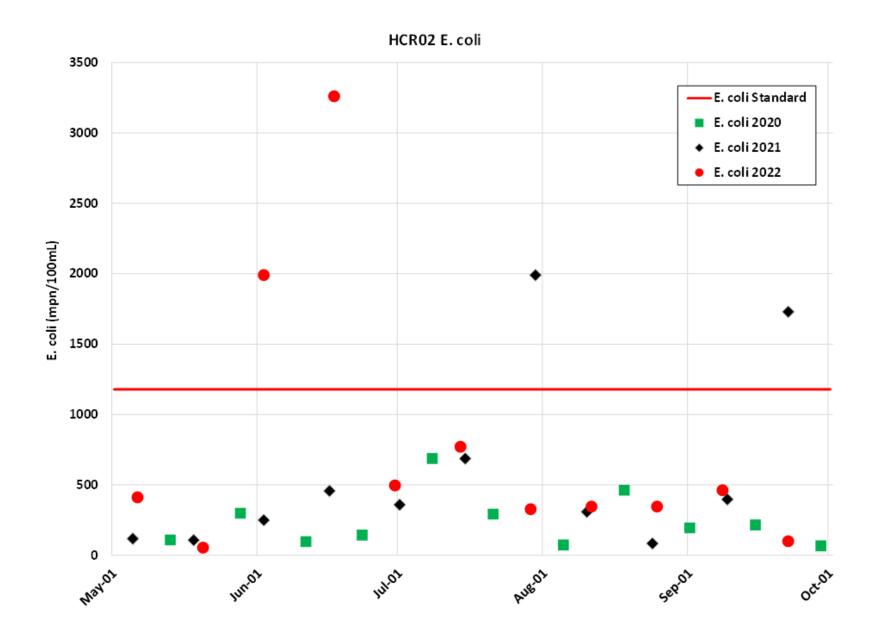
Figure 5-20. BFRWP *E. coli* Sampling Results at Monitoring Site HCR02 on Horse Creek from May – September during 2020, 2021, and 2022.

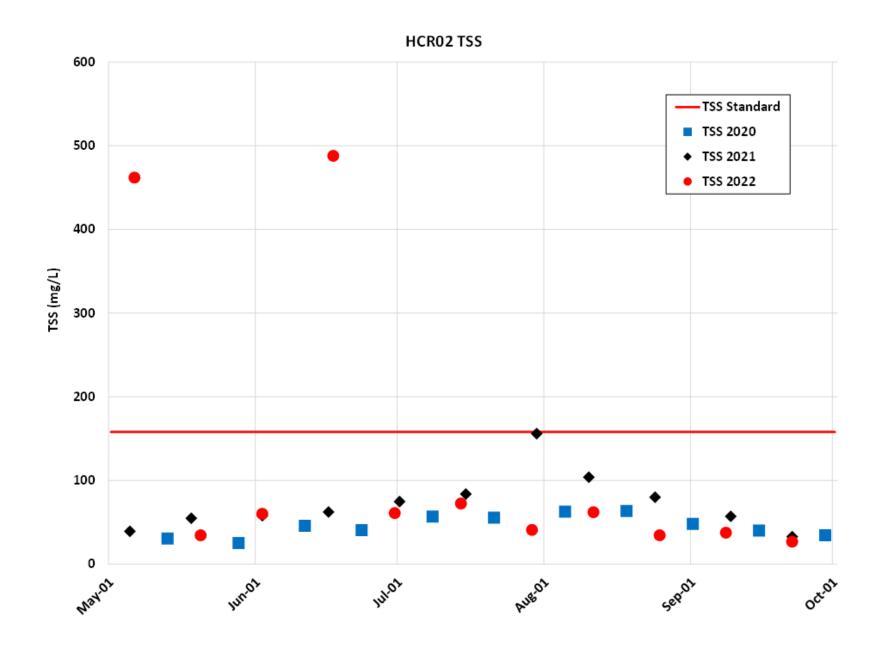
Figure 5-21. BFRWP Total Suspended Sediment (TSS) Sampling Results at Monitoring Site HCRO2 on Horse Creek from May–September during 2020, 2021, and 2022.
