**CLEAN WATER ACT SECTION 319 NONPOINT POLLUTION CONTROL  
PROGRAM**

**FINAL REPORT**

**SOUTH CENTRAL WATERSHED IMPLEMENTATION PROJECT SEGMENT 1**

**SPONSOR JAMES RIVER WATER DEVELOPMENT DISTRICT**

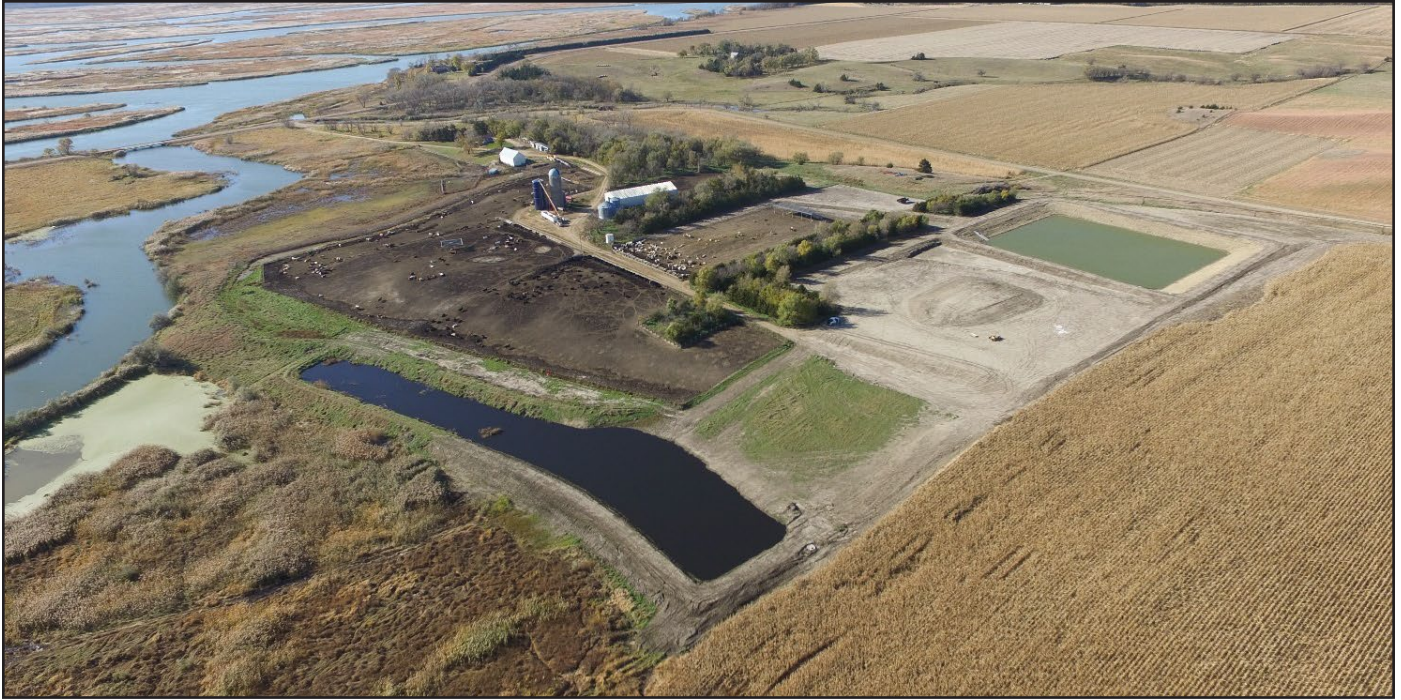
**Figure 1. Full ag waste containment system abutting Snatch creek and Missouri River.**

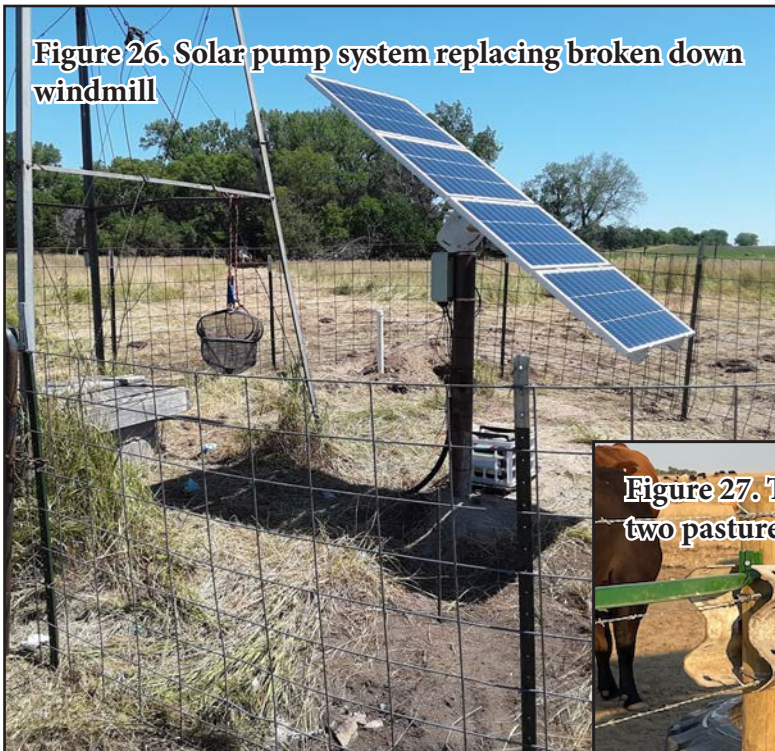
**Figure 26. Solar pump system replacing broken down windmill**

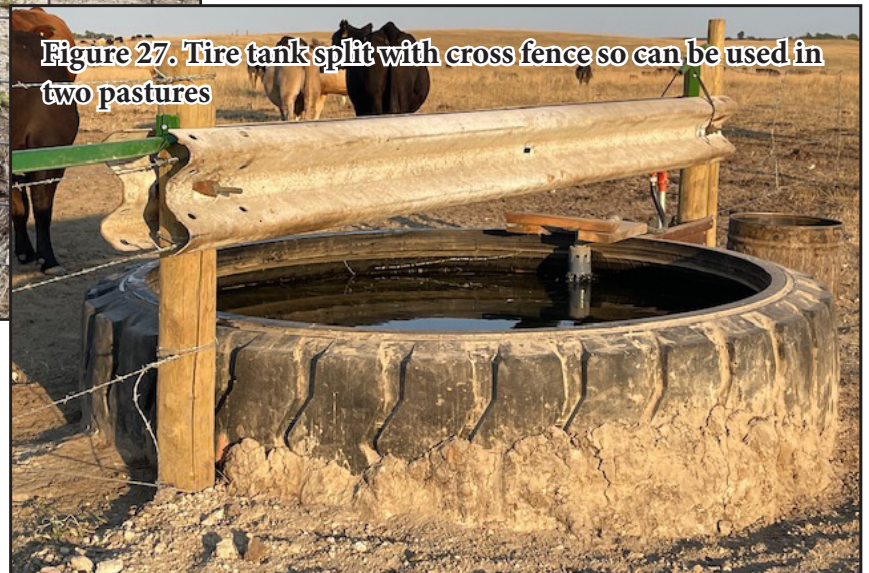
**Figure 27. Tire tank split with cross fence so can be used in two pastures**

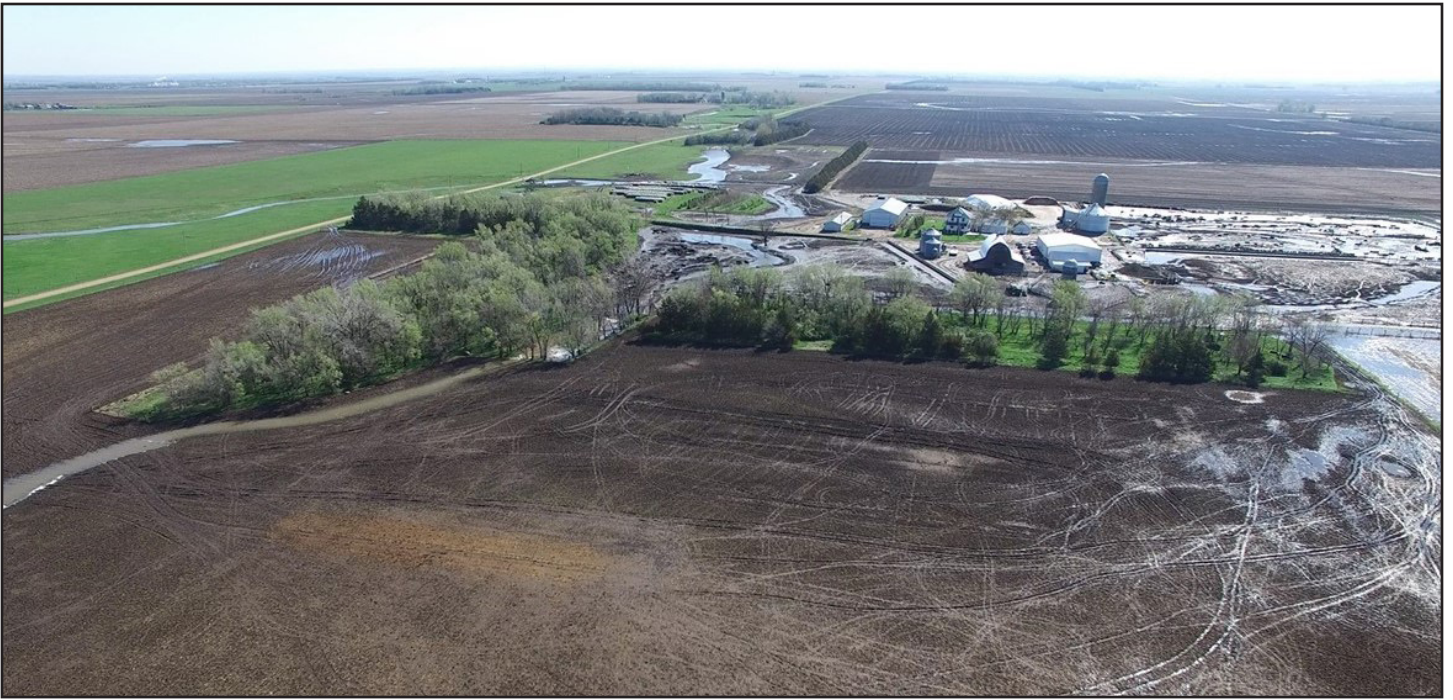
Figure 44, 45, 46 .Photos from feedlot prior to construction, site was on a creek that when flooded would flood the feedlot pens.

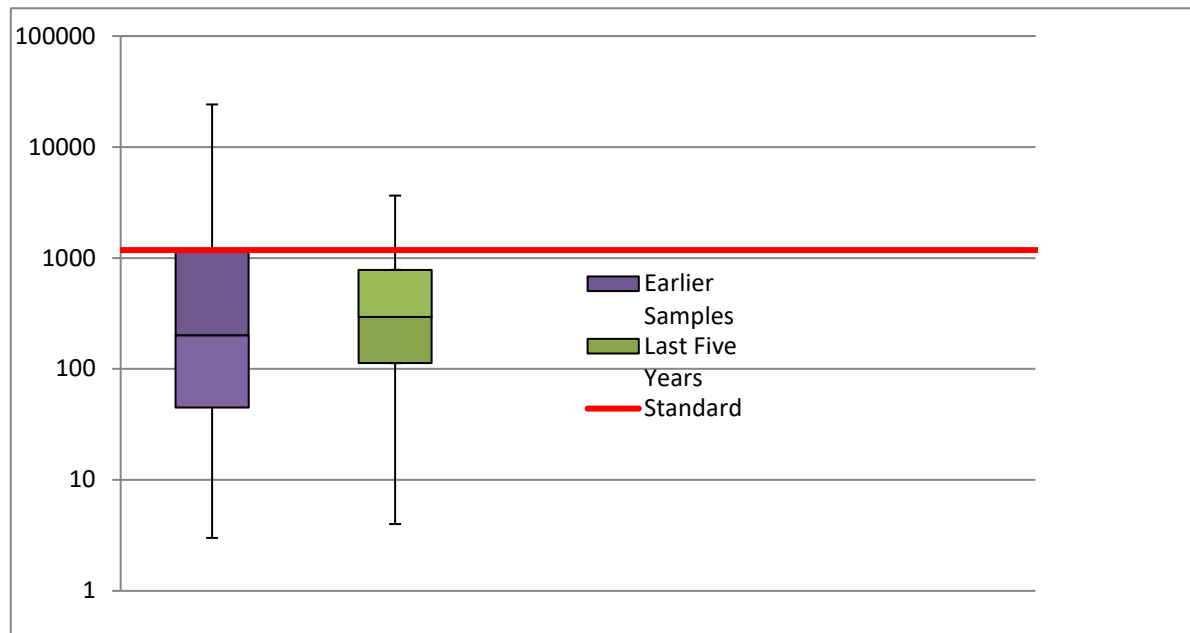
**Figure 65: Keya Paha River E-coli Box and Whisker Plot**

There is an upward trend in *E. coli* between the two time periods for Keya Paha with regards to *E. coli* sampling (Figure 65). Here the median value increased from 203 to 273 CFU/100mL in comparing the Earlier Samples to the Last Five Years data set. The standard for *E. coli* on the Keya Paha River is 1178 CFU/100mL.

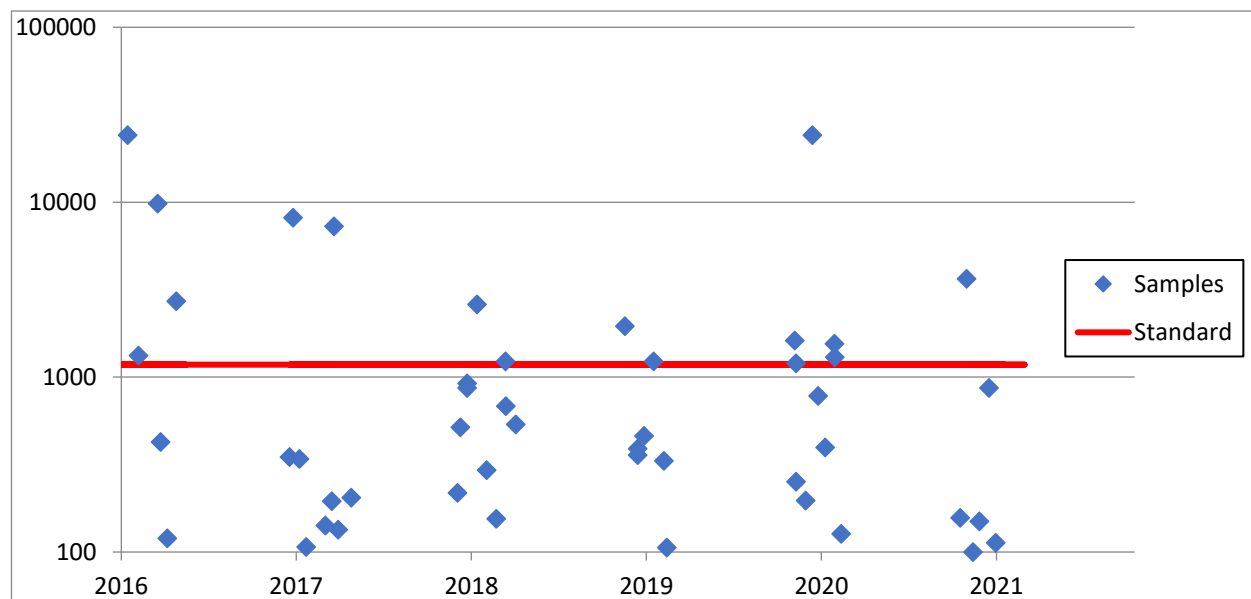
**Figure 66: Keya Paha River E-coli Samples**

All E-coli samples from 2016 to 2021 taken at the Keya Paha WQM site are displayed below on Figure 66. There is a 22% exceedance rate for the Last Five Years data set compared to a 26% for the Earlier Samples data set.

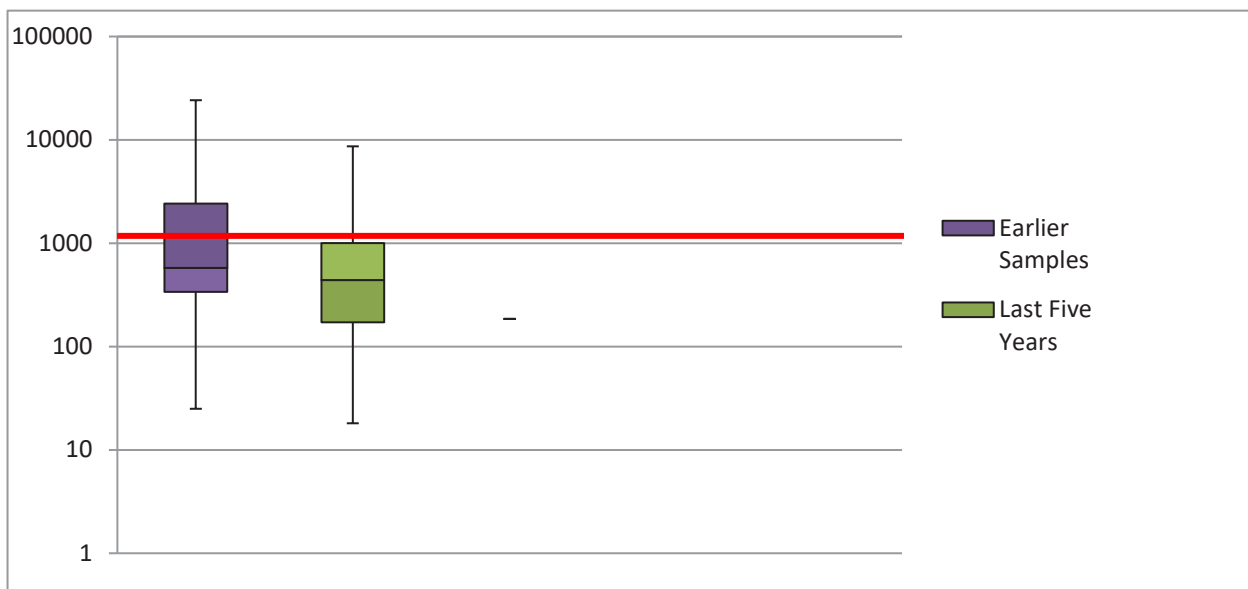
**Figure 73: Ponca Creek Ecoli Box and Whisker Plot**

E-coli median values decreased from 576.5 CFU/100mL to 440 CFU/mL when comparing data sets from Earlier Samples to Last Five Years samples. The E-coli standard for Ponca Creek is 1178 CFU/mL. There was a 34% exceedance for the Earlier Samples in comparison to a 16.5% rate for the Last Five Year's data set.

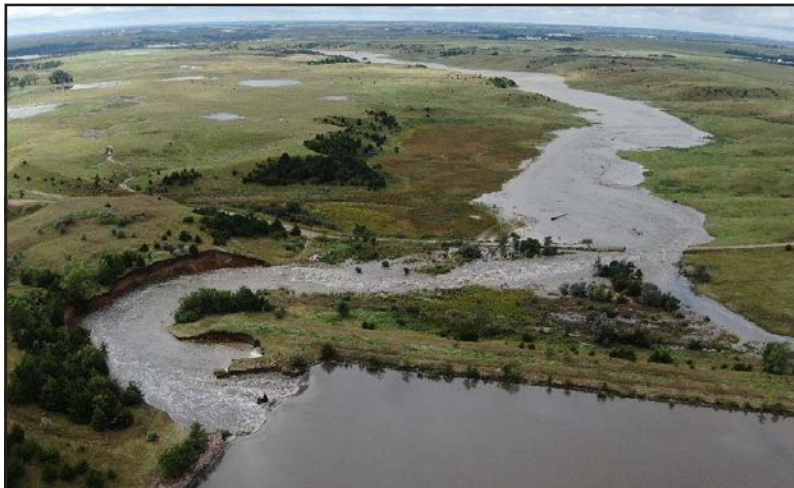
**Figure 113. Picture shows the breaching of Lake Hanson a few hours after Lake Platte broke. Again, another WPA era dam on Pierre Creek in the project area.**
