BAD RIVER PHASE II WATER QUALITY PROJECT

FINAL REPORT

PROJECT SPONSOR
STANLEY COUNTY CONSERVATION DISTRICT

PROJECT PERIOD
MARCH 12, 1990 THROUGH JUNE 30, 1996

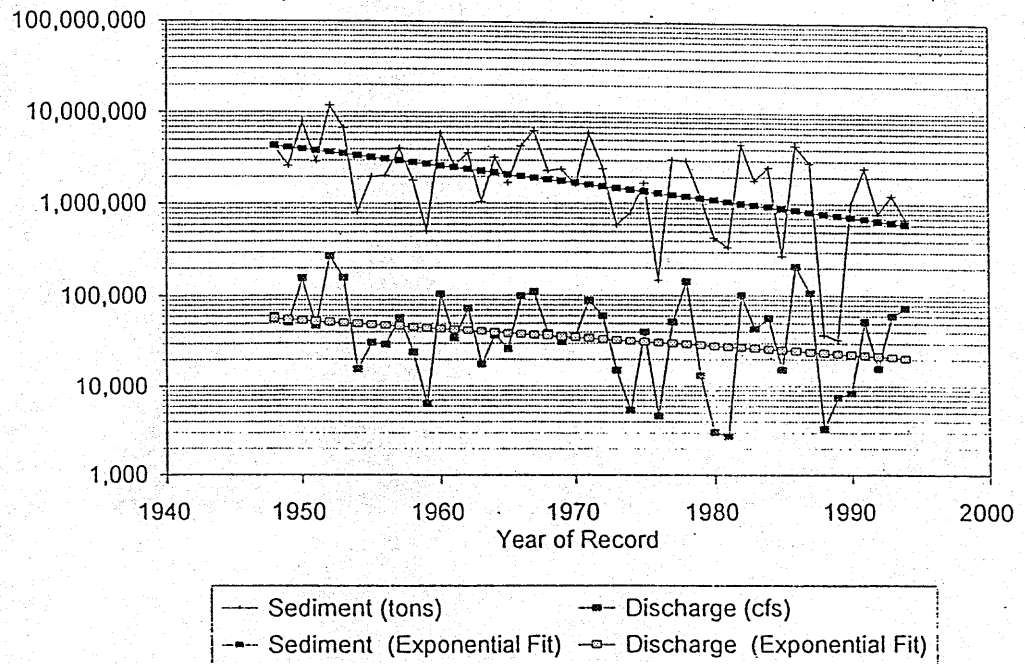
Figure #1

Bad River Sediment vs. Discharge

The Bad River enters the Missouri River within the city limits of the city of Ft. Pierre, SD directly across the Missouri River from Pierre, SD (see Map 1). The Bad River has a notorious past due to its unpredictability of flow and the sediment it transports during runoff events. The U.S. Geological Survey has monitored the mouth of the Bad River for rate of discharge and sediment delivery since 1948. The average annual sediment delivery has been slowly decreasing over that period of time when compared to discharge. (See Figure 1, page 4).

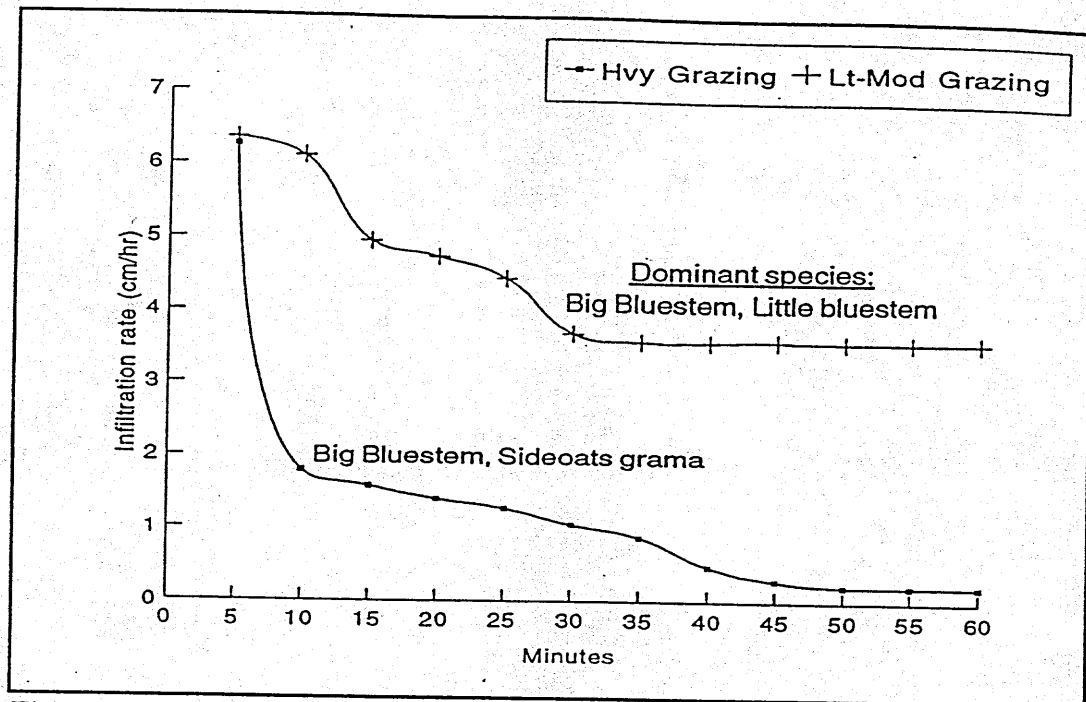
Figure 3. Infiltration of heavy vs. light-moderate grazing on a Sansarc, Shallow Clay range site (25% slope).

There was no difference in 5-minute infiltration rates on the Sansarc (25% slope, Fig. 3) treatments. Both the LMG and HG treatments contained tall grass components, however difference in height of vegetation was significant: 9.9 cm (3.9 in) for (HG) and 54.9 cm (21.6 in) for (LMG).

At 15 minutes, infiltrability was about 2/3 higher on the LMG treatments for the Sansarc (5% slope), Promise (5% slope), and Sansarc (25% slope) sites (See Figs. 1, 2, and 3).

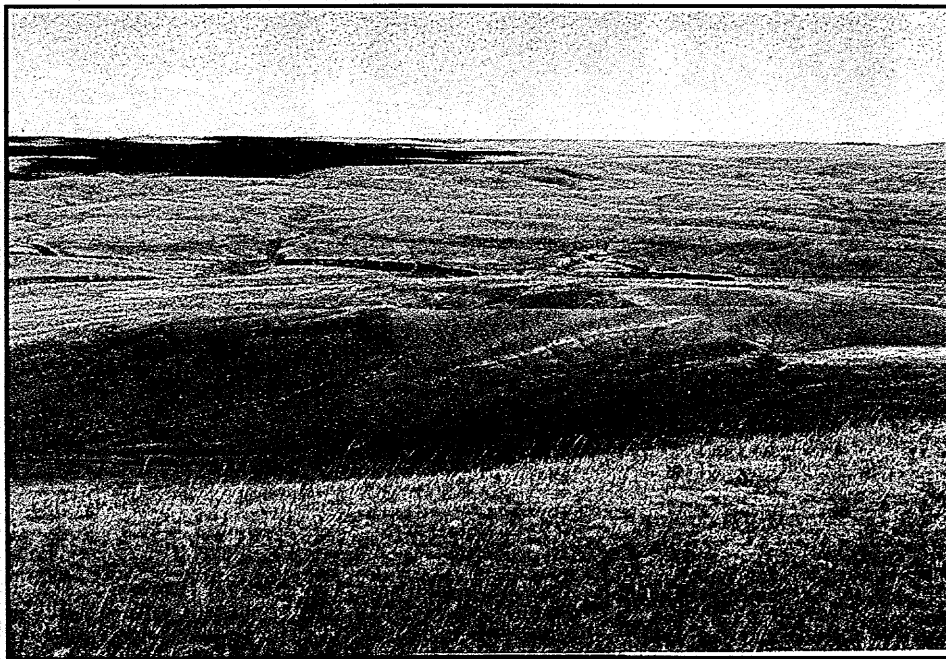
The landscape also shows the barren shale outcrops that are typical in the watershed. These outcrops do not support vegetation in any period of the growing season and are subject to developing a layer of highly erodible soil as a result of the freeze-thaw action on the soil.

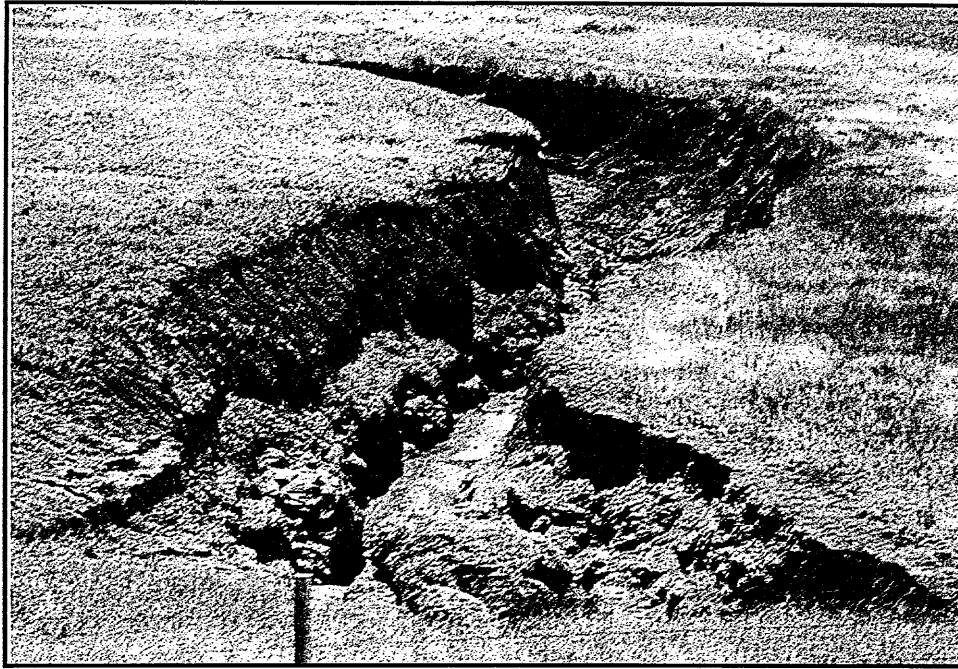
Gully erosion and channel scouring have been identified as major sources of erosion in the project area. This is apparent in the above photo taken after a recent severe summer storm.

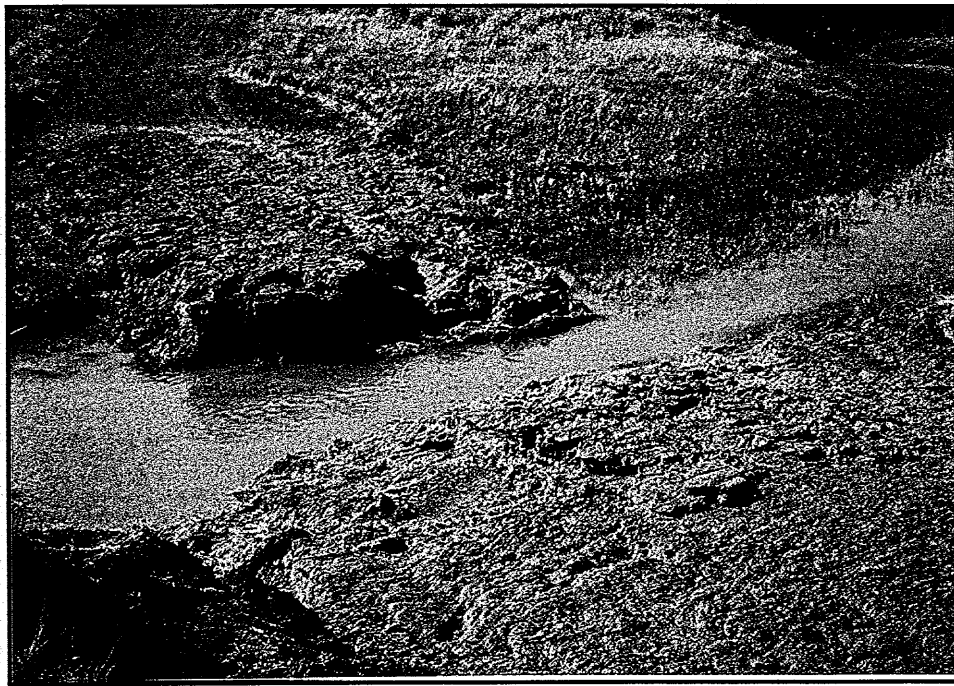
Several times during the summer months, depending on storm events, the crossings are destroyed by heavy runoff and need to be repaired. The sediment washed away increases the sedimentation problems.

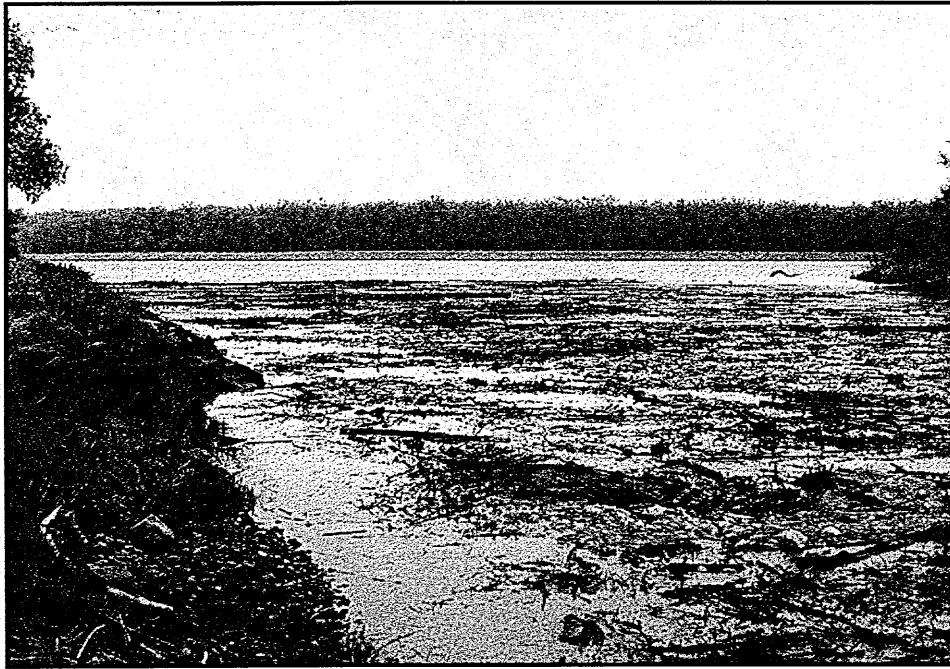
The sediment created by erosion eventually reaches the mouth of the Bad River. When the Bad River is flowing and the Oahe Dam is discharging water, a situation arises where the outflow of the Bad River into Lake Sharpe is stalled as shown in these pictures. The sediment and trash coming down the Bad River are held at the mouth.

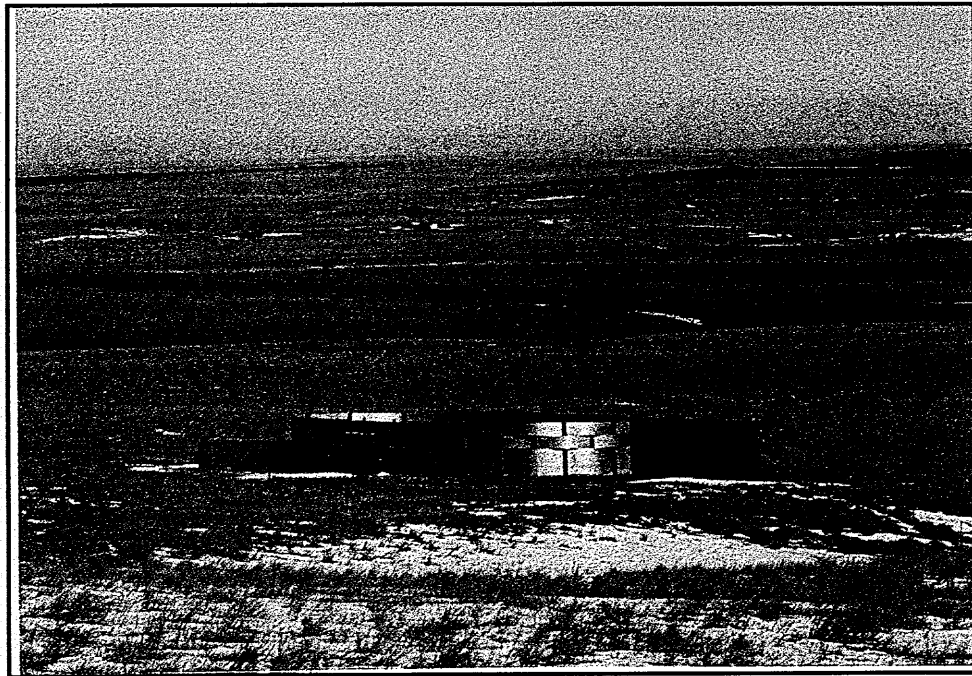
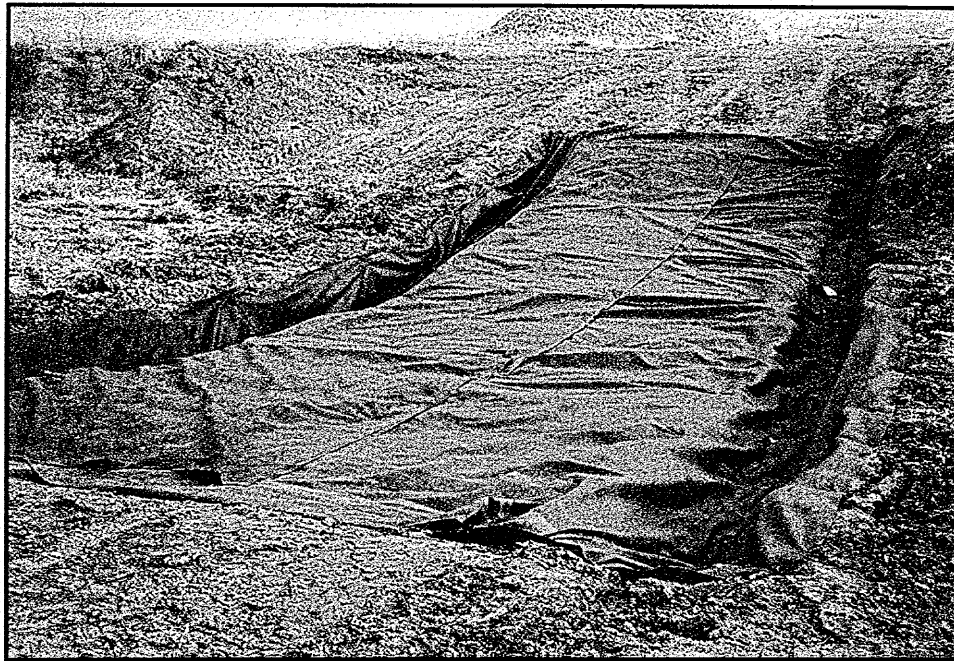
A special practice that was used in the project was the construction of fabricated livestock windbreaks. These are located away from traditional riparian areas and as close as possible to a reliable water source. They are rangeland structures and were not constructed at the ranch headquarters. They are of a size that will hold 100 adult cows. Ranchers added small calf shelters around the perimeter of the windbreak for protection of the young calves away from their mothers.

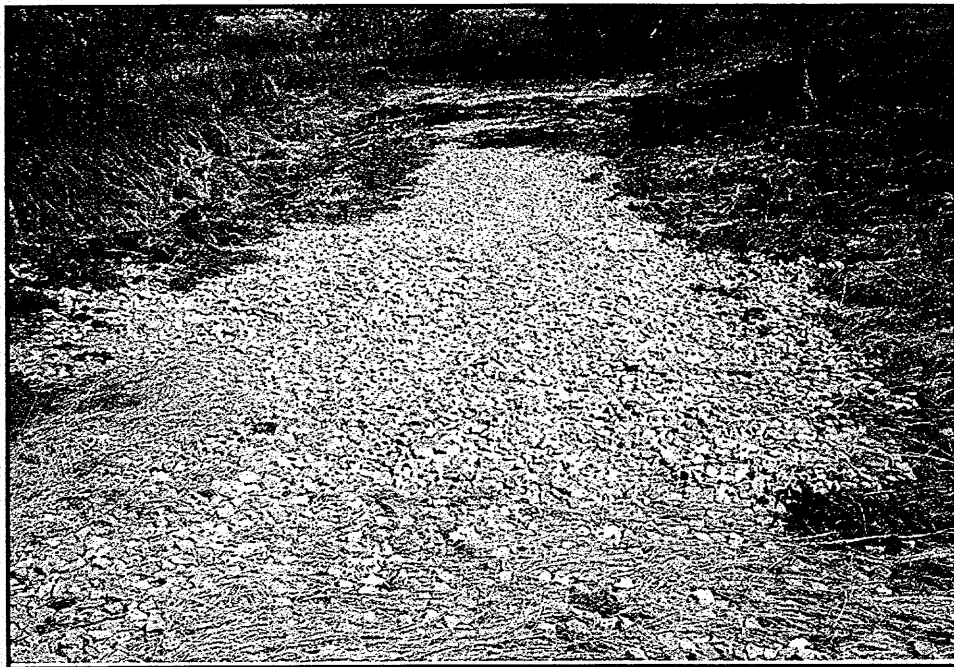
A finished crossing is installed at channel grade level using angular crushed rock. With the filter fabric underlay, it allows for livestock and vehicle usage during times of low stream flow.

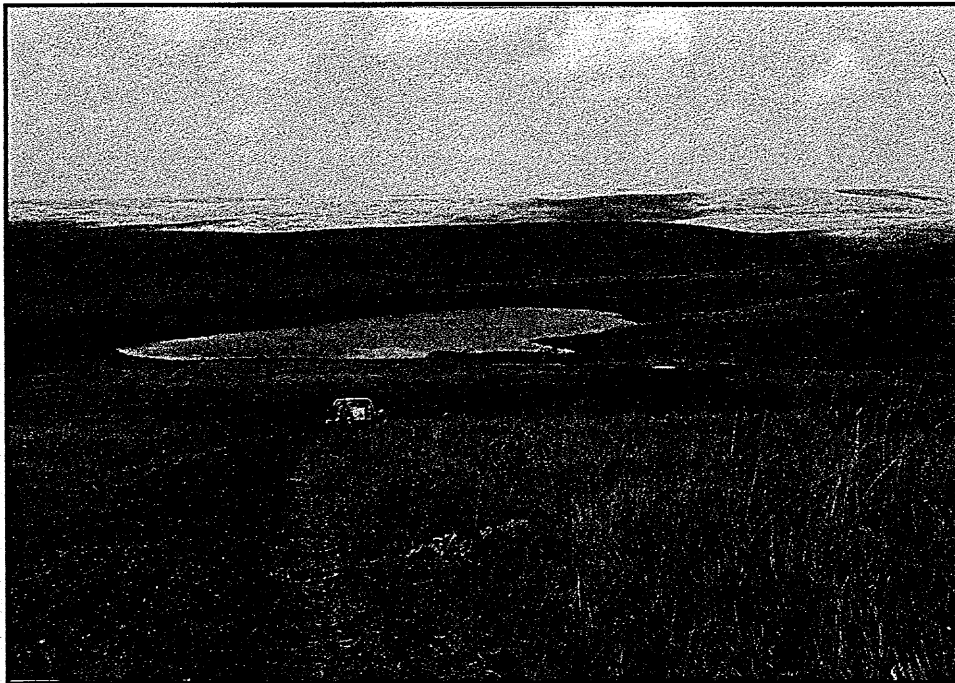
Pipelines and tanks were installed to provide for proper distribution of water. Where possible, tanks were placed close to existing dams to provide additional water and storage from the overflow produced by the flowing wells.

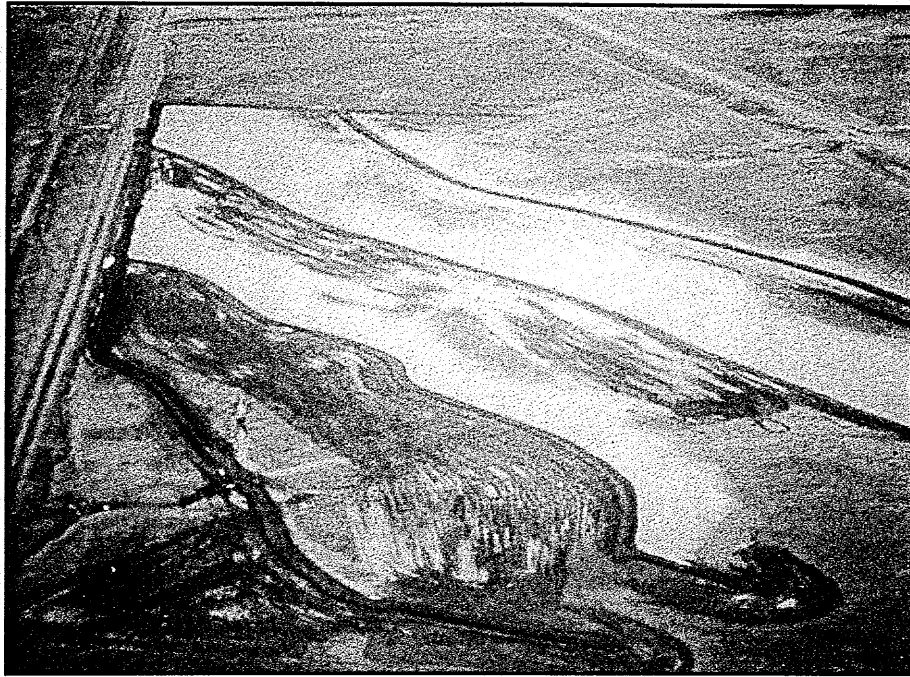
A water spreader system collects runoff that is heavily laden with suspended sediment. It also provides moisture for increased forage production.

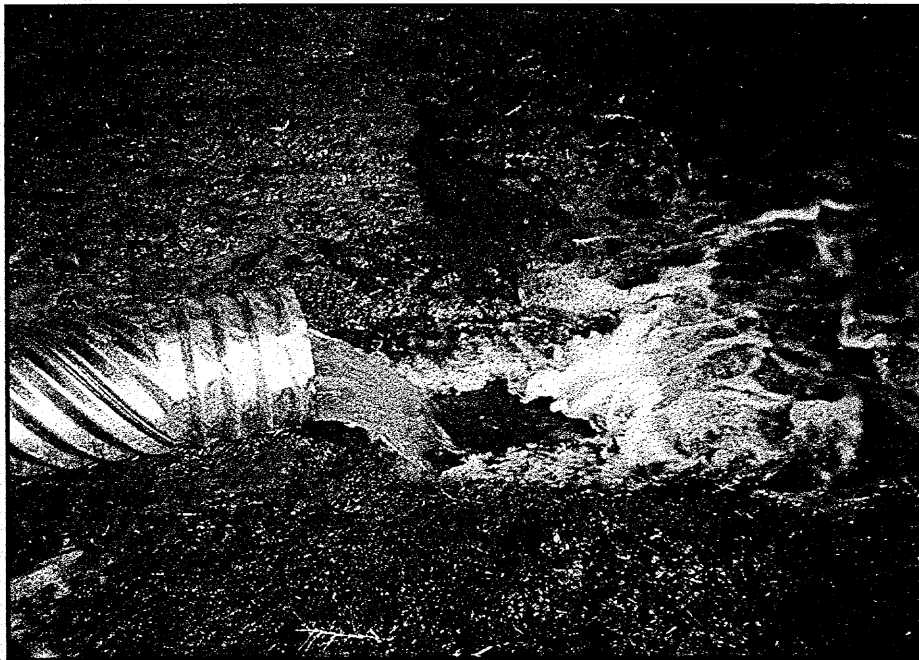
After 7-10 days within the dikes of the spreader system, the water is released through a gated valve to a lower dike. The sediment has had time to settle out and is released much cleaner than when it entered the spreader.

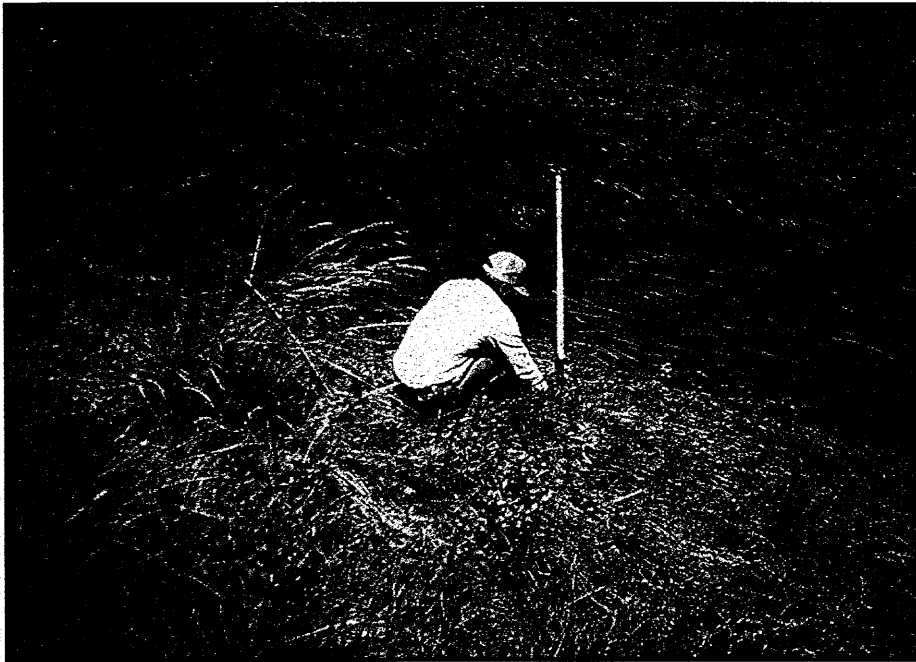
Riparian vegetation re-establishment was accomplished by machine planting of woody species on the floodplains and

hand planting of willows and cottonwoods closer to the stream channel.

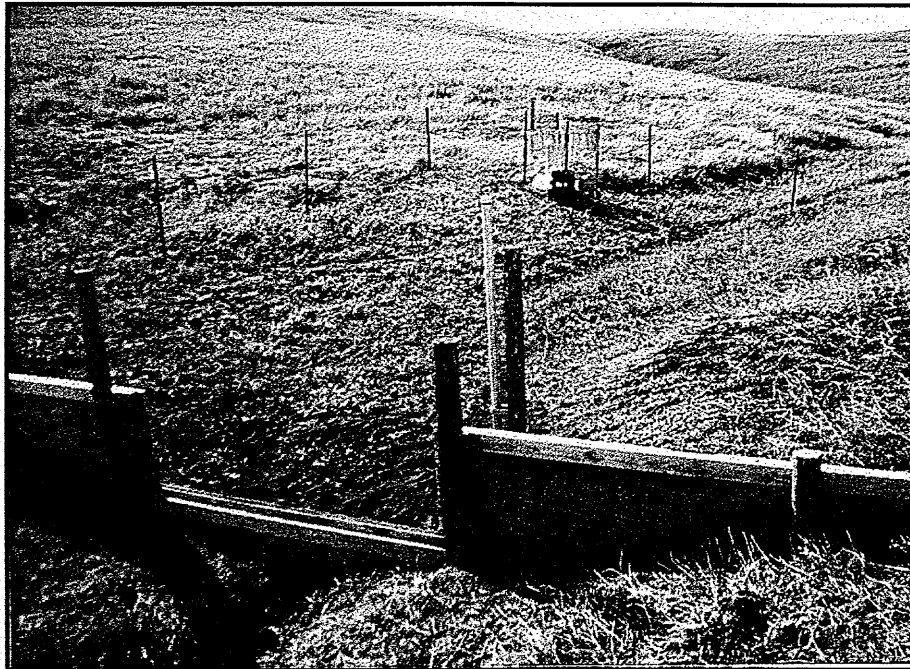
Because of the project's inability to collect water samples as planned from the monitoring sites that were established, rainfall simulation was utilized. A small portable simulator was constructed. Dr. Kenneth Spaeth, NRCS Range Specialist, conducted rainfall simulation trials on rangeland with varying soil types, slopes, and vegetative species in the watershed.

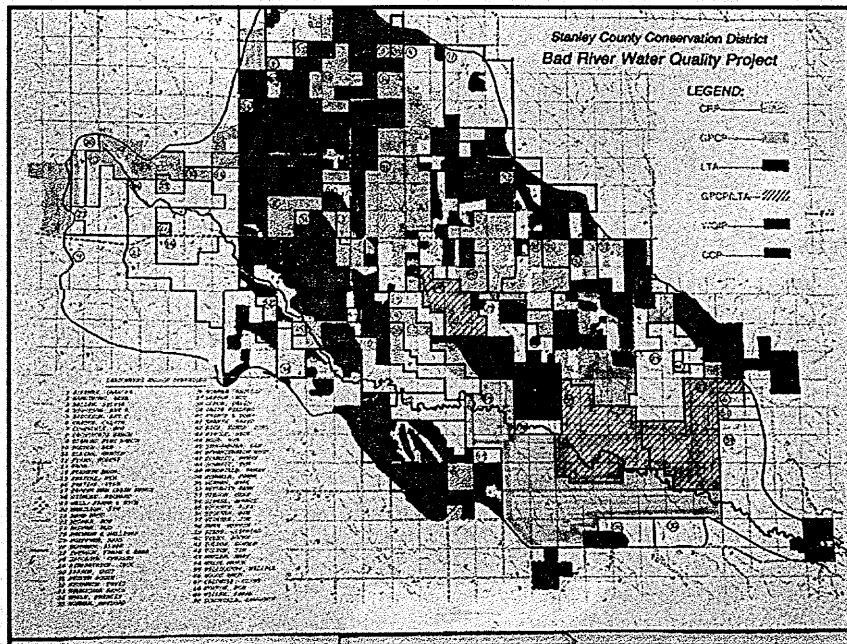
The project has been considered successful. In the target watershed, 90% of the landowners voluntarily participated in the project and treatment was applied to approximately 95% of the land. This is apparent with the colored areas of the treated watershed being those with plans applied. The sediment in this 160,000 acre watershed has been reduced from 82.7 tons of sediment per acre/foot of runoff during 1990, the base year of sampling, to an average of 10.2 tons of sediment per acre/foot of runoff for the years of 1993 through 1995.
