**BAD RIVER SECTION 319 NATIONAL MONITORING PROJECT  
FINAL REPORT**

South Dakota Department of Environment and Natural Resources

For  
U.S. Environmental Protection Agency

October 2013

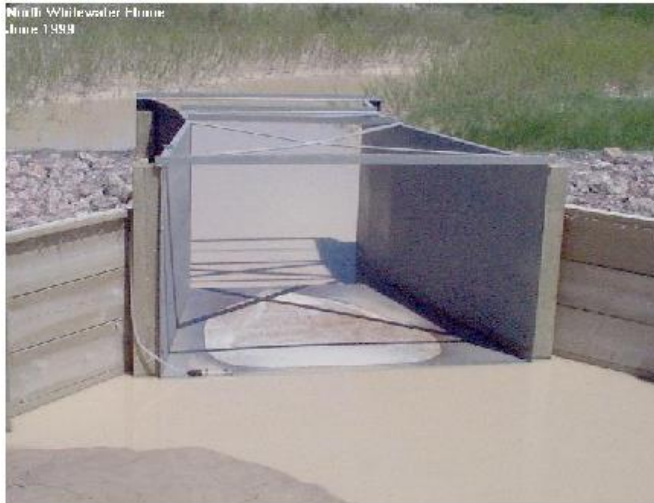
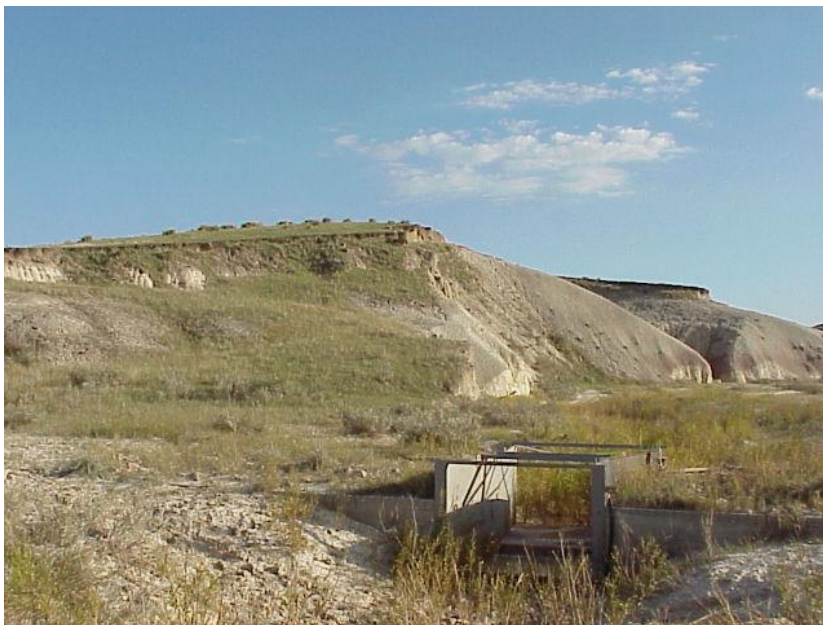
Flume installed at Whitewater Creek North during Whitewater Creek North Implementation Project (SD DENR). And below, after installation.

The streams in this area are ephemeral, so monitoring is storm-event driven. Stream gaging was done using Parshall Flumes with Isco bubbler flow meters calibrated to the flumes. Samples were collected using Isco auto samplers with composite bases. Sampling was done on a flow paced basis during storm events. Storm event occurrence, rainfall amounts, and rainfall intensity were to be compared with the hydrologic discharge and sediment loads. Composite samples were to be collected and analyzed for the duration of flow of each storm event. The water quality parameters to be measured were total suspended solids, stream discharge, and rainfall. Problems arose when collecting data as flow meters clogged frequently. Rainfall and storm intensity varied from site to site, activation switches corroded, and rodents ate through the insulation and the wire core of the activation switches. Due to the drought and natural low flow conditions only 28% of events sampled at Whitewater Creek actually had nonzero flow (Rigge, 2013). 32% of events at Powell Creek had nonzero flow.

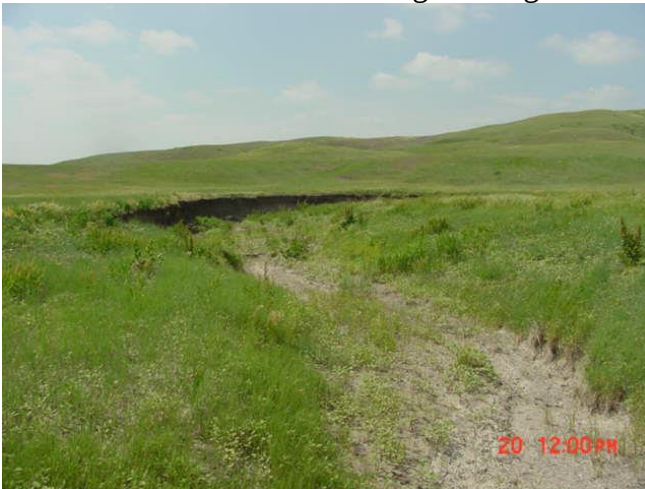
Ash Creek in June 2003 with vegetation growth in stream channel.

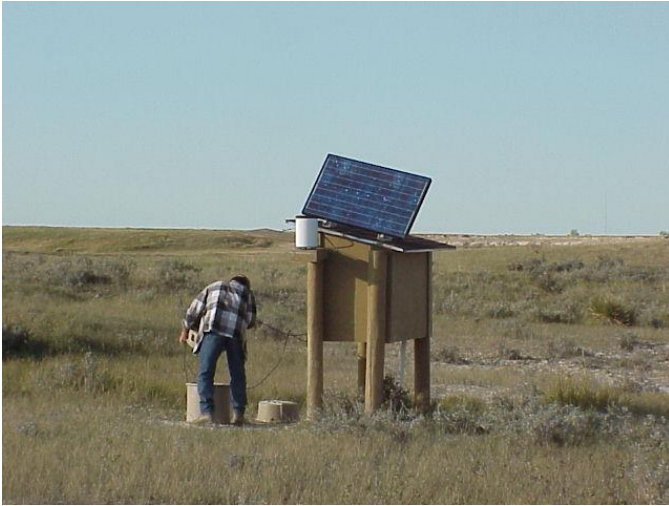
Solar powered equipment box

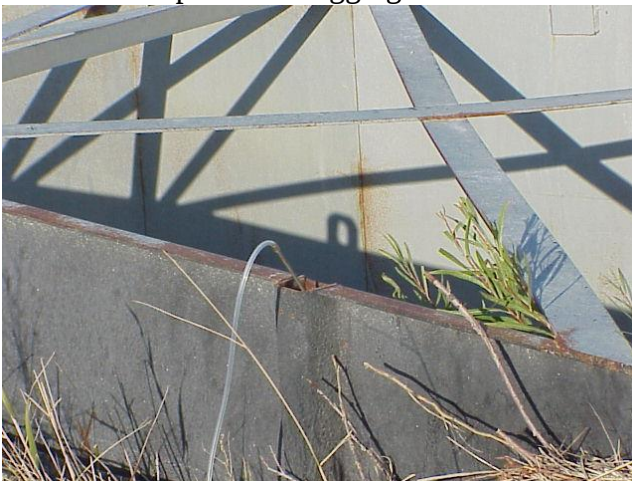
Bubbler tube prone to clogging

clogged often and produced data of questionable quality. Problems occurred collecting data with flow meters clogging frequently. Storm intensity and precipitation varied from site to site, activation switches corroded, and rodents ate through the insulation and the wire core of the activation switches. Water quality monitoring was flawed with meters and sampling units that did not work well in the sediment-laden Bad River. There were not enough TSS samples taken to gain any information from that source. Due to the drought and natural low flow conditions only 28% of events sampled at Whitewater Creek actually had nonzero flow (Rigge, 2013). 32% of events at Powell Creek had non-zero flow. Even restricting TSS data collection to storm events, only 45% of Powell collection events registered non-zero flow.

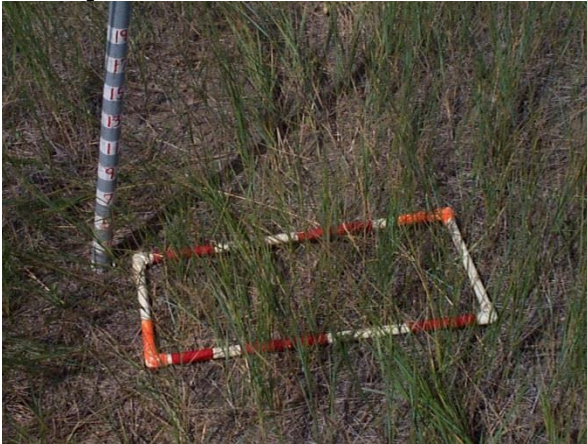
Robel pole and cover class data collection

The Robel Pole method was used to determine vegetative cover at permanent transects located within each subwatershed (Ash Creek — 21 transects, Powell Creek — 13 transects, Whitewater North — 10 transects, and Whitewater South — 9 transects). The Robel Pole measurements were to be taken 3 times per transect per year, spring, summer and fall. Daubenmire frames were utilized to estimate cover classes of ‘rock’ ‘bare ground’ ‘shrub’ ‘forbs’ and ‘grass’. Stations were classified either as warm or cool season dominated grasses. Riparian condition was to be monitored using photopoints and bank pins to measure erosion.

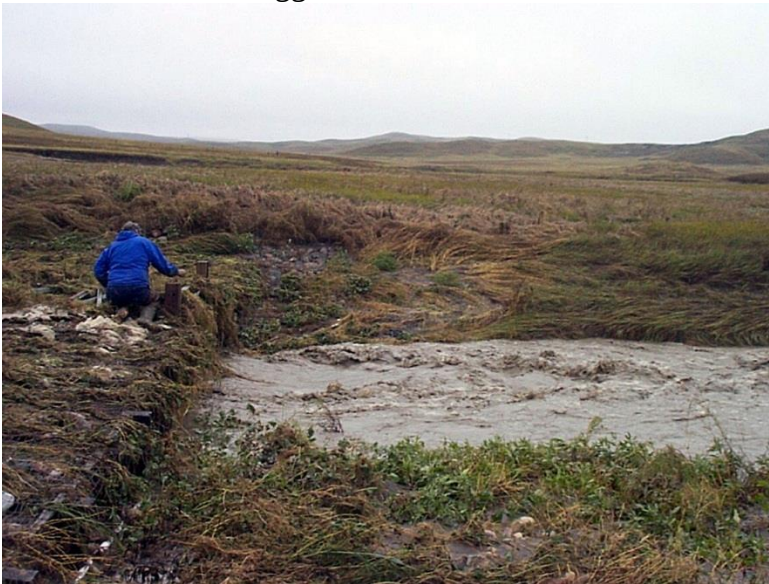
Ash Creek Flume clogged with debris.
