BELLE FOURCHE RIVER WATERSHED MANAGEMENT AND PROJECT IMPLEMENTATION PLAN SEGMENT 8 WATERSHED PROJECT FINAL REPORT SECTION 319 NONPOINT SOURCE POLLUTION CONTROL PROGRAM

OCTOBER 2019

RESPEC
3824 Jet Drive
Rapid City, South Dakota 57703

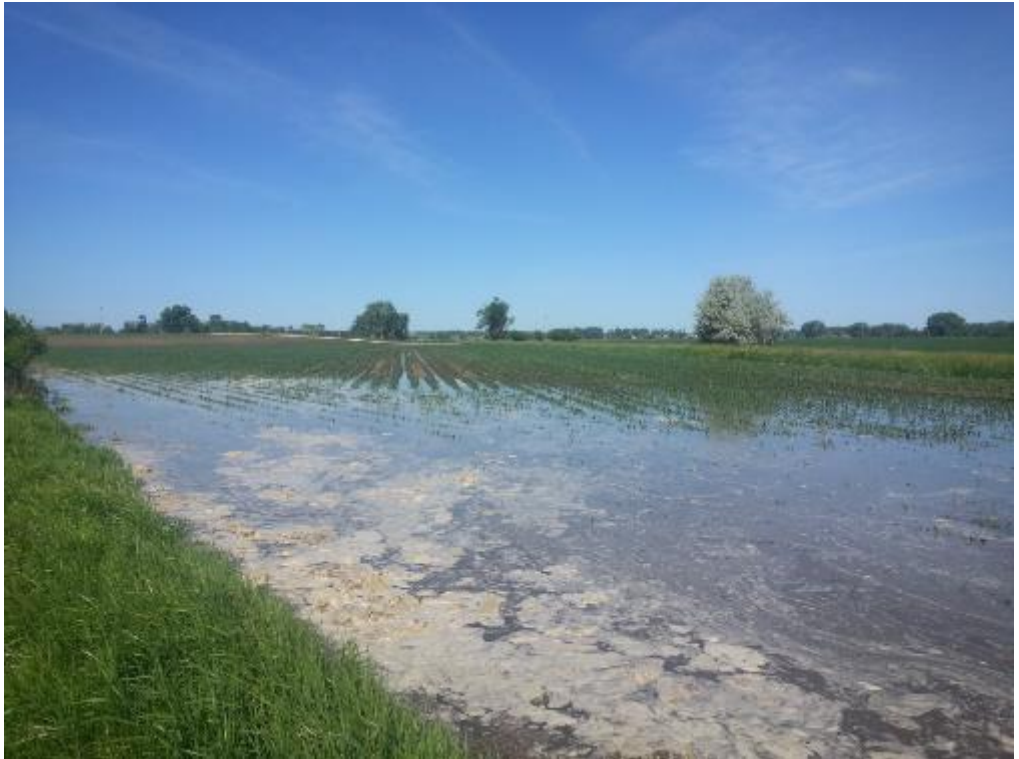
Figure 3-3. Flood-Irrigated Field Demonstrating Inefficient Water Use That Leads to Sediment Runoff.

Eleven center-pivot sprinklers were installed to replace flood irrigation on 888 acres during Segment 8. Figure 3-3 shows a flood-irrigated field and inefficient water use that leads to an increased sediment load in the river. Figure 3-4 shows a Segment 8 partially-funded center-pivot irrigation system that greatly reduces runoff of excess water. There have been 242 center-pivot sprinklers on approximately 19,930 acres installed in the watershed. The BFRWP has partnered on 133 of those 242 sprinklers systems with the remaining systems funded by NRCS or by individual producers.

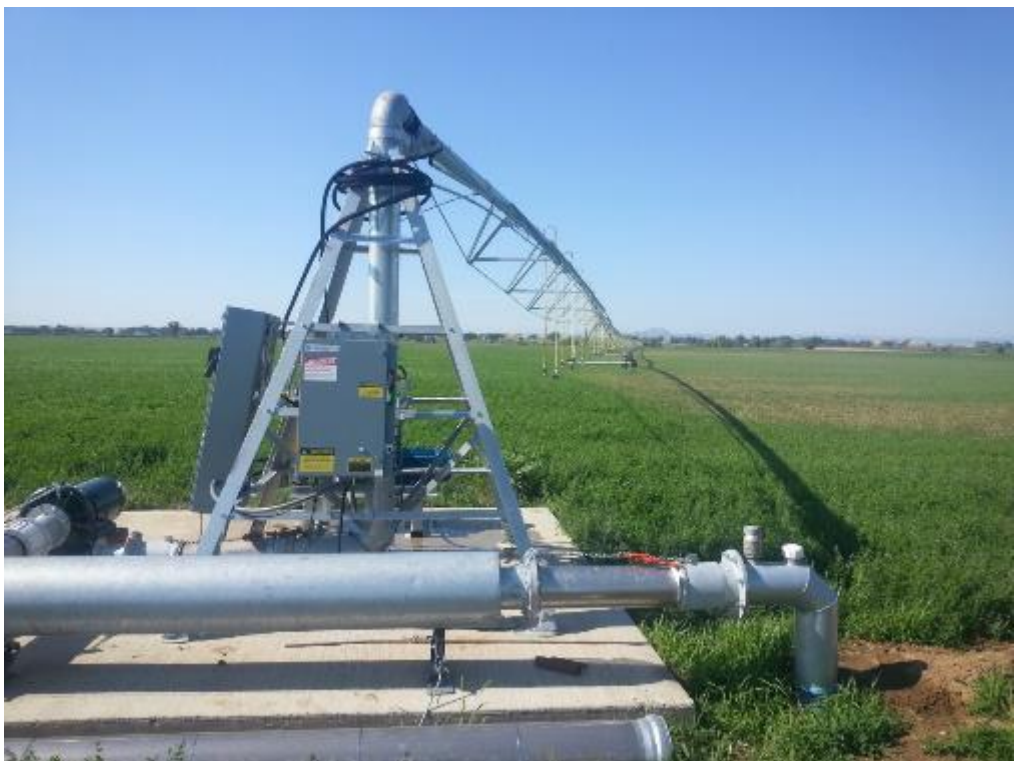
Figure 3-4. Center-Pivot Irrigation System Installed in the Belle Fourche River Watershed.

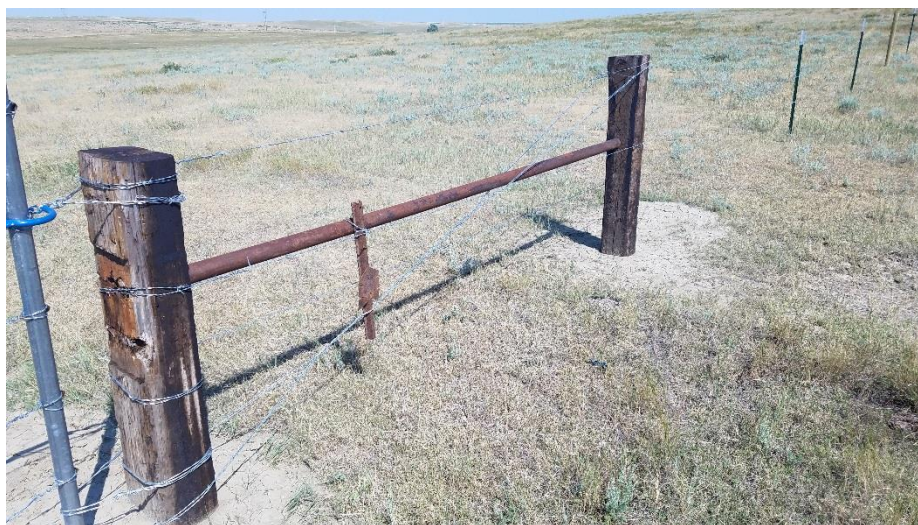
Figure 3-5. Cross Fence Installed in the Uplands to Improved Grazing Management within the Belle Fourche River Watershed.

Seventeen producers participated in range/riparian improvement projects during this segment. These producers installed 13 water development projects, 3 water development and riparian fencing projects, 3 pasture cross-fencing projects, and 1 creek crossing project. These projects improved 2,000 riparian acres and 22,000 rangeland acres within the watershed. The location of the riparian/range improvement projects completed before and during Segment 8 are shown in Figure 3-2. In addition to 319 projects, the NRCS EQIP and CSP-funded projects in the watershed. Figure 3-5 shows a cross fence installation for improving grazing management. Figure 3-6 shows a livestock watering facility installed in the uplands to replace watering on the Belle Fourche River and Figure 3-7 is a photograph buried pipe being installed for livestock water development.

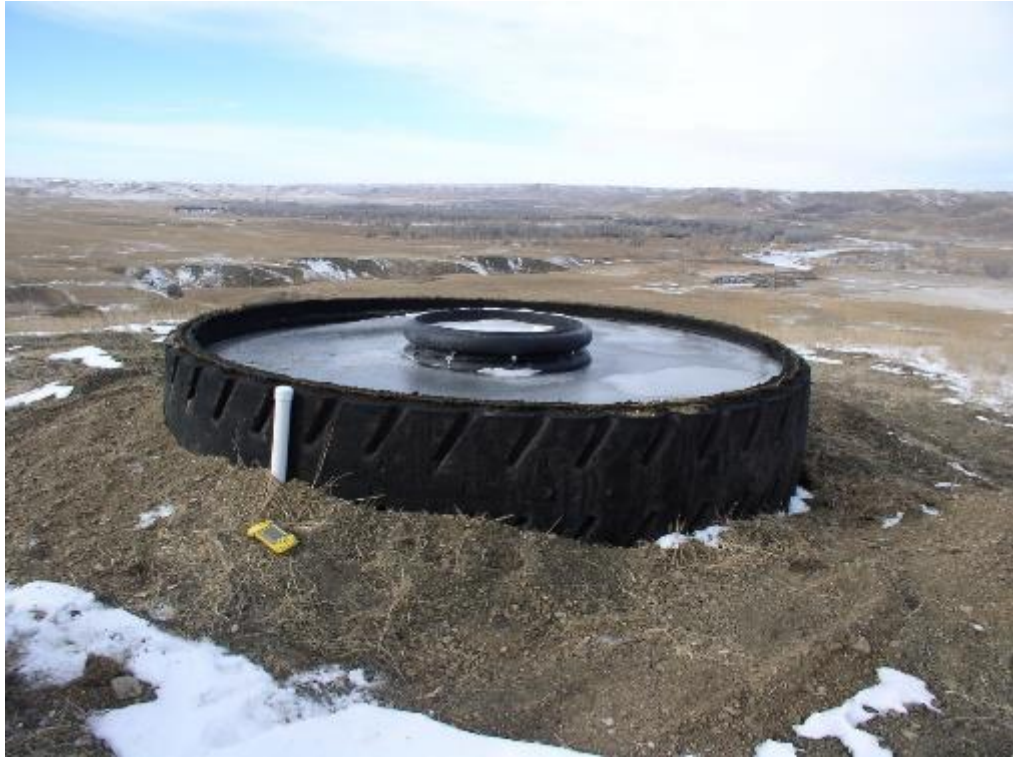
Figure 3-6. Livestock Watering Facility Installed in the Uplands to Replace Watering on the Belle Fourche River.

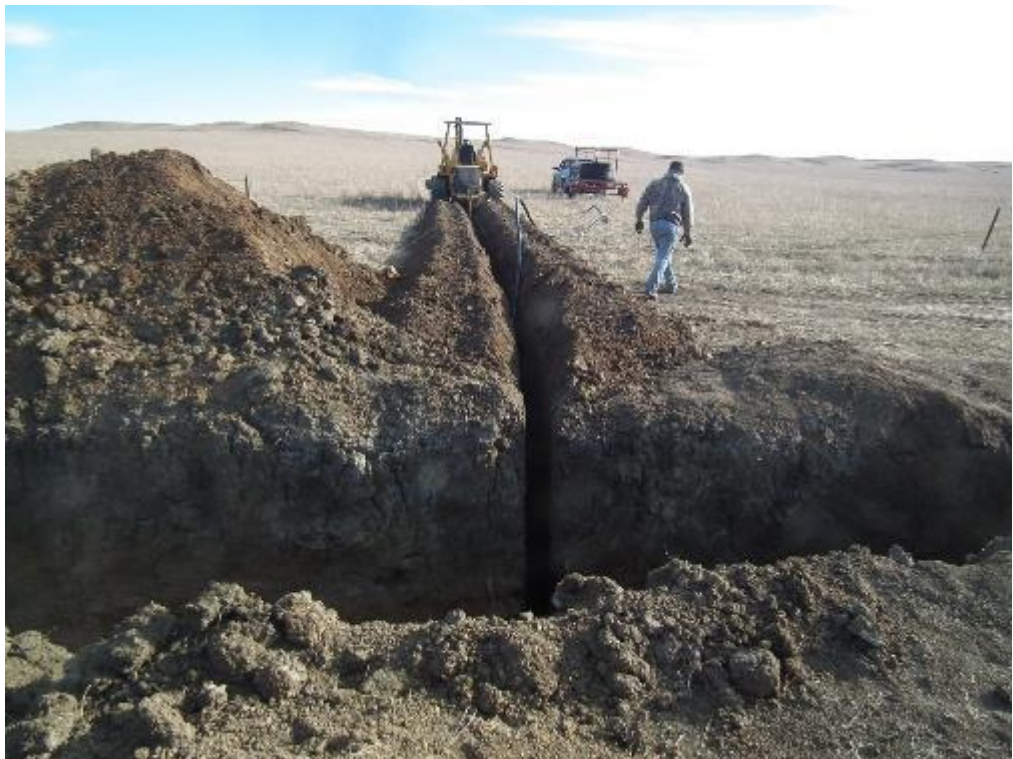
Figure 3-7. Buried Pipeline Installed to Supply Livestock Watering Facilities within the Belle Fourche River Watershed

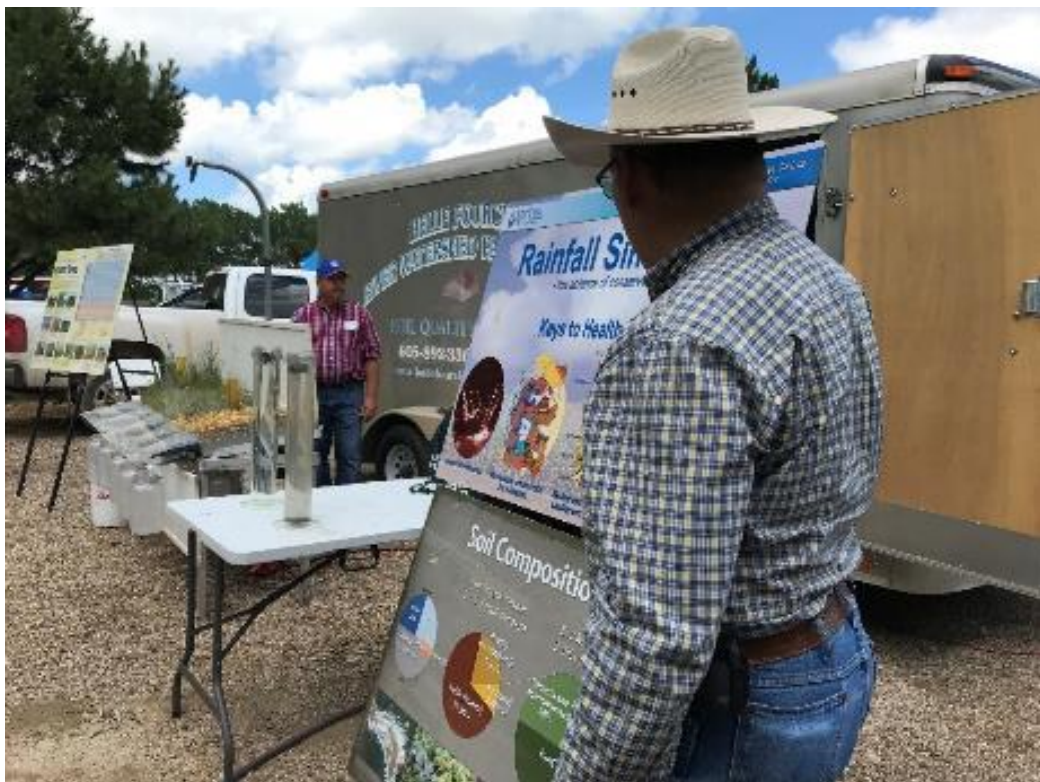
Figure 4-2. Belle Fourche River Watershed Partnership Soil Health and Rainfall Simulator Demonstration.

These tours showcased projects that were sponsored by the BFRWP that included irrigation demonstrations in the BFID, rangeland demonstrations on ranches in the watershed, and an improved cropping system demonstration site tour. These outreach activities helped increase participation and support for the BFRWP and also gave the BFRWP several contacts for BMP installation. The Elk Creek Conservation District's Range and Soil Health Tour in the Belle Fourche River Watershed demonstrates accomplishments is illustrated in Figure 4-1. Figure 4-2 shows a Belle Fourche River Watershed Partnership Soil Health and Rainfall Simulator Demonstration during a watershed tour.

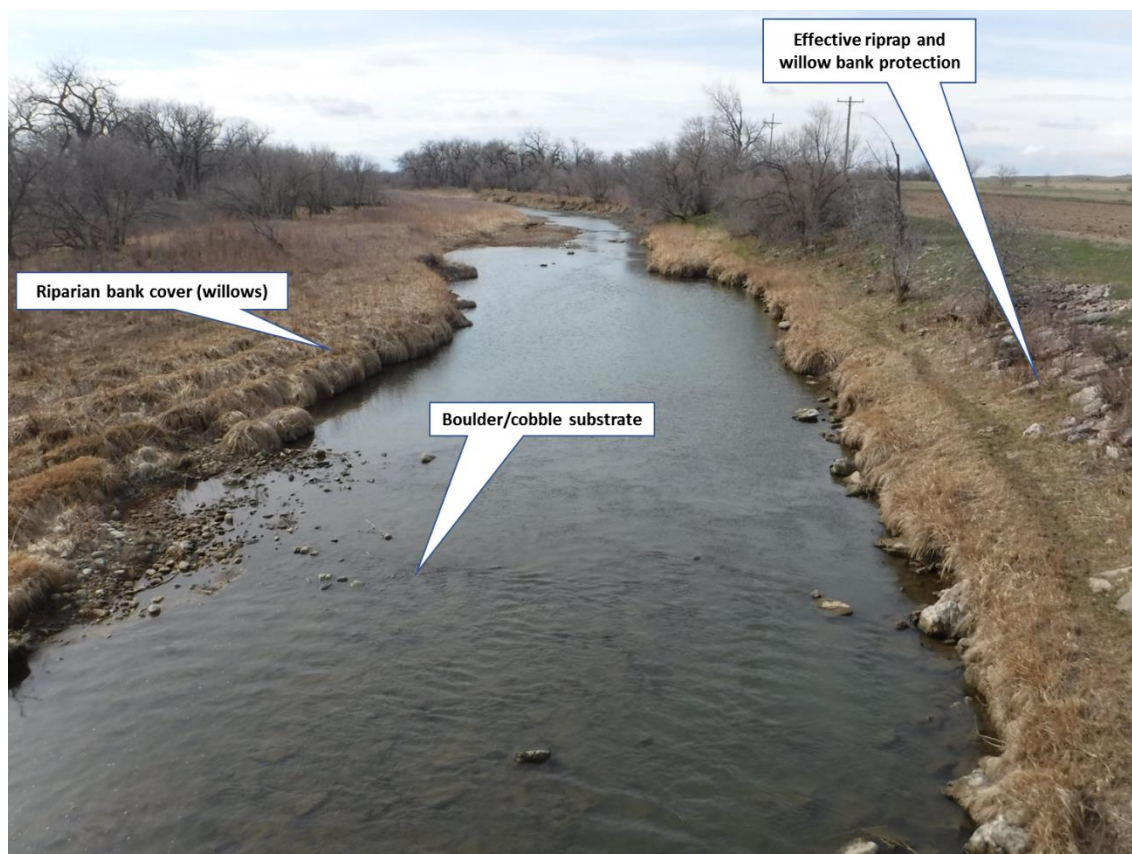
Figure 5-1. Bank Cover, Boulder/Cobble Substrate, and Bank Protection on the Belle Fourche River Above the Fruitdale Road Bridge.

In March 2017, SD DENR staff evaluated 25 sites along the Belle Fourche River, Horse Creek, and Indian Creek using a Rapid Geomorphic Assessment (RGA). Channels near public bridges were assessed using the RGA's metrics for bed material bed, bank protection, incision, constriction, erosion, bank instability, riparian cover, accretion, and channel evolution stage. Some channels have stable bank profiles as shown in Figure 5-1. Also, there were no channels observed that occurred directly downstream of tributaries or irrigation returns entering the river. Other channels observed had conditions similar to those shown in Figure 5-2, Figure 5-3, and Figure 5-4.

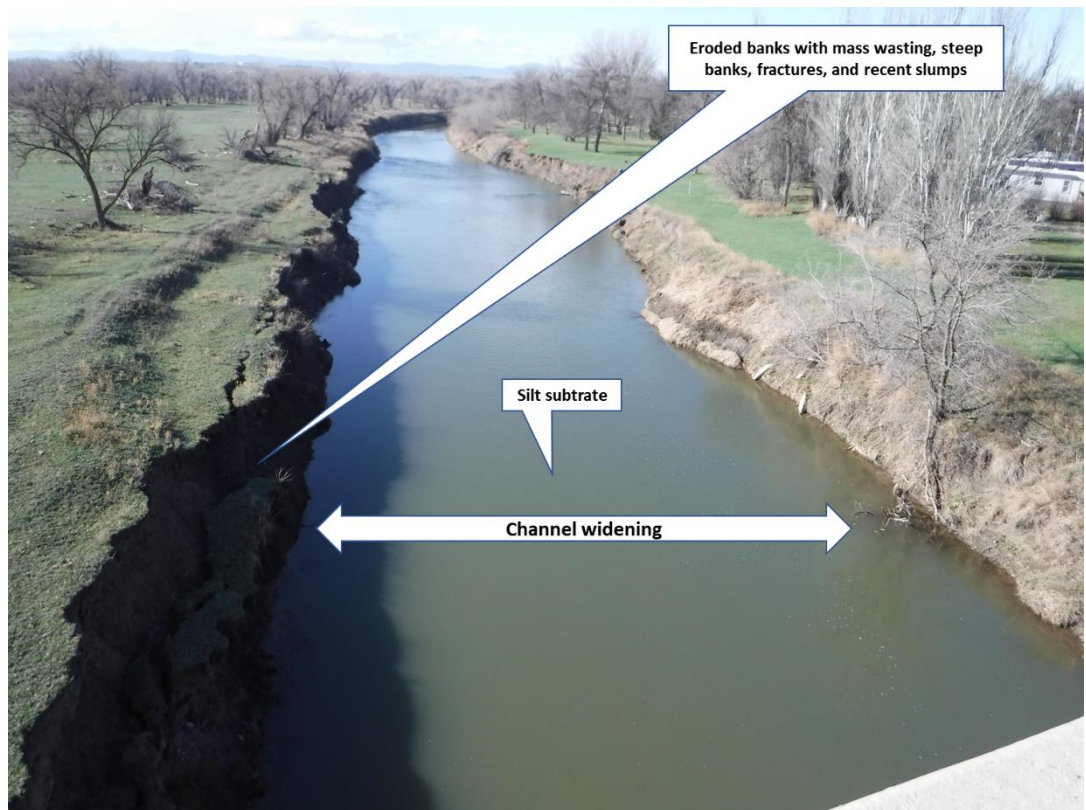
Figure 5-2. Eroded Banks, Silt Substrate, and Channel Widening on the Belle Fourche River Above the US Highway 212 Bridge.

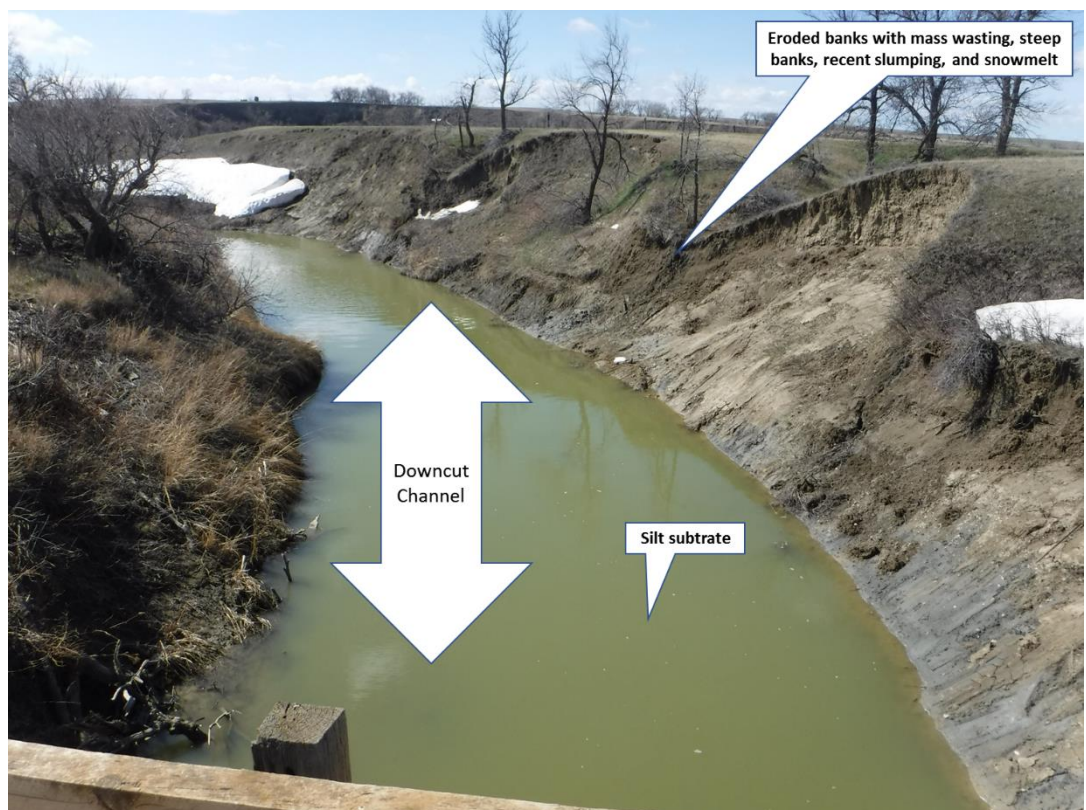
Figure 5-3. Eroded Banks, Silt Substrate, and Downcut Channel on Horse Creek Above the Eichler Road Bridge.

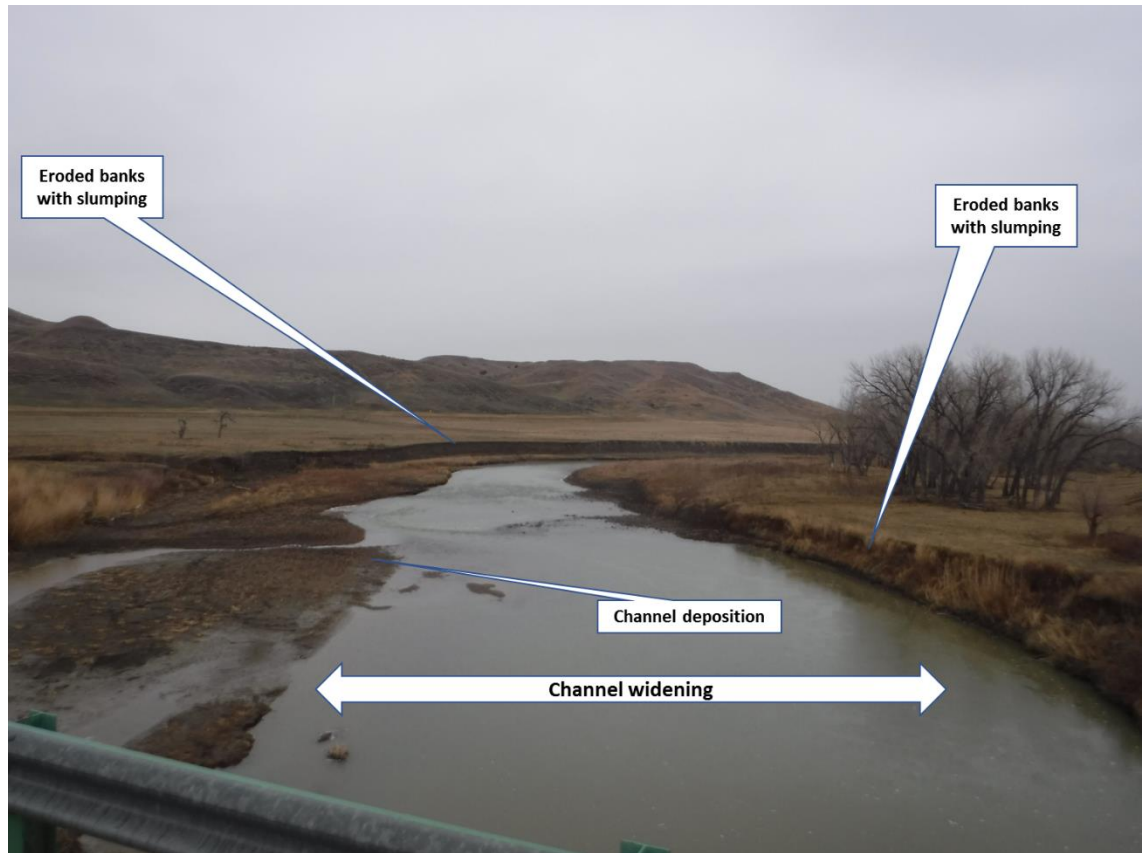
Figure 5-4. Eroded Banks, Channel Deposition and Widening on the Belle Fourche River Below the Elm Springs Road Bridge.

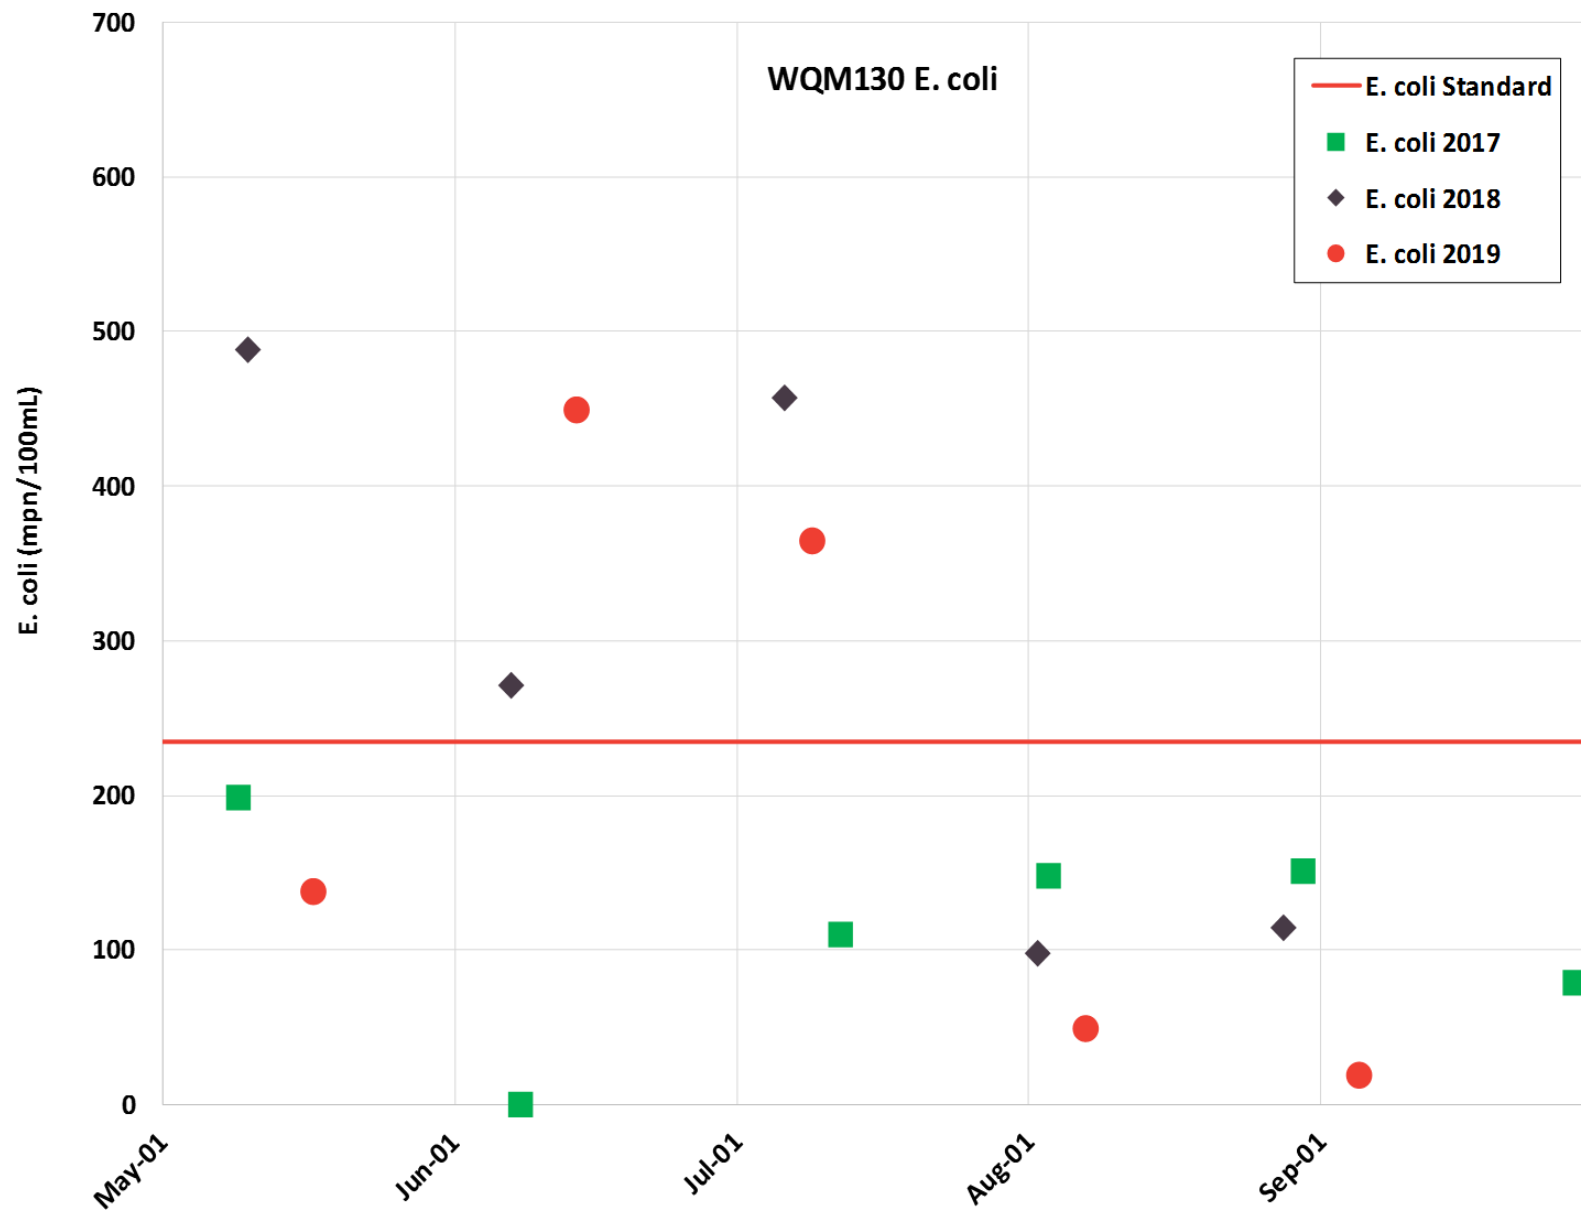
Figure 5-6. *E. coli* Water Quality Sampling Results at Site WQM130 (460130) on the Belle Fourche River from May–September during 2017, 2018, and 2019.

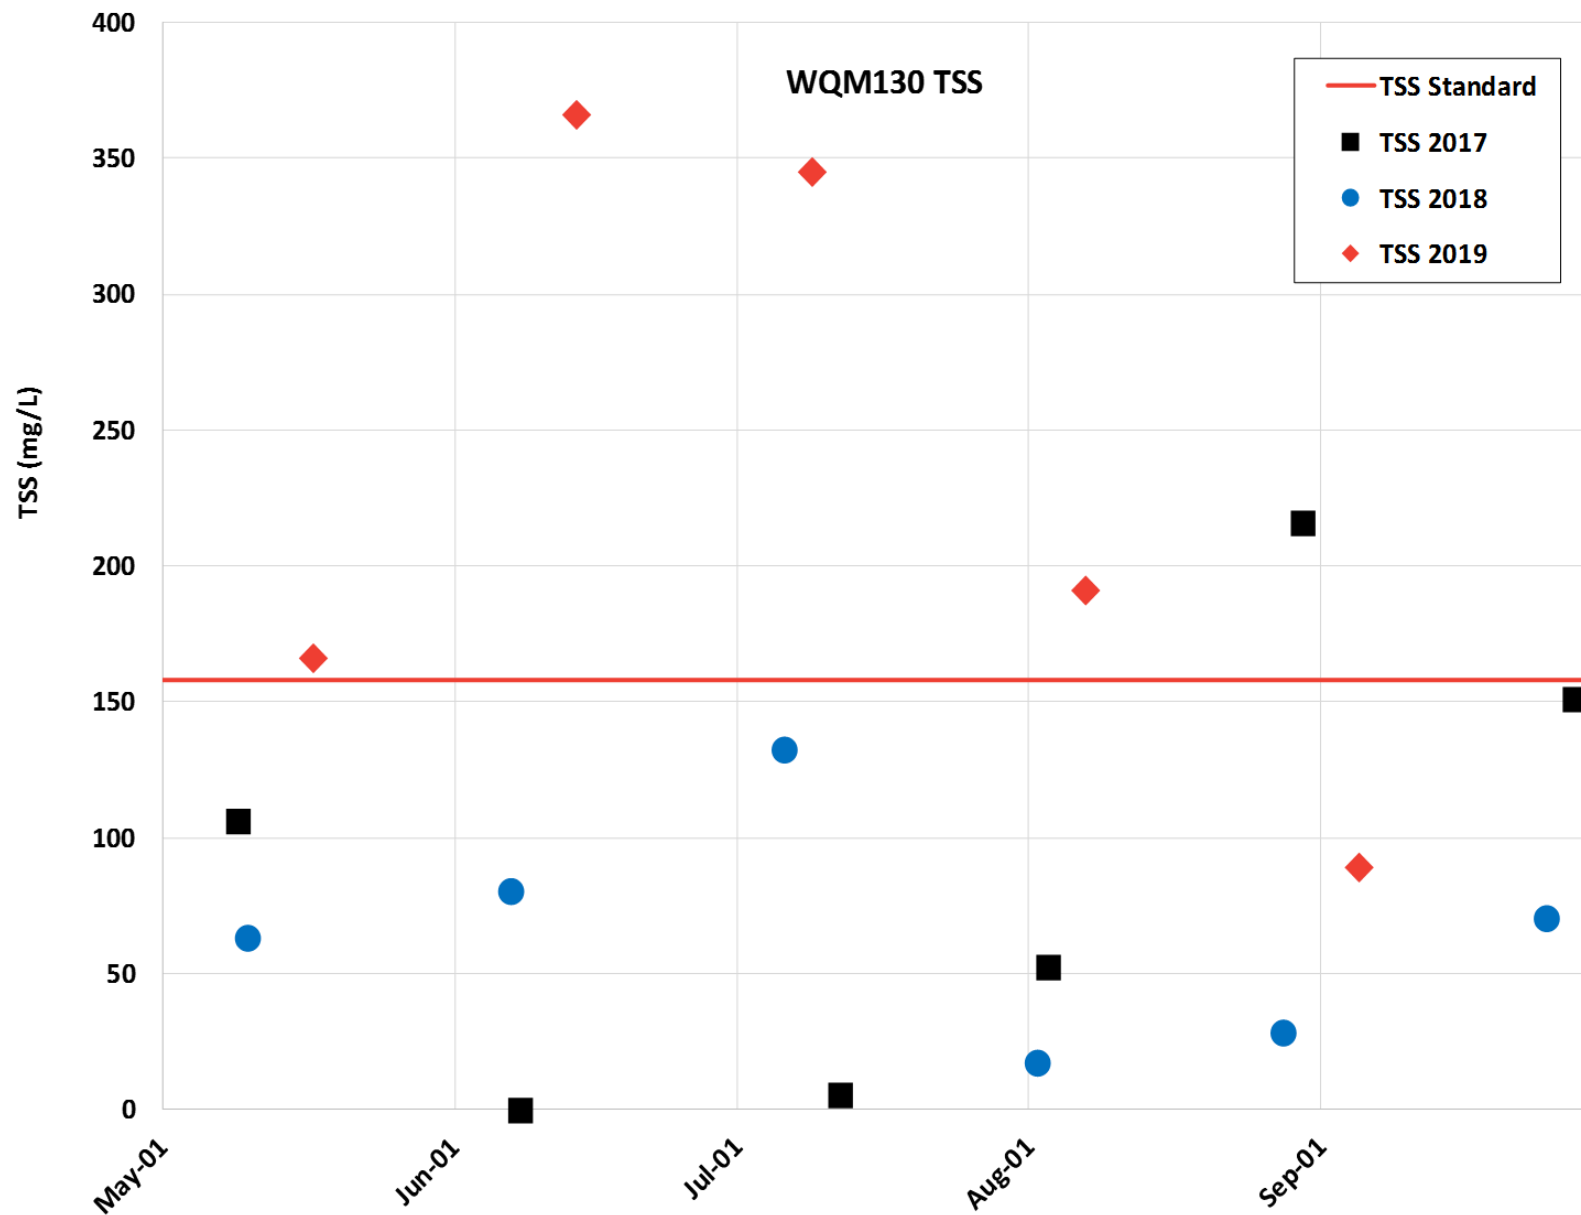
Figure 5-7. Total Suspended Sediment (TSS) Sampling Results at Monitoring Site WQM130 (460130) on the Belle Fourche River from May–September during 2017, 2018, and 2019.

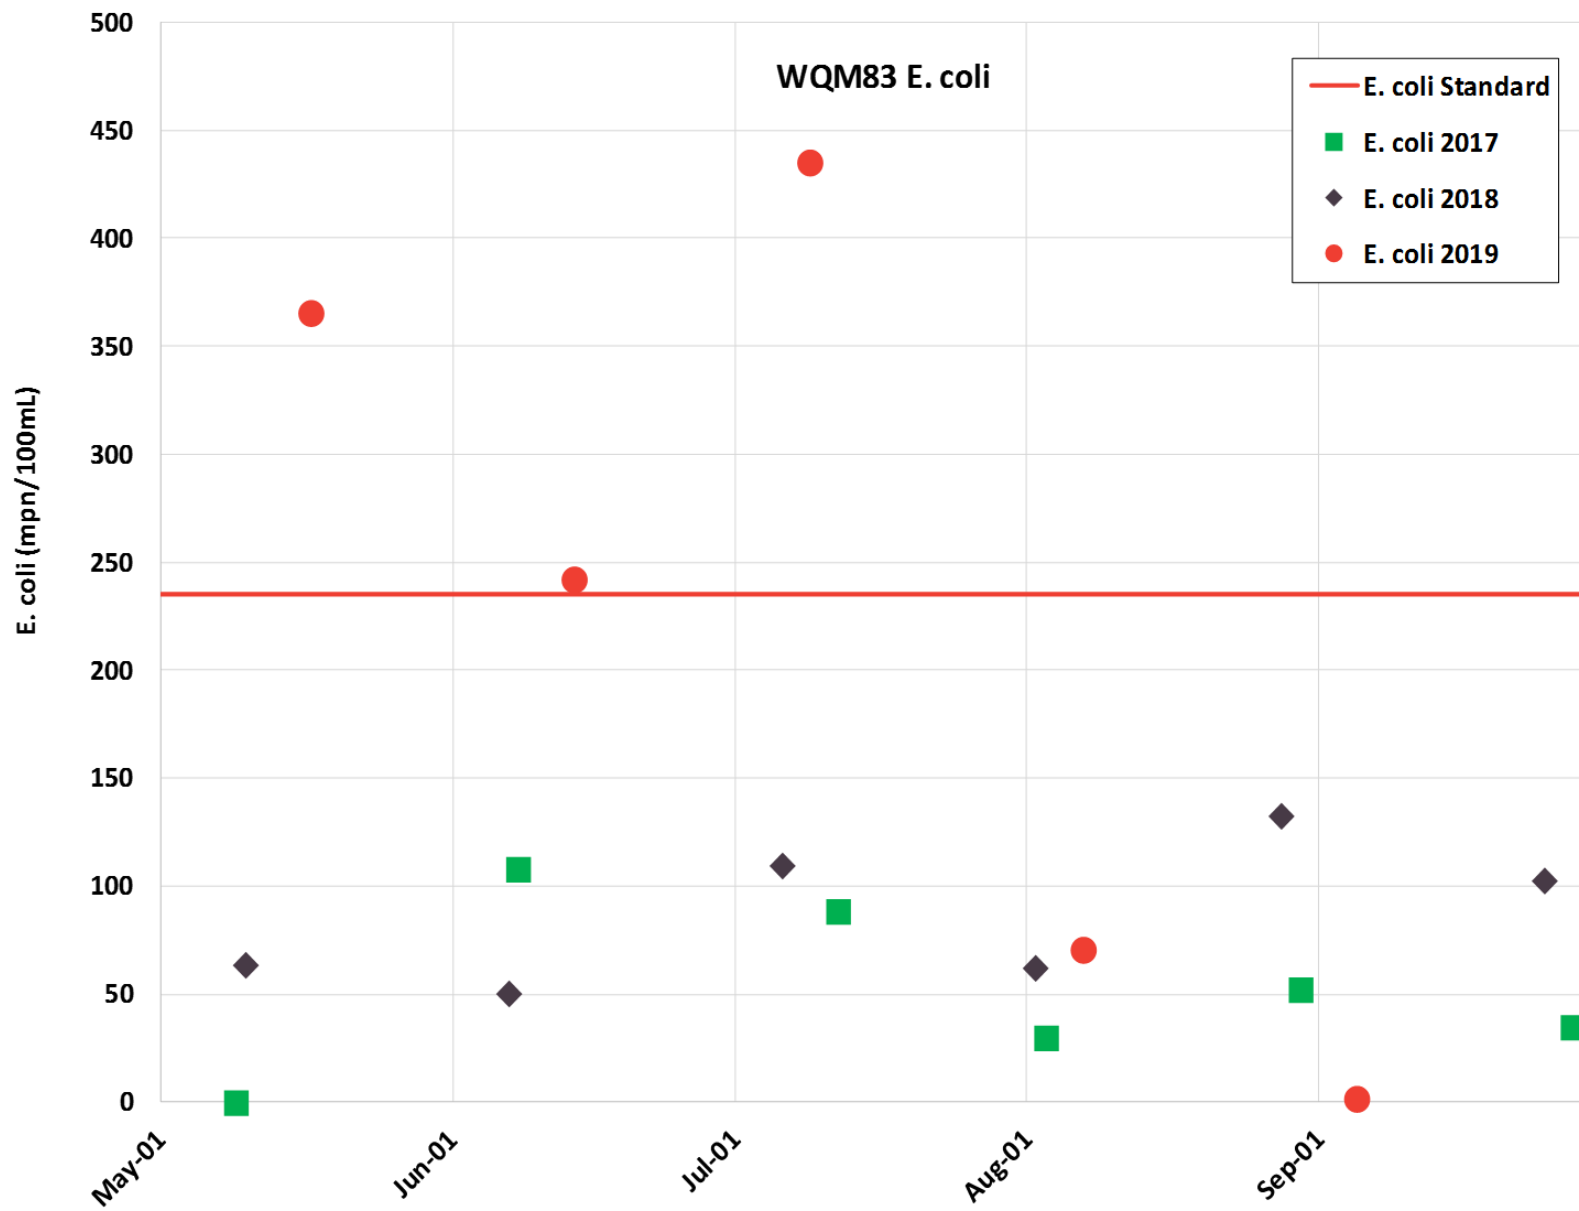
Figure 5-8. *E. coli* Sampling Results at Monitoring Site WQM83 (460683) on the Belle Fourche River from May–September during 2017, 2018, and 2019.

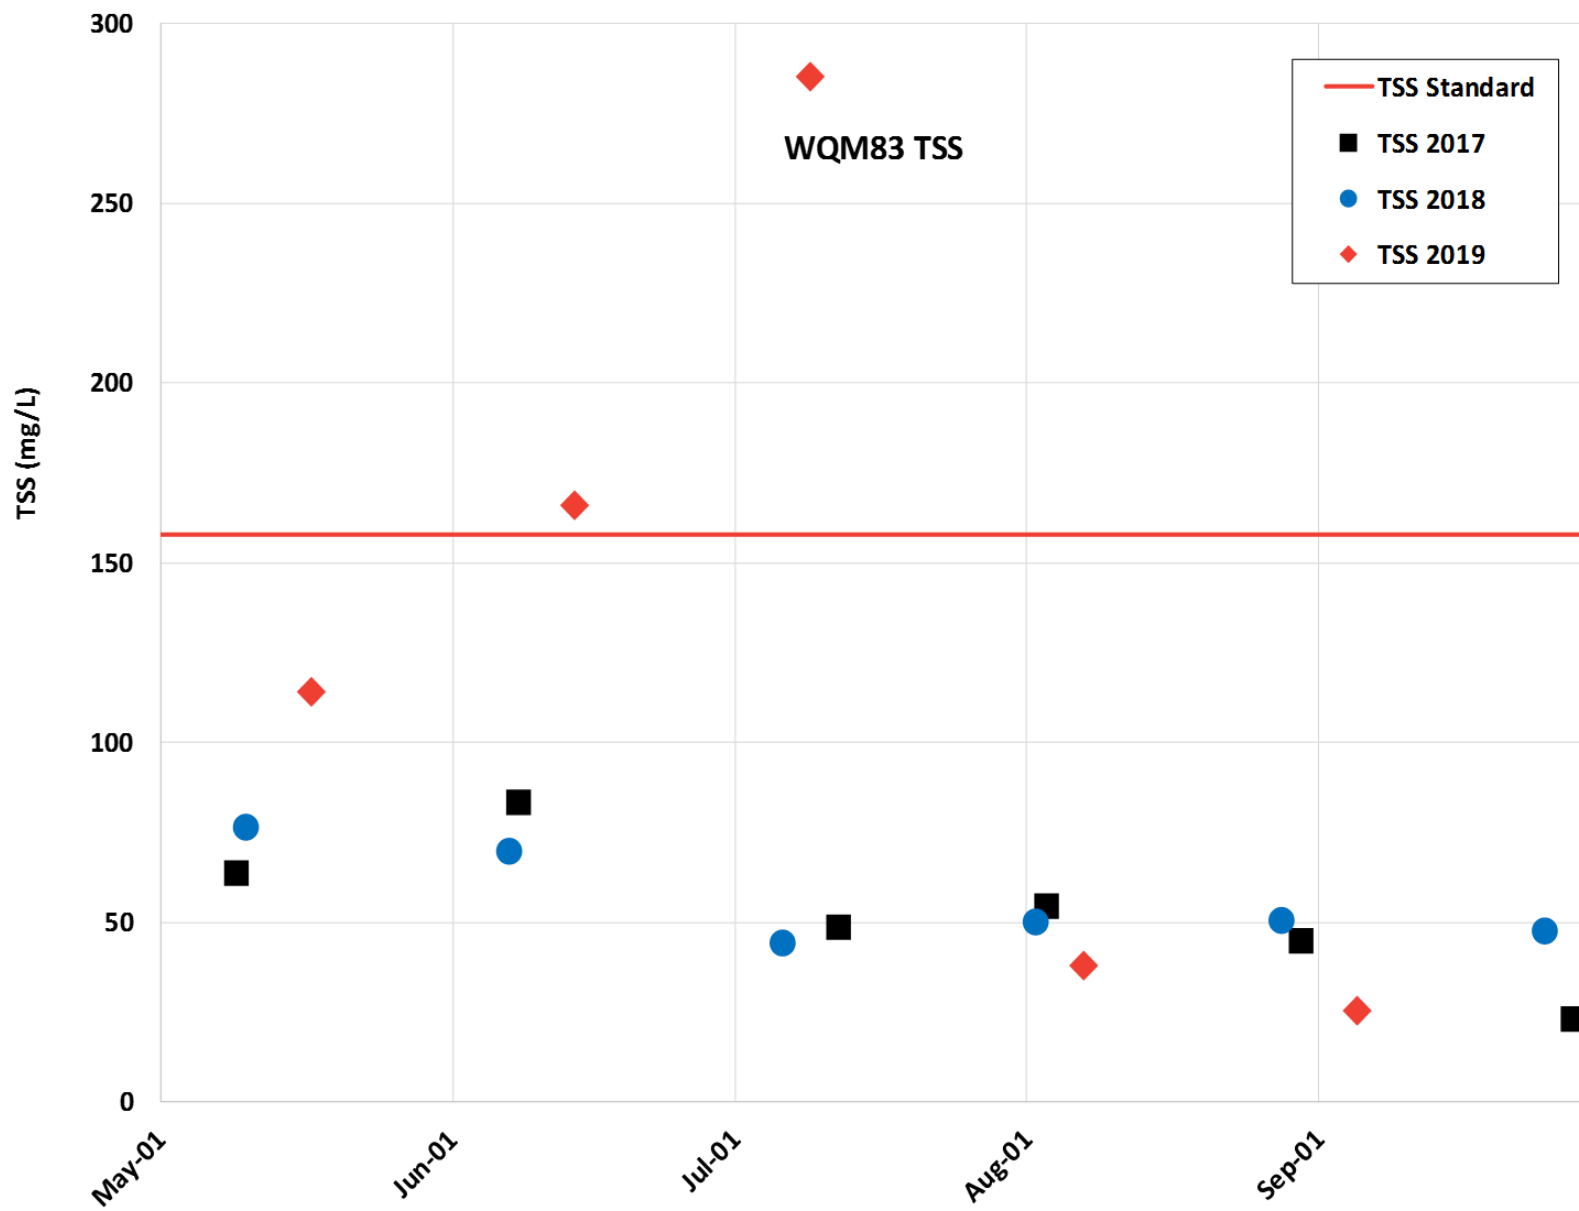
Figure 5-9. Total Suspended Sediment (TSS) Sampling Results at Monitoring Site WQM83 (460683) on the Belle Fourche River from May–September during 2017, 2018, and 2019.

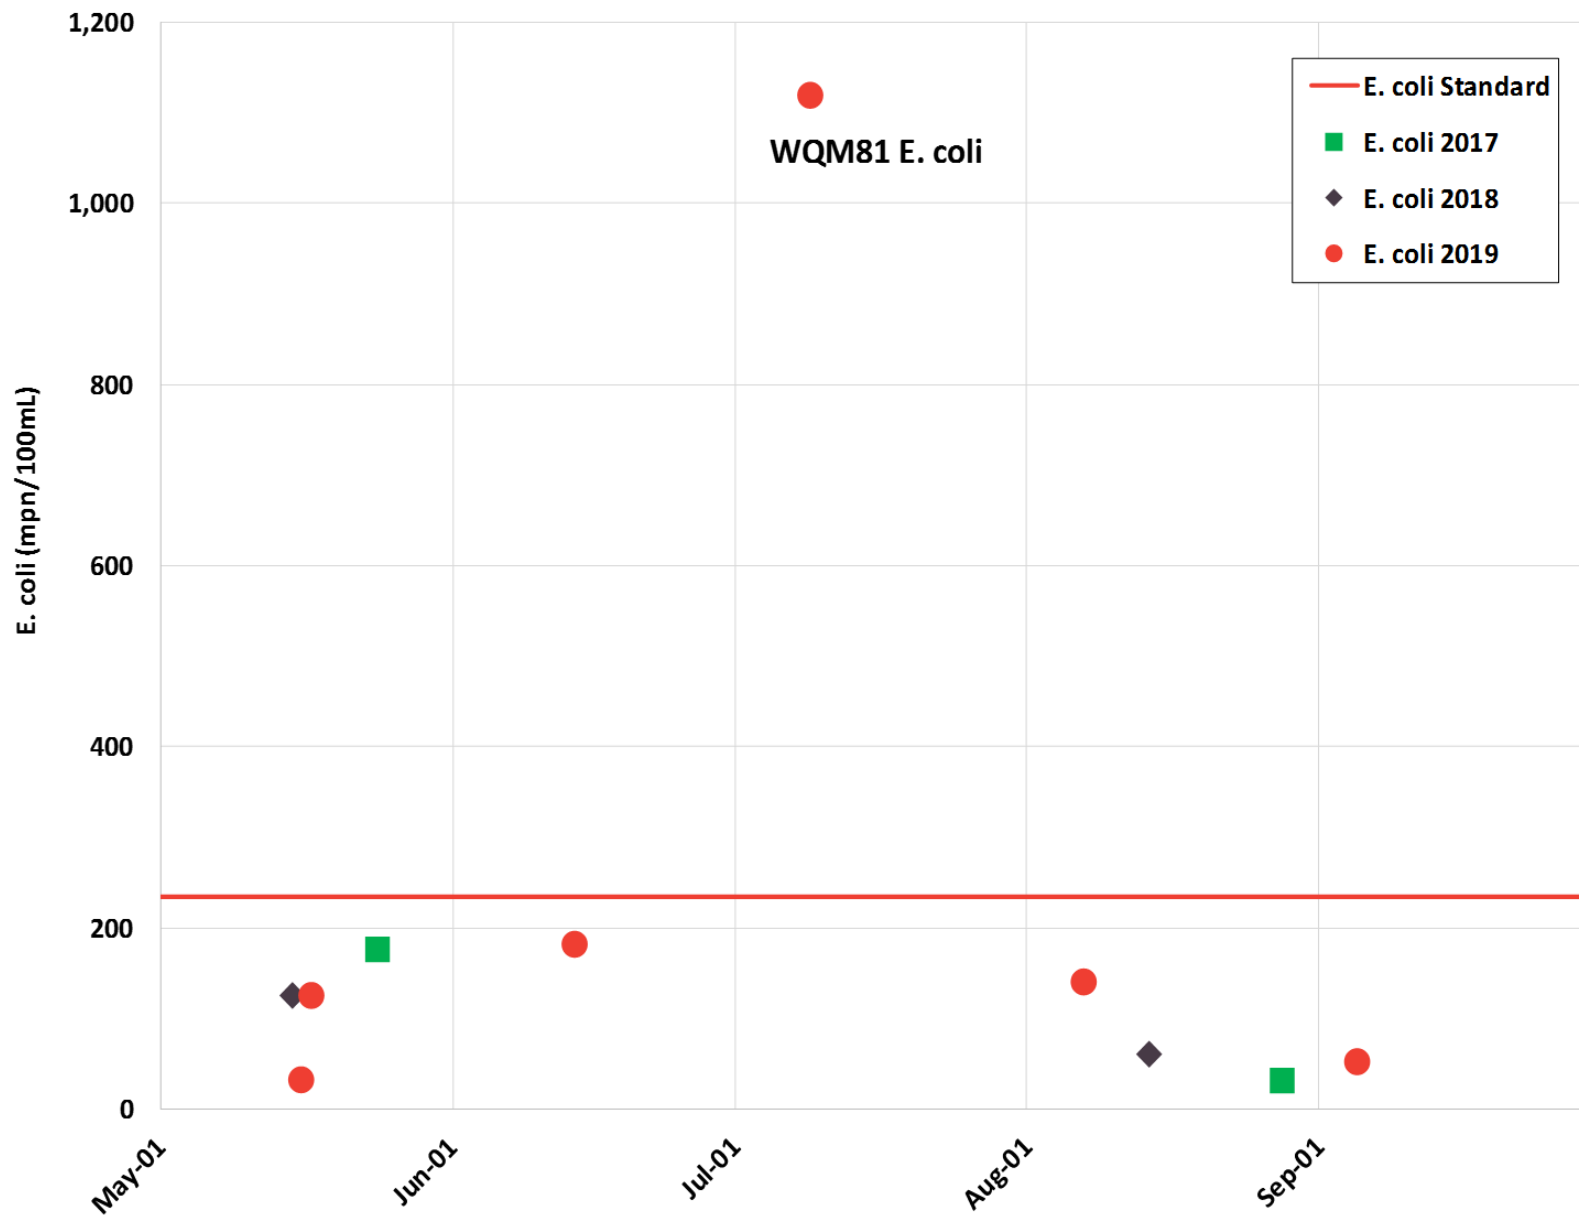
Figure 5-10. *E. coli* Sampling Results at Monitoring Site WQM81 (460681) on the Belle Fourche River from May–September during 2017, 2018, and 2019.

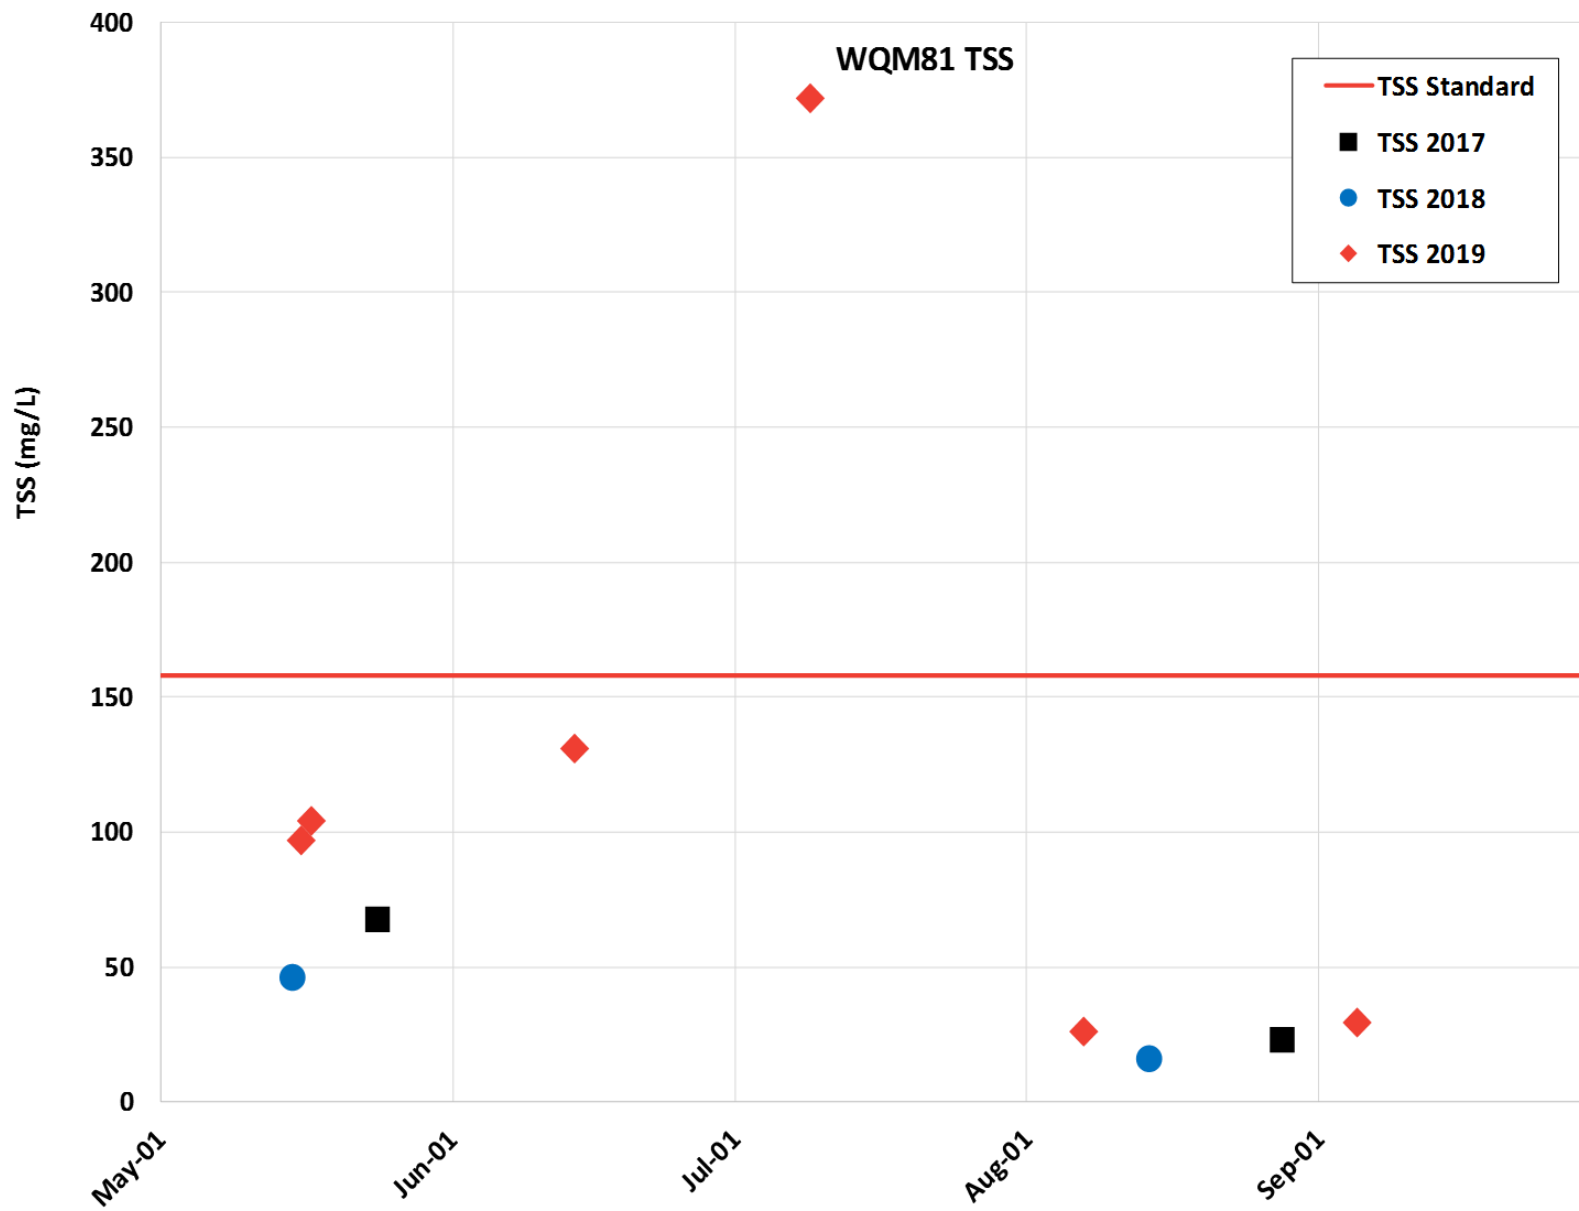
Figure 5-11. Total Suspended Sediment (TSS) Sampling Results at Monitoring Site WQM81 (460681) on the Belle Fourche River from May–September during 2017, 2018, and 2019.

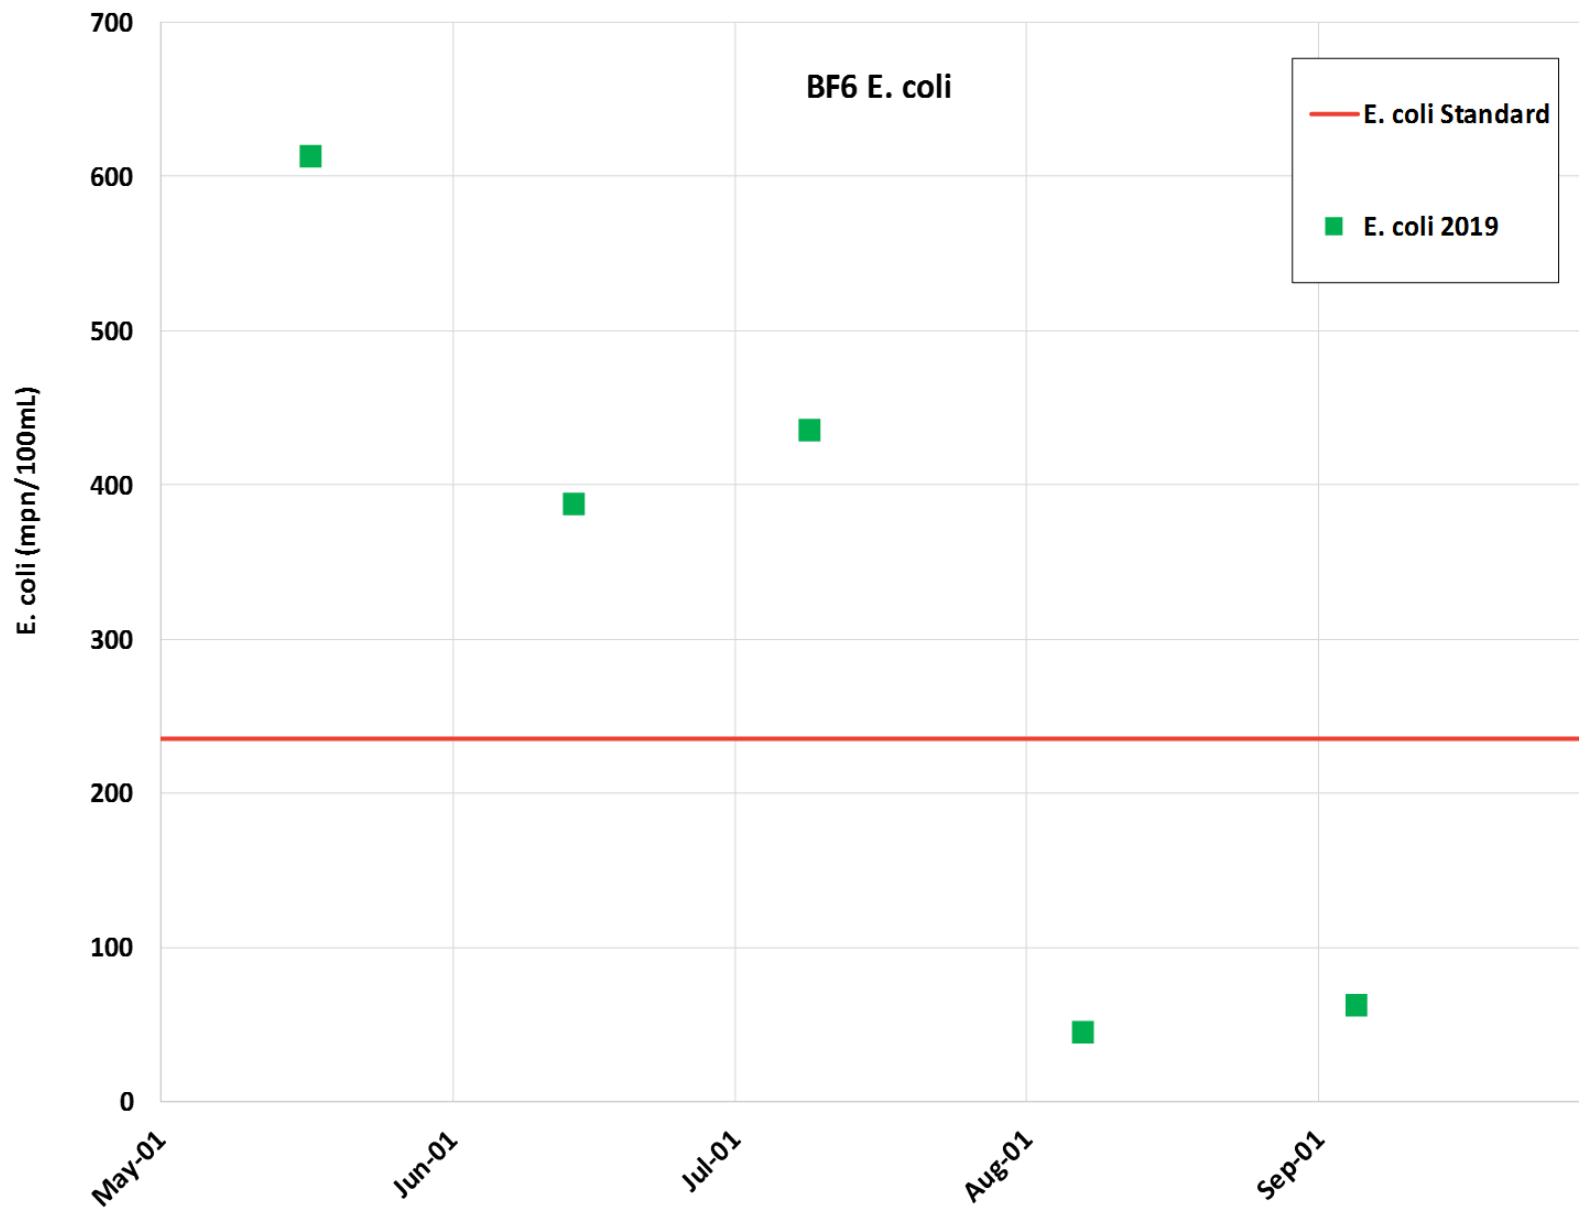
Figure 5-12. *E. coli* Sampling Results at Monitoring Site BF6 on the Belle Fourche River from May–September during 2017, 2018, and 2019
