BELLE FOURCHE RIVER WATERSHED MANAGEMENT AND PROJECT IMPLEMENTATION PLAN SEGMENT 8 WATERSHED PROJECT FINAL REPORT SECTION 319 NONPOINT SOURCE POLLUTION CONTROL PROGRAM

OCTOBER 2019

RESPEC
3824 Jet Drive
Rapid City, South Dakota 57703

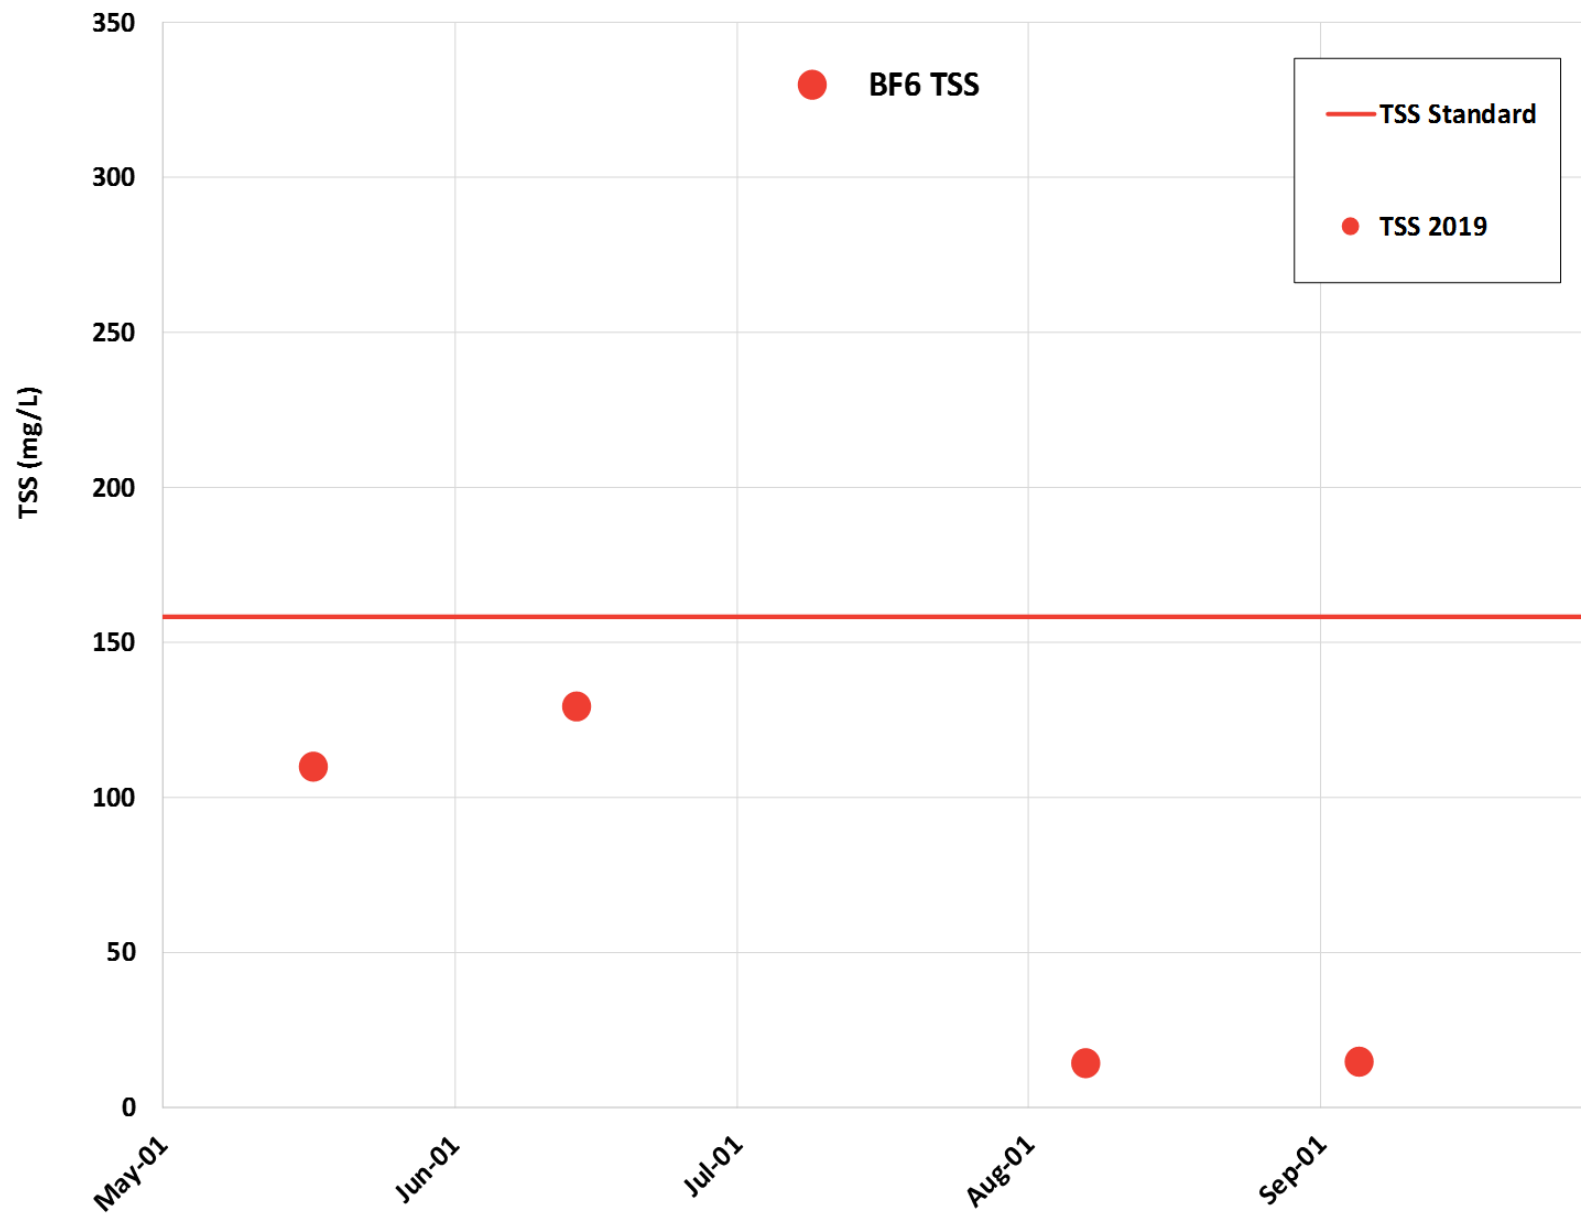
Figure 5-13. Total Suspended Sediment (TSS) Sampling Results at Monitoring Site BF6 on the Belle Fourche River from May–September during 2017, 2018, and 2019.

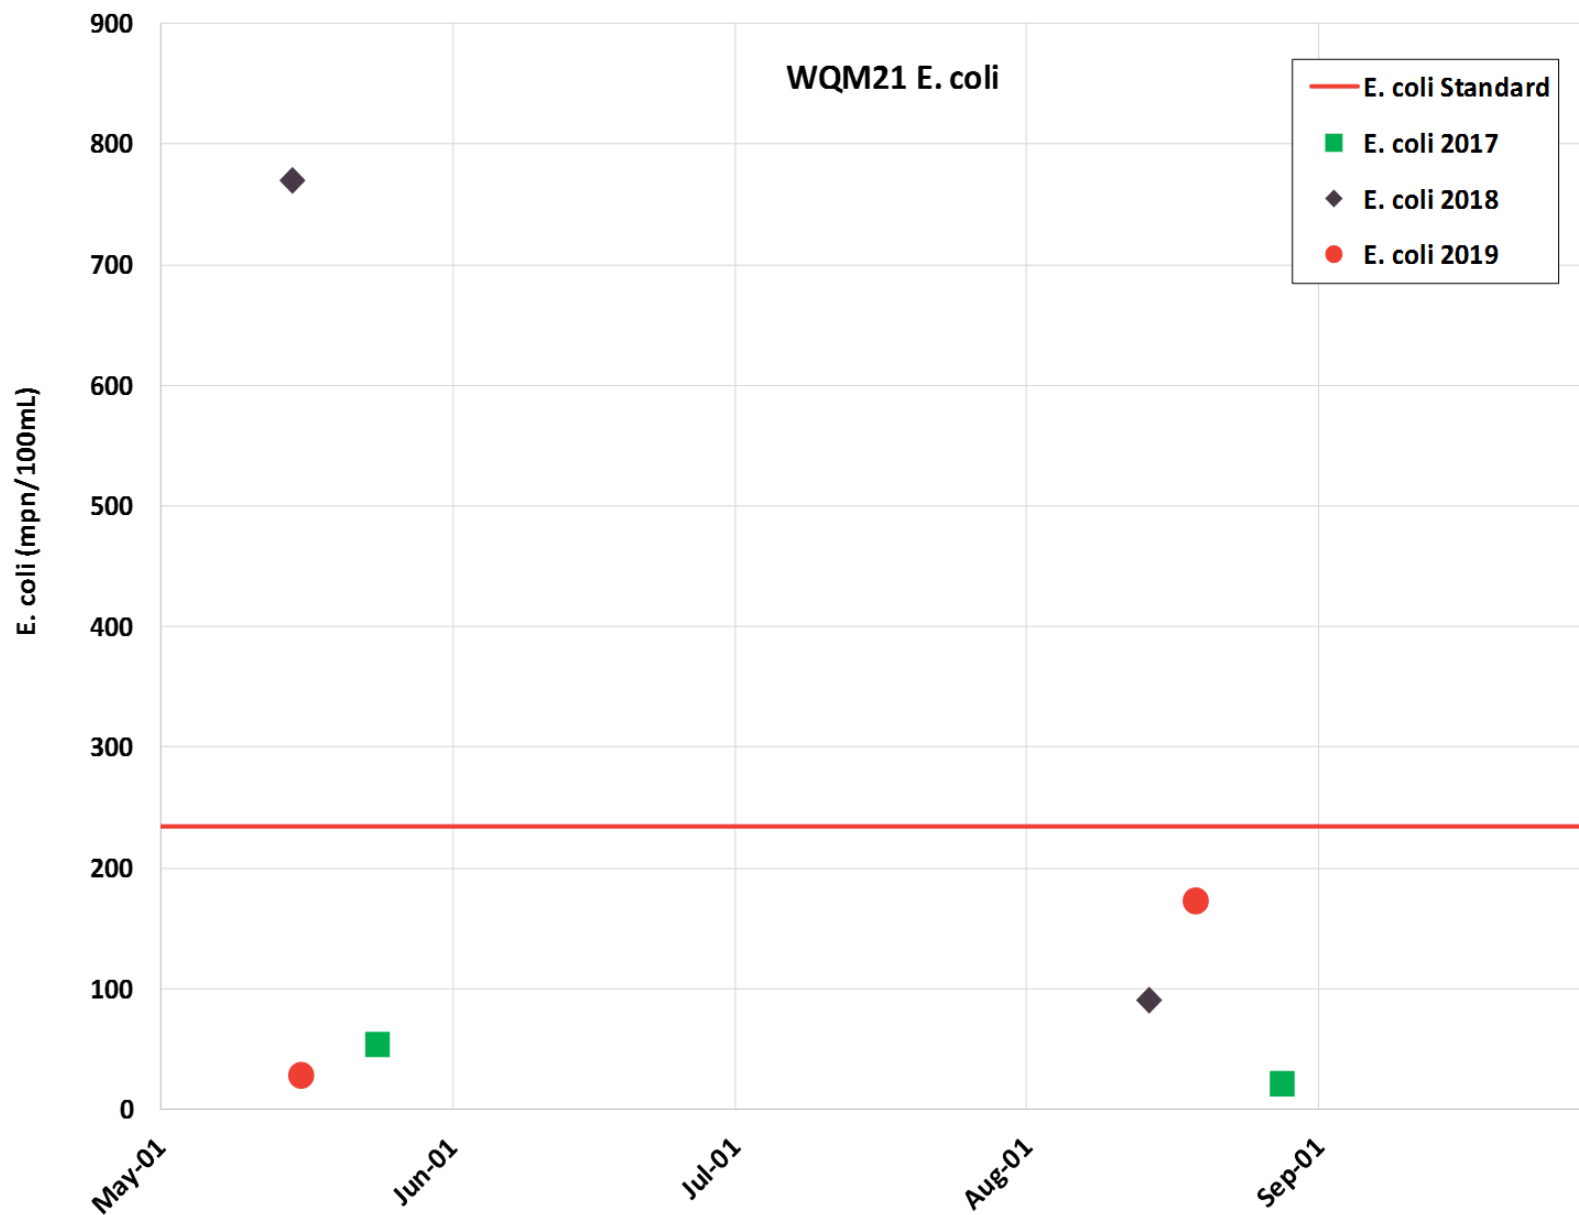
Figure 5-14. *E. coli* Sampling Results at Monitoring Site WQM21 (460880) on the Belle Fourche River from May–September during 2017, 2018, and 2019.

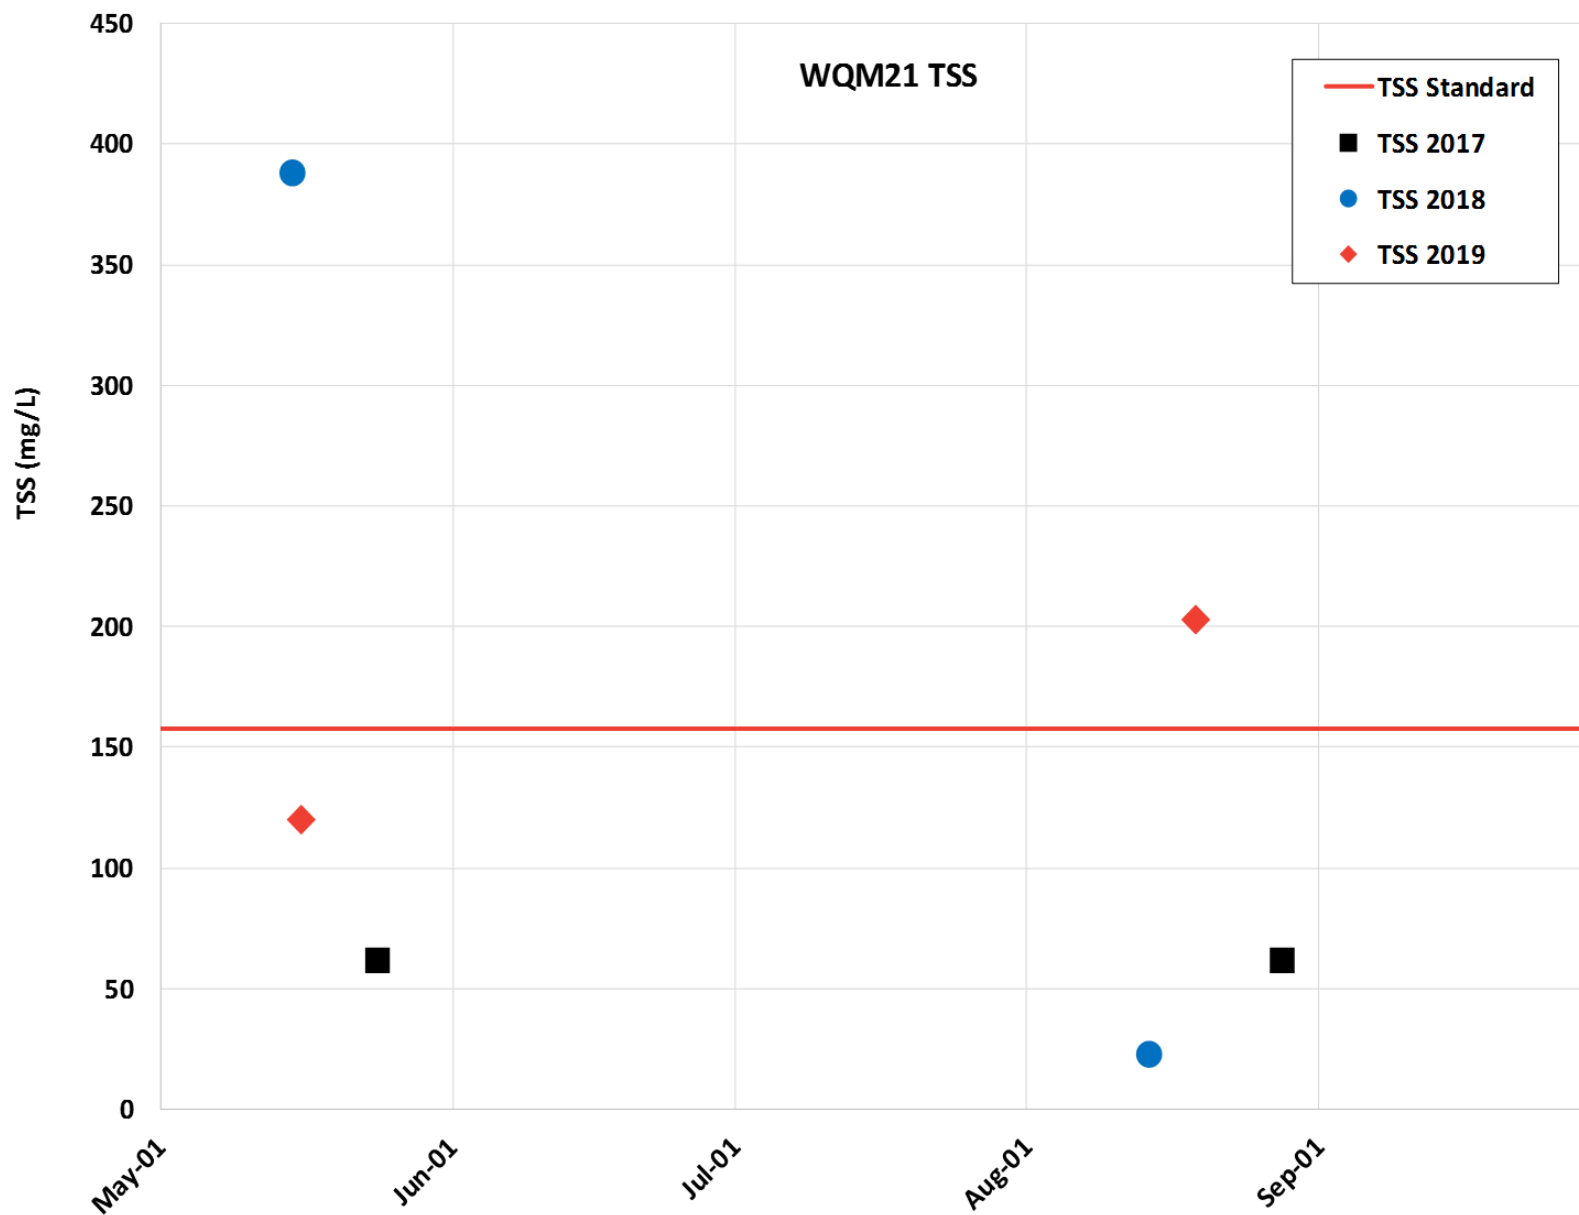
Figure 5-15. Total Suspended Sediment (TSS) Sampling Results at Monitoring Site WQM21 (460880) on the Belle Fourche River from May–September during 2017, 2018, and 2019.

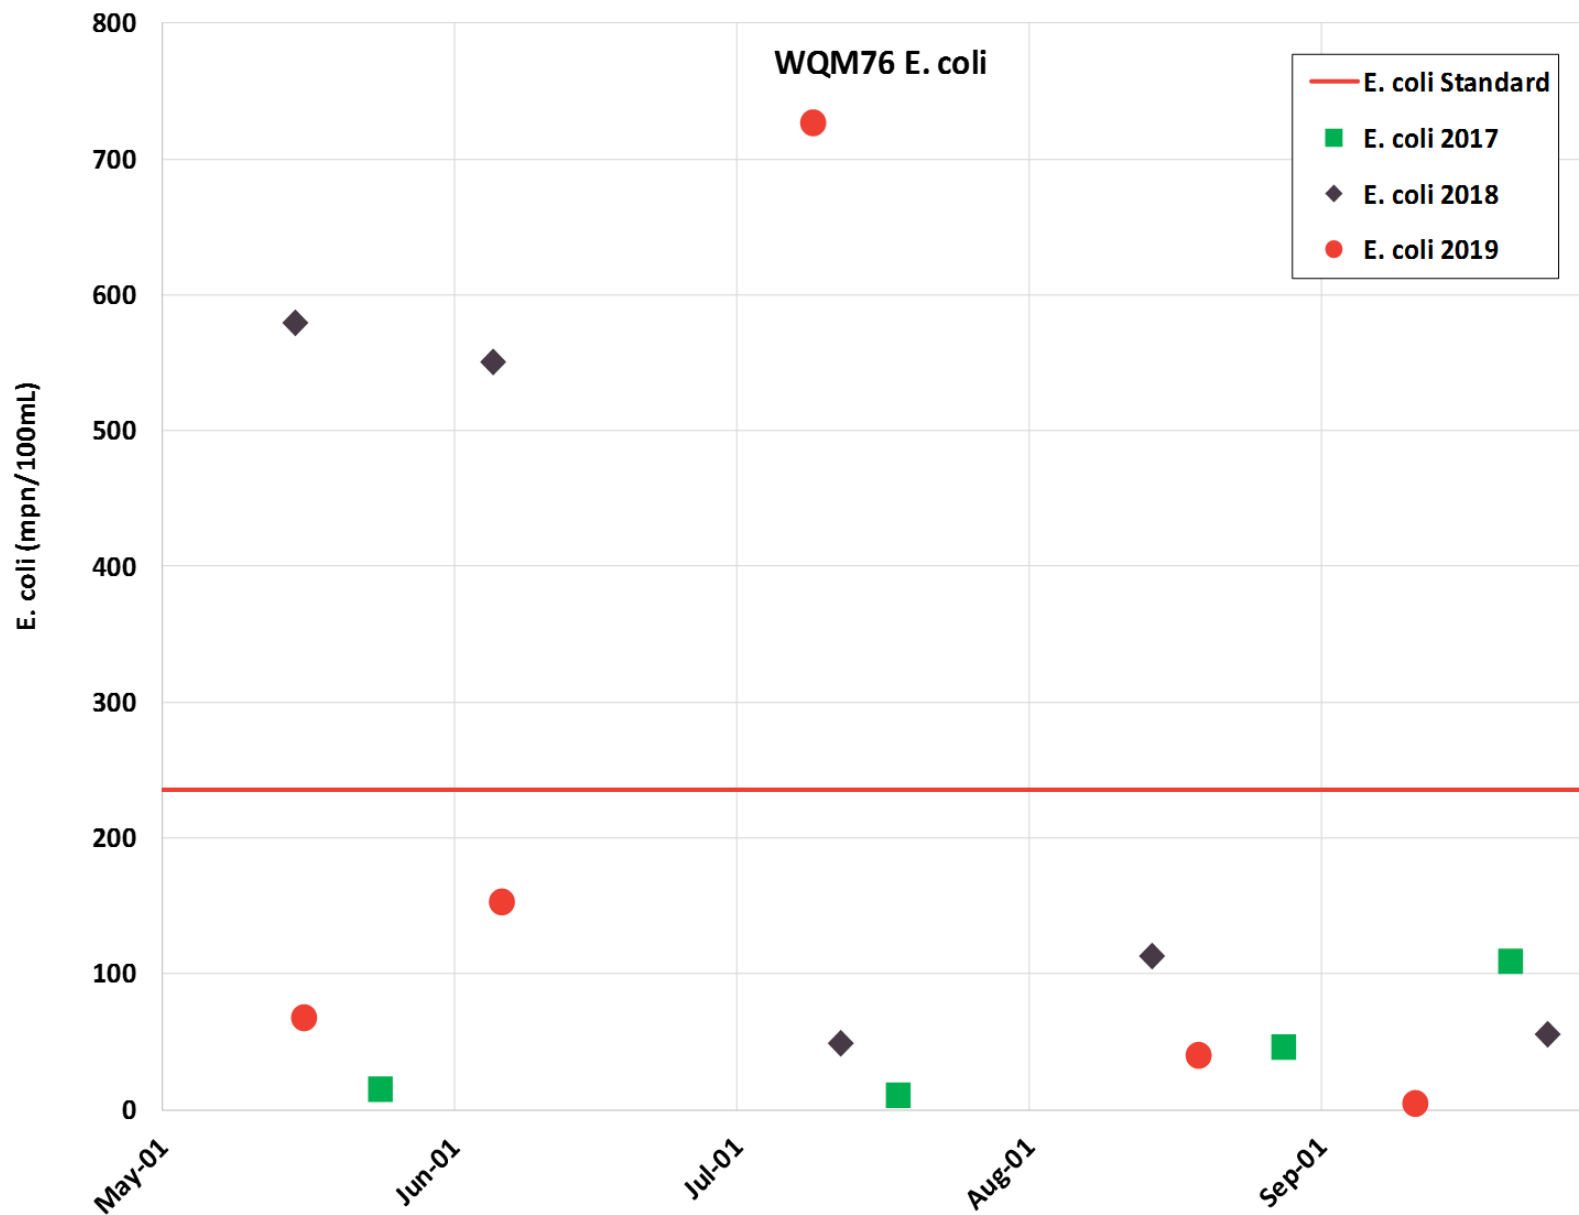
Figure 5-16. *E. coli* Sampling Results at Monitoring Site WQM76 (460676) on the Belle Fourche River from May–September during 2017, 2018, and 2019.

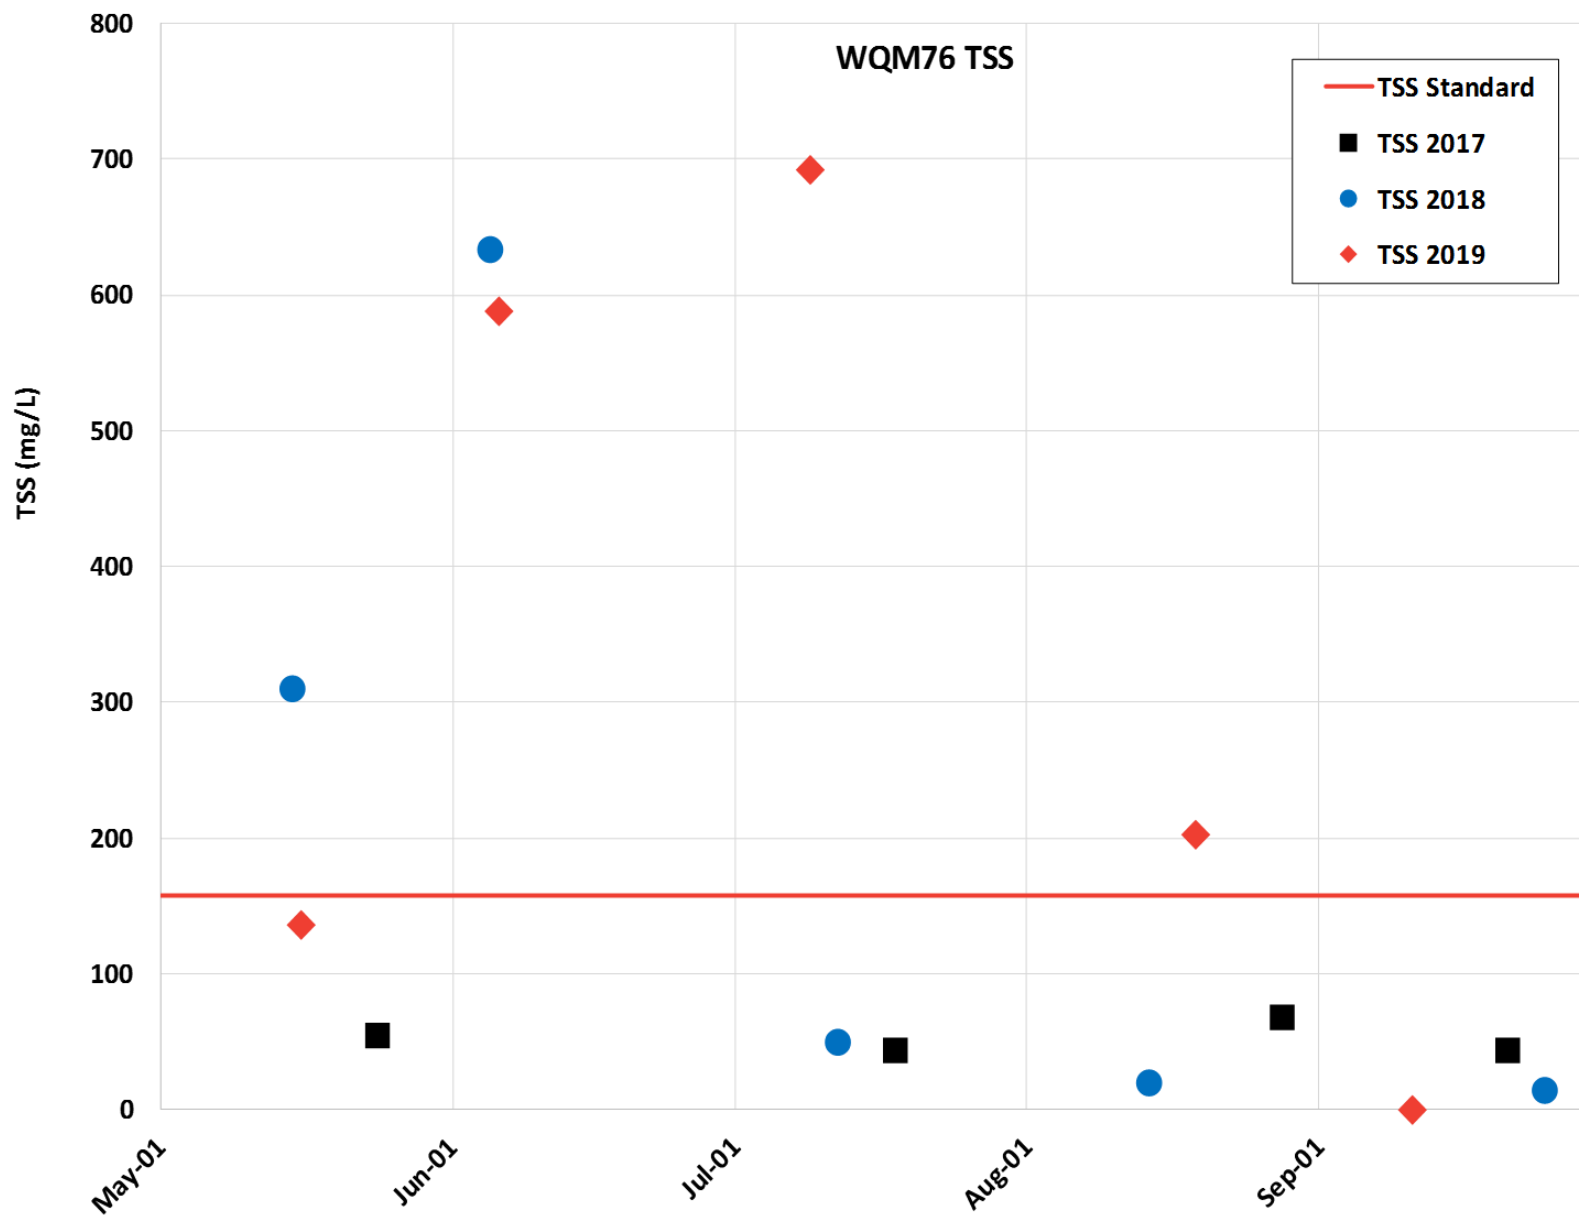
Figure 5-17. Total Suspended Sediment (TSS) Sampling Results at Monitoring Site WQM76 (460676) on the Belle Fourche River from May–September during 2017, 2018, and 2019.

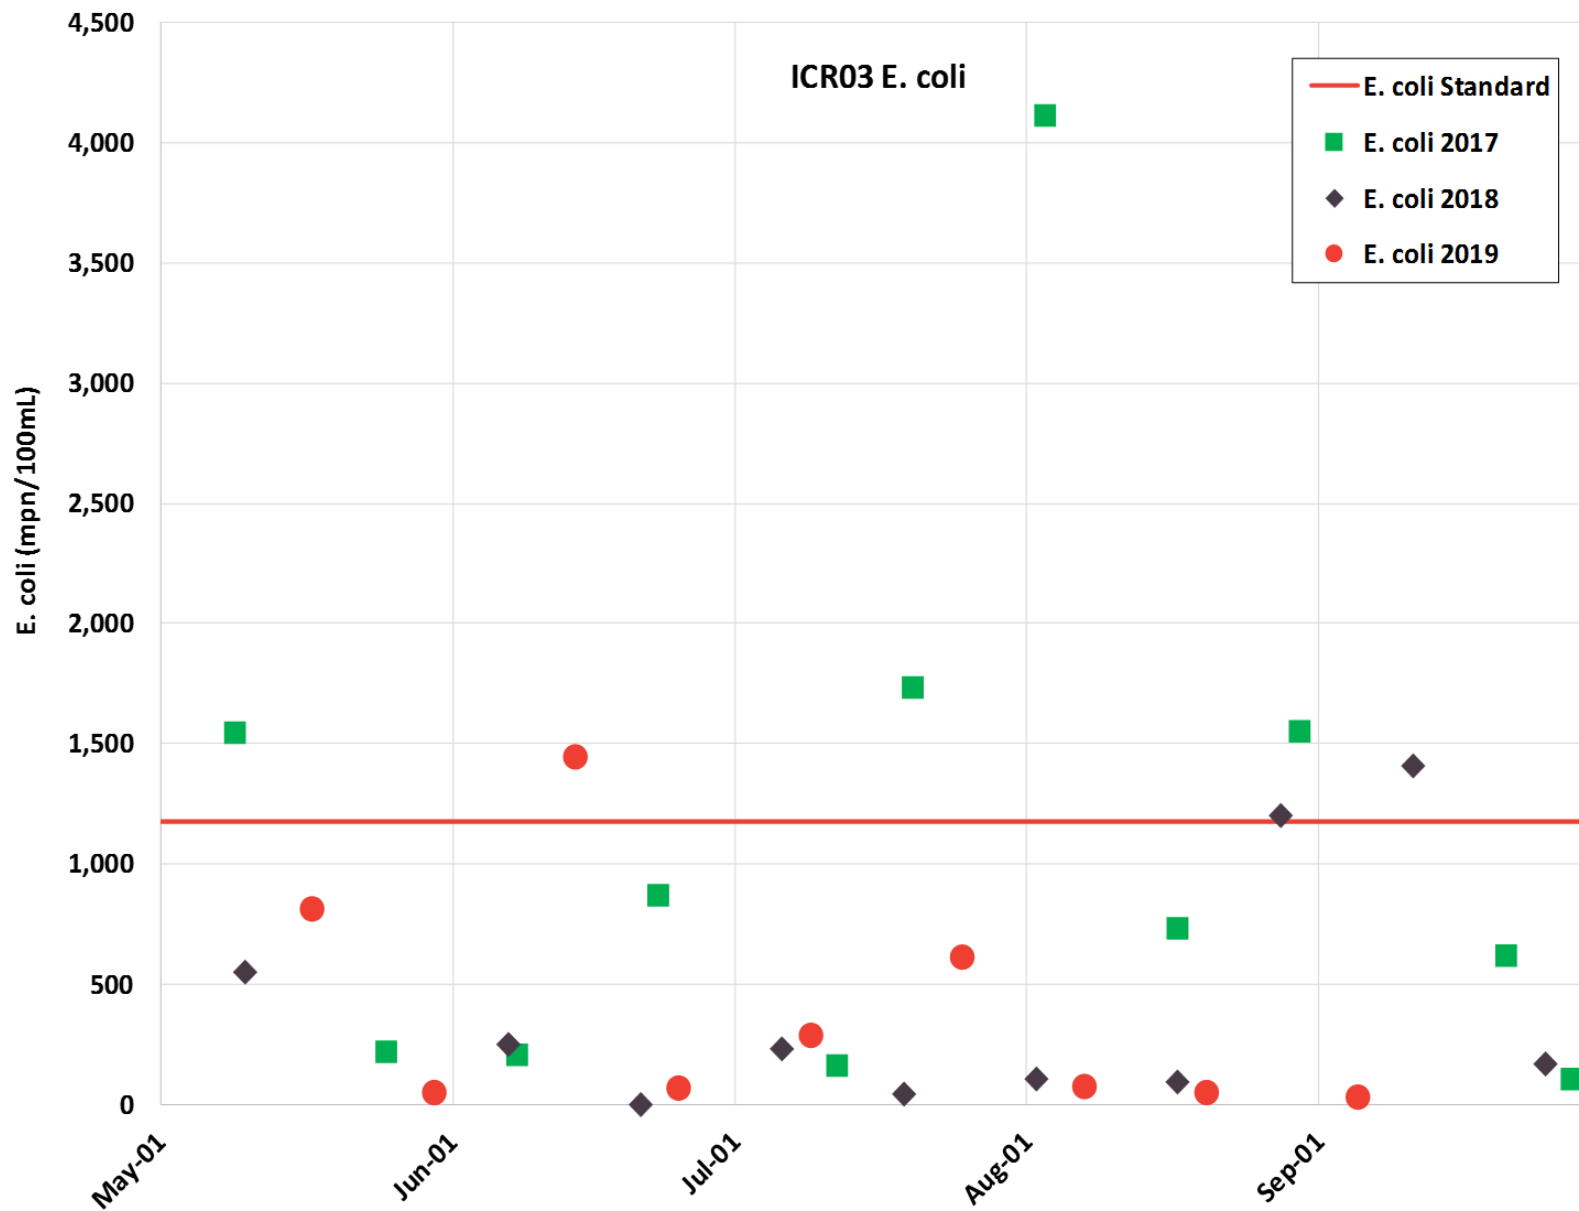
Figure 5-18. *E. coli* Sampling Results at Monitoring Site ICR03 on Indian Creek from May–September during 2017, 2018, and 2019.

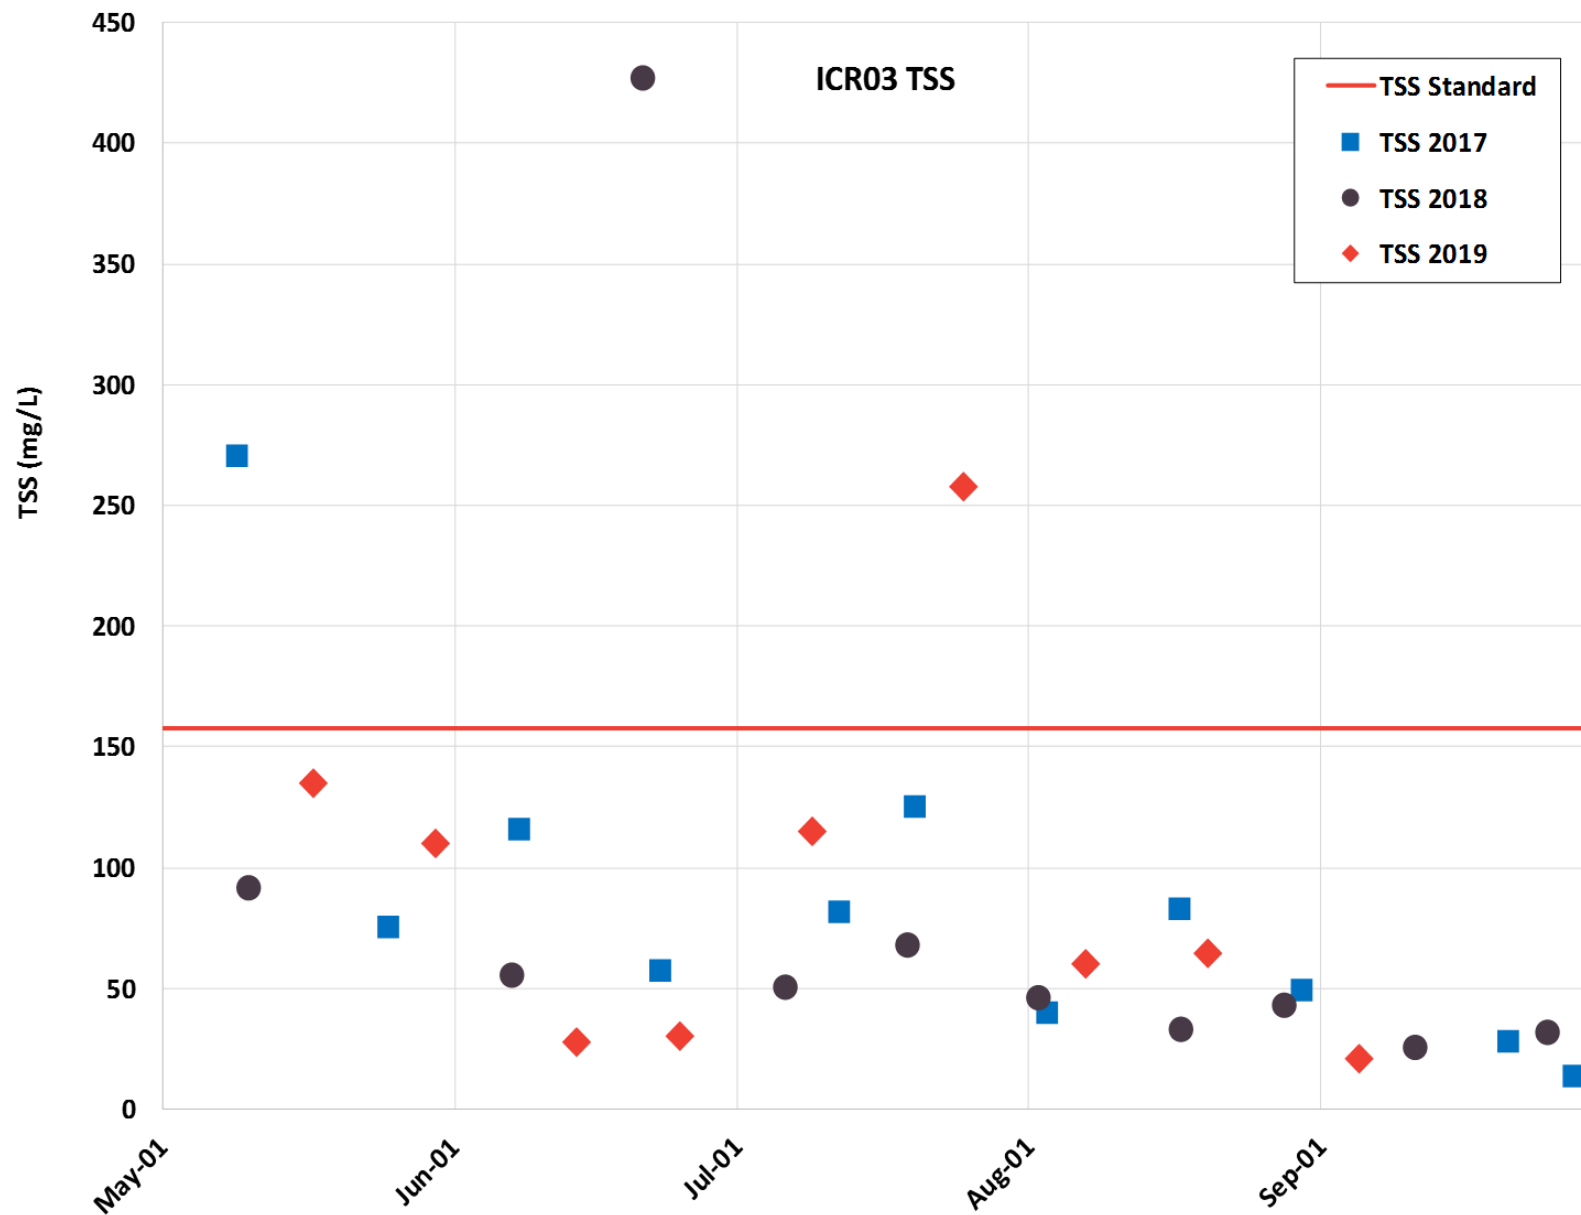
Figure 5-19. Total Suspended Sediment (TSS) Sampling Results at Monitoring Site ICR03 on Indian Creek from May–September during 2017, 2018, and 2019.

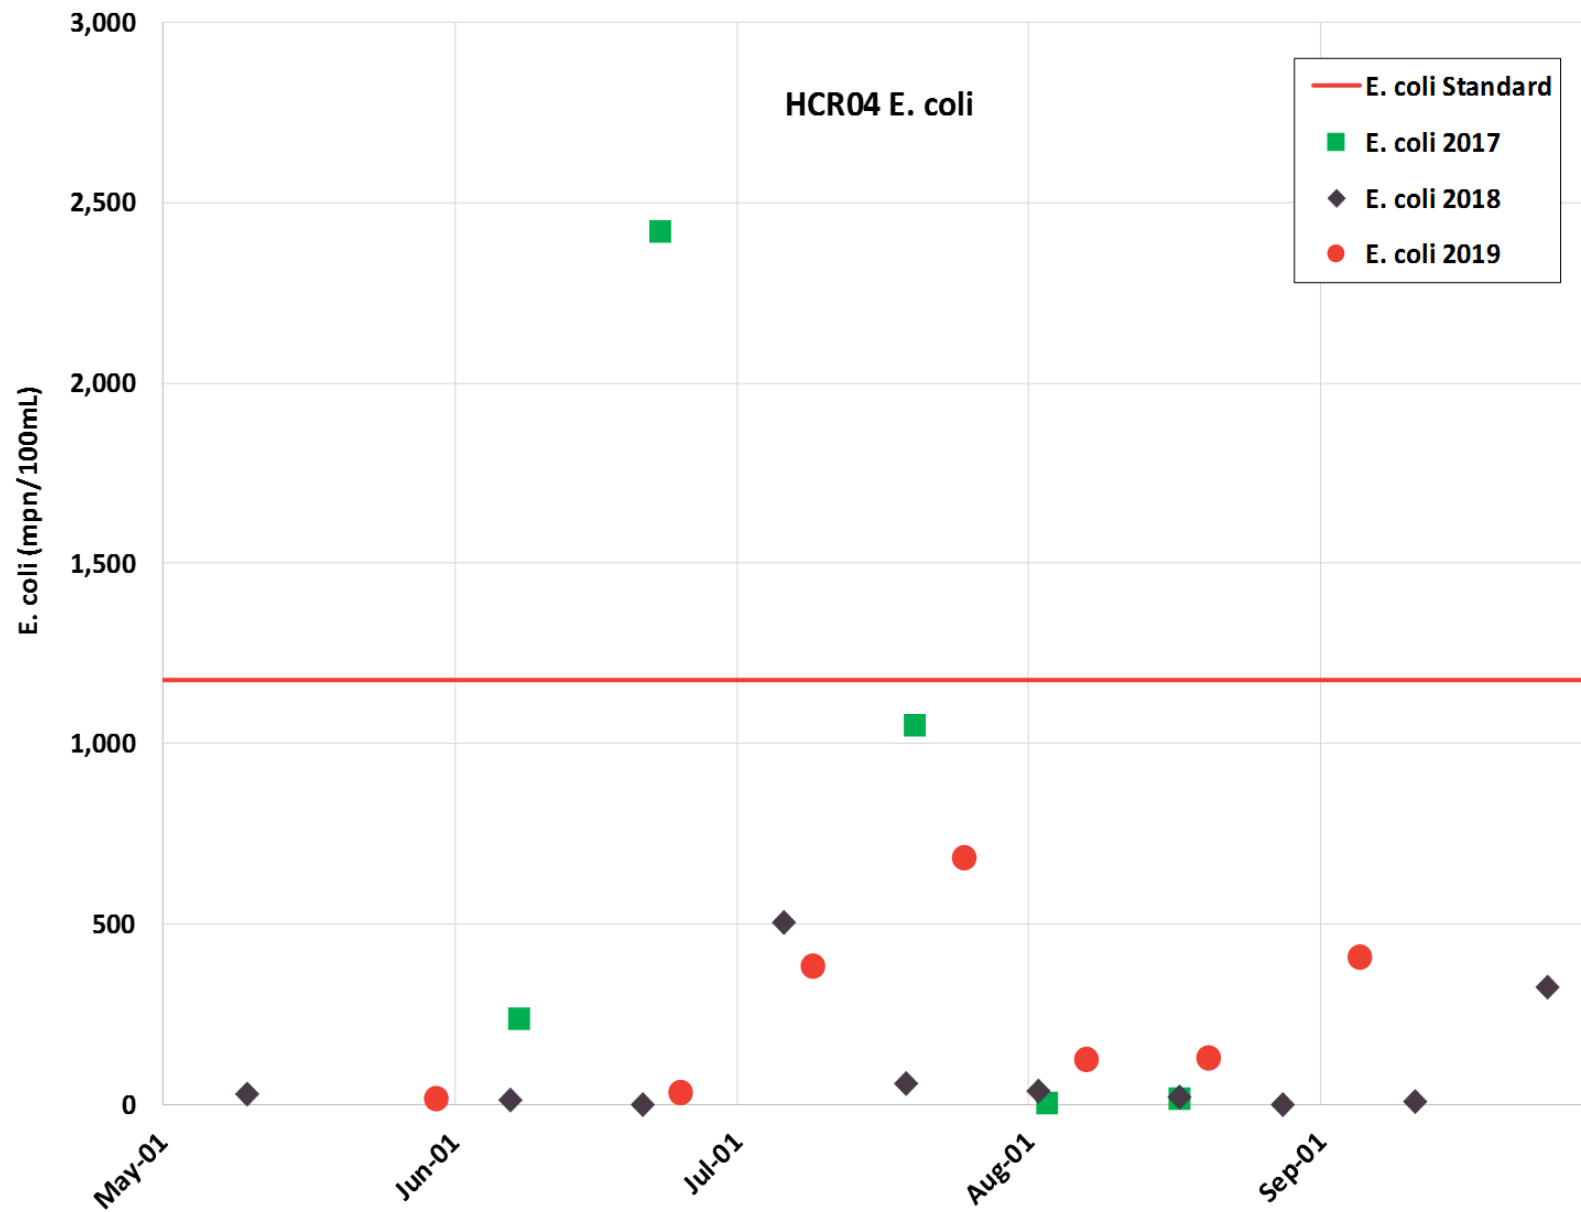
Figure 5-20. *E. coli* Sampling Results at Monitoring Site HCR04 on Horse Creek from May–September during 2017, 2018, and 2019.

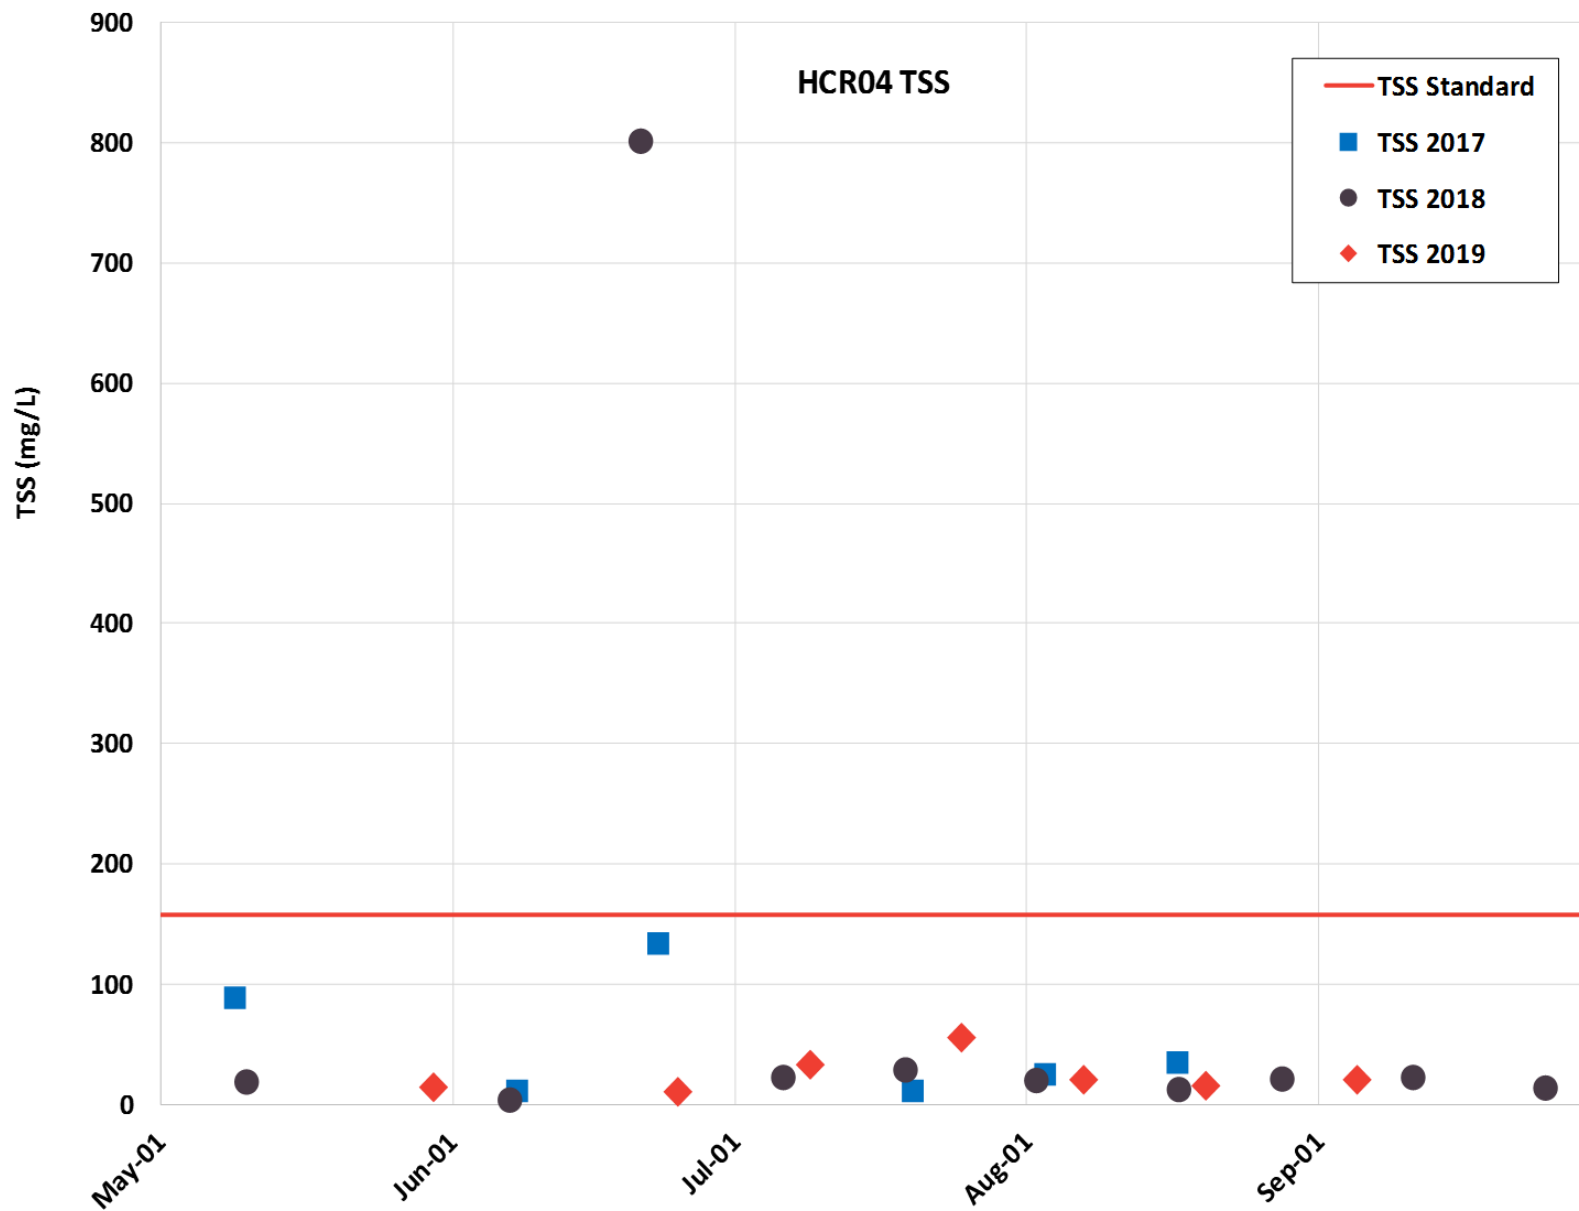
Figure 5-21. Total Suspended Sediment (TSS) Sampling Results at Monitoring Site HCR04 on Horse Creek from May–September during 2017, 2018, and 2019.

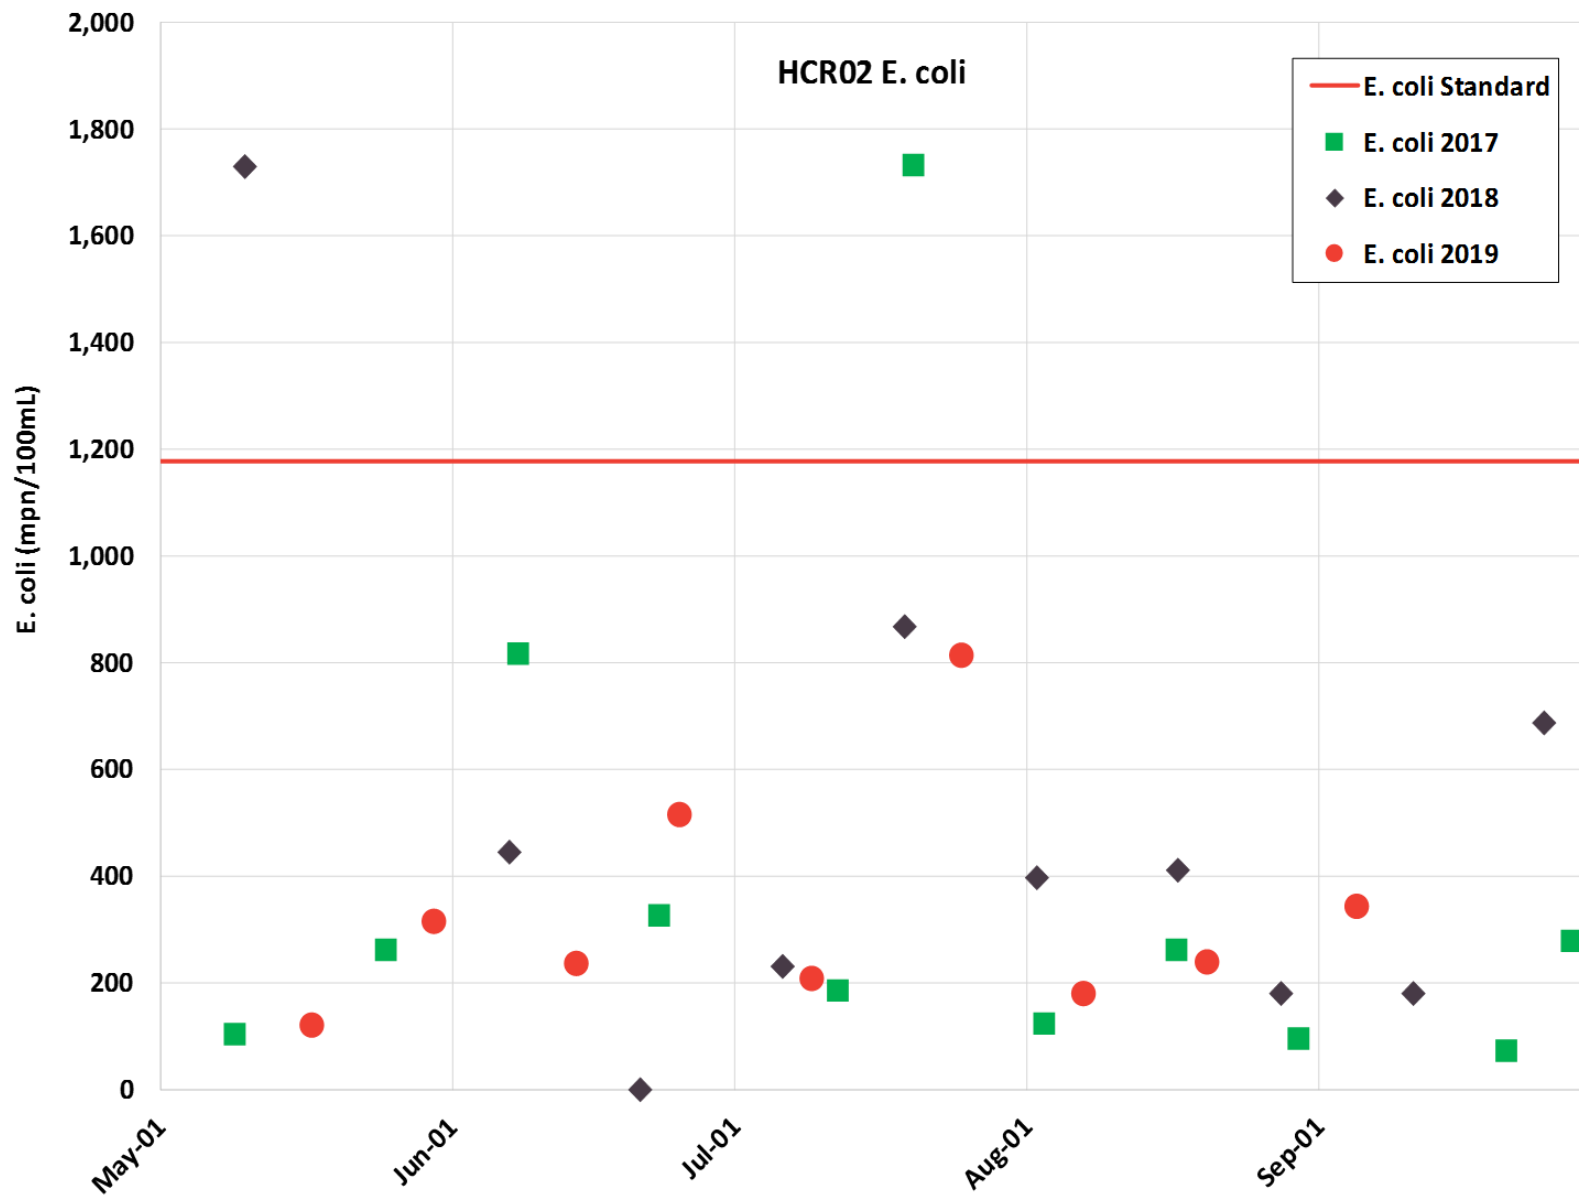
Figure 5-22. *E. coli* Sampling Results at Monitoring Site HCR02 on Horse Creek from May–September during 2017, 2018, and 2019.

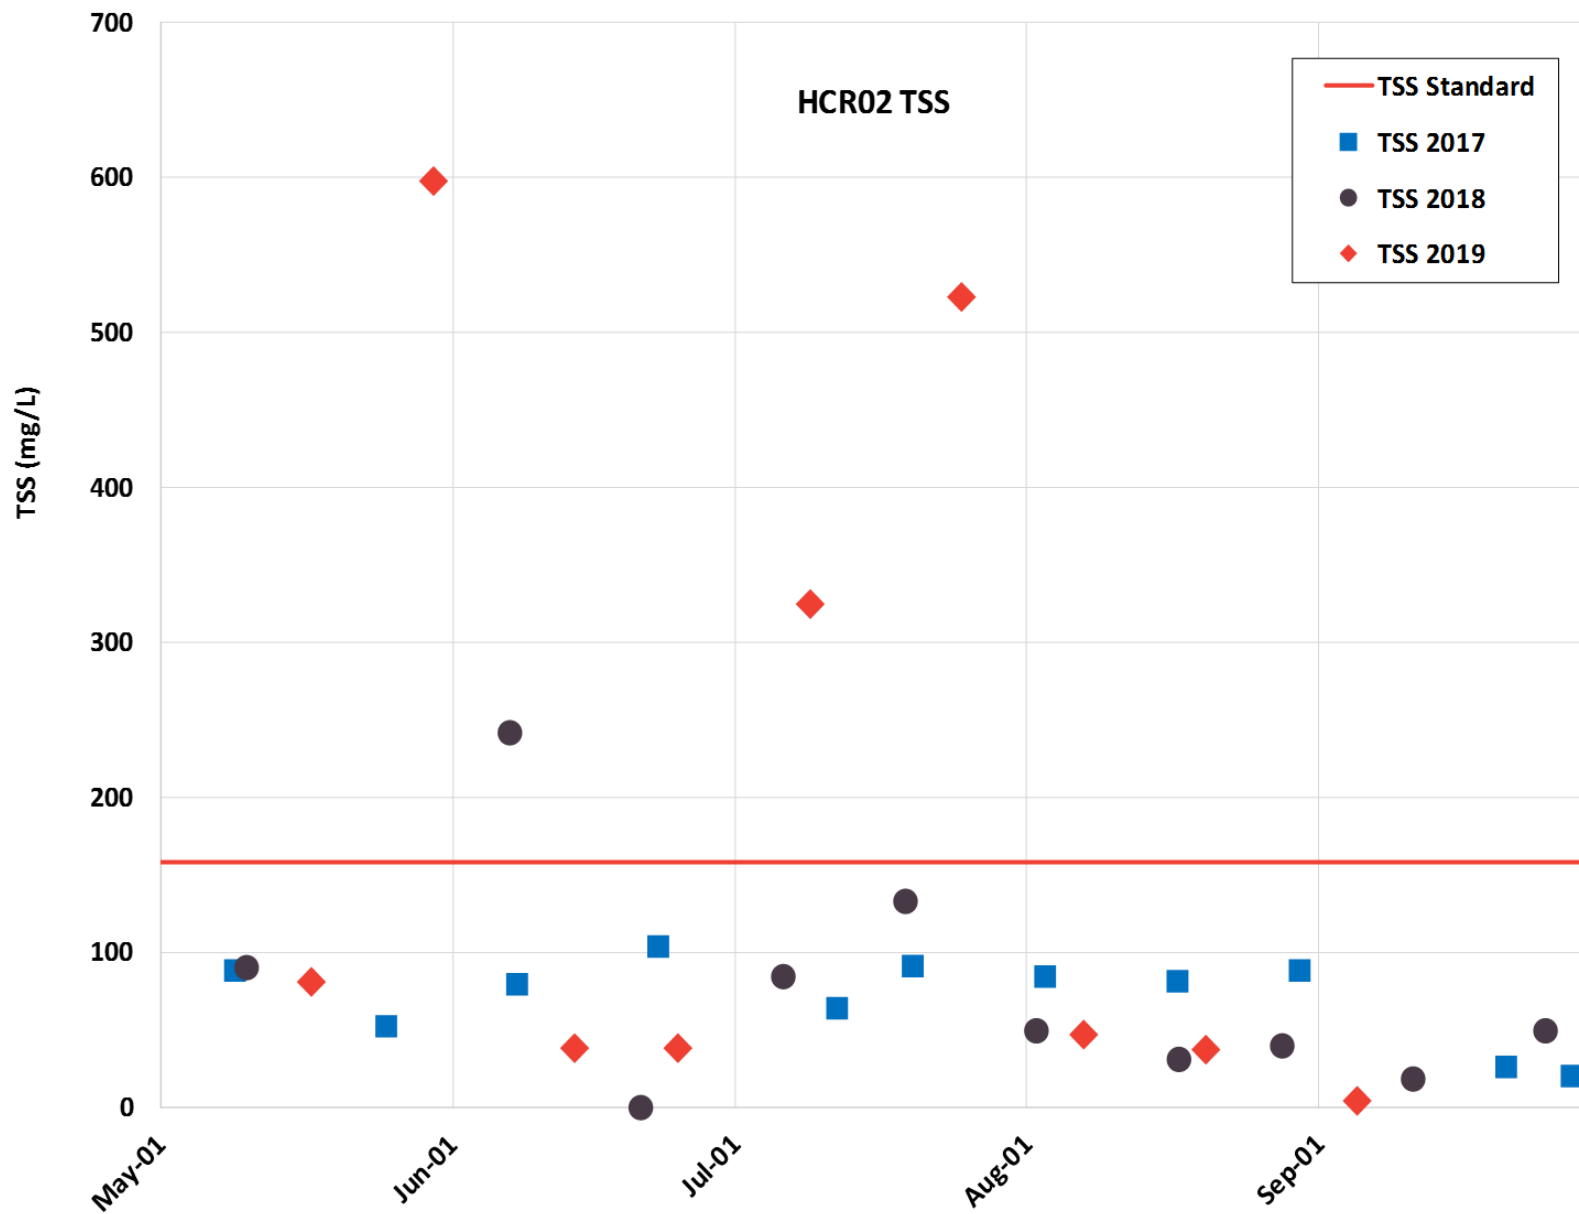
Figure 5-23. Total Suspended Sediment (TSS) Sampling Results at Monitoring Site HCR02 on Horse Creek from May–September during 2017, 2018, and 2019.
