**DIAGNOSTIC/FEASIBILITY STUDY REPORT  
BURKE LAKE  
GREGORY COUNTY, SOUTH DAKOTA**

**OFFICE OF WATER RESOURCES MANAGEMENT  
SOUTH DAKOTA DEPARTMENT OF ENVIRONMENT  
AND NATURAL RESOURCES**

**April 1991**

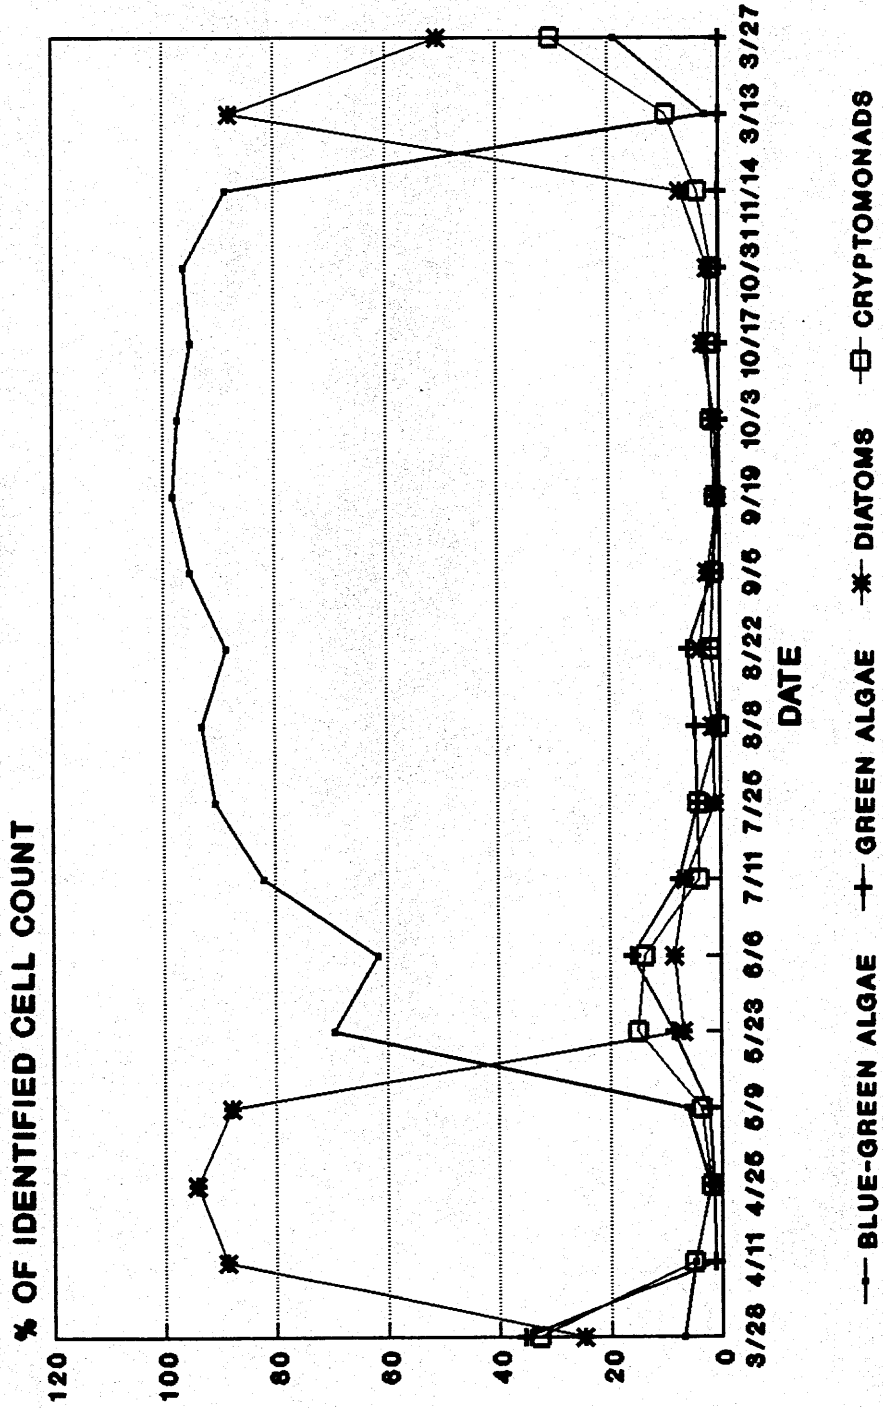
**Figure 3.  
Algal Cell Counts for Burke Lake**

SAMPLING PERIOD FROM 3/28/89 - 3/27/90

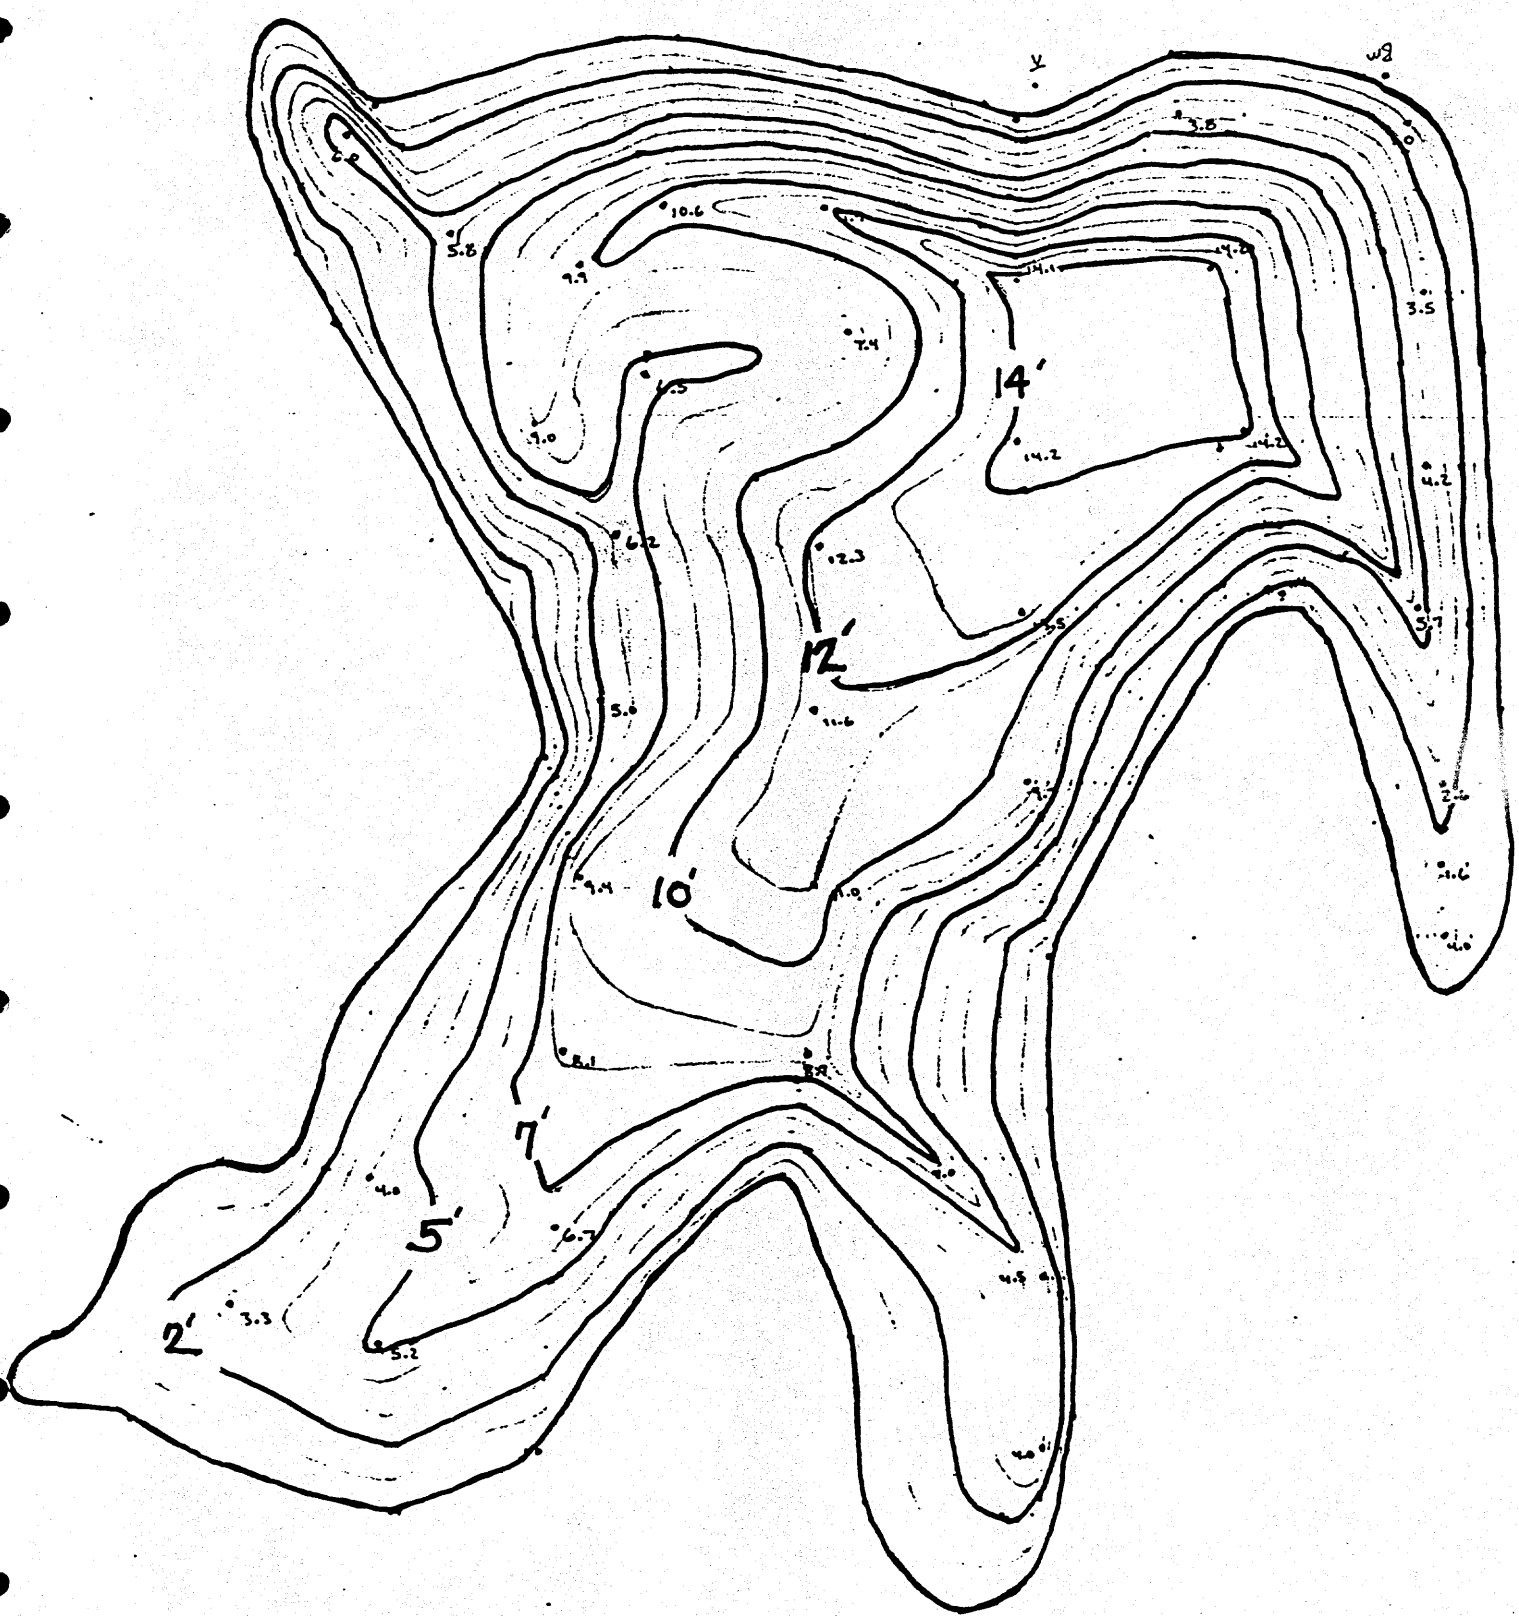
Figure 4. Burke Lake Bathymetric Map.

The maximum water depth found during the survey was 14.2 feet in the northcentral part of the lake (Figure 4). Most nearshore areas (50 feet from shore) have water depths less than 4 feet deep.

Note: Survey Data Collected 2/16/89.  
 Scale: 1 INCH = 180 FEET

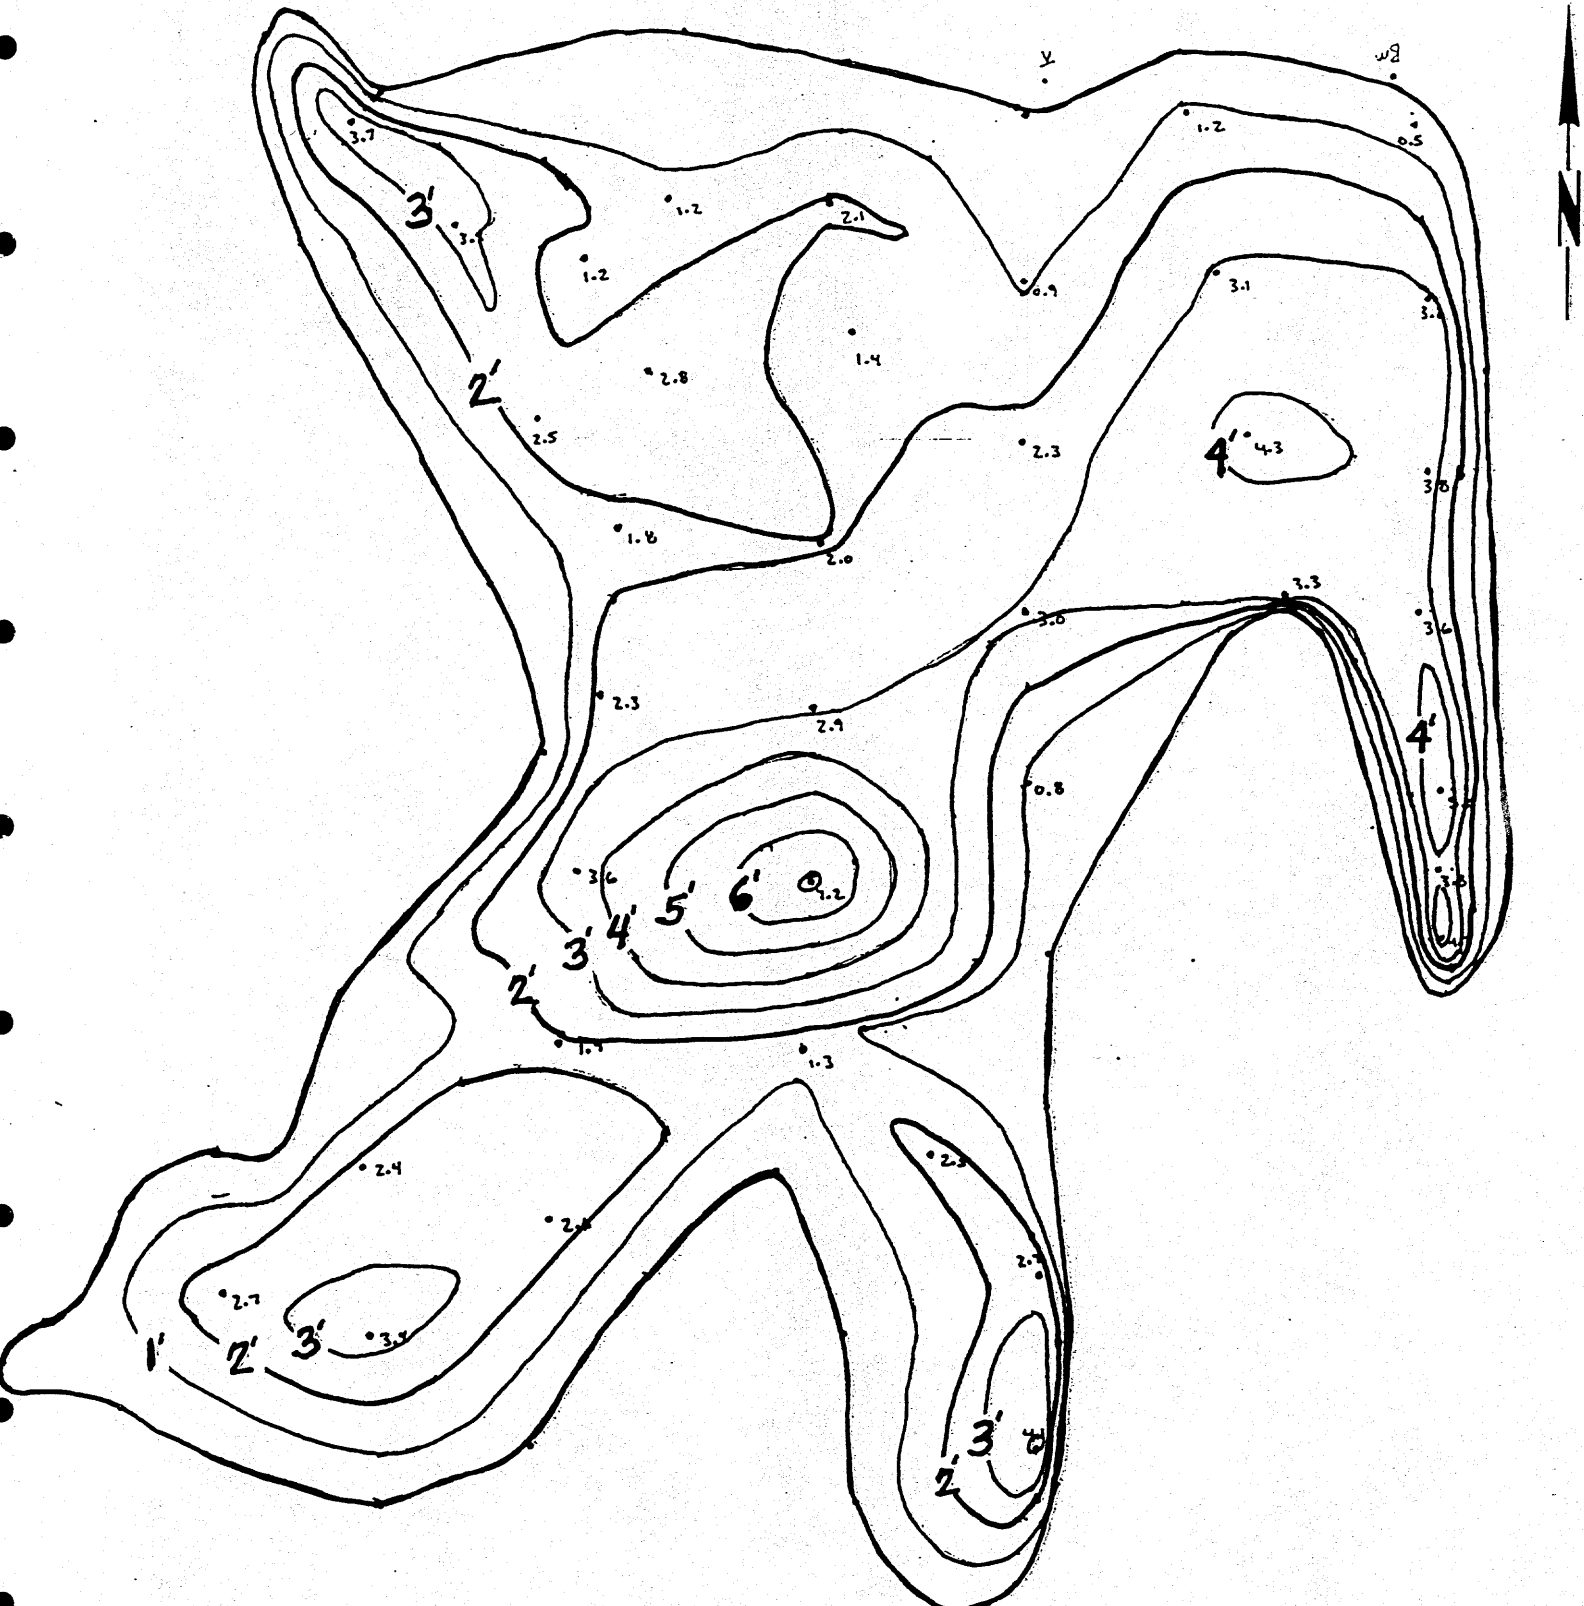
Figure 5. Burke Lake Sediment Thickness Contour Map.

Note: Survey Data Collected 2/16/89.  
 Scale: 1 INCH = 180 FEET

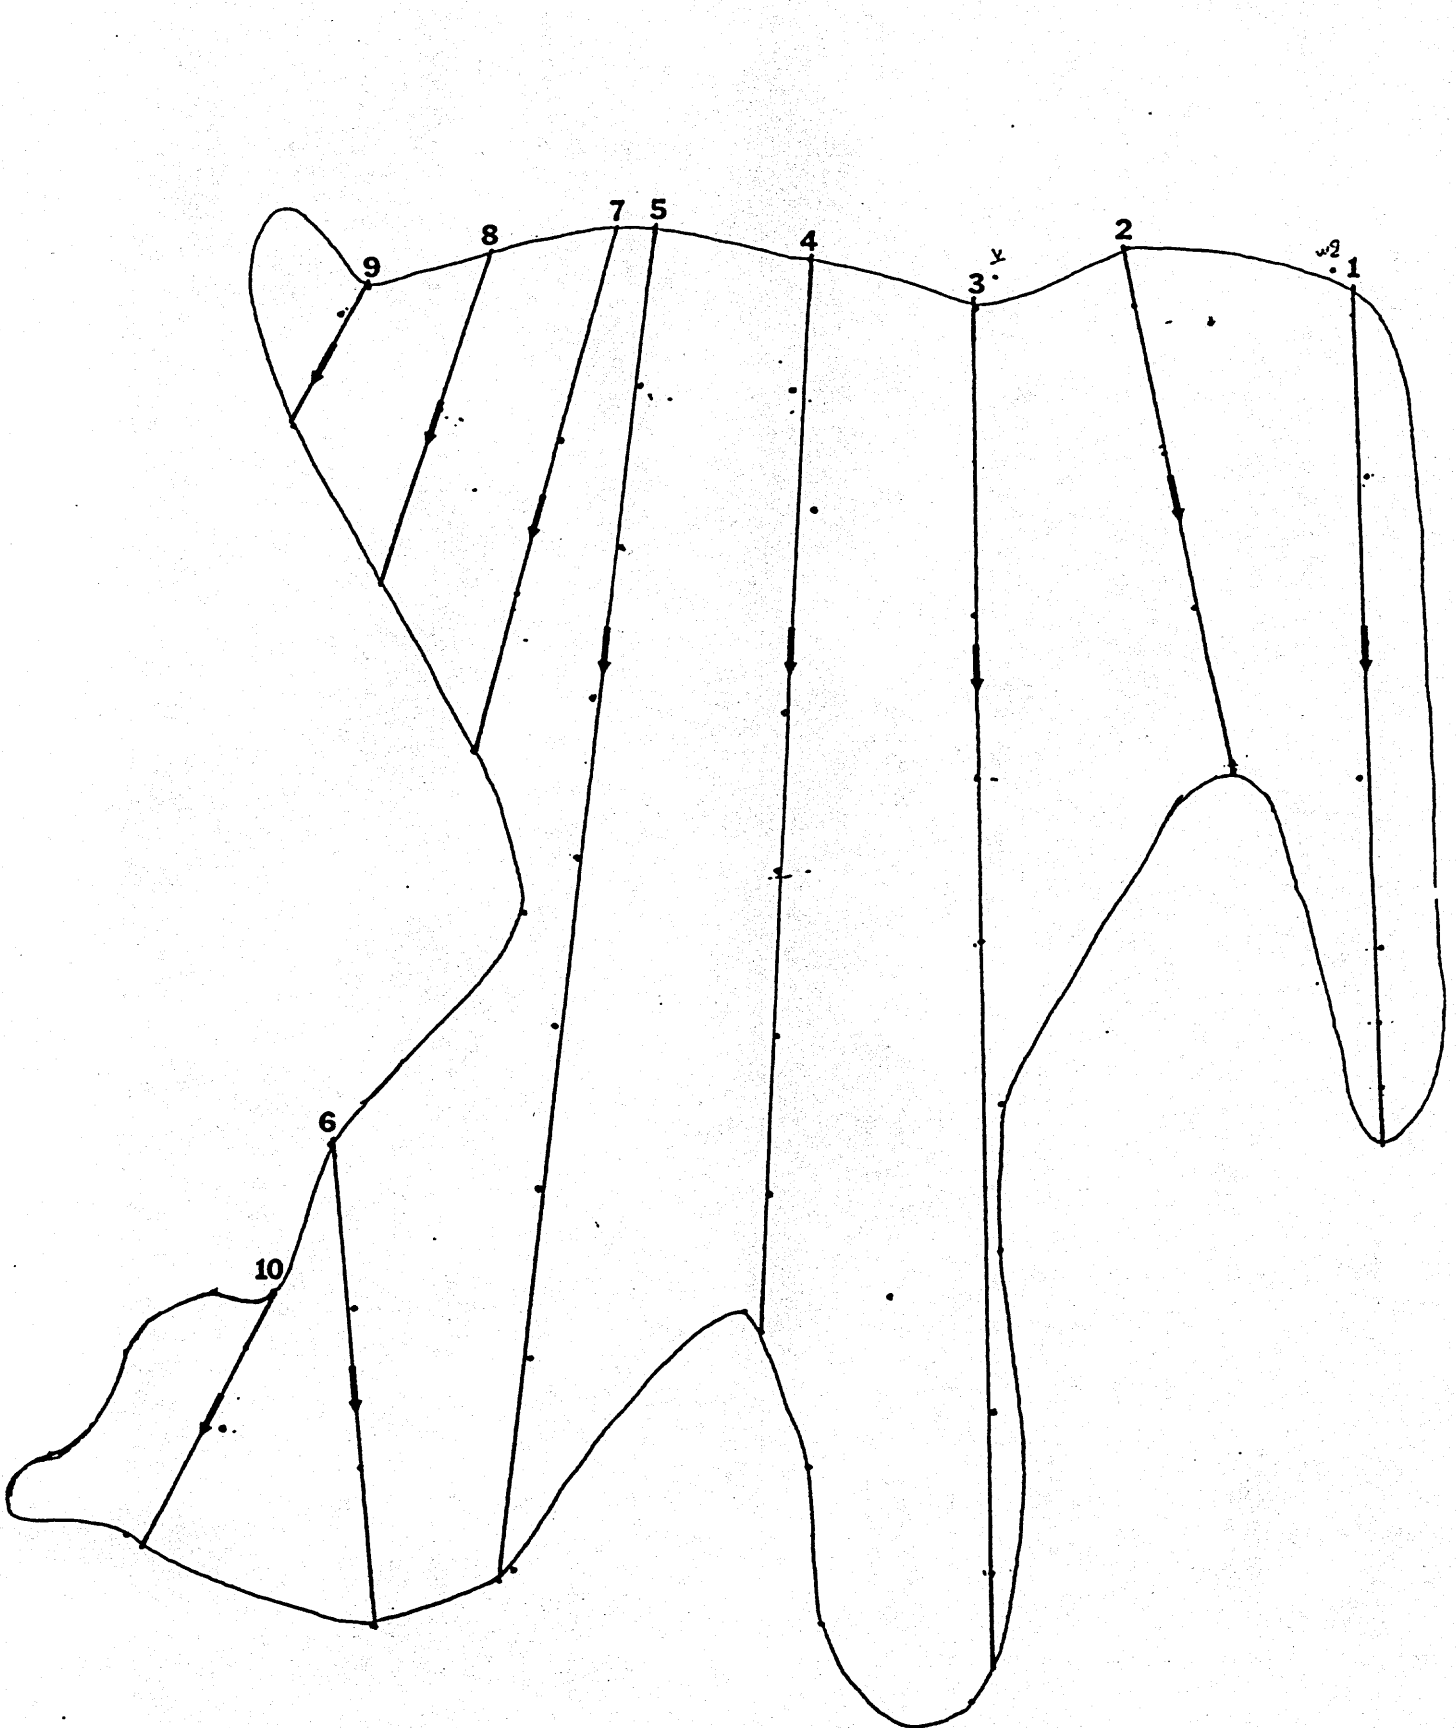
# Burke Lake Survey Cross-Section Locations.

Note: Survey Data Collected 2/16/89.

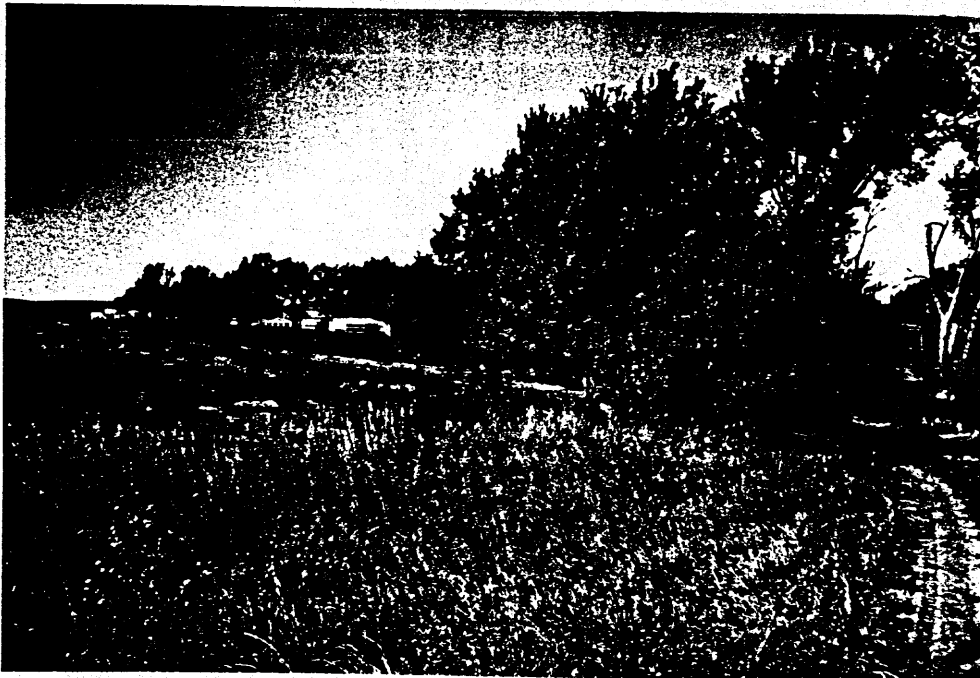
Photograph 6.

Orientation: Looking west from the southwest shore of Burke Lake.

Description: Dairy operation located along the southwest and west borders of Burke Lake.

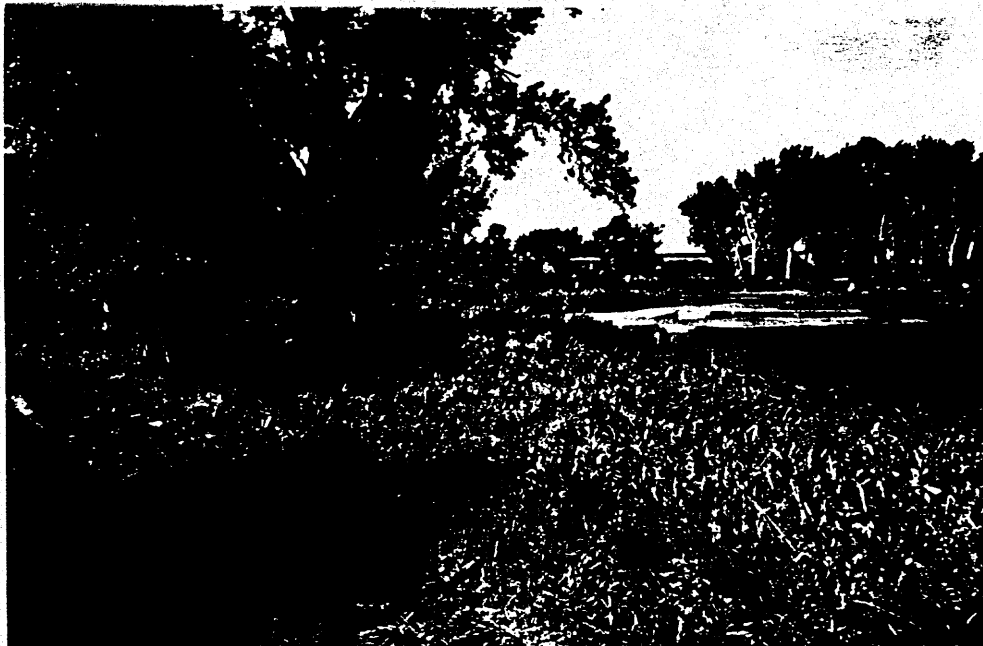
**Photograph 7.**

**Orientation:** Looking east from the dairy operation.

**Description:** Aquatic vegetation on Burke Lake.

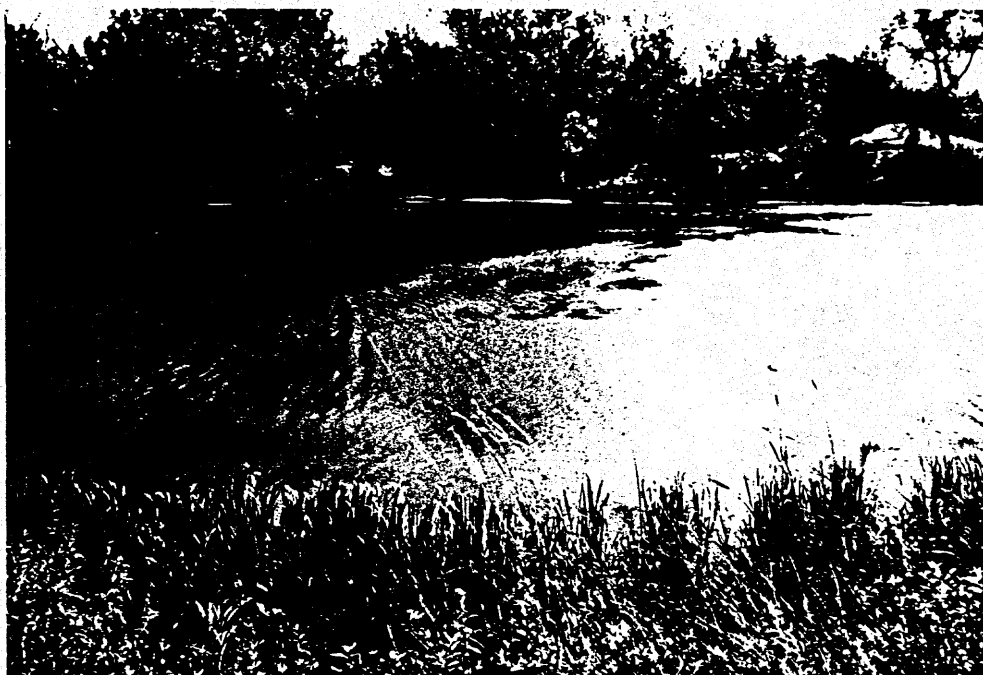
**Photograph 8.**

**Orientation:** Looking east at Burke Lake near tributary sampling site #3.

**Description:** Turbidity in Burke Lake.

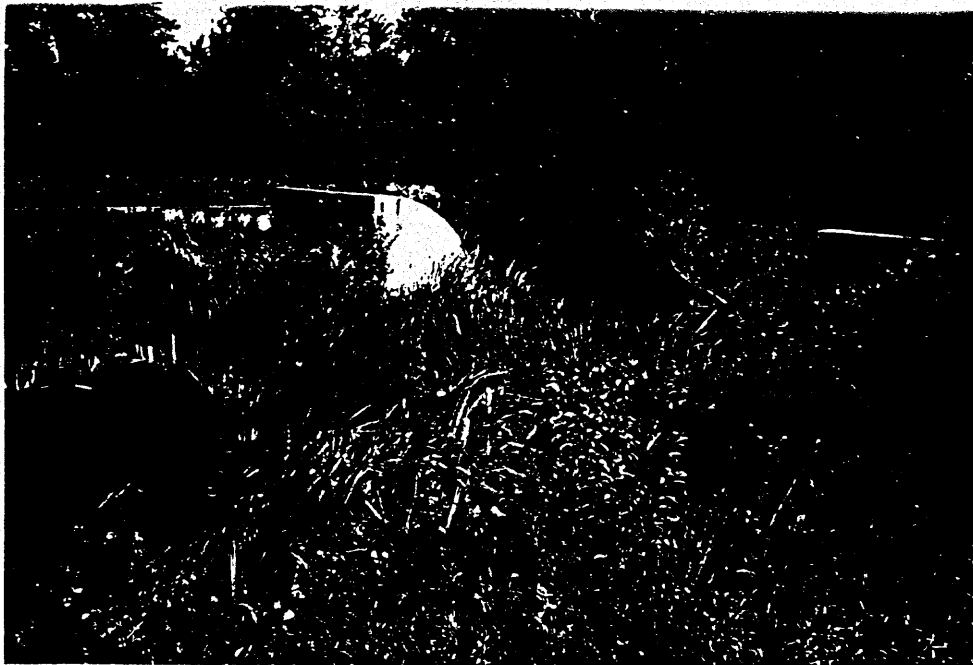
Photograph 9.

Orientation: Looking northeast.

Description: The outlet structure at Burke Lake.  
The structure is overgrown with vegetation.
