**LAKE ASSESSMENT REPORT  
EAST LAKE EUREKA  
MCPHERSON COUNTY, SOUTH DAKOTA**

**DIVISION OF WATER RESOURCES MANAGEMENT  
SOUTH DAKOTA DEPARTMENT OF ENVIRONMENT AND NATURAL RESOURCES  
ROBERT E. ROBERTS, SECRETARY**

August, 1993

Prepared by  
William C. Stewart

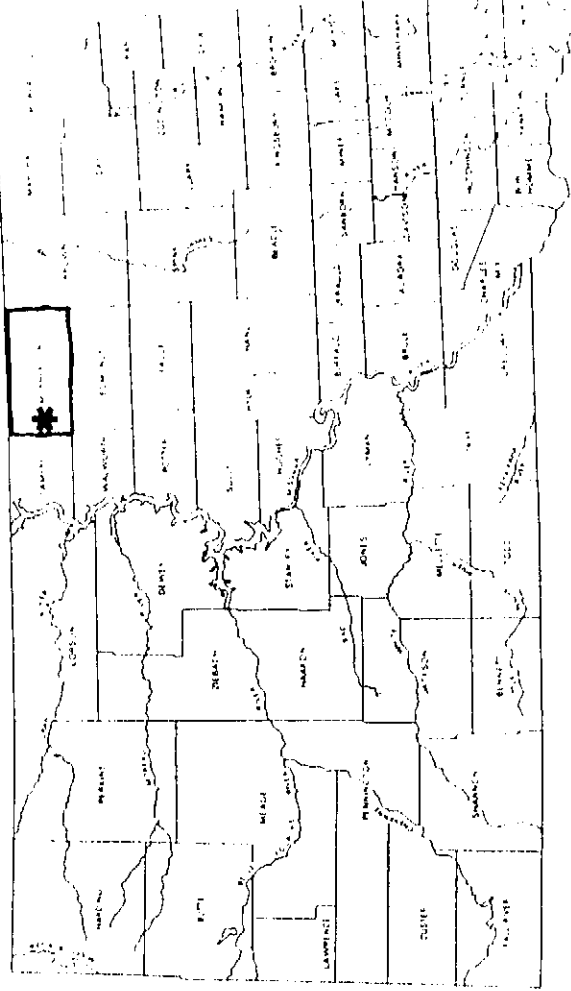
FIGURE 1 . STUDY AREA MAP

East Lake Eureka is a small lake approximately 40 acres (11.4 hectares) in surface area (Figure 1.). The origin of the lake goes back to the 1930's. Prior to 1933, the area was used as a solid waste dump and as a discharge point for the city's wastewater sewer line. The Lake was created as a Public Works Administration (WPA) project beginning in 1933. The existing low spot was cleaned up, solid waste was relocated and the sewer line was rerouted away from the lake. Rather than a typical impoundment type reservoir, the lake was excavated, the shoreline rip-rapped, and a park was developed around the perimeter.

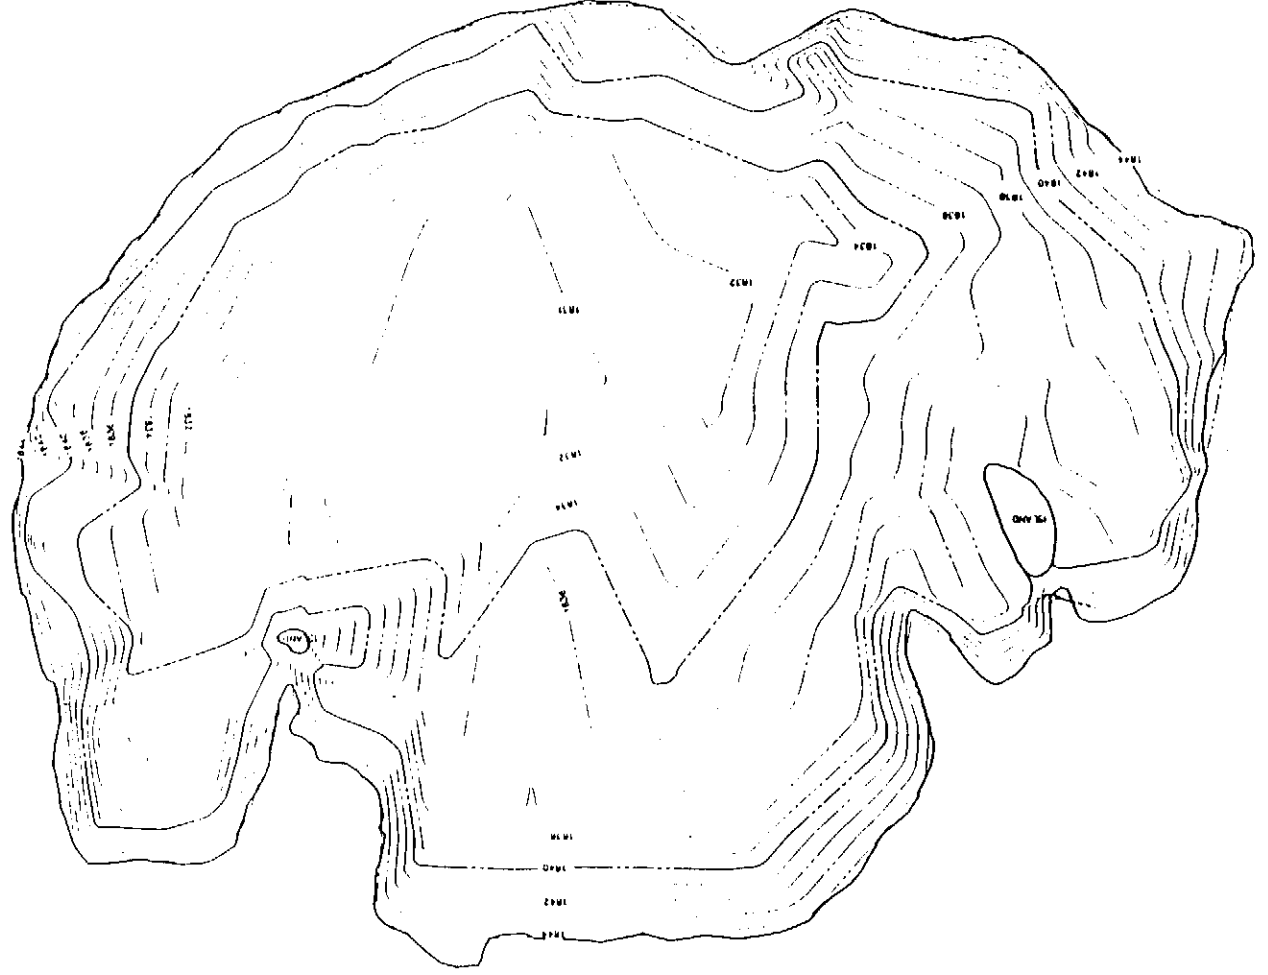
**FIGURE 3. CONTOUR MAP OF WATER DEPTH**

DENR in cooperation with Helms and Associates, conducted a sediment depth survey on April 26 - 28, 1993 to measure the accumulation of loose, soft sediments in East Lake Eureka. Maps were plotted showing both the water depth and the soft sediment depth. Figure 3 is a map of the water depth in East Lake Eureka and Figure 4 is a map of the depth of the water and the soft sediment. The total measured volume of soft sediment in the lake is 139,599.5 cubic yards.
