SECTION 319 NONPOINT SOURCE POLLUTION CONTROL PROGRAM
FINAL REPORT

Evaluating the performance of vegetated treatment areas

Todd P Trooien et al.

South Dakota State University

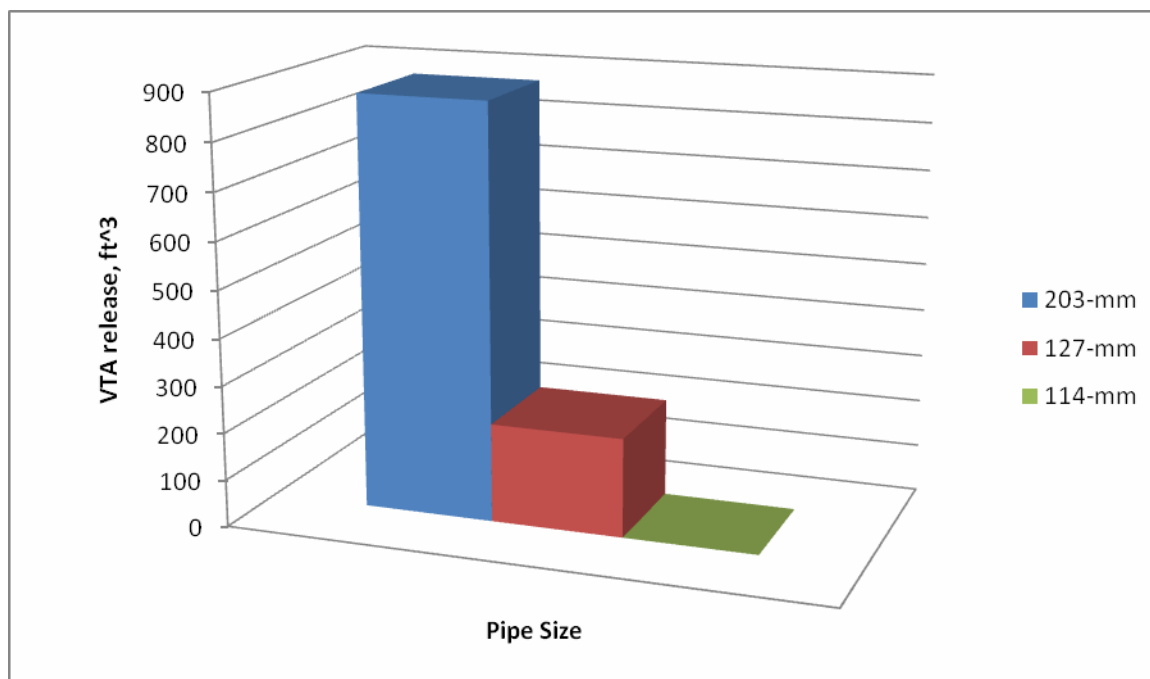
Figure 2. Simulated water discharge from the VTA for three sediment basin outlet pipe sizes.

Simulations also have been used to show that discharge from the VTA is sensitive to the water release rate from the sediment basin. A slower release from the sediment basin results in greater infiltration in the VTA and reduces discharge from the VTA. This is important because rate of release from the sediment basin is relatively easy to adjust (lengthen or reduce) by changing the sediment basin outlet. Even better would be use of a valve at the sediment basin outlet to completely control or stop basin outflow until the VTA dries, at least somewhat, after a storm. Care must be taken to make sure the sediment basin is drained within 72 hours, as required if the basin is not lined with clay or other impermeable material. An illustration of reduced VTA discharge with reduced sediment basin release rate is shown with a repeated model runs with a simulated storm at the Miner County site (Fig. 2), varying the sediment basin release pipe size (and outflow rate). Simulations showed that water discharged from the VTA was reduced from 878 to 210 to 0 ft³ by reducing the sediment basin outlet pipe size from 203-mm to 127-mm to 114-mm (Fig. 2), respectively.

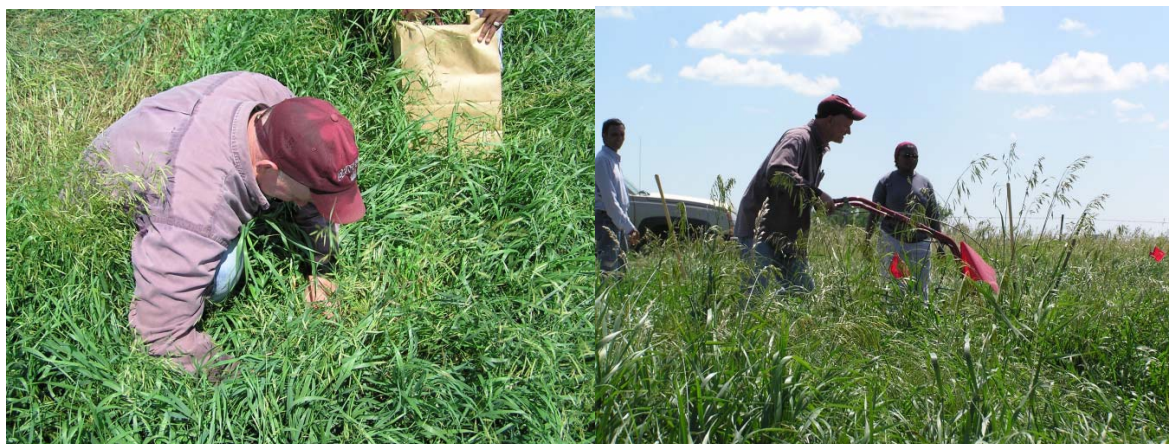
Figure 6. Smooth brome grass within the Miner VTA.

The smooth brome within the VTA at the Miner site was highly productive (Fig. 6, note the lush growth). Two locations for harvest treatments were established within the VTA. One location was in the southeast corner of the VTA, near a VTA outlet. This was a wet area, low in the landscape, where water often ponded during wet periods. The other area was near the top of the VTA, about 2 m from the gated pipe. The treatments applied were three harvest strategies- one, two, or three harvests per year. The one-harvest treatment was harvested during late June or early July shortly after anthesis at peak standing crop. The two-harvest treatment was harvested at peak standing crop and the end of the growing season. The three-harvest treatment was harvested at peak standing crop, mid-summer, and

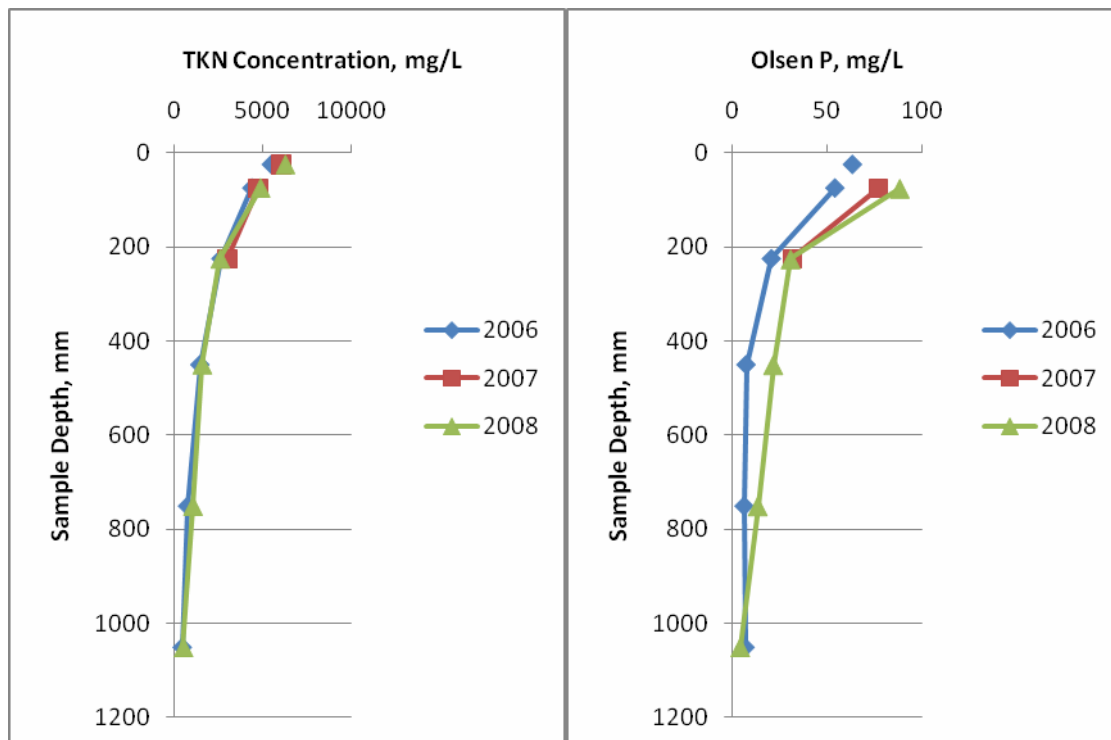
Figure 8. TKN and Olsen P concentrations in the soil profile in the VTA of the Miner site.

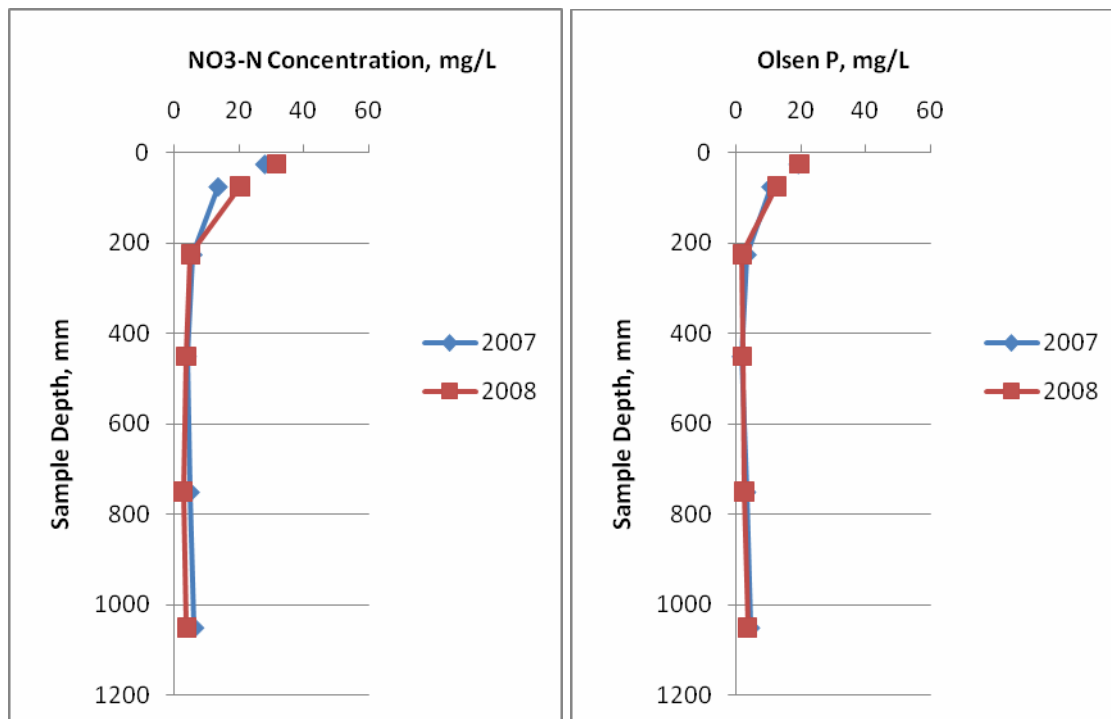
Figure 11. Nitrate-N and Olsen phosphorus concentrations in the soil profile at the Meade site, 2007 and 2008.

The nutrient (nitrate-N and P) concentrations in the soil profile of the VTA showed little increase from 2007 to 2008 (Fig 11). There was some addition of nitrate-N in the 0 to 150 mm layer. These values reflect the modest net inflows of 48.4 kg N/ha and 10.8 kg P/ha. The TKN concentrations showed similar trends (data not shown). The data shown are averages of 6 locations- top and bottom of each of the three VTA cells.

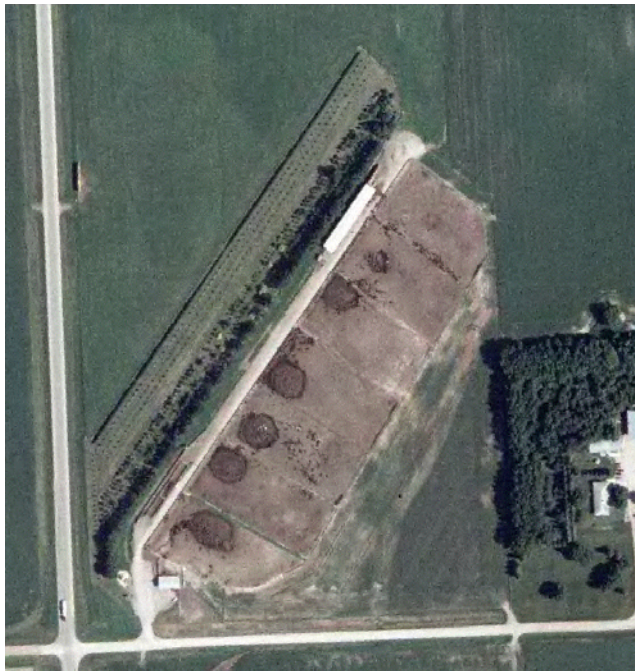
Figure 16. Aerial view of the Stevens County site. Runoff flows from the pens in the middle of the image in a southeasterly direction. The VTA is most of the triangular area between the pens and trees in the bottom center of the image.

Water moves in this VTS via gravity flow. The runoff from the pens is held in concrete-lined sediment basins at the bottom of the pens (Figs 16 and 17). Gates are used at the sediment basin outlets to

control the sediment basin outflow manually. When the gates are opened, water from the sediment basins flows into a curb-and-gutter system to spread the water laterally at the top of the VTA.

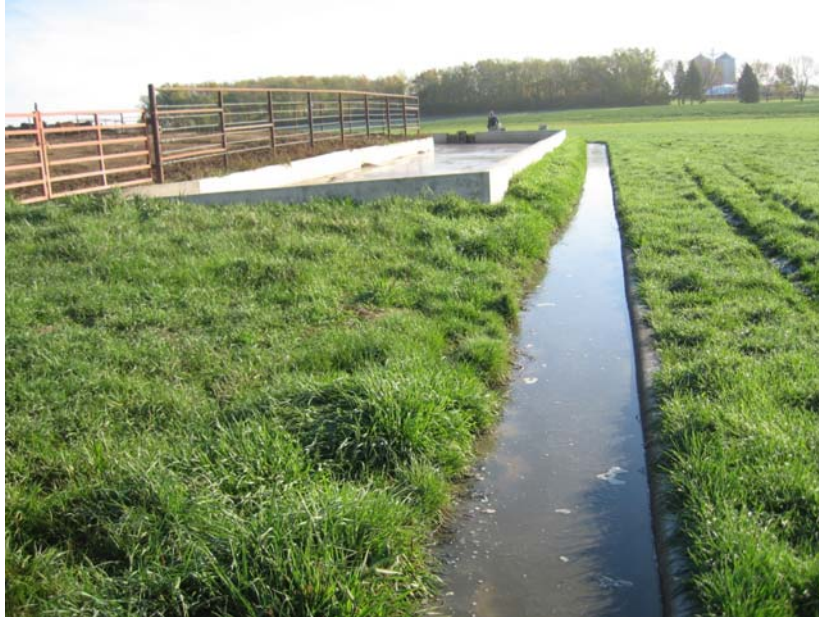
Figure 17. Side view of the Stevens VTS at the south end, looking ENE. In the image are pens (far left), sediment basin (within the concrete walls), curb-and-gutter distribution system (center of image), and the VTA (far right). Runoff flows from left to right in the image.
