SYLVAN LAKE RESTORATION PROJECT
FINAL REPORT

Greg Wierenga
Utility Engineering Corporation
Rapid City, South Dakota 57709

Grant No. S008293-01

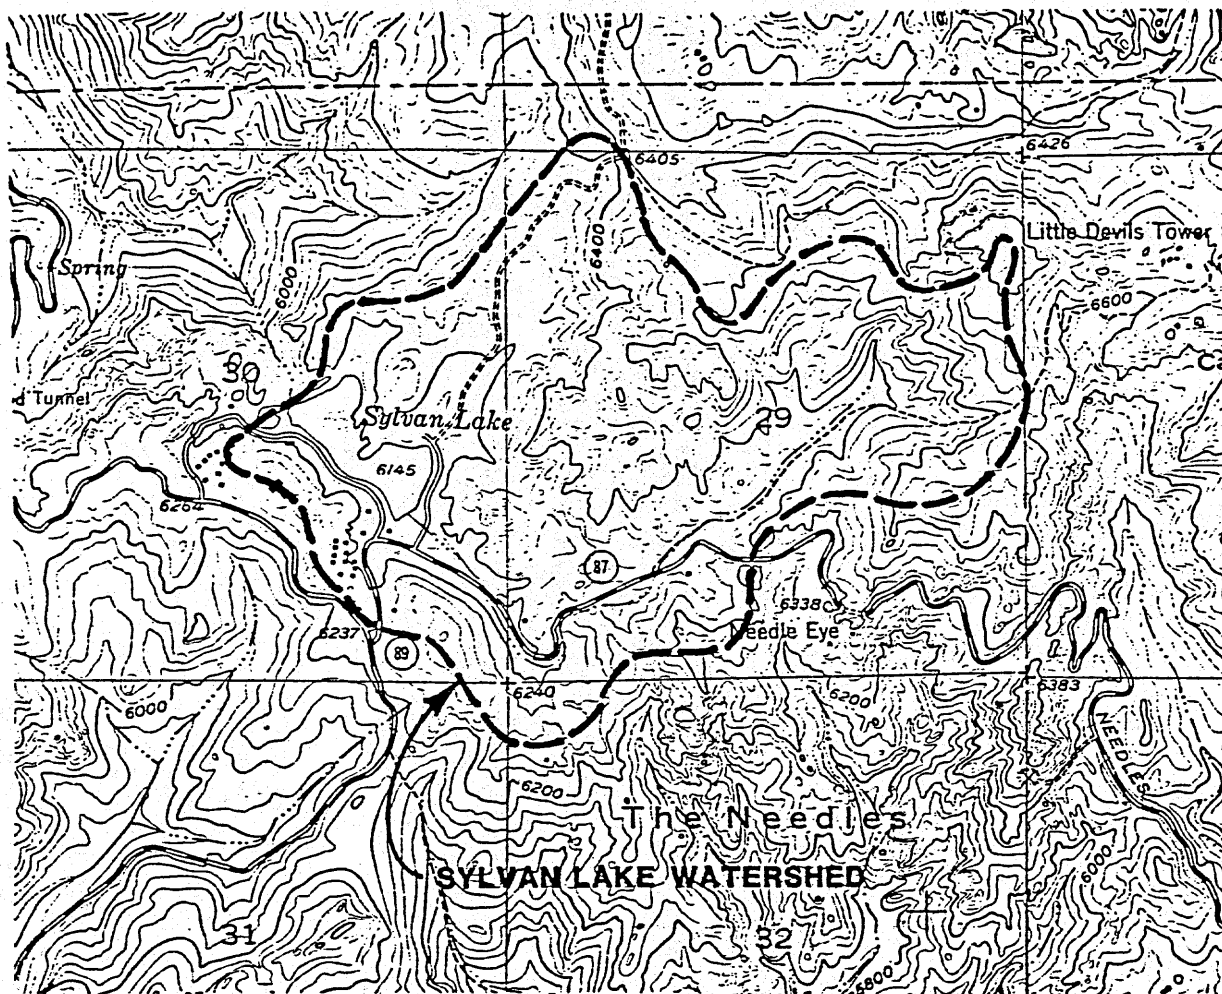
Sylvan Lake has a surface area of about 7.5 Ha (18.6 acres), with an average depth of 4.6 m (15 feet), and a maximum depth of 11 m (36 feet). The lake is recharged solely by natural precipitation from a 275 Ha (1.06 square mile) watershed and is depleted by evaporation and seepage. Excess runoff spills over the concrete dam during periods of high inflow. Figure 2 illustrates the lake and watershed topography and presents descriptive data for the lake and watershed hydrologic characteristics.

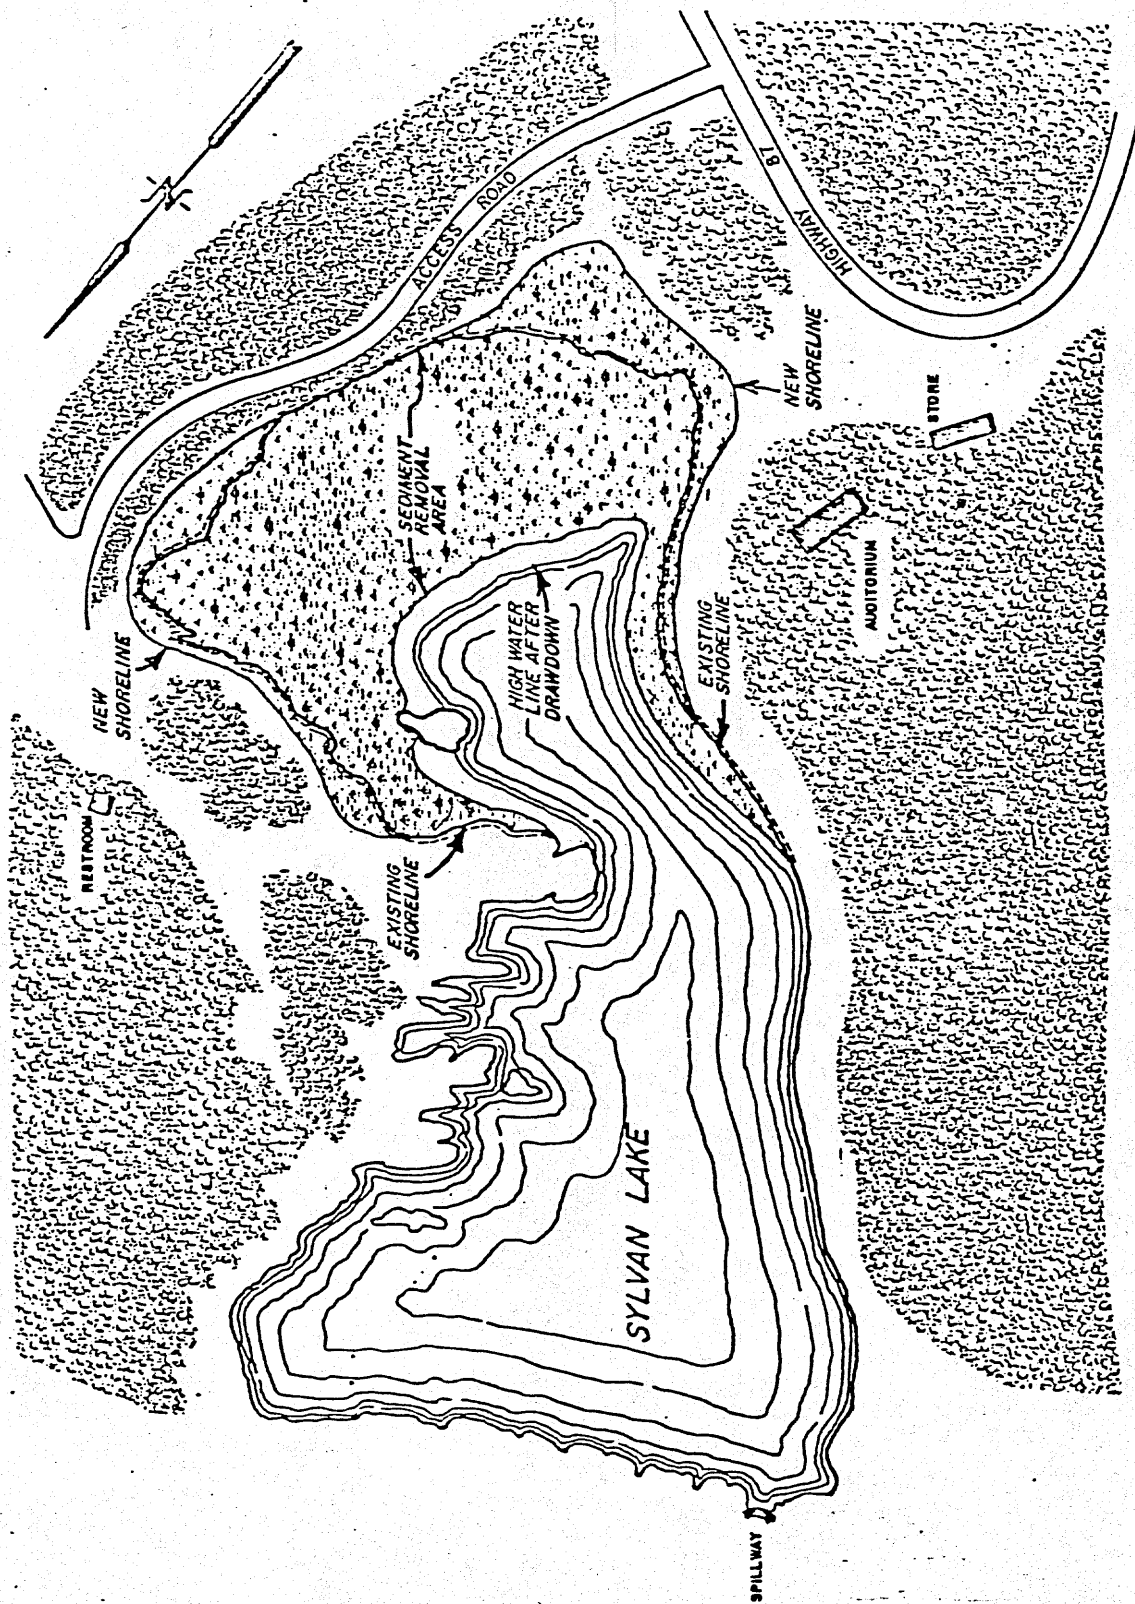
Figure 8. Sediment removal area map

Sediment removal was accomplished under a competitively-bid unit-price contract, by a private contractor. The contractor elected to employ conventional earth-moving equipment for the work: wheeled and tracked loaders and excavators, with hauling by dump truck. Removed sediment was disposed of by dumping at two predetermined disposal sites: 1) a borrow pit from a previous highway construction project located approximately 0.8 km southwest of the lake, and 2) an older borrow pit and dump site located about 1.2 km south of the lake. The sediment deposits
