# **Lake Poinsett Watershed Project**

# Segment Two Final Report

# **EPA Section 319 Nonpoint Source Pollution Control Program**

Sponsored by Hamlin County Conservation District

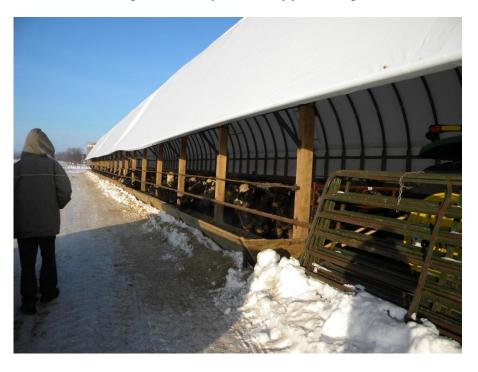
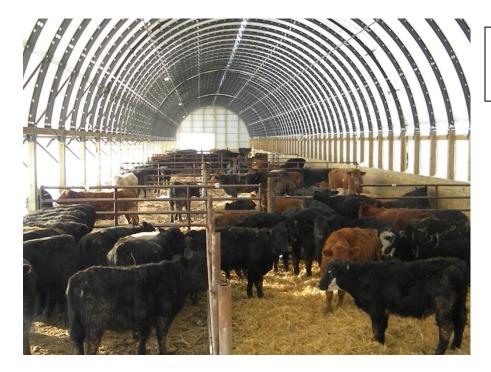
New confinement barn on Dolph Creek for 200 head with manure storage

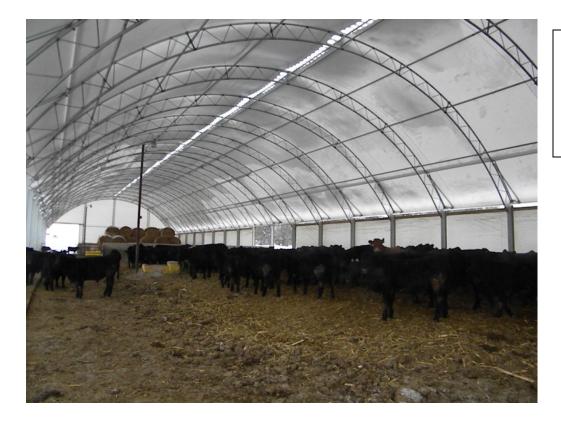
Snow on roof and wet outside, but 400 head facility keeps livestock and manure confined

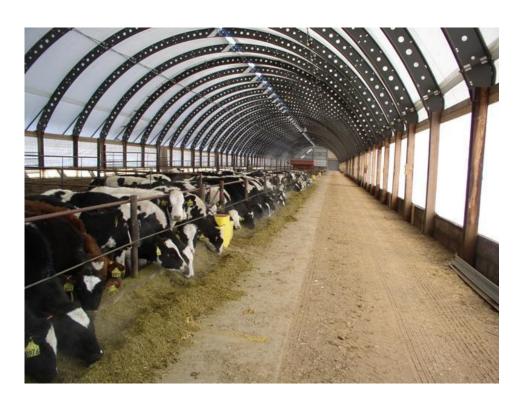
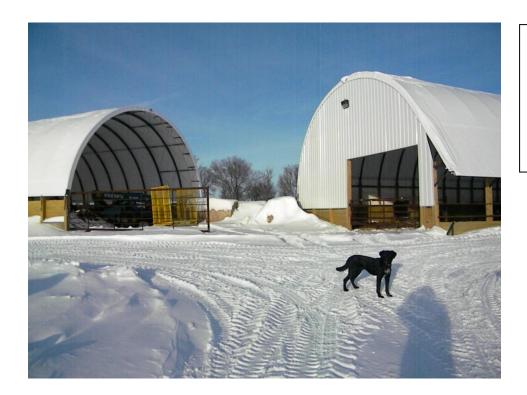
Hoop barn using compost method with inside feeding alley for replacement dairy heifers

Secondary hoop barn to store manure during winter from scraped alley in 200 head facility

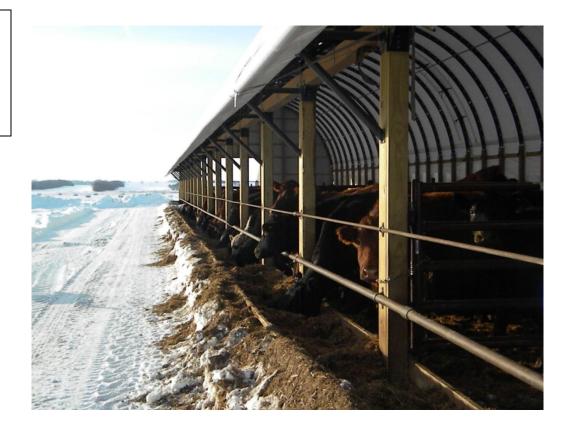
Sunny day for animals in double hoop barn facility

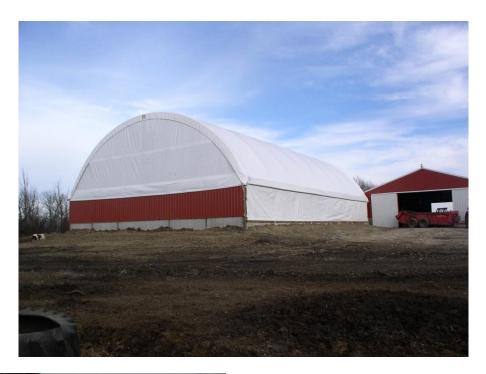
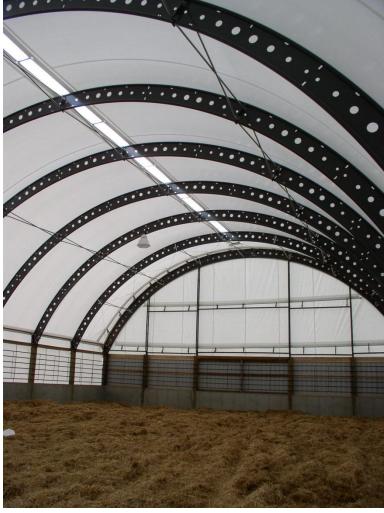
Dairy compost barn for manure storage of 50 milking cows

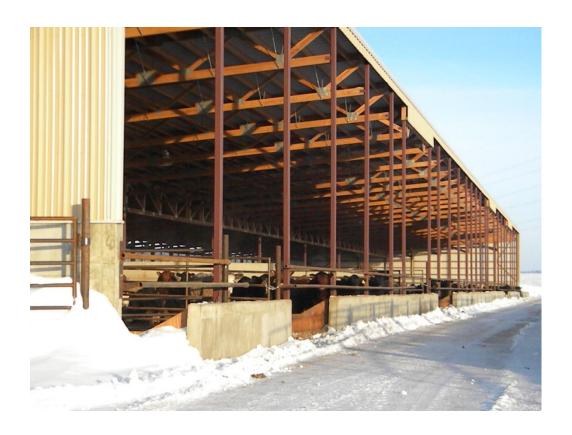
Outside feeding alley of 600 head monoslope feeding barn, that combined the livestock of three noncontainment open lots locations into one confinement structure

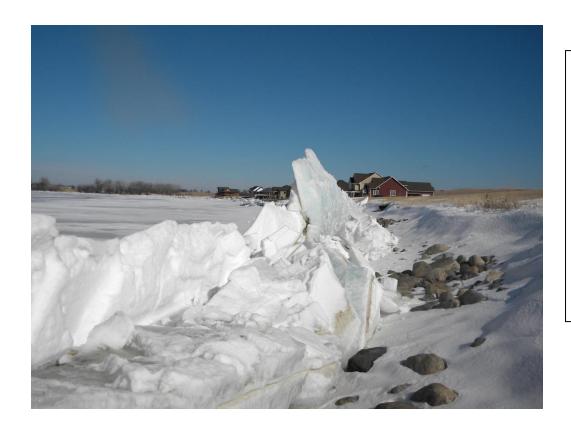
First danger in spring of 2011 was the impact of ice damage to shorelines and homes. Project advised owners to empty out chemicals and petroleum products from structures.

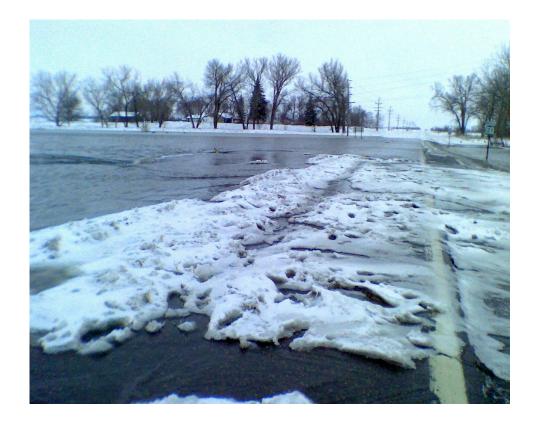
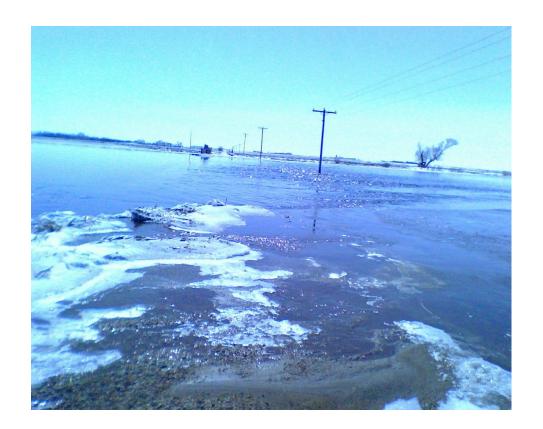
2011 Dolph Creek overflowing Highway 21 north of Lake Norden

Big Sioux River out of its banks and spilling into the Boswell diversion ditch

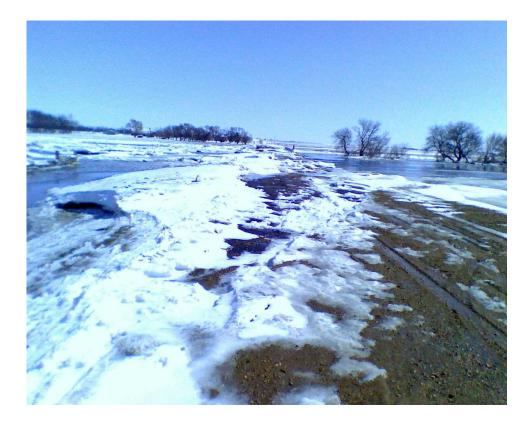
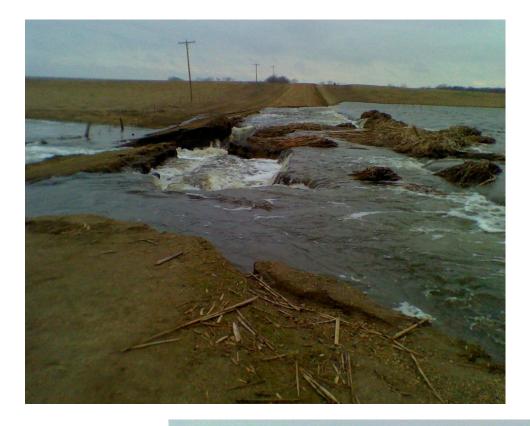
Big Sioux River below Stray Horse Creek flowing over county highway

North Lake Marsh drainage ditch taking out county highway and culverts

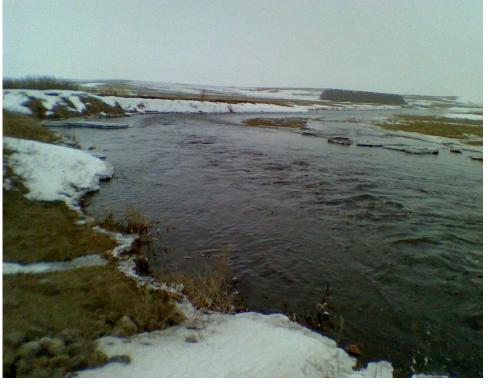
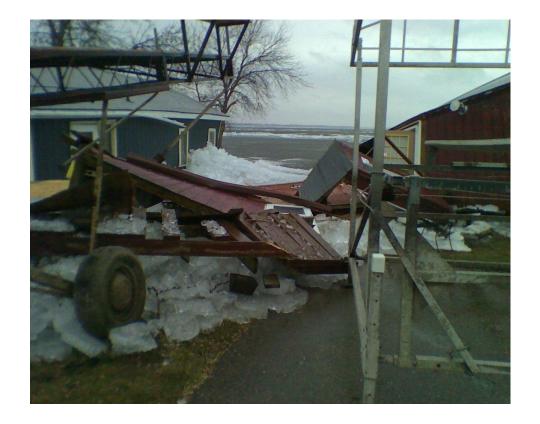
Stray Horse Creek east of Castlewood out of banks

Rising water levels combined with wind drives ice into south side cabins on Lake Poinsett

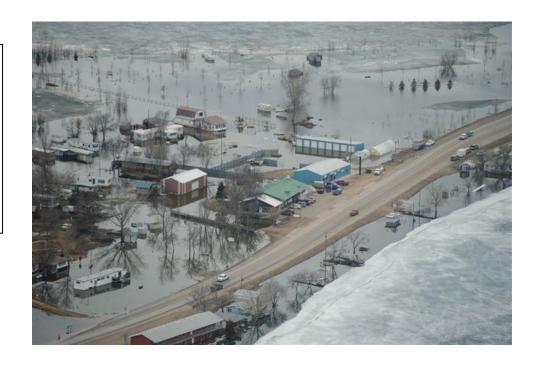
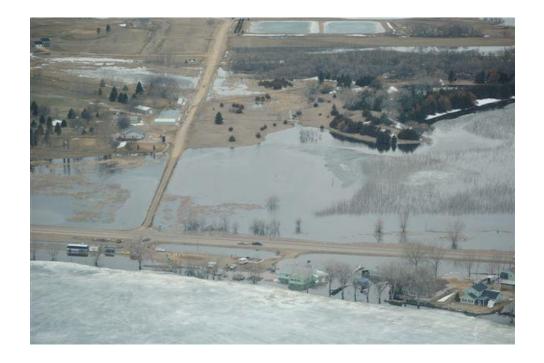
Waters still rising and eventually floods Highway 81 on west side of Lake Poinsett

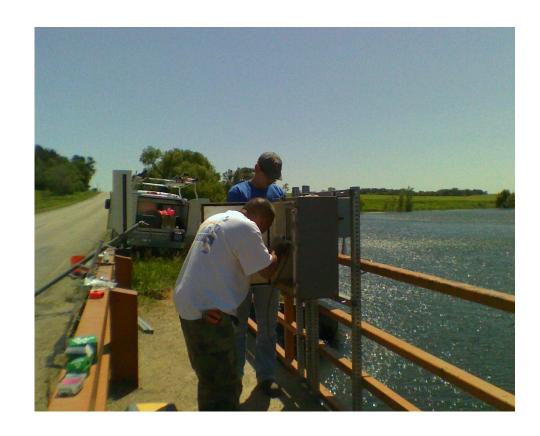
Coordinator
assists Corps
of Engineers
in setting up
automated
gauging
station to
monitor flood
levels on
Lake Poinsett
outlet

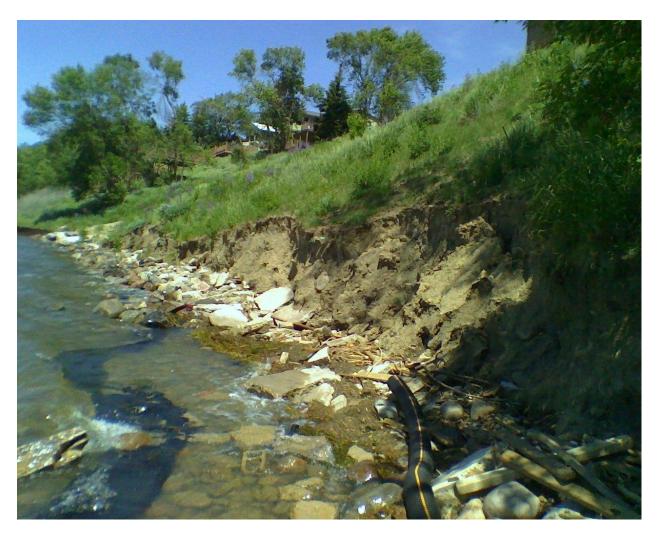
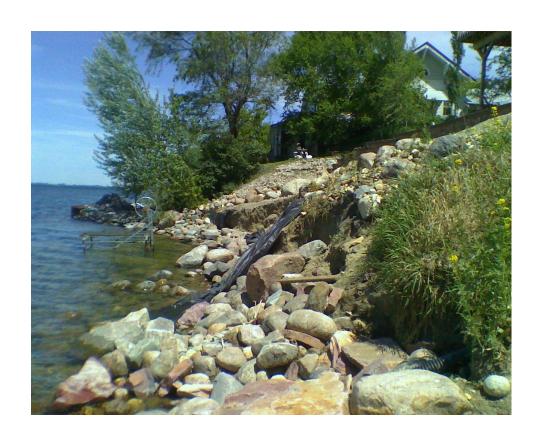
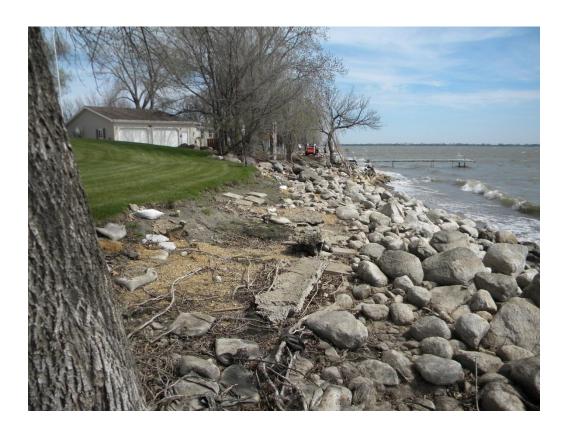
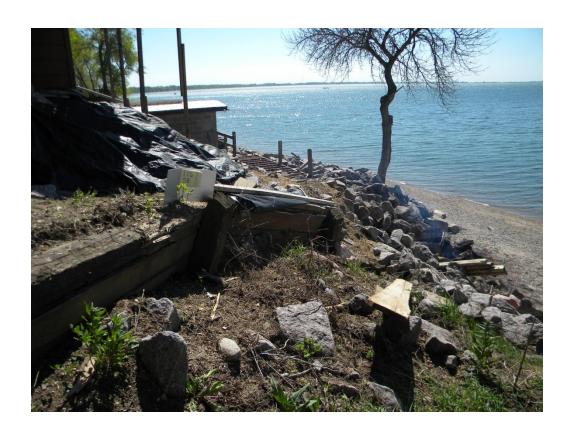
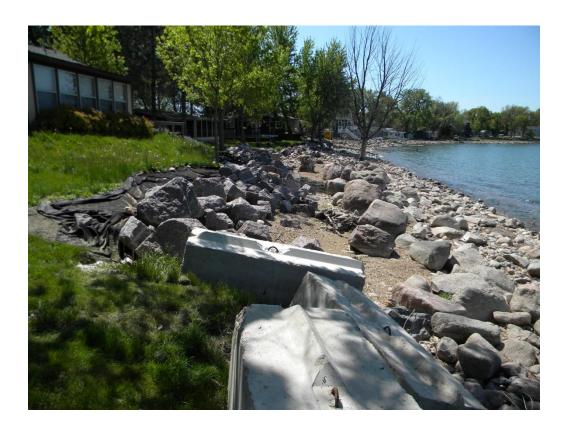
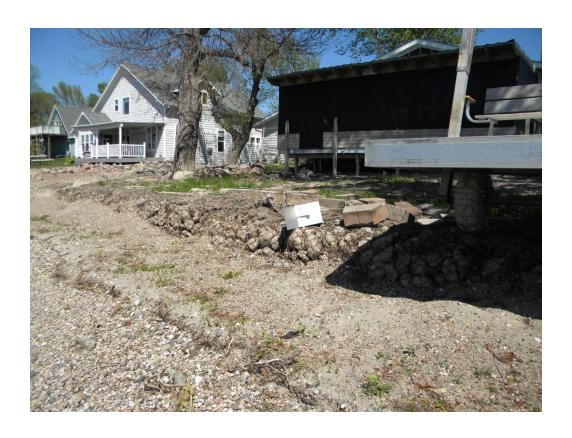
Assessing the damage, coordinating restoration designs with homeowners and contractors will take the next 2 ½ years of the Project and require over \$1.1 million for 200 homeowners.

2012 and 2013 provided good working water conditions and resulted in restoration work on all areas of Lake Poinsett. Homeowners followed new Lake Poinsett Watershed formulated guidelines. Raising the required elevation of rip rap to a height 7 ft above ordinary high water was needed. The project also suggested practices of using new geotextile root stabilizing materials under lawn turf and restoring more shrub and tree plantings to stabilize shorelines.

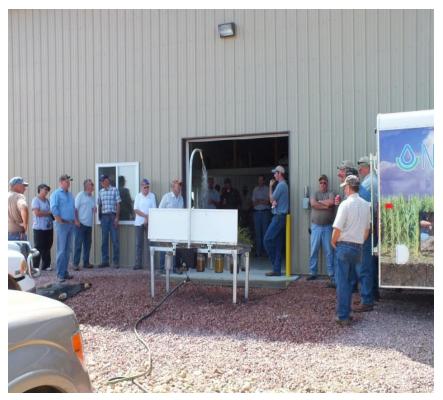
NRCS Rainfall Simulator ready to run.

From the largest farm operations to the youngest students, the Rainfall Simulator sparked interest in how water moves upon and within the soil.

Starting in late 2012 the Project Coordinator became involved in actively promoting Soil Health quality to reduce surface water runoff in Eastern South Dakota. Cover crop workshops were well attended winter events and demonstrating the effect of agricultural practices on runoff and infiltration with the NRCS Rainfall Simulator were summer tour and field day hits.

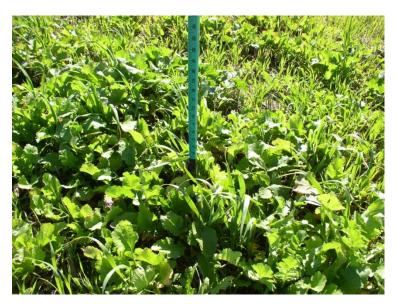
Cover crops growing in Hamlin County
