**PHASE I
WATERSHED ASSESSMENT
AND TMDL
FINAL REPORT**

**LAKE ALICE
DEUEL COUNTY, SOUTH DAKOTA**

JULY, 2002

**SECTION 319 NONPOINT SOURCE POLLUTION CONTROL PROGRAM
ASSESSMENT/PLANNING PROJECT FINAL REPORT**

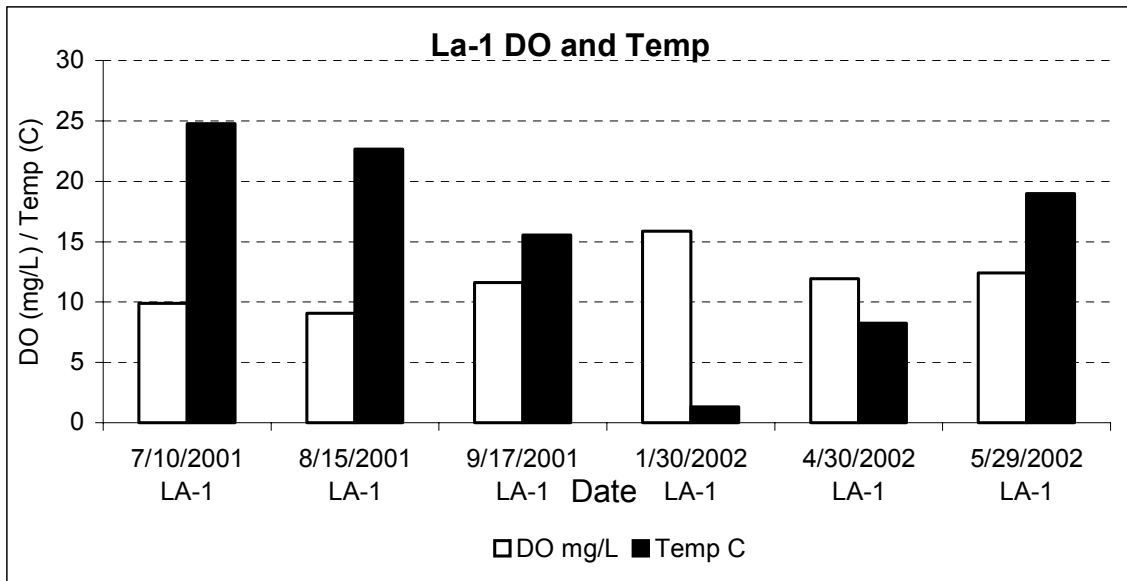
Figure 5. Site LA1 Dissolved Oxygen and Temperature

Oxygen levels in Lake Alice were sufficient to maintain requirements for the fishery of the lake. The lowest level was 9.1 mg/L and was recorded during the month of August 2001, and the highest in January 2002 was recorded at 15.8 mg/L.

The lowest water temperatures were recorded in January, this is the only sample that was taken while the lake was completely covered in ice. There were several periods of freezing and thawing in the lake throughout the winter. This may have allowed for some increases in water temperature. The peak annual temperatures were reached during July at 25.9C, which is below the state standards that require it to maintain a maximum temperature under 32.2C.

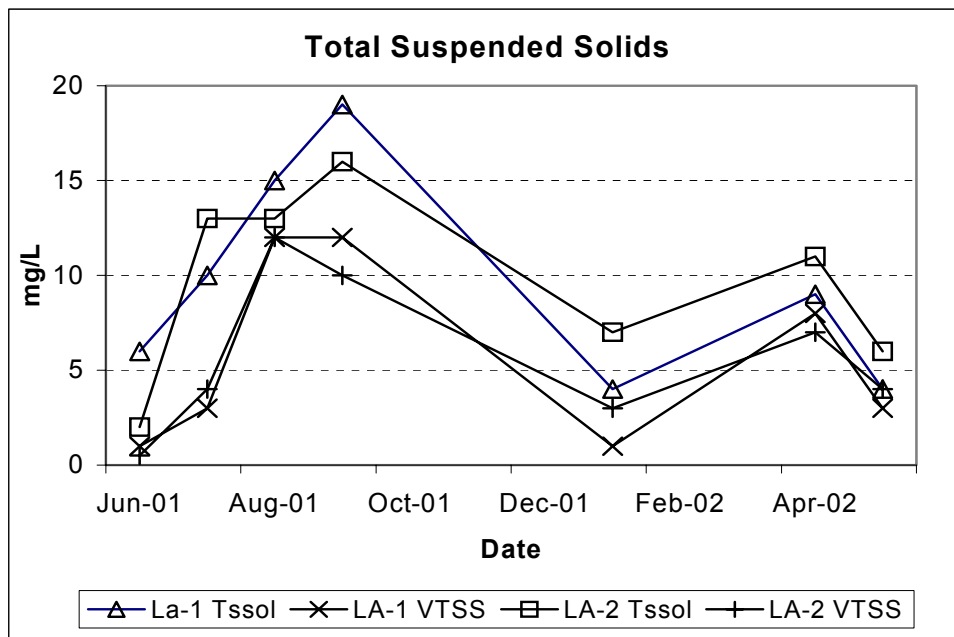
Figure 9. Total and Volatile Suspended Solids for Lake Alice

Lake Alice exhibited very little variation in total solids and dissolved solids concentrations through the course of the year. Peak values were observed during periods of ice cover in January of 2001. The lowest values were observed during the month of June 2001. Suspended solids concentrations in Lake Alice remained fairly low throughout the course of the year. The lowest values were observed during the January sample and the highest during the September sample. Volatile suspended solids followed the same trend as the suspended solids.

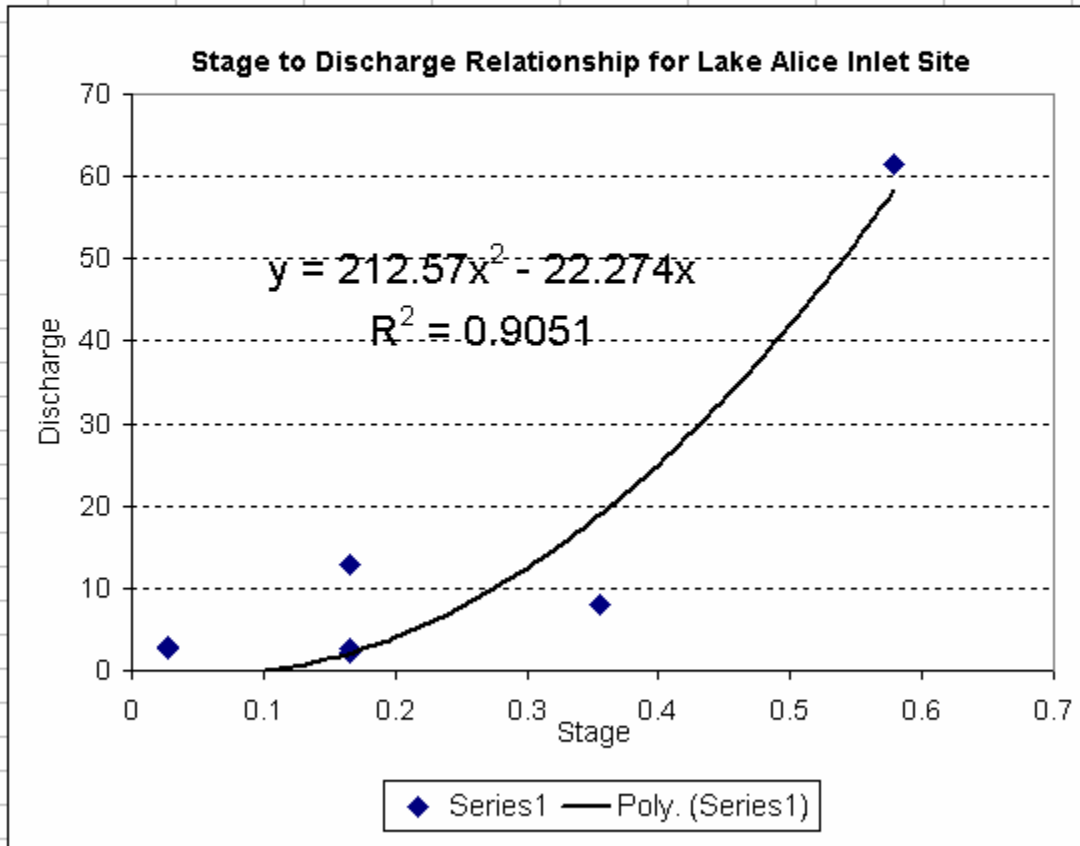
Appendix A. Stage to Discharge Tables

Stage	Discharge
	0.627	0.027
	0.027	2.688
	0.627	0.027
	0.027	2.97
	0.766	0.166
	0.166	2.688
	0.766	0.166
	0.166	2.169
	0.765	0.165
	0.165	12.854
	1.179	0.579
	0.579	61.57
	0.956	0.356
	0.356	8.075

A single inlet site on an unnamed tributary to Lake Alice was monitored. This site was selected to determine the sediment and nutrient loadings to Lake Alice. The site was equipped with an ISCO model 4230 Flow meters attached to a GLS auto-sampling unit. Water stages were monitored and recorded to the nearest 1/100th of a foot during times of discharge. A Marsh-McBirney velocity meter was used to determine flows at various stages. The stages and flows were then used to create a stage/discharge table for the site, which may be found in Appendix A.
