# SOUTH DAKOTA WELL AND TEST HOLE PLUGGING REPORT

Name City of Sioux Falls Public Works Dept.

# CITY OF SIOUX FALLS
## SIOUX FALLS REGIONAL LANDFILL
## SIOUX FALLS, SOUTH DAKOTA

MONITORING WELL INSTALLATION & ABANDONMENT

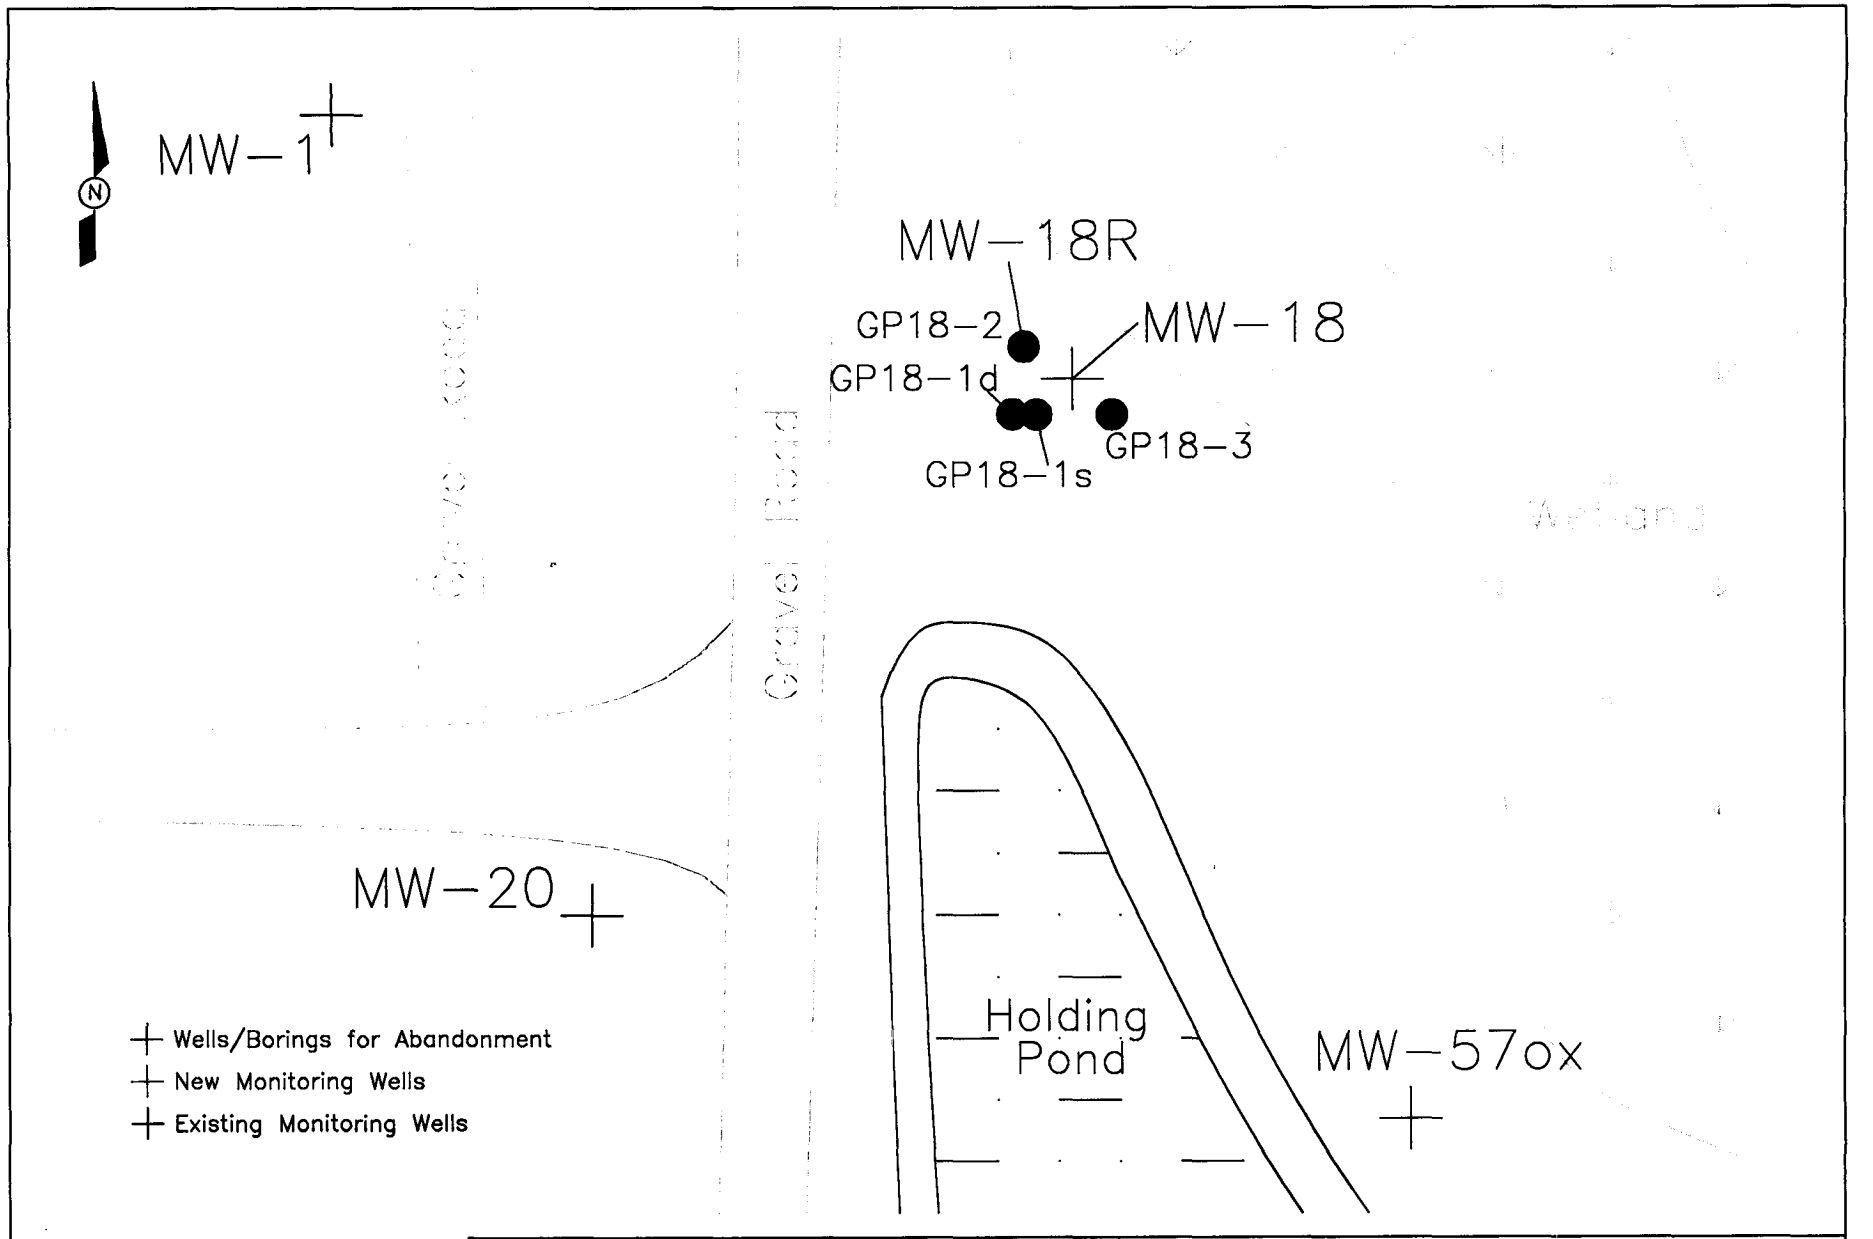
Please mark well location with an "X"
See inclosed Site Plan MW-18-1D

Describe plugging procedure: Clean Sand placed from 45' to 25'. Bentonite chips (hydrated) placed from 25' to 21'. Neat cement placed from 21' to 2'. Native material placed from 2' to surface. All hand placed.
