**Removal of Certain
Classified Impoundments
From
Administrative Rules of South Dakota
Chapter 74:51:02**

October 2022

**South Dakota
Department of Agriculture and Natural Resources
Office of Water
Pierre, South Dakota**

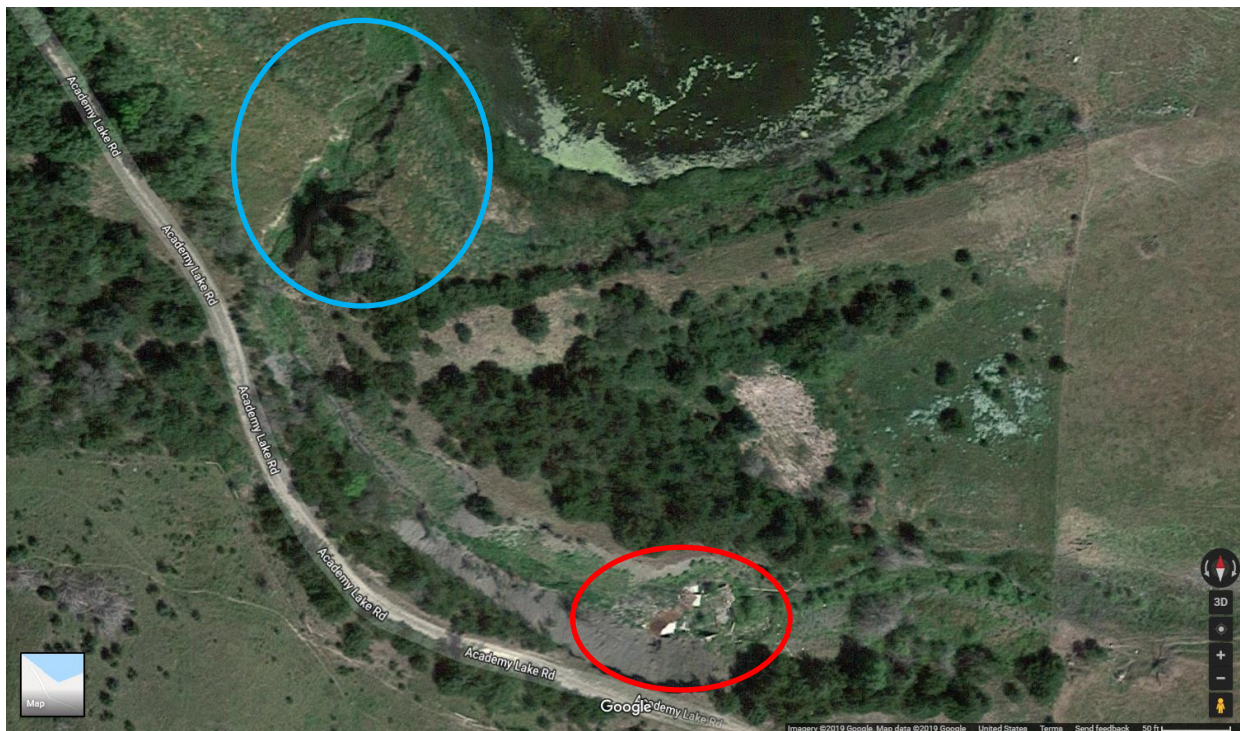
Figure 3. Google image of Academy Dam with cut visible (blue circle) and remnants of the concrete spillway (red circle) laying in the channel (Google, 2015).

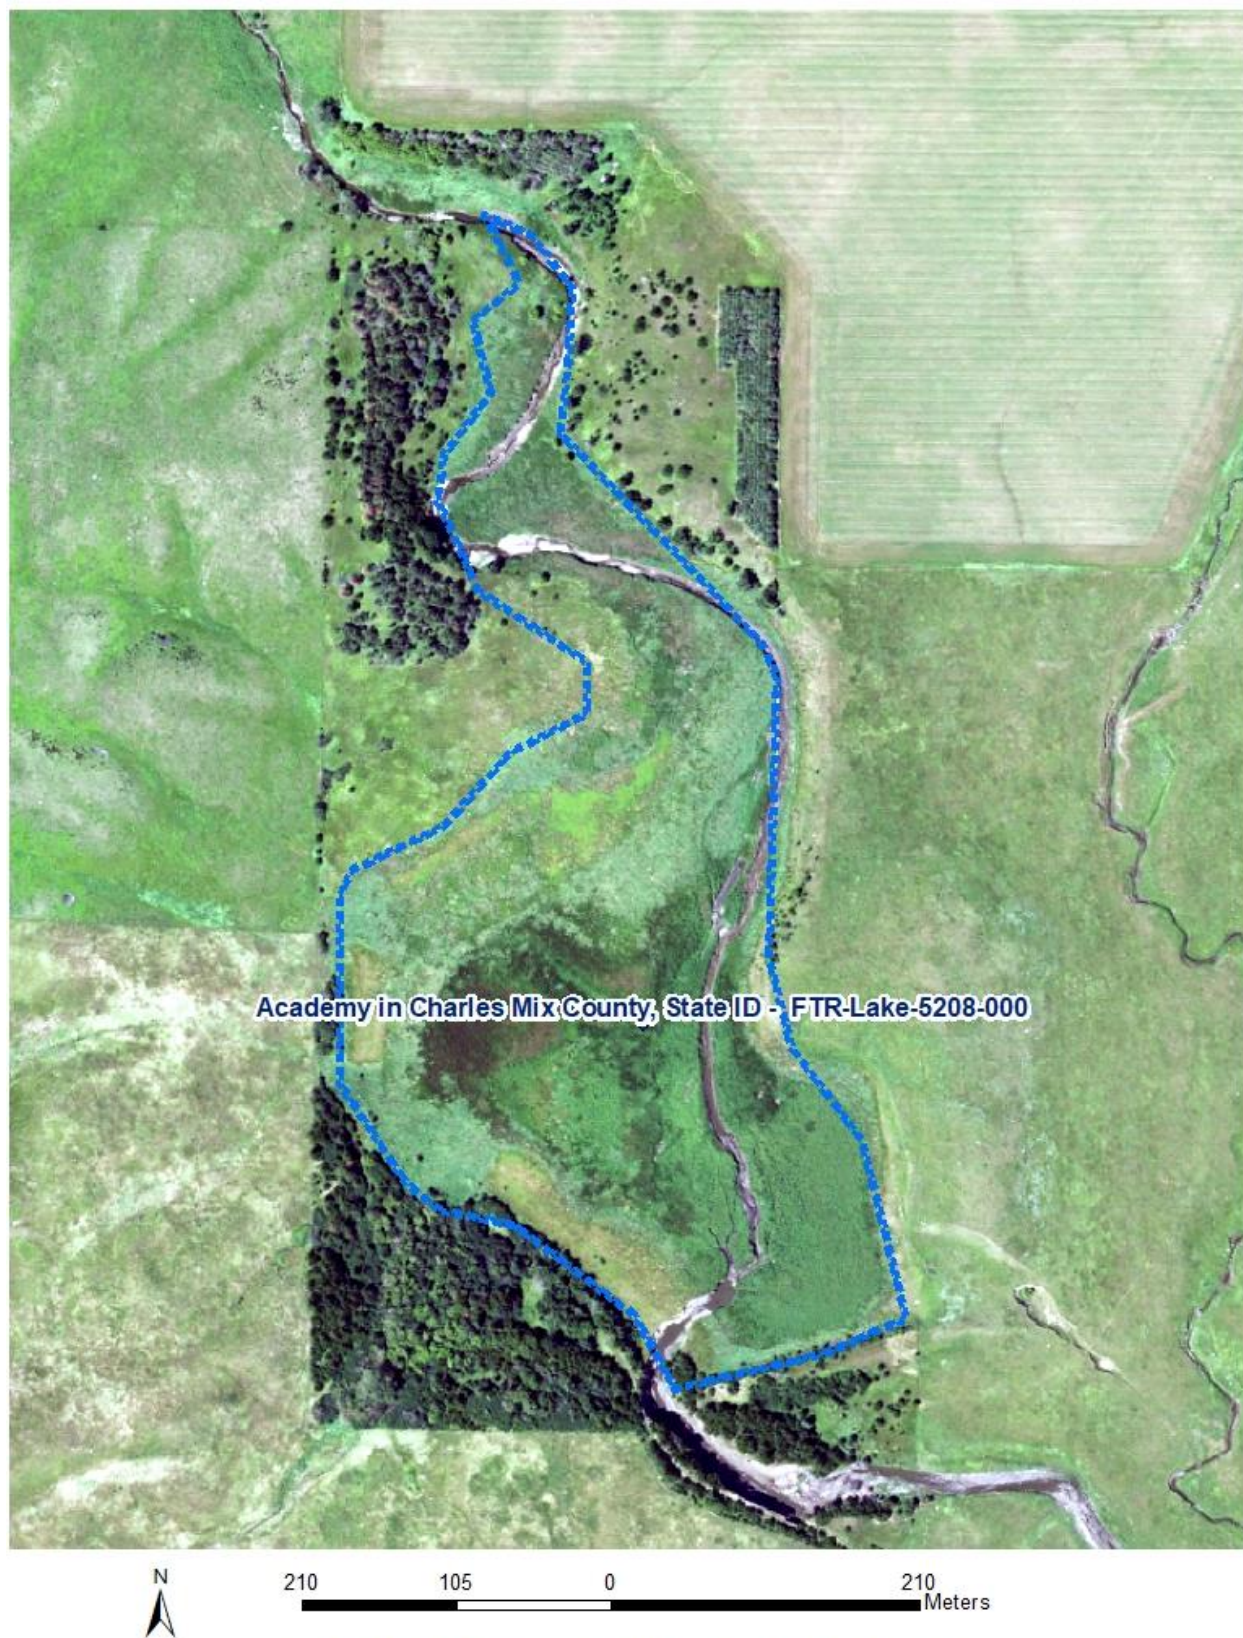
2020 NAIP Imagery with outline of dry basin.

Figure 5. 2020 NAIP imagery of Academy Lake in Charles Mix County. Blue outline represents the extent that water was present prior to the dam breach and lake draining.

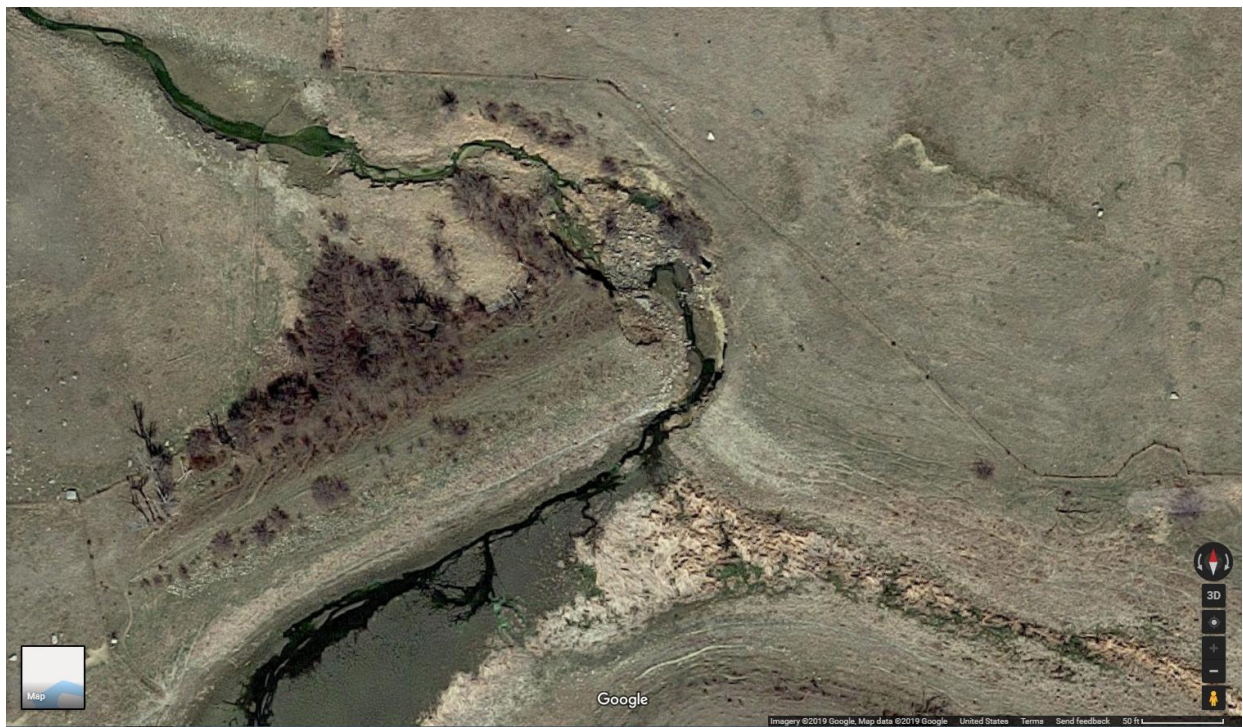
Figure 7. Google Image of Bergers Lake Dam and channel formation through dam grade (Google, 2014)

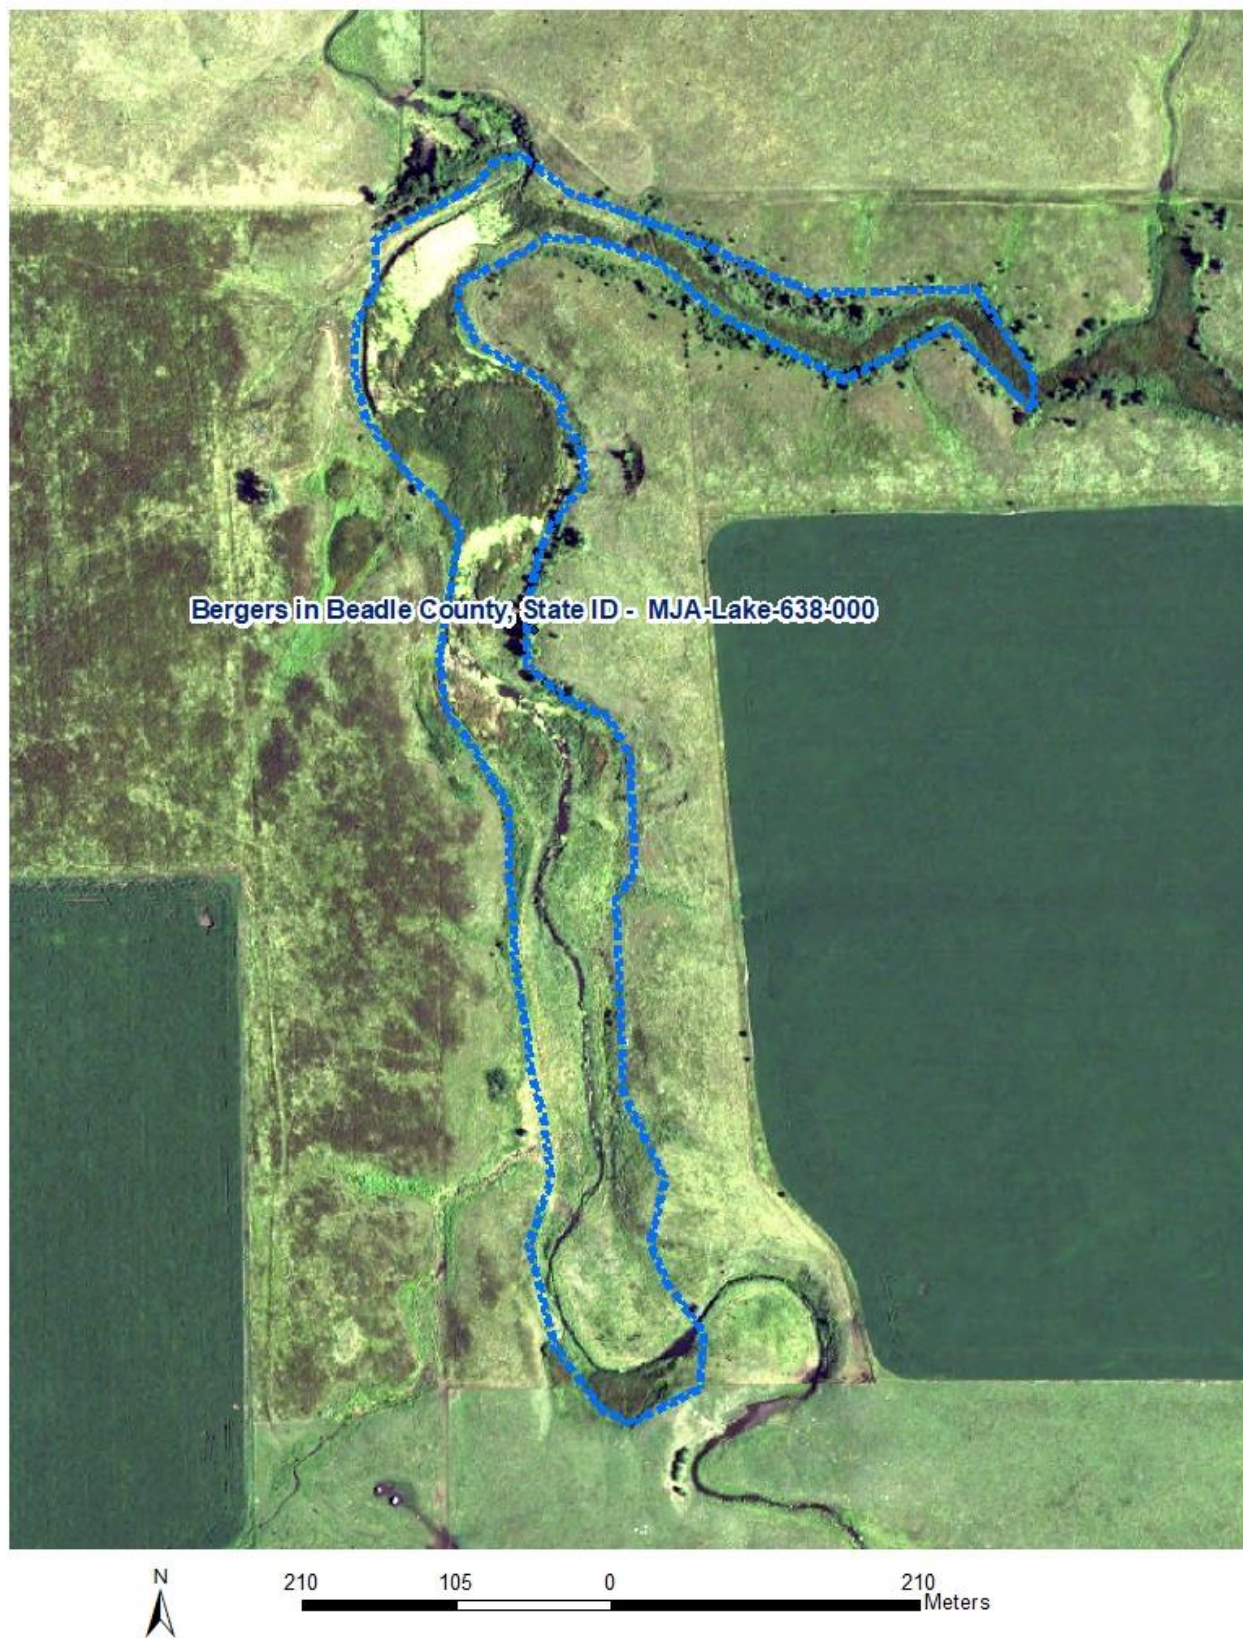
2020 NAIP Imagery with outline of dry basin.

Figure 9. 2020 NAIP imagery of Bergers Lake in Beadle County. Blue outline represents the extent that water was present prior to the dam breach and lake draining.

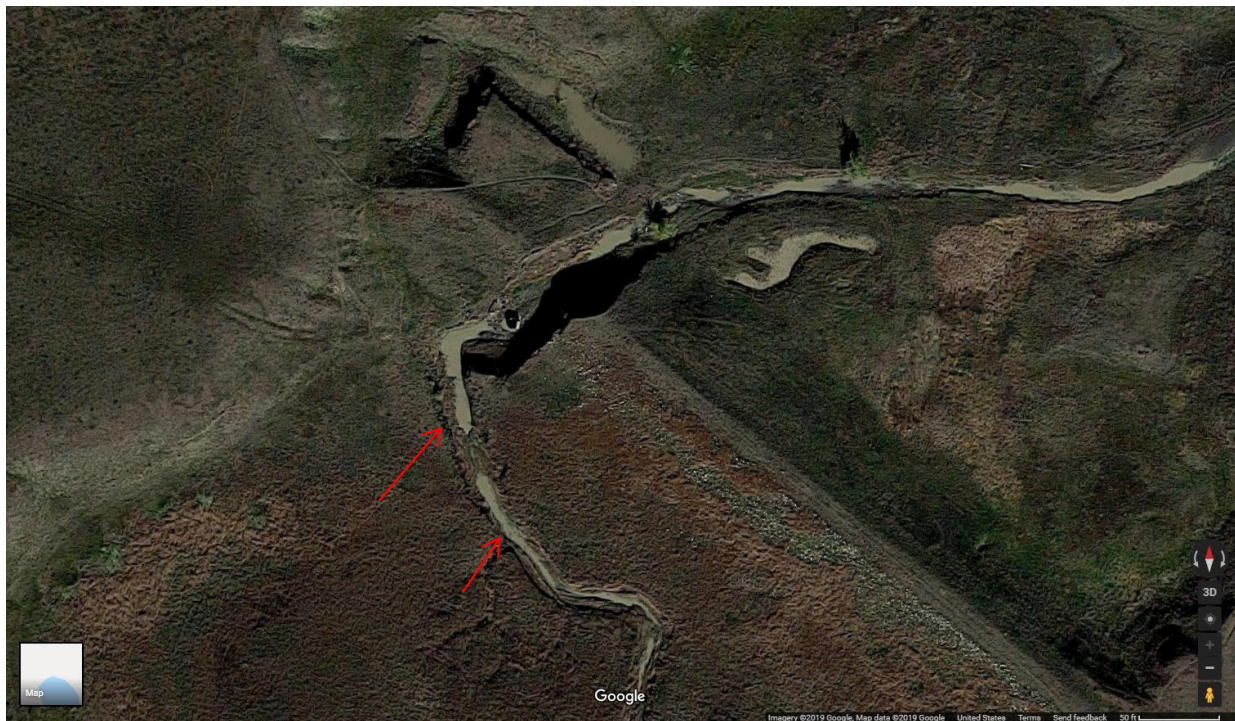
Figure 11. Google image of the Bochart Dam breach and stream channel in the lakebed (red arrows) (Google, 2013).

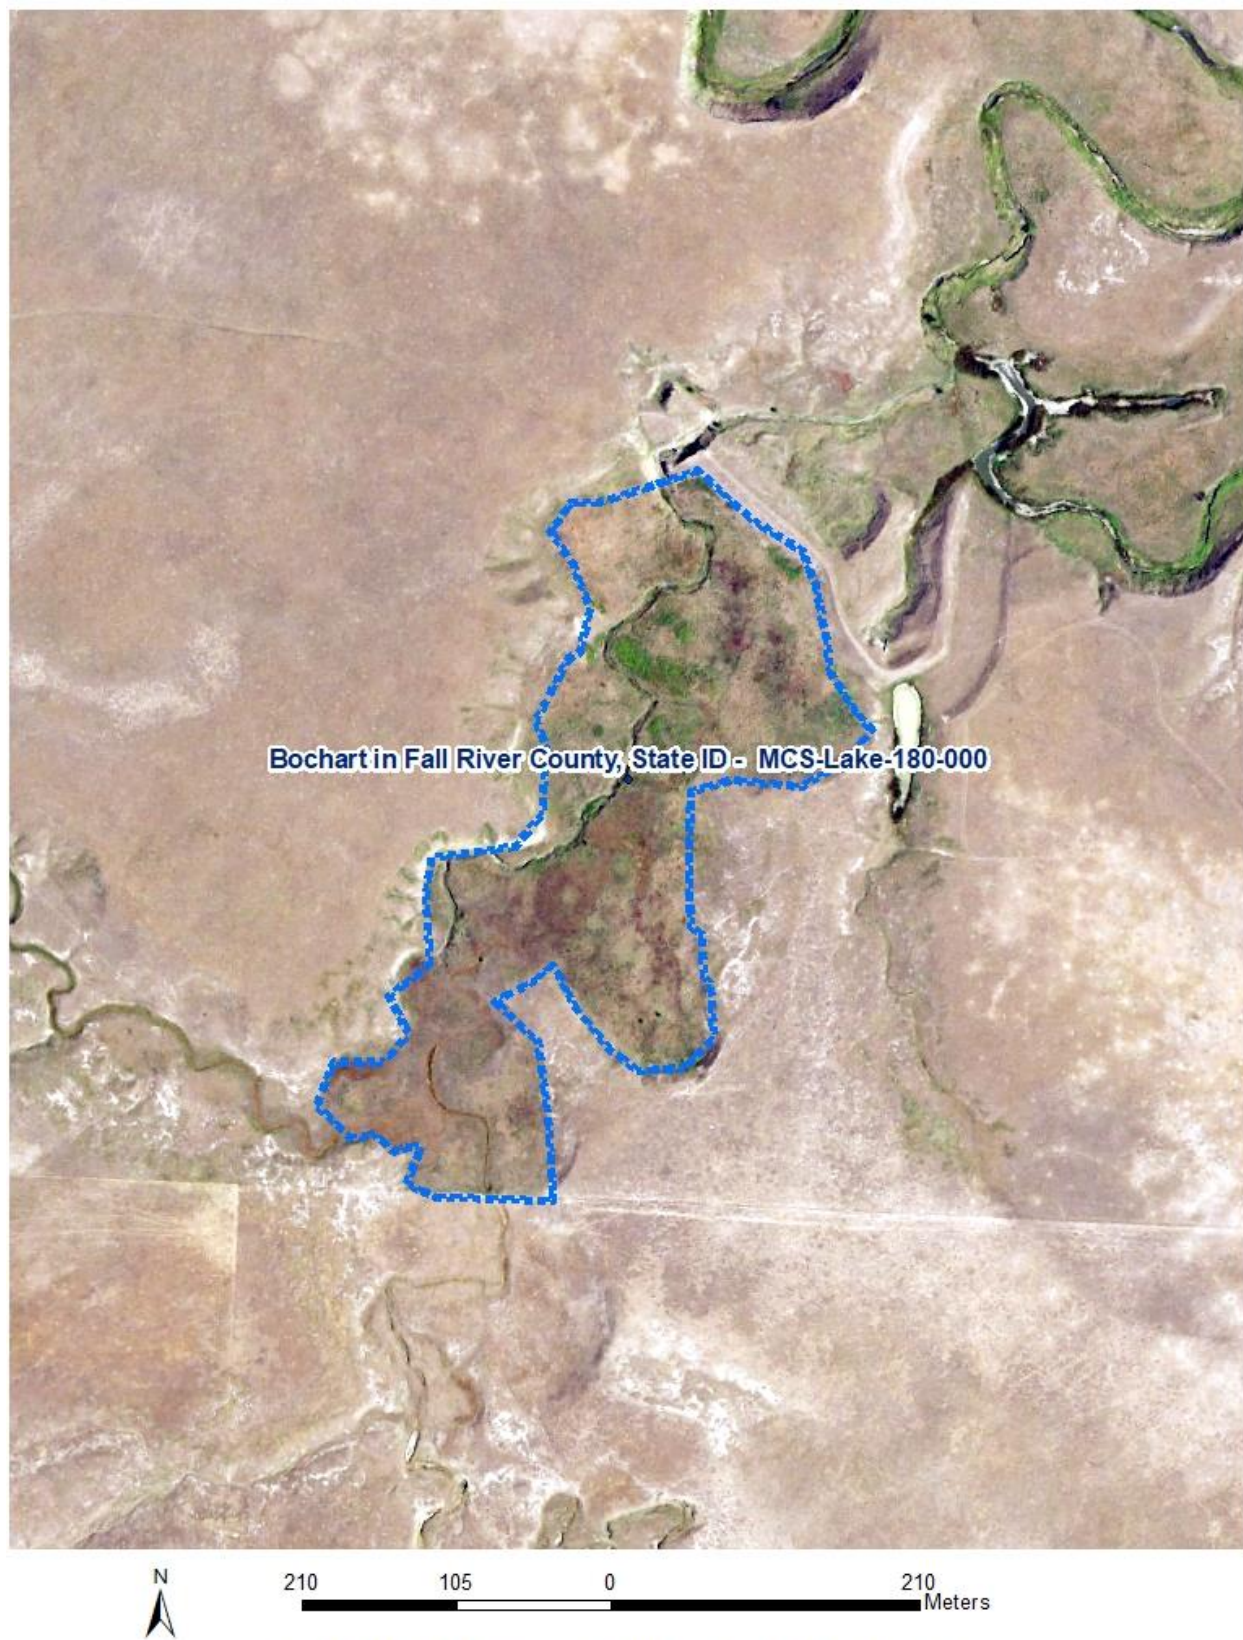
2020 NAIP Imagery with outline of dry basin.

Figure 13. 2020 NAIP imagery of Bochart Lake in Fall River County. Blue outline represents the extent that water was present prior to the dam breach and lake draining.

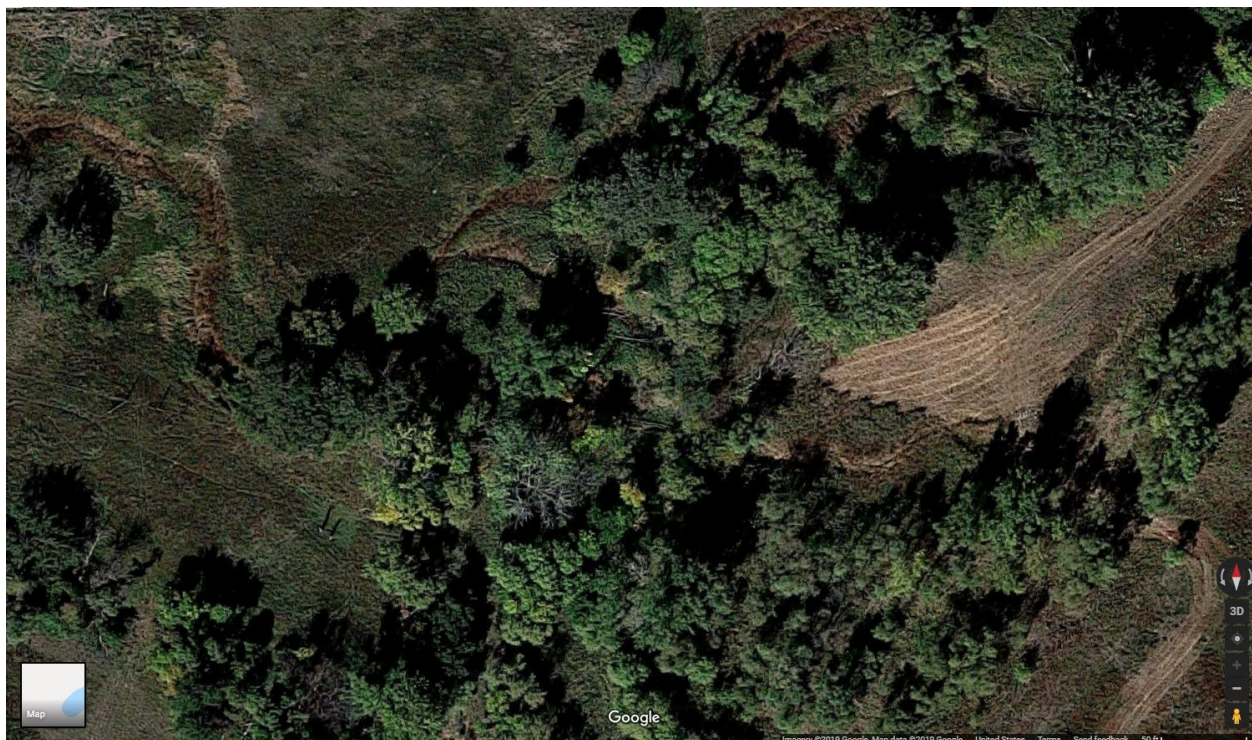
Figure 15. Google image of breach in Carter Dam, mostly obscured by trees in center of image (Google, 2013).

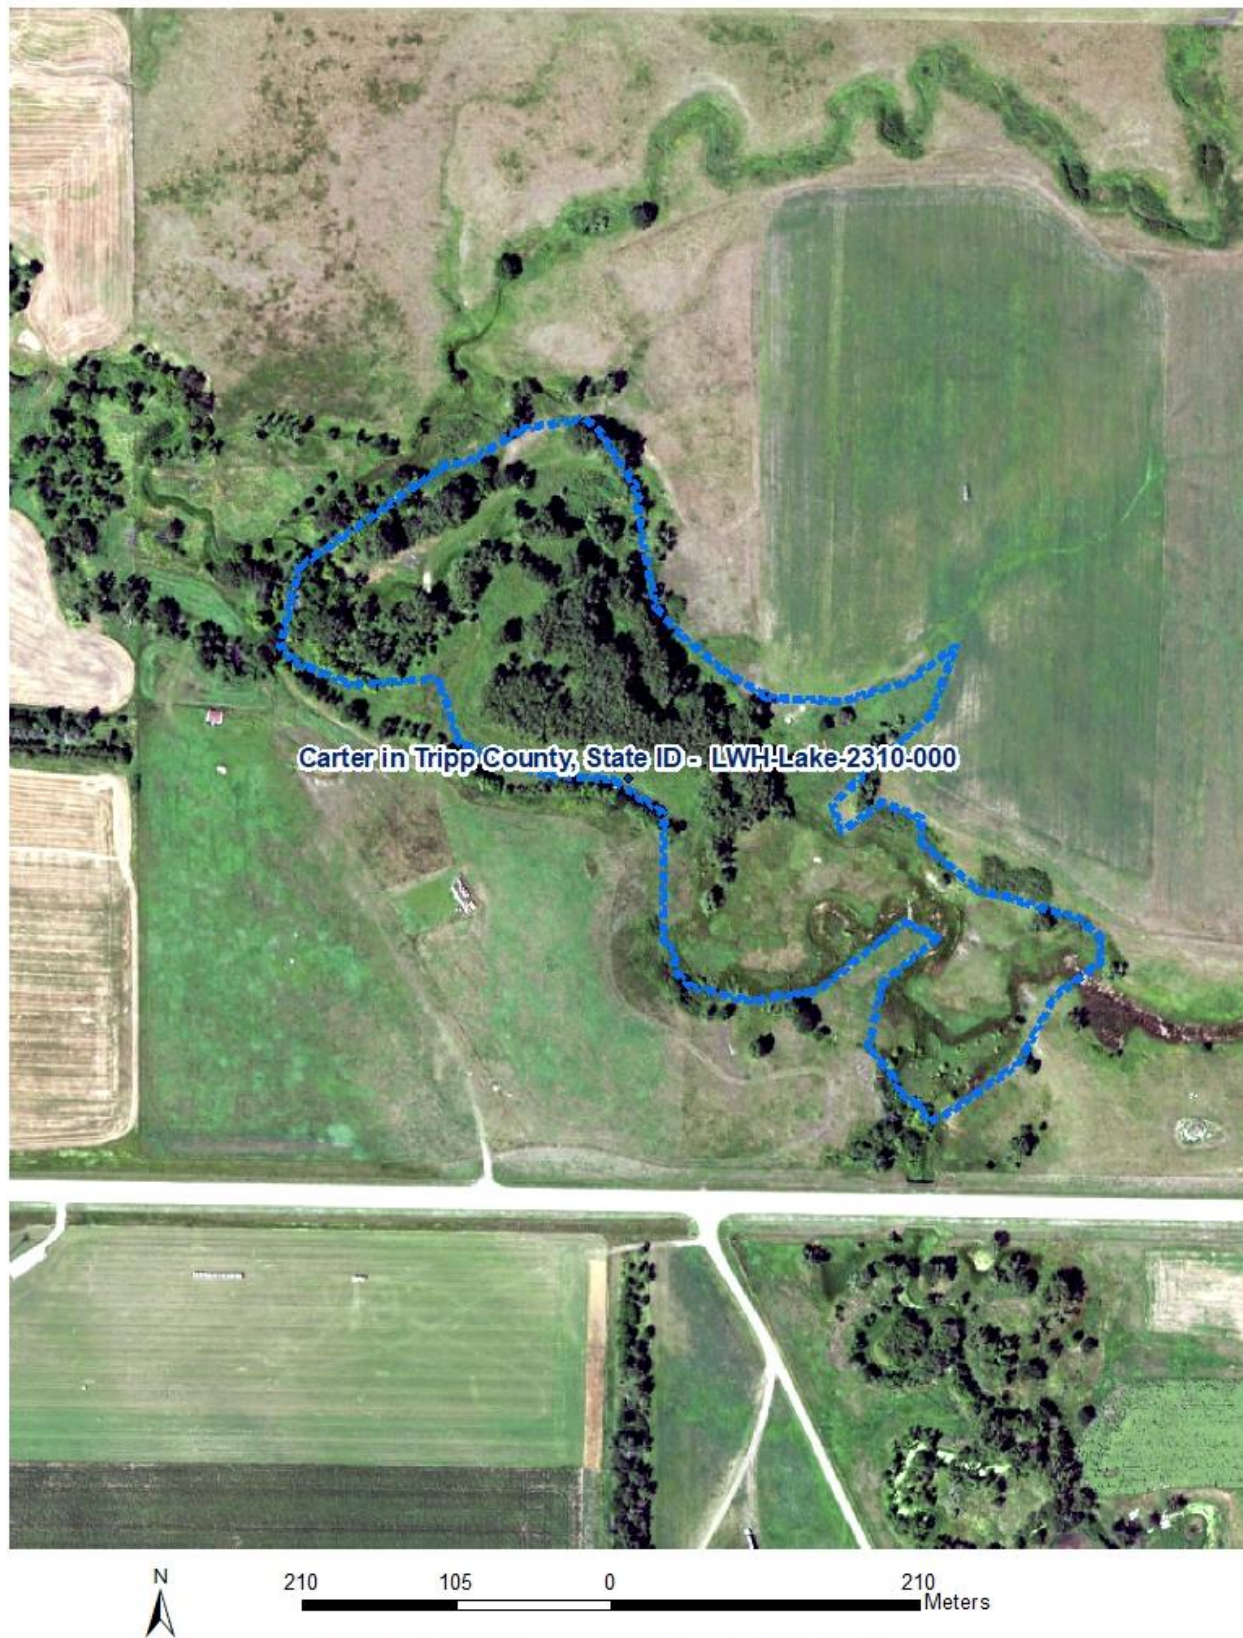
2020 NAIP Imagery with outline of dry basin.

Figure 17. 2020 NAIP imagery of Carter Lake in Tripp County. Blue outline represents the extent that water was present prior to the dam breach and lake draining.

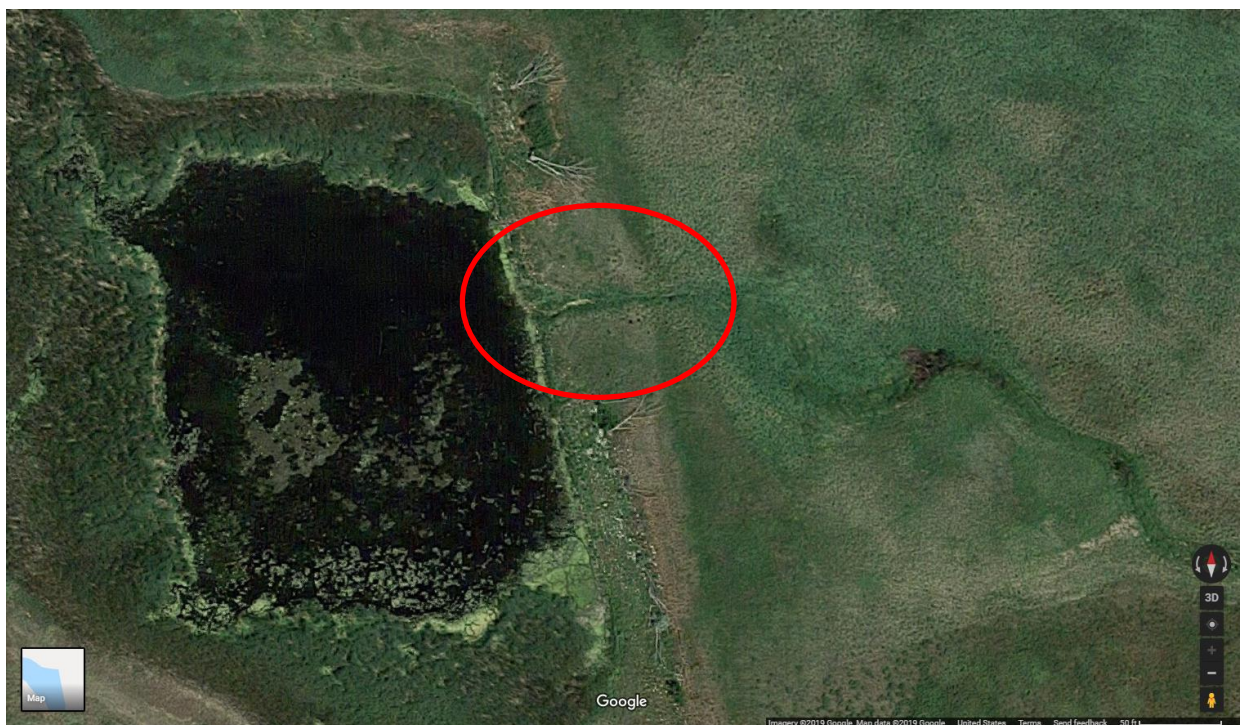
Figure 19. Google Image of Caspers Dam with developing breach visible in red circle (Google, 2016).

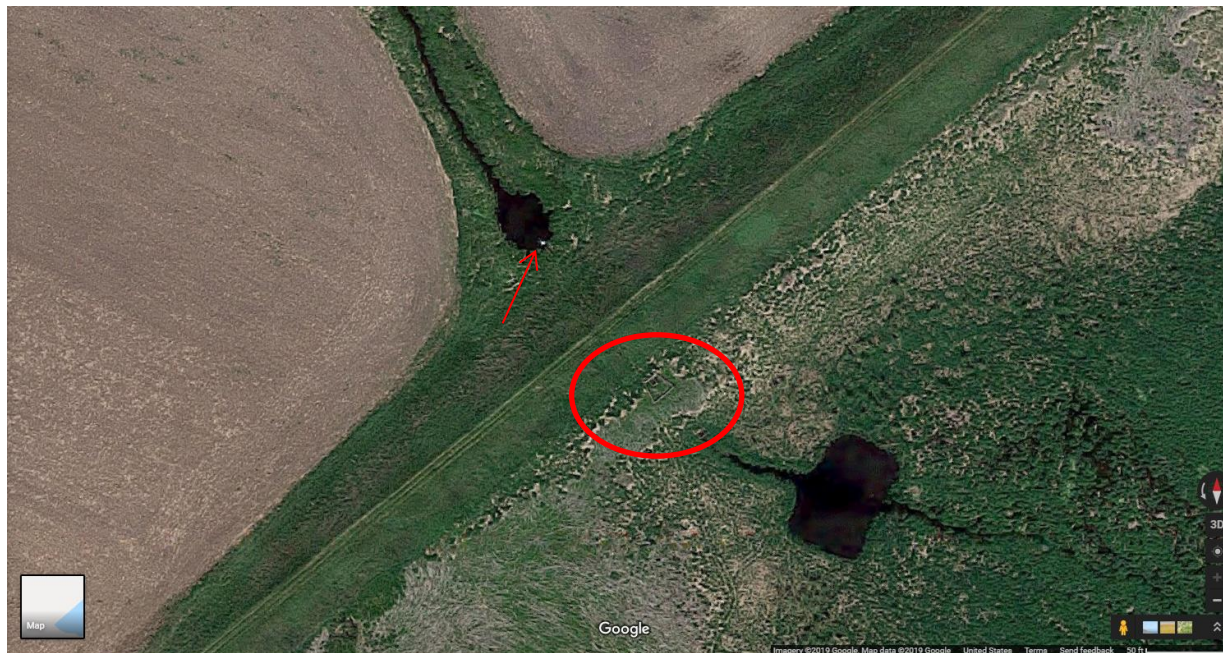
Figure 23. Google Maps Image of the Dam Grade at Cole Lake (Google, 2017). No breach is visible where the stream channel crosses the grade, however a structure, presumed to be a culvert inlet is faintly visible at the center of the circle and the tip of a pipe (arrow) appears at the scour pool to the NW of the red circle.

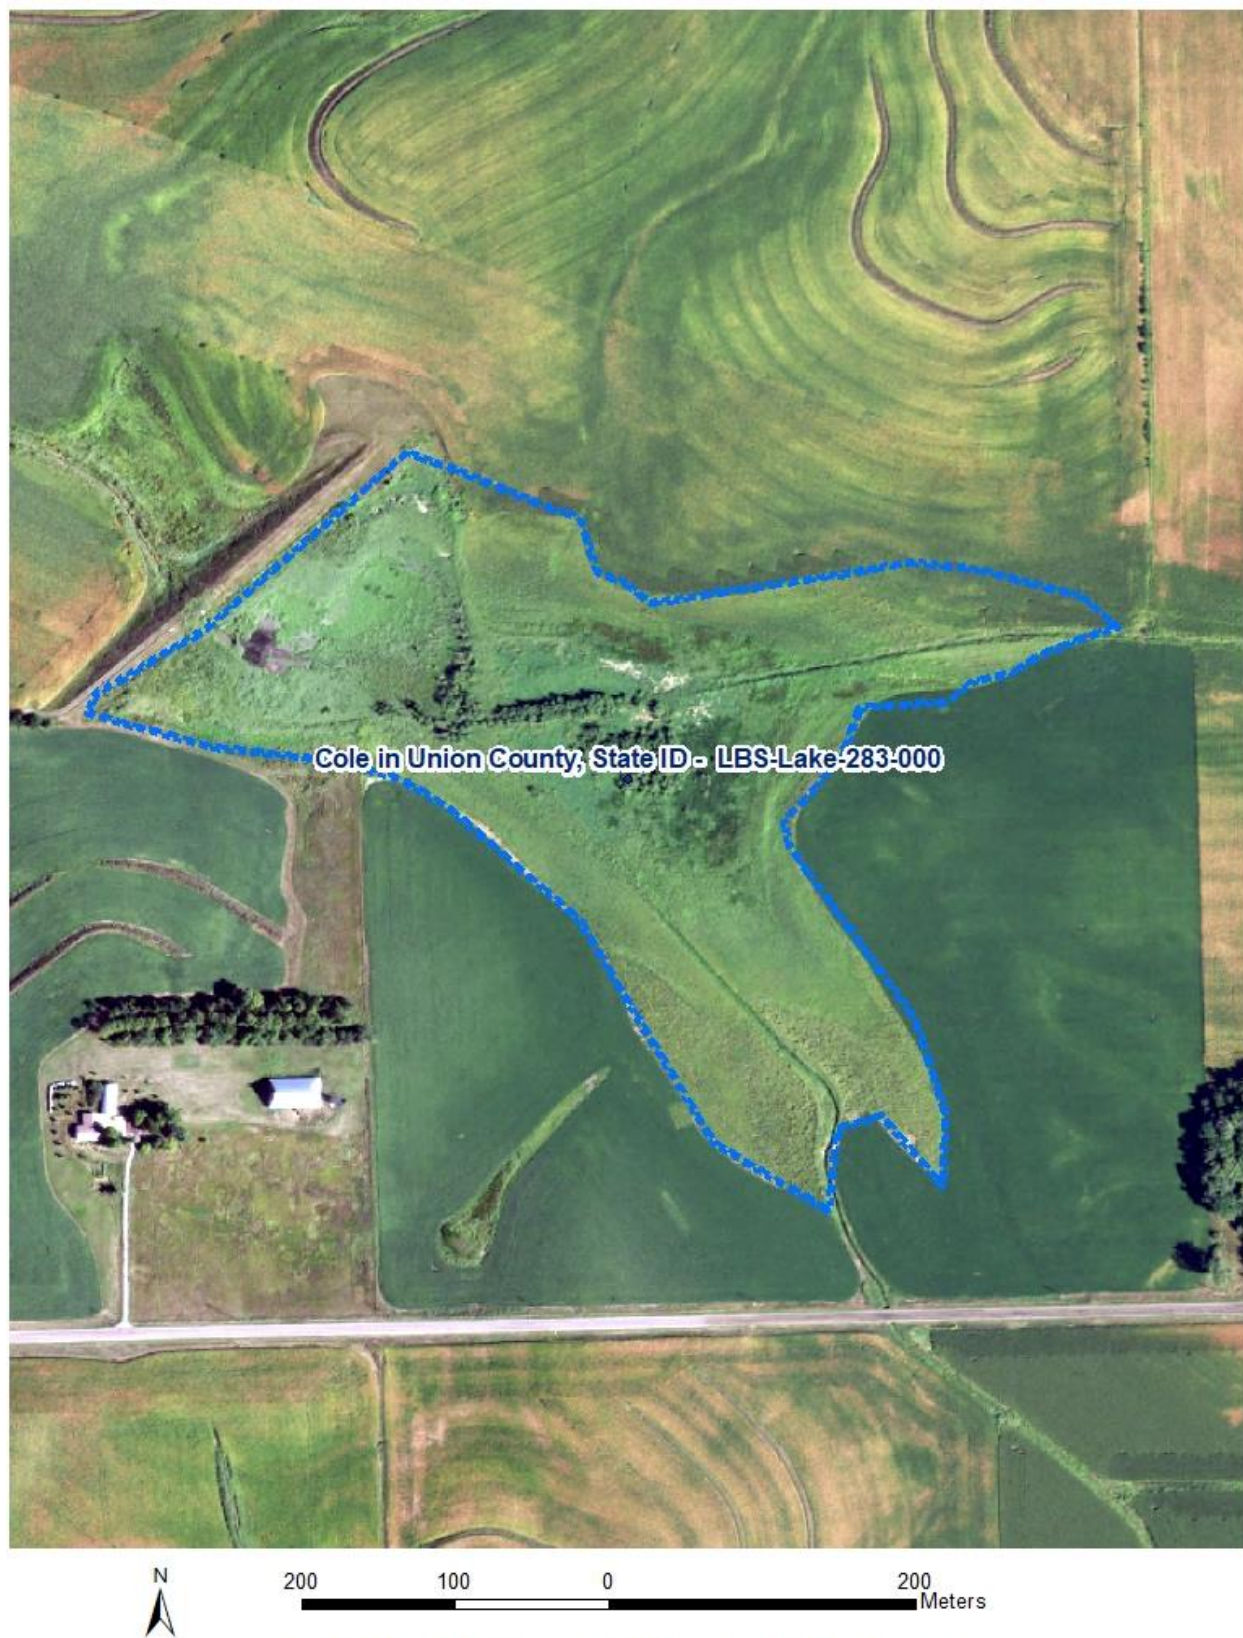
2020 NAIP Imagery with outline of dry basin.

Figure 25. 2020 NAIP imagery of Cole Lake in Union County. Blue outline represents the extent that water was present prior to the dam breach and lake draining.

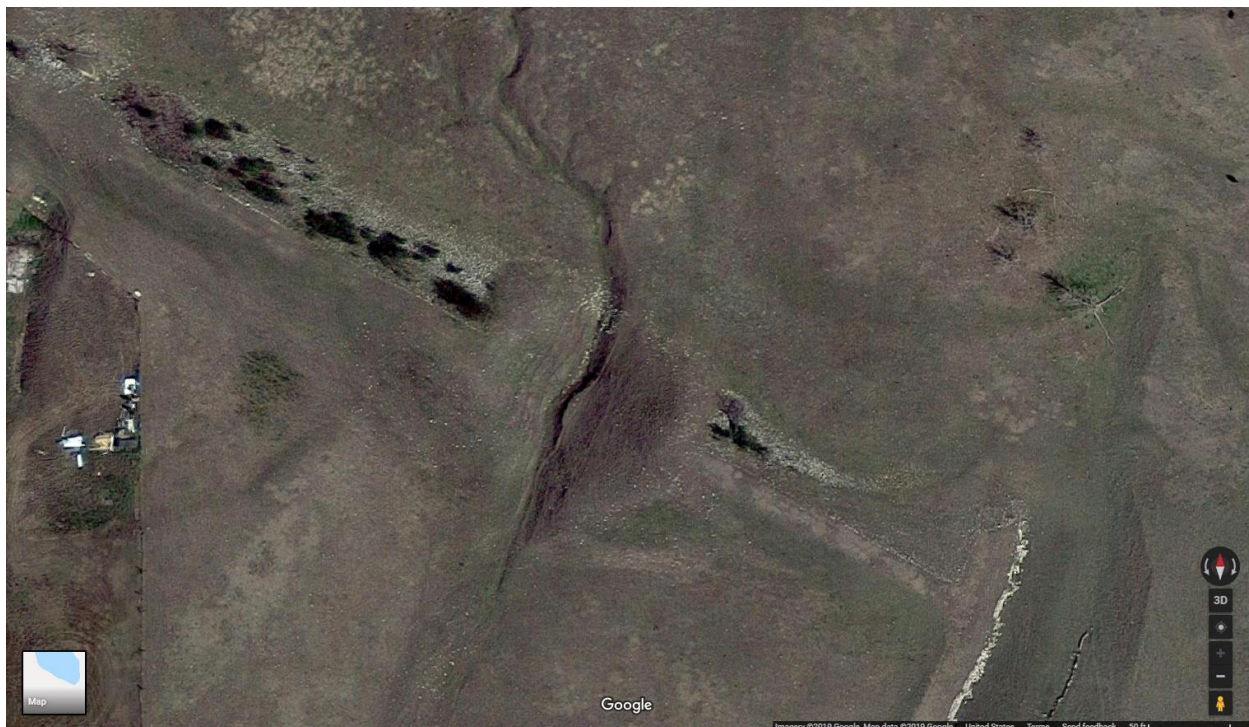
Figure 35. Breach with evenly tapered sides (Google, 2017)

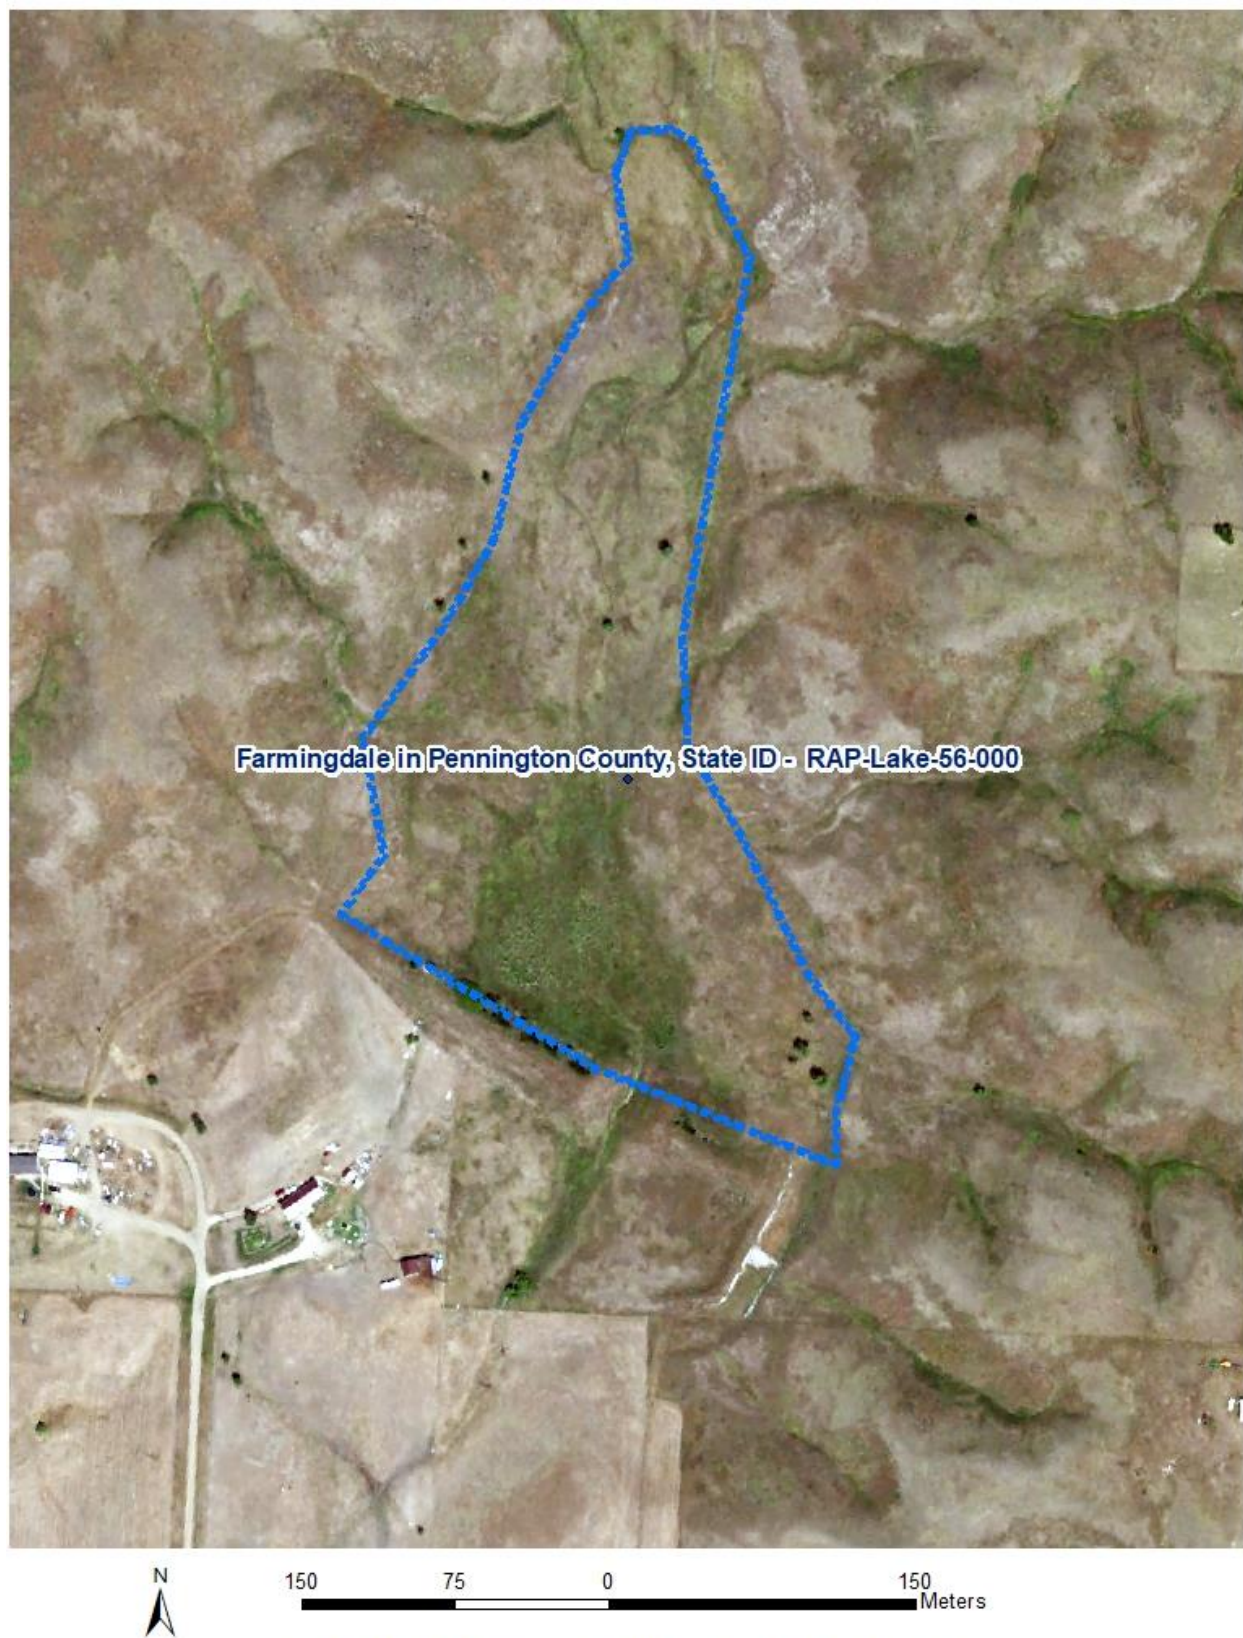
2020 NAIP Imagery with outline of dry basin.

Figure 37 2020 NAIP imagery of Farmingdale Lake in Pennington County. Blue outline represents the extent that water was present prior to the dam breach and lake draining.

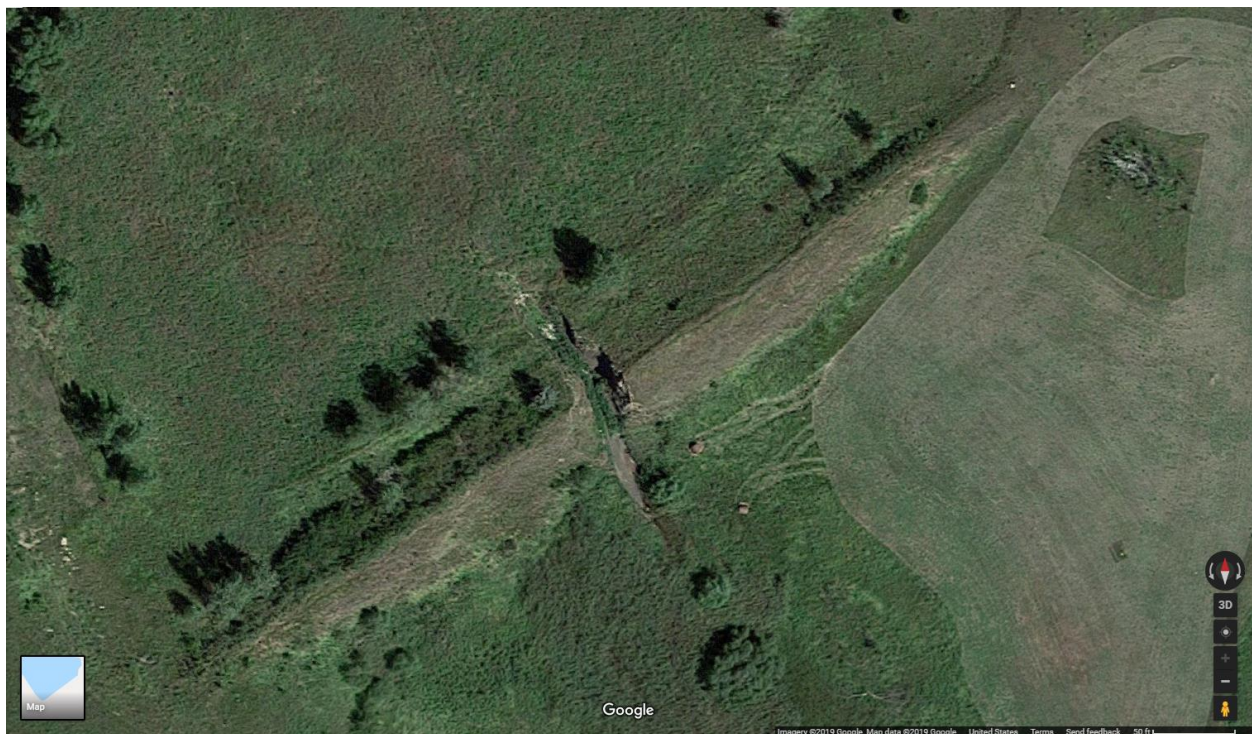
Figure 39. Google image of Fenenga Dam breach (Google, 2015).

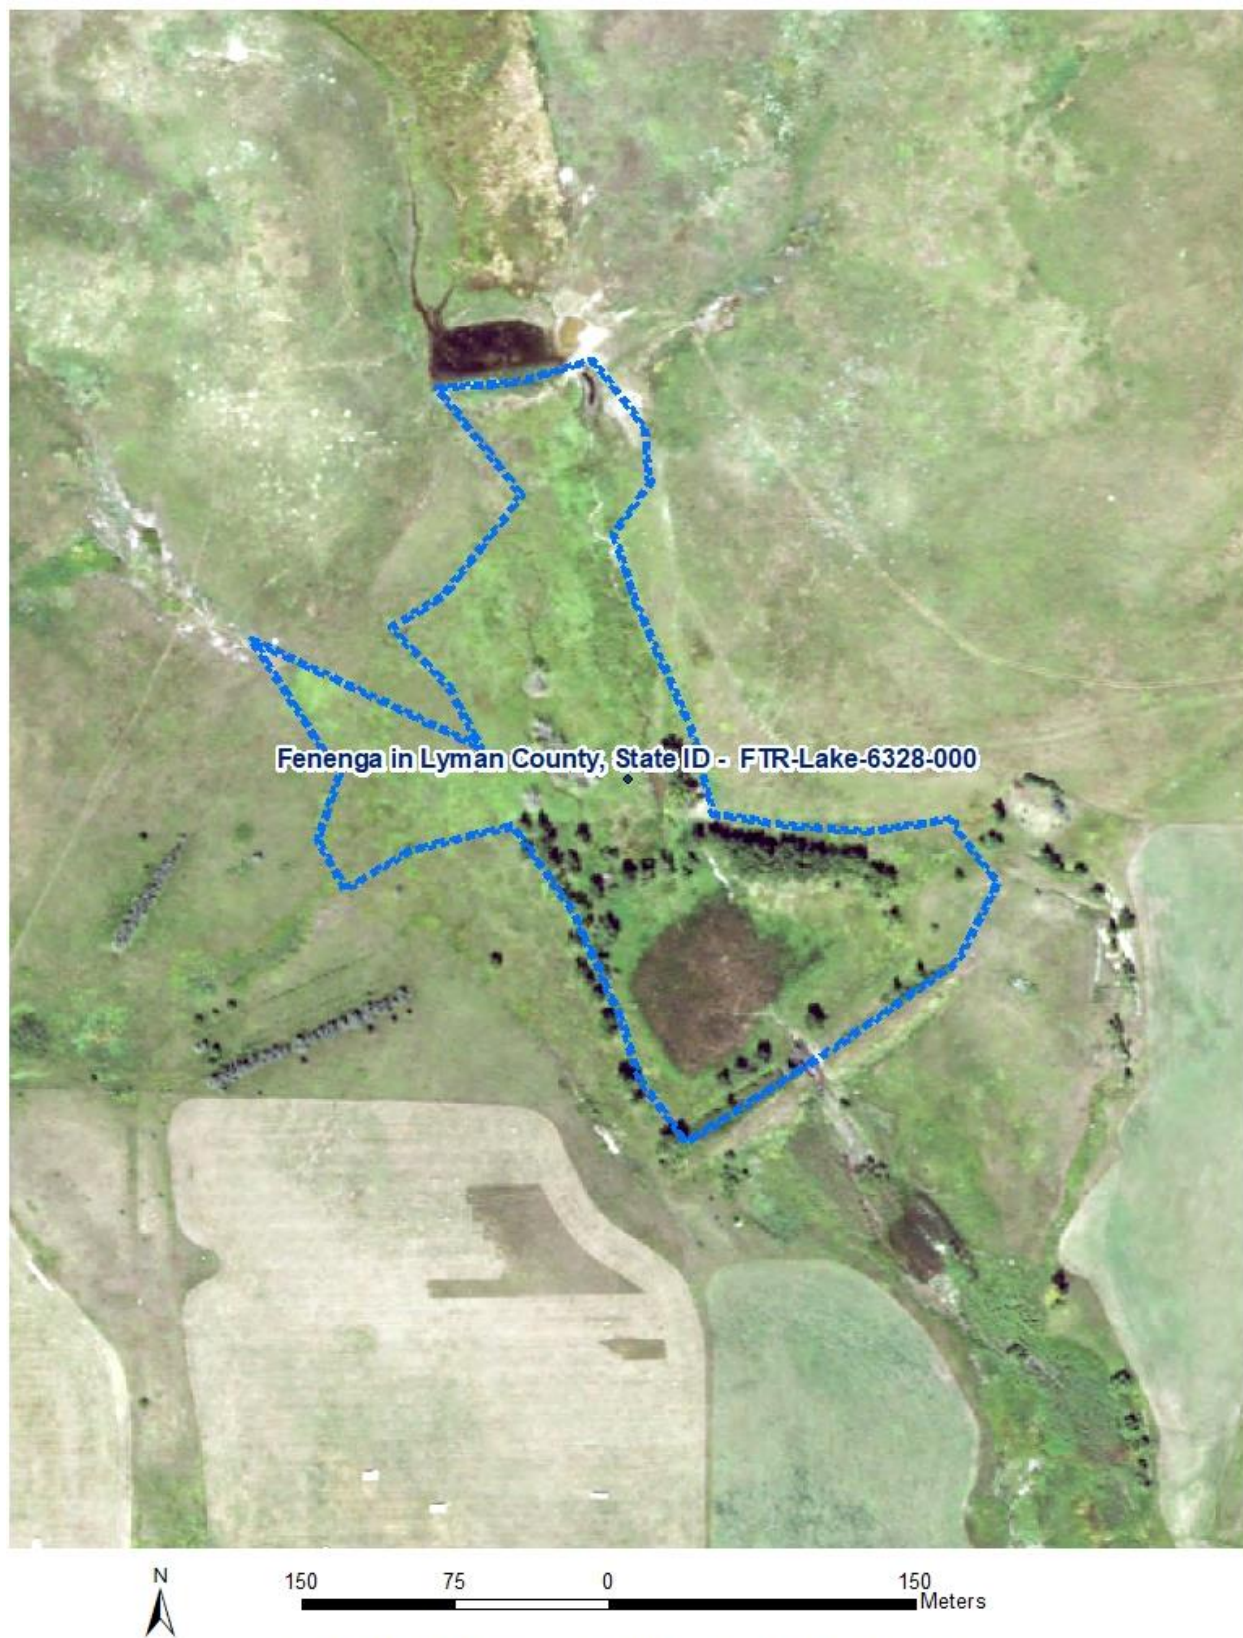
2020 NAIP Imagery with outline of dry basin.

Figure 41. 2020 NAIP imagery of Fenenga Lake in Lyman County. Blue outline represents the extent that water was present prior to the dam breach and lake draining.

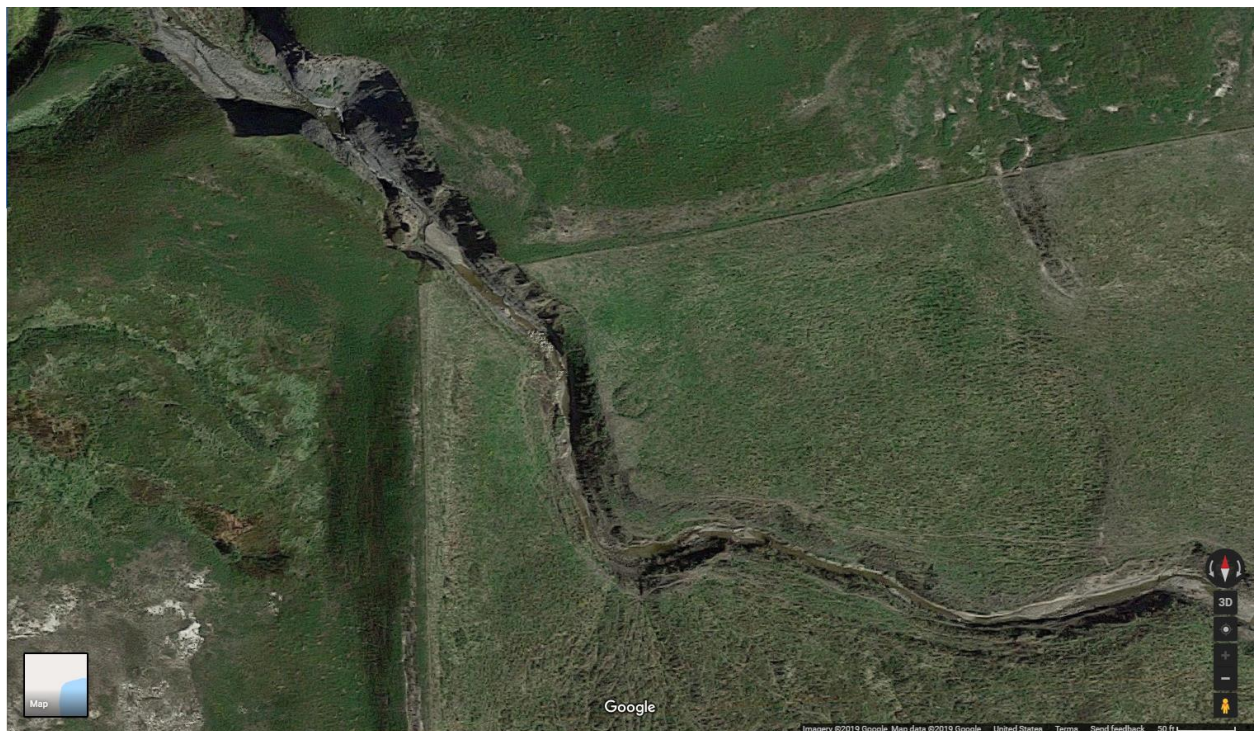
Figure 43. Google image of Goose Creek Dam breach and channel eroded into lakebed (Google, 2014).
