**Removal of Certain
Classified Impoundments
From
Administrative Rules of South Dakota
Chapter 74:51:02**

October 2022

**South Dakota
Department of Agriculture and Natural Resources
Office of Water
Pierre, South Dakota**

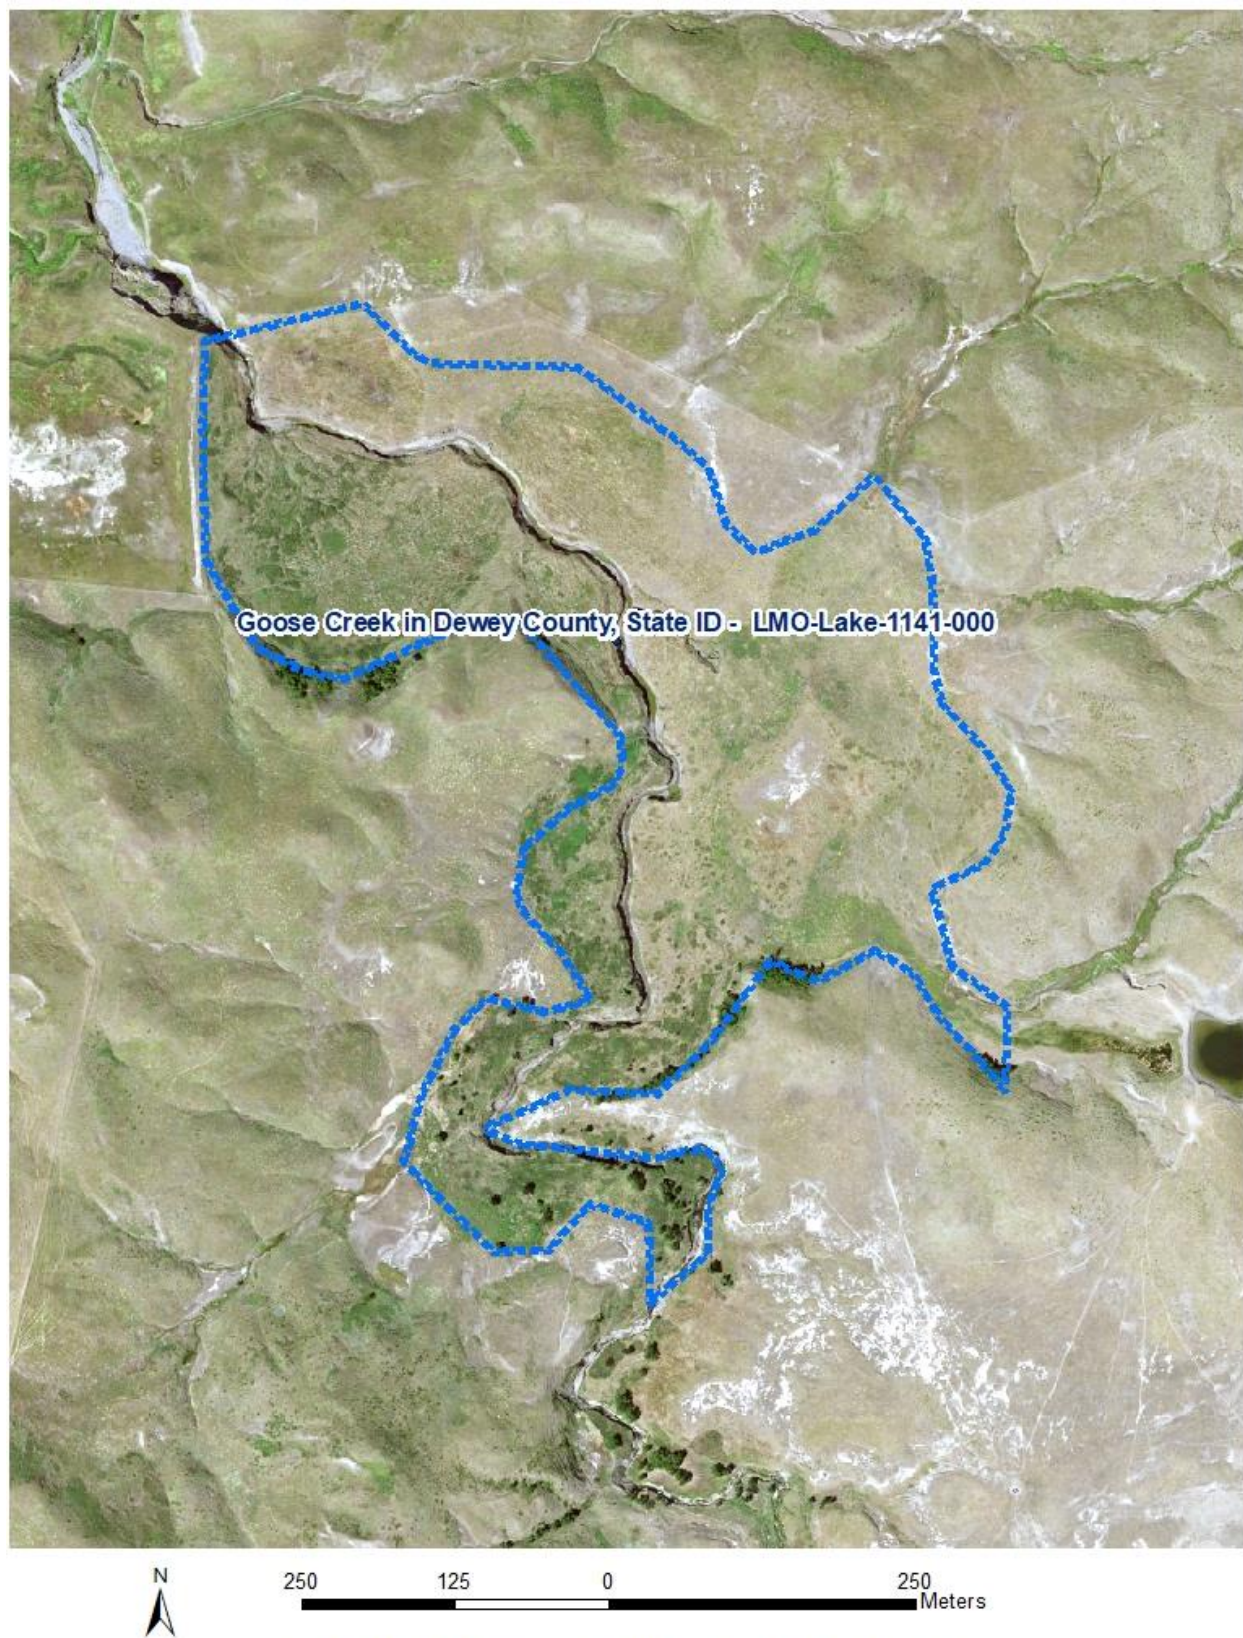
2020 NAIP Imagery with outline of dry basin.

Figure 45 2020 NAIP imagery of Goose Creek Lake in Dewey County. Blue outline represents the extent that water was present prior to the dam breach and lake draining.

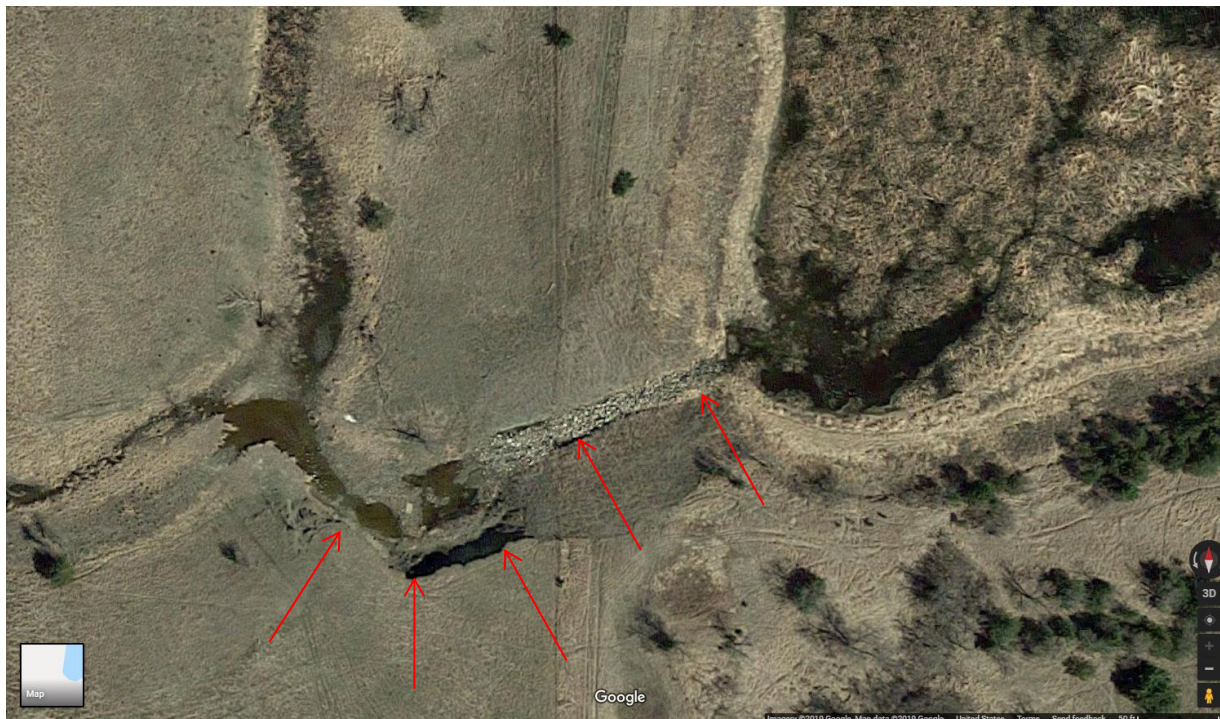
Figure 47. Google image of Iroquois Dam breach (Google, 2014)

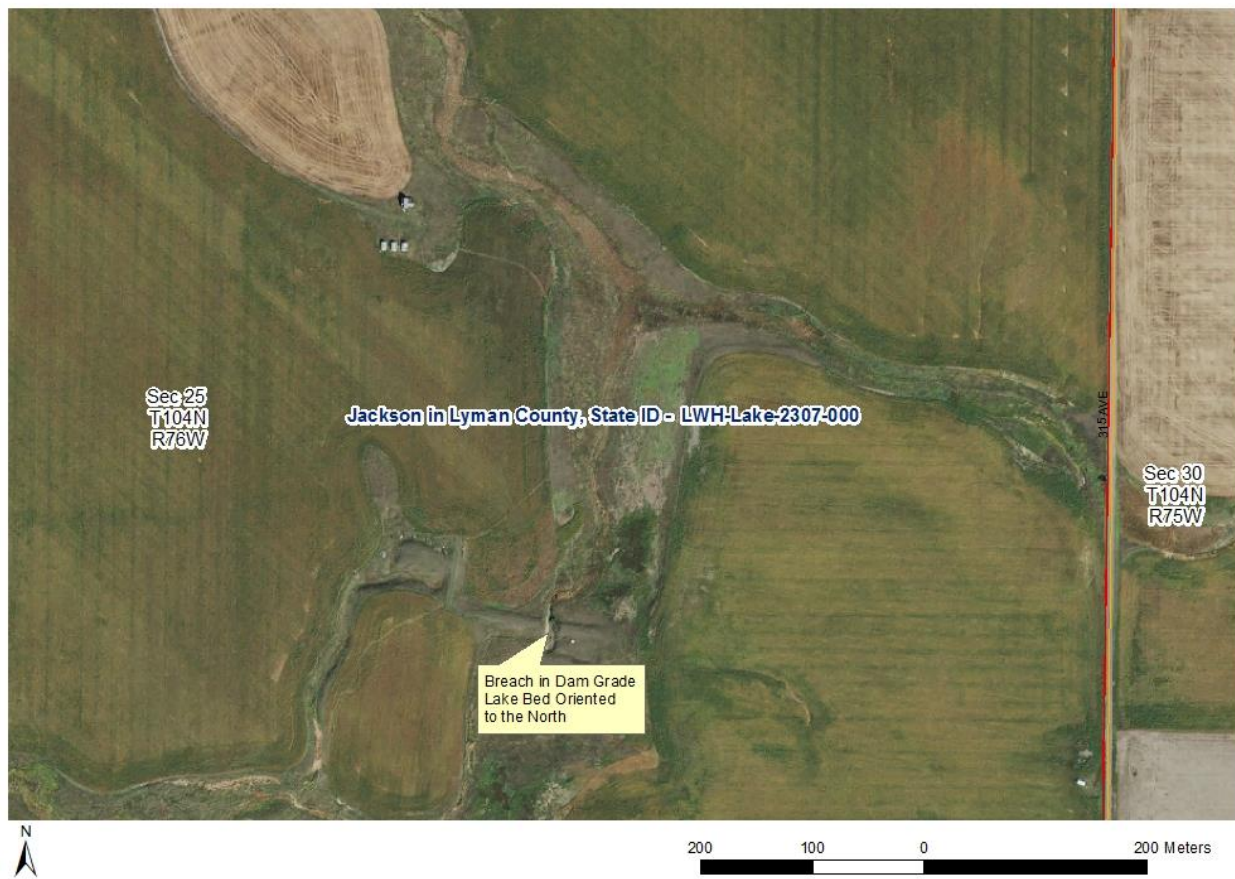
Jackson Lake was created by damming an unnamed tributary to the White River at S25 T104N R76W in Lyman County. The breached dam and historic lakebed are privately owned and no public access exists. The lake was assigned the use (6) warmwater marginal fish life propagation and only stocked a single time in 1940 (SDGFP, 2018). Recreation uses assigned to the lake include both (7) immersion and (8) limited contact. The 1990 beneficial use review indicated the dam was already breached (visible in Figure 50 and Figure 51) and that the lake should be reclassified to just wildlife use. The drainage which was dammed to form the lake has re-established its old channel and the 1990 recommendation remains accurate. Due to the long duration since the dam was breached, it is unlikely that the dam will be repaired.

Figure 51. Google image of breach (red circle) in Jackson Dam and developed channel in lakebed (arrows) (Google, 2013).

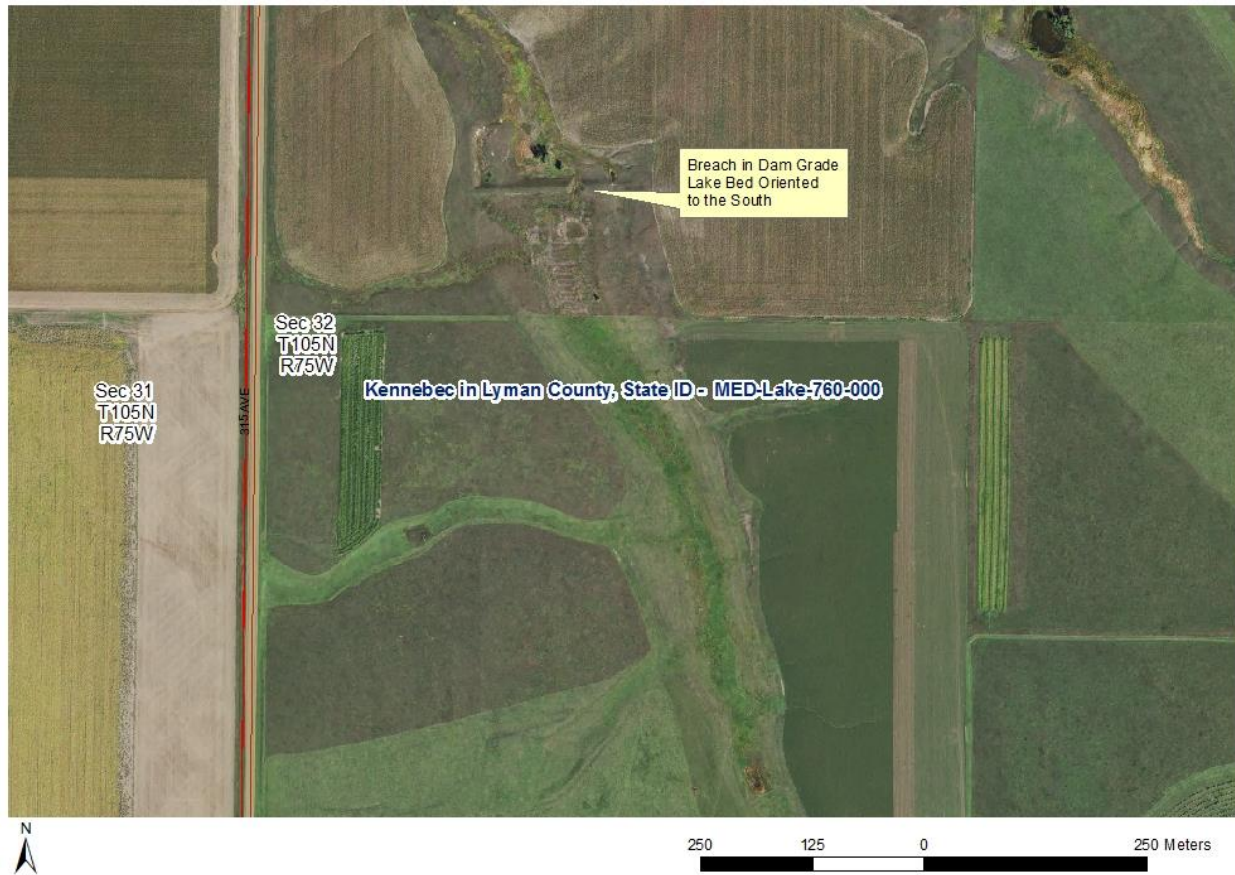
Kennebec Lake was created by damming an unnamed tributary to Medicine Creek at S32 T105N R75W in Lyman County. The breached dam and historic lakebed are privately owned, and no public access exists. The lake was assigned the use (6) warmwater marginal fish life propagation and was last stocked in 1950 (SDGFP, 2018). Recreation uses assigned to the lake include both (7) immersion and (8) limited contact. The 1990 beneficial use review indicated the dam was already breached and that the lake should be reclassified to just wildlife use. The DOQ image from 1991 shows what the dam grade had begun to fail at that point and had reduced the pool level in the lake. The 1990 recommendation remains accurate as the 2016 NAIP image (Figure 56) shows that the stream channel has been reestablished through most of the lakebed. Due to the long duration since the dam was breached, it is unlikely that the dam will be repaired.

Figure 55. Google image showing the breach in the Kennebec Dam (Google, 2013)

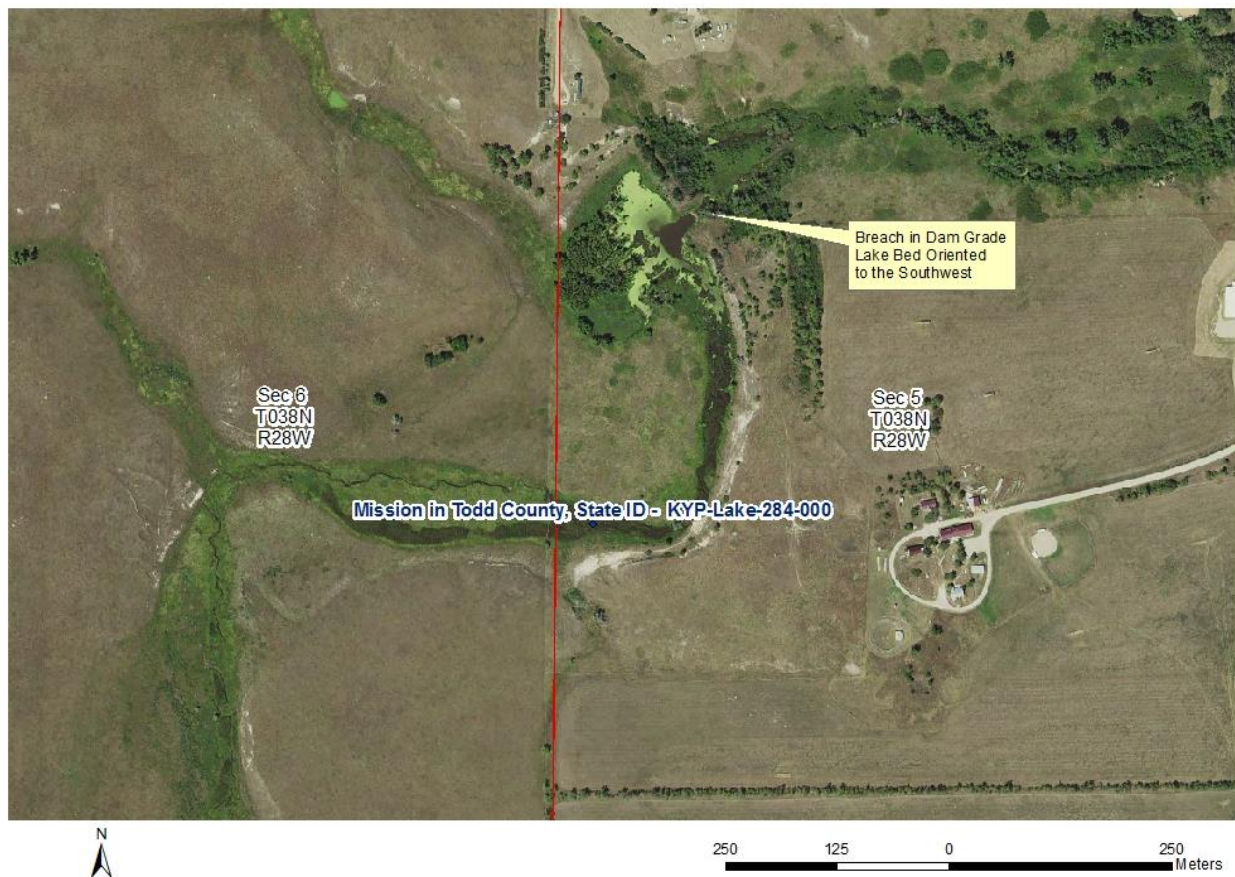
Figure 59. Google image of Mission Dam Breach with flooded trees and beaver dam visible (Google, 2016).

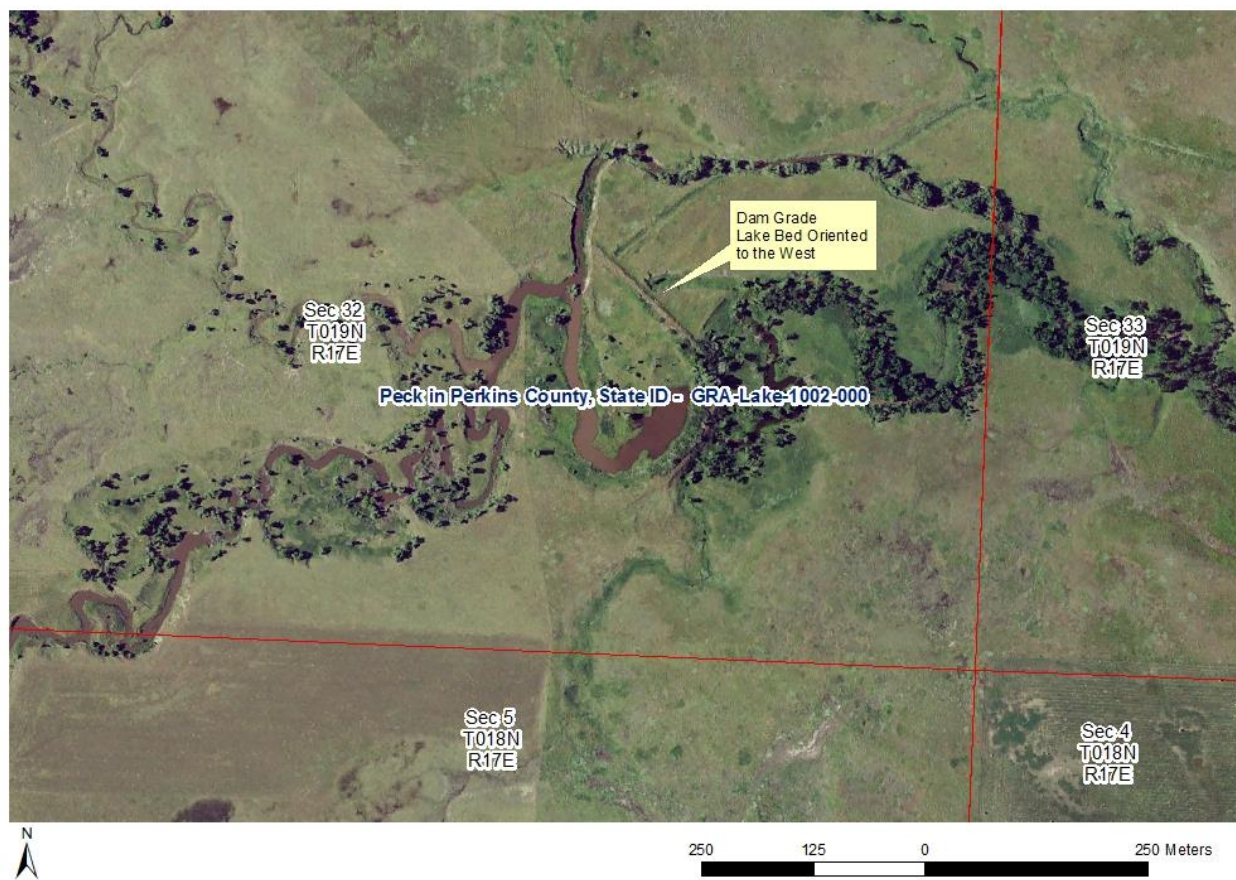
The ravine referenced is presumed to be the channel to the north that currently drains the lakebed. The oldest available aerial imagery from 1997 shows a lakebed with a well-developed stream channel and mature trees similar to what is visible in the 2016 NAIP image (Figure 64). The history of failures and long duration since the last rebuild make it unlikely the dam will be repaired.

Figure 63. Google image of Peck Dam, ravine (blue arrows) and ditch (red arrows) referenced in writers document visible (Google, 2014).

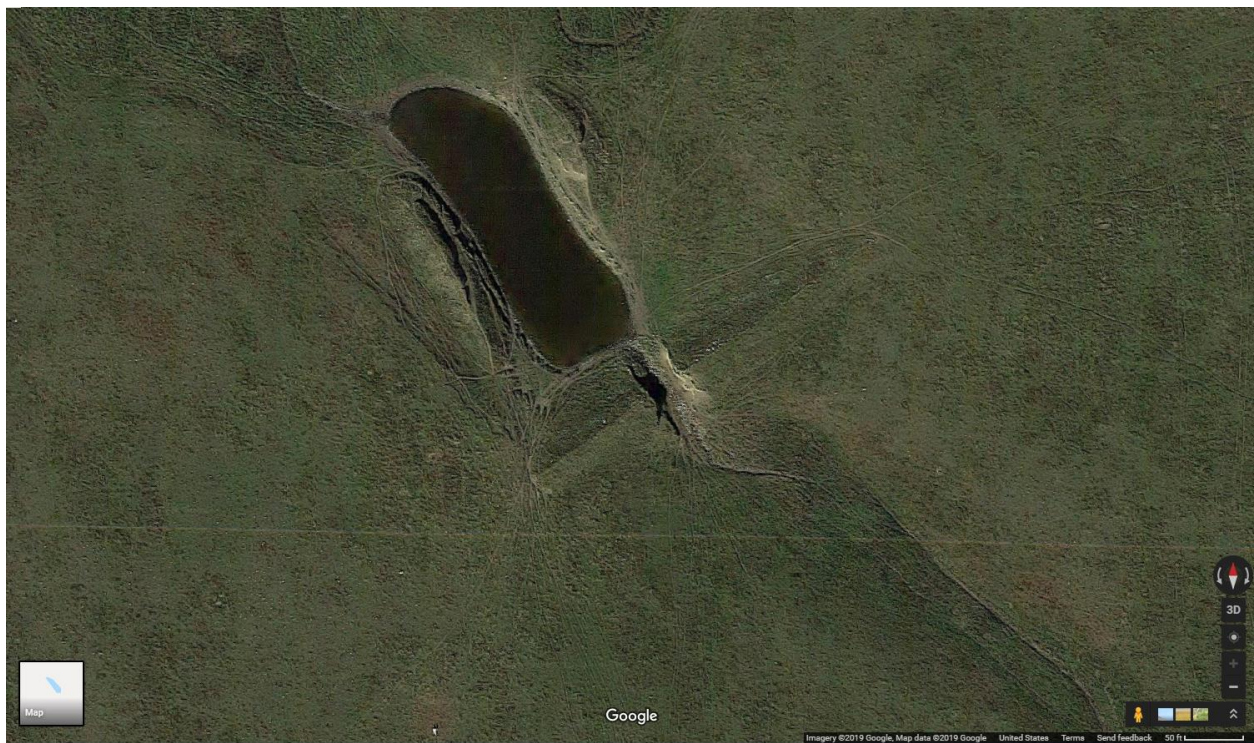
Figure 68. Google image of the dam breach north of 136th street which may be Picton Lake.

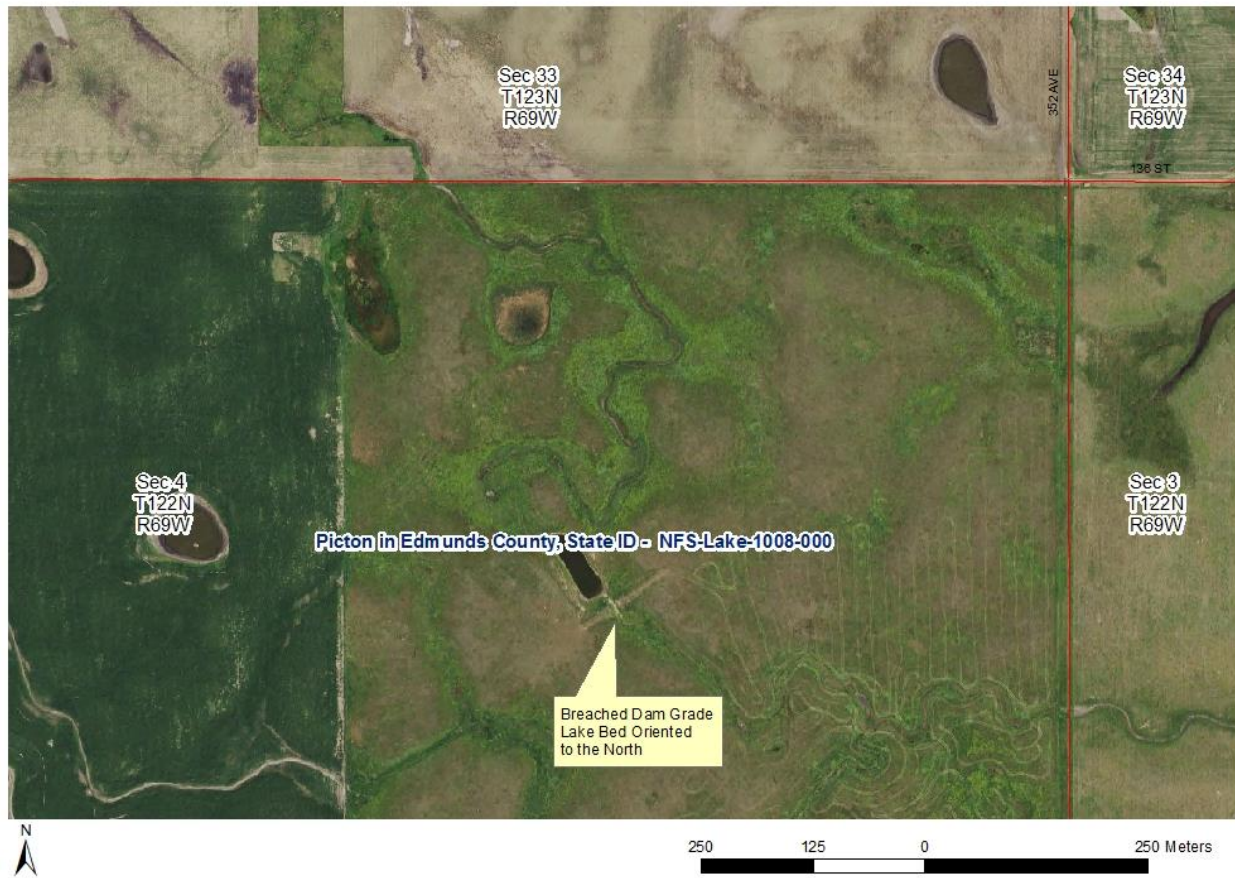
Figure 69. Google image the dam breach south of 136th street and remnant pool (Google, 2014).

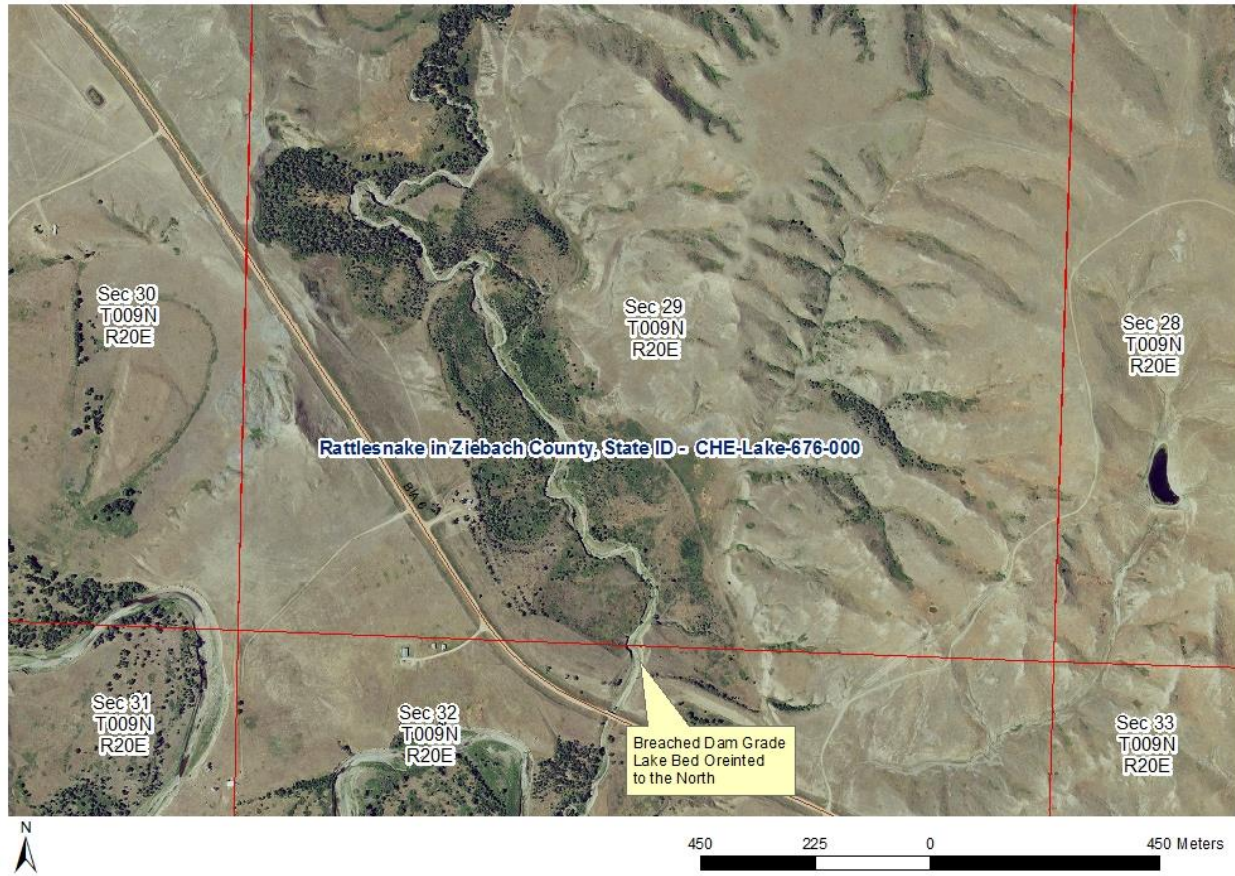
Rattlesnake Lake was created by damming an unnamed tributary to Cherry Creek at S29 T9N R20E in Ziebach County. The breached dam and dry lakebed are located within the Cheyenne River Indian Reservation boundary and no public access exists. The lake was assigned the use (6) warmwater marginal fish life propagation and state stocking records indicate it was stocked with fish in 1936 and 1937 (SDGFP, 2018). Recreation uses assigned to the lake include both (7) immersion and (8) limited contact. The oldest available image from 1997 depicts mature trees and a well-developed channel in the lakebed similar to those visible in Figure 74. The Google image in Figure 75 shows that mature trees are growing where part of the dam was once located. Due to the long duration since the dam was breached, it is unlikely that the dam will be repaired.

Figure 73. Google image of Rattlesnake Dam with trees growing next to a channel where a portion of the dam once stood demarked by the red circle (Google, 2014).

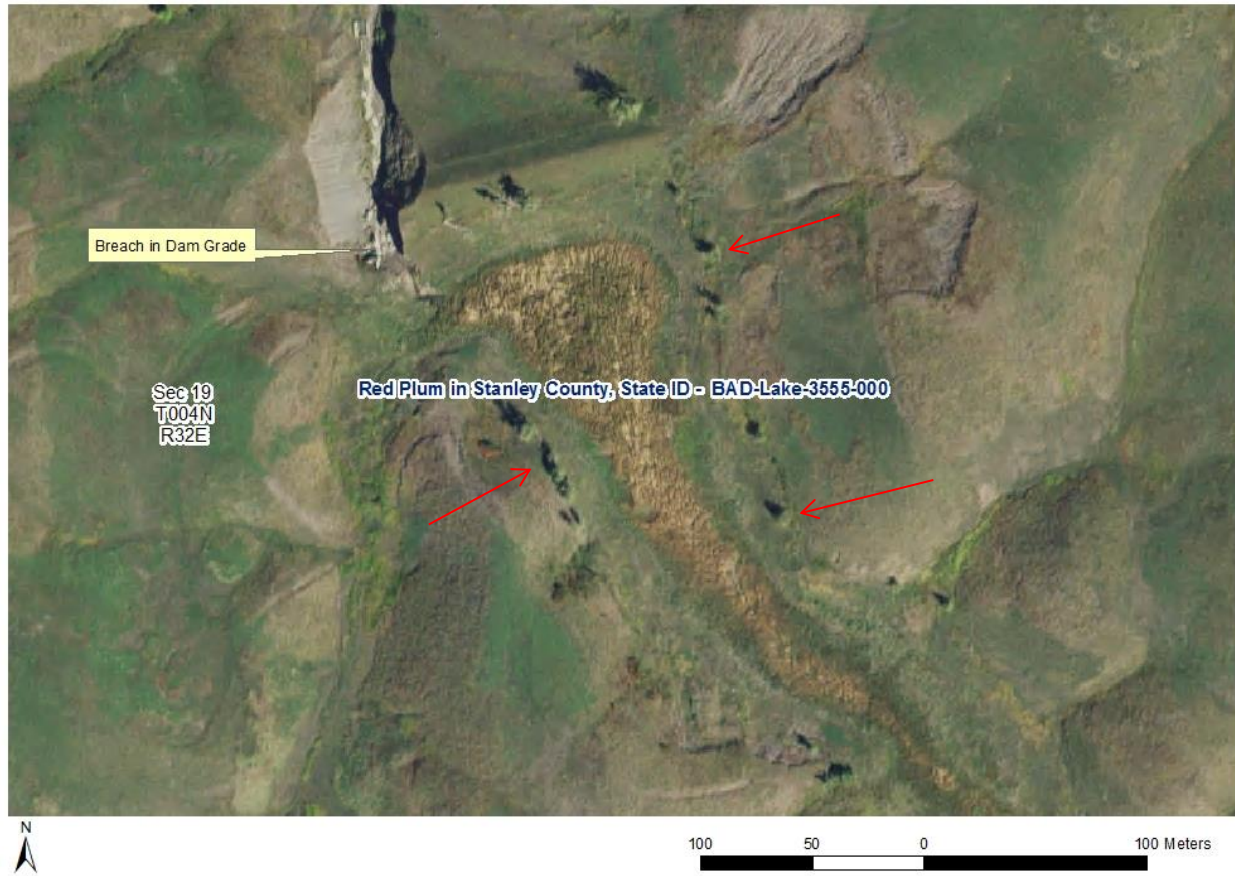
Red Plum Lake was created by damming an unnamed tributary to the Bad River at S19 T4N R32E in Stanley County. The breached dam and dry lakebed are located on private property and no public access exists. The lake was assigned the use (5) Warmwater semipermanent fish life propagation with stocking records that include three entries: 1936, 1939, and 1976 (SDGFP, 2018). Recreation uses assigned to the lake include both (7) immersion and (8) limited contact. A breach in the dam grade began sometime after the 1990 review and progressed through 2016 where the last of the pool had been replaced with cattails, see Figure 82. A scattered line of trees in the image demarks the original edge of the lake, marked with red arrows in Figure 82. In the absence of any repair efforts over the past 20 years, it is expected that the drainage network will be allowed to continue reestablishment of its old channel.

Figure 81. Google image of breached spillway on Red Plum Dam (Google, 2014)

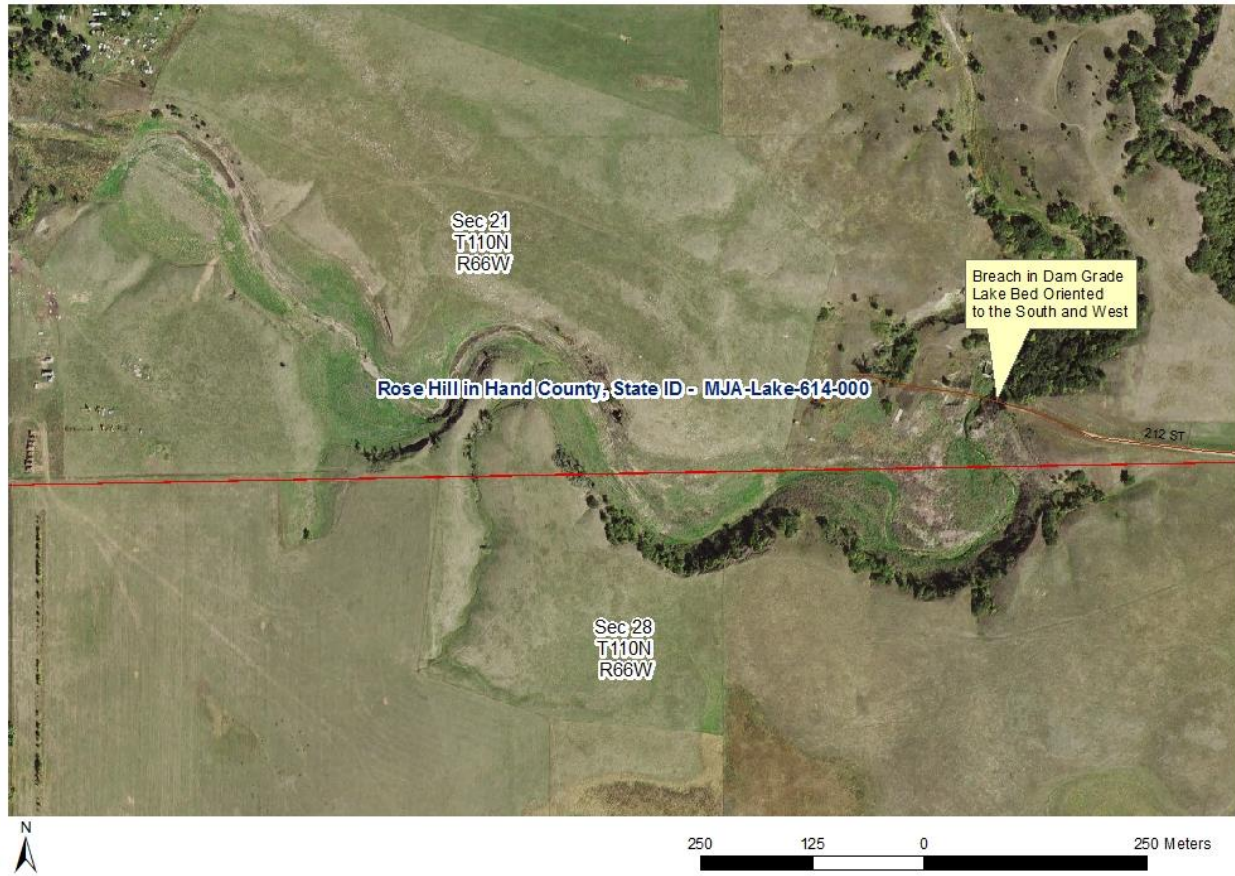
Rose Hill Lake was created by damming Sand Creek at S21 T110N R66W in Hand County. The breached dam is located on SDGFP land while the dry lakebed extends onto private lands to the west. The lake was assigned the use (4) warmwater permanent fish life propagation and stocked with fish regularly until 2004 (SDGFP, 2018). Recreation uses assigned to the lake include both (7) immersion and (8) limited contact. The dam first failed in 1955, required repair work in 2007, and then failed again in 2010. The 2016 photo in Figure 86 and the close-up in Figure 87 show the re-establishment of the channel in the former lakebed. Despite the relatively recent breach, the channel is well developed, and no remnant pools remain within the historic lakebed. SDGFP indicated the agency has no plans to repair the dam (SDGFP, 2018) and as a result the drainage network will continue to re-establish its former channel in the lakebed.

Figure 85. Google image of Rose Hill Dam after most recent breach, out let structure (red circle) and boat ramp (blue circle) are visible (Google, 2014).

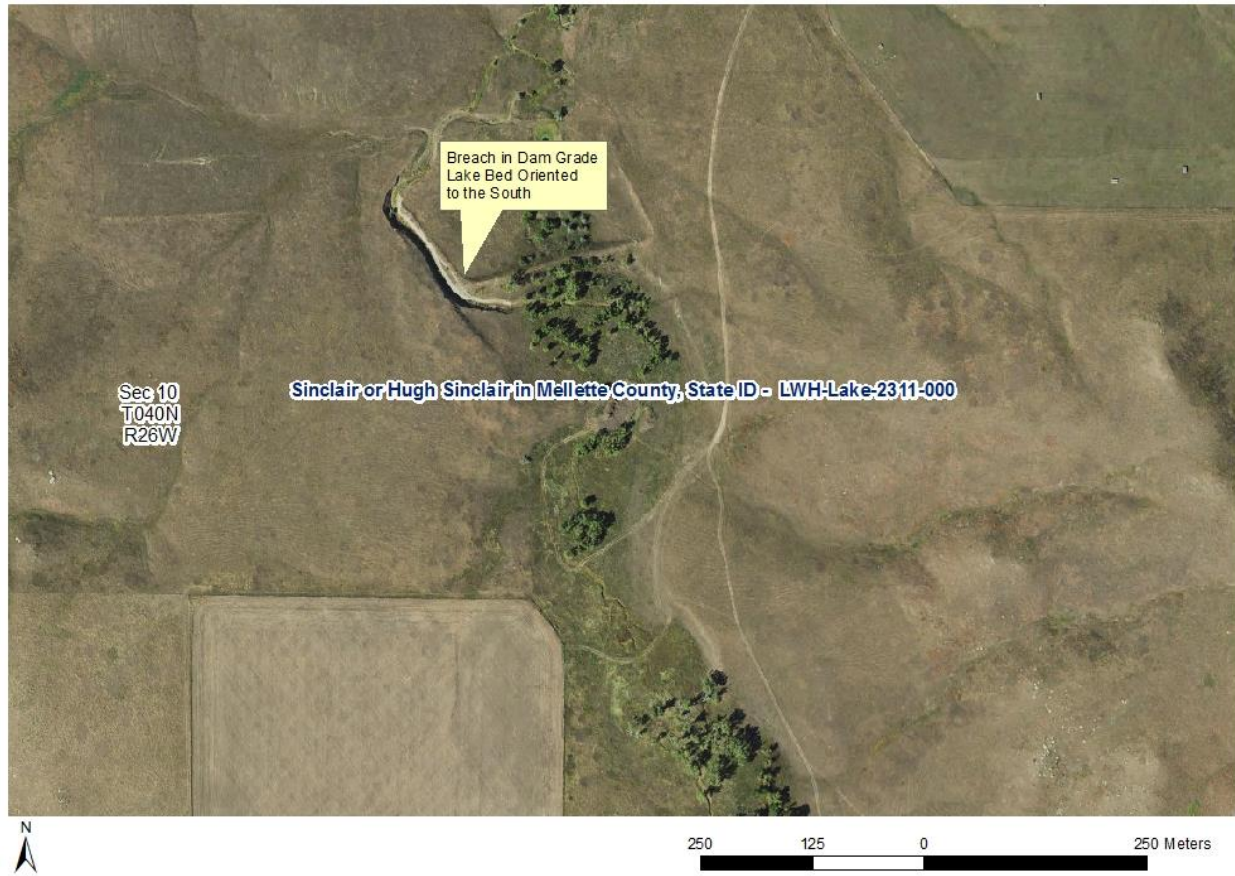
Figure 89. Google image of Sinclair Dam breach with view of mature trees that were present in the 1997 image (Google, 2016).

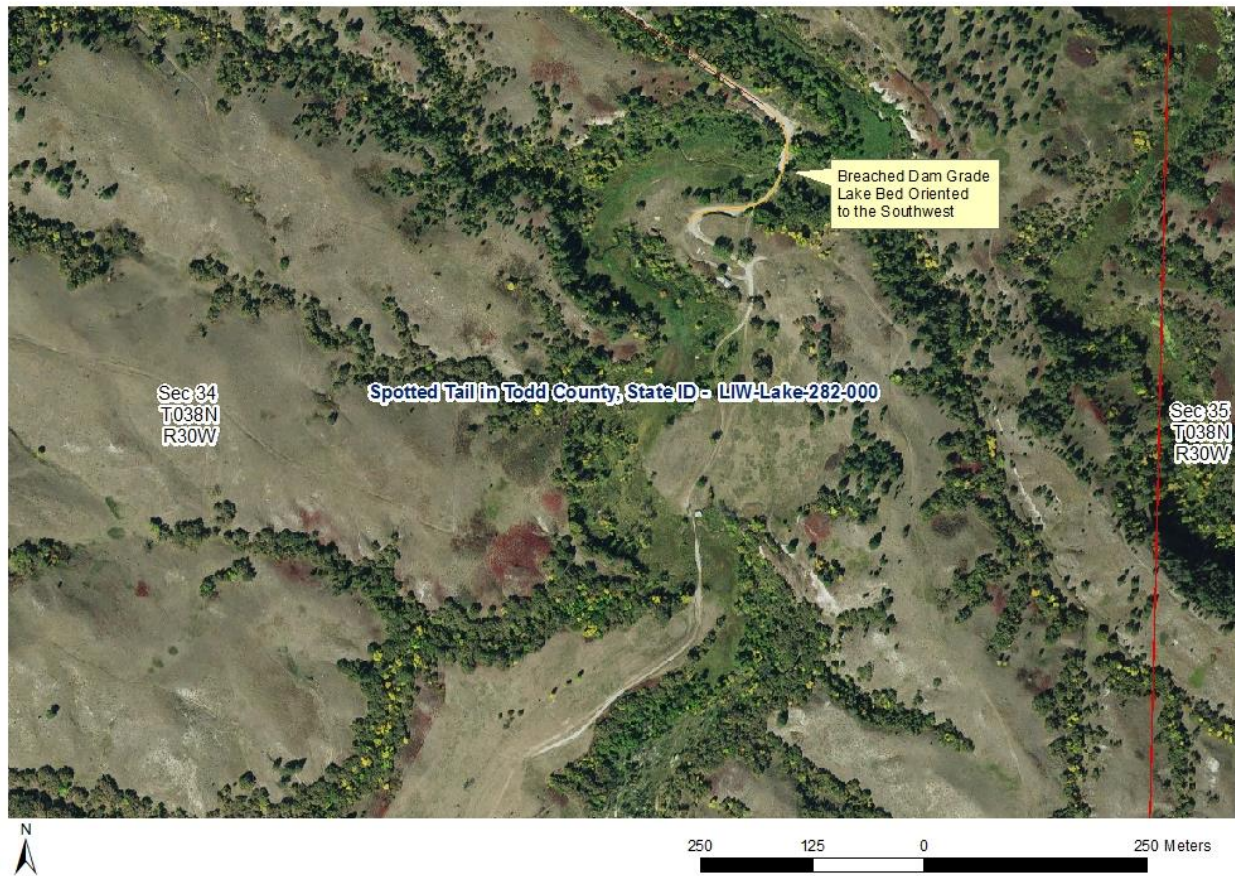
Spotted Tail Lake was created by damming West Branch Rosebud Creek at S34 T38N R30W in Todd County. The breached dam and dry lakebed are located within the Rosebud Indian Reservation boundary and no public access exists. The lake was assigned the use (3) coldwater marginal fish life propagation; and state stocking records indicate it was only stocked one time with Rainbow Trout in 1972 (SDGFP, 2018). Recreation uses assigned to the lake include both (7) immersion and (8) limited contact. The oldest available image from 1997 depicts mature trees and a well-developed channel in the lakebed similar to those visible in the 2016 NAIP image, Figure 94. The Google image from 2016 (Figure 95) shows that there is a well-developed channel crossed by a maintained road supported by either a culvert or small bridge, the presence of which reinforces there is no intent to repair or replace the dam. Due to the long duration since the dam was breached, it is unlikely that the dam will be repaired.

Figure 93. Google image of Spotted Tail Dam outlet with culvert and roadway established. (Google, 2016)

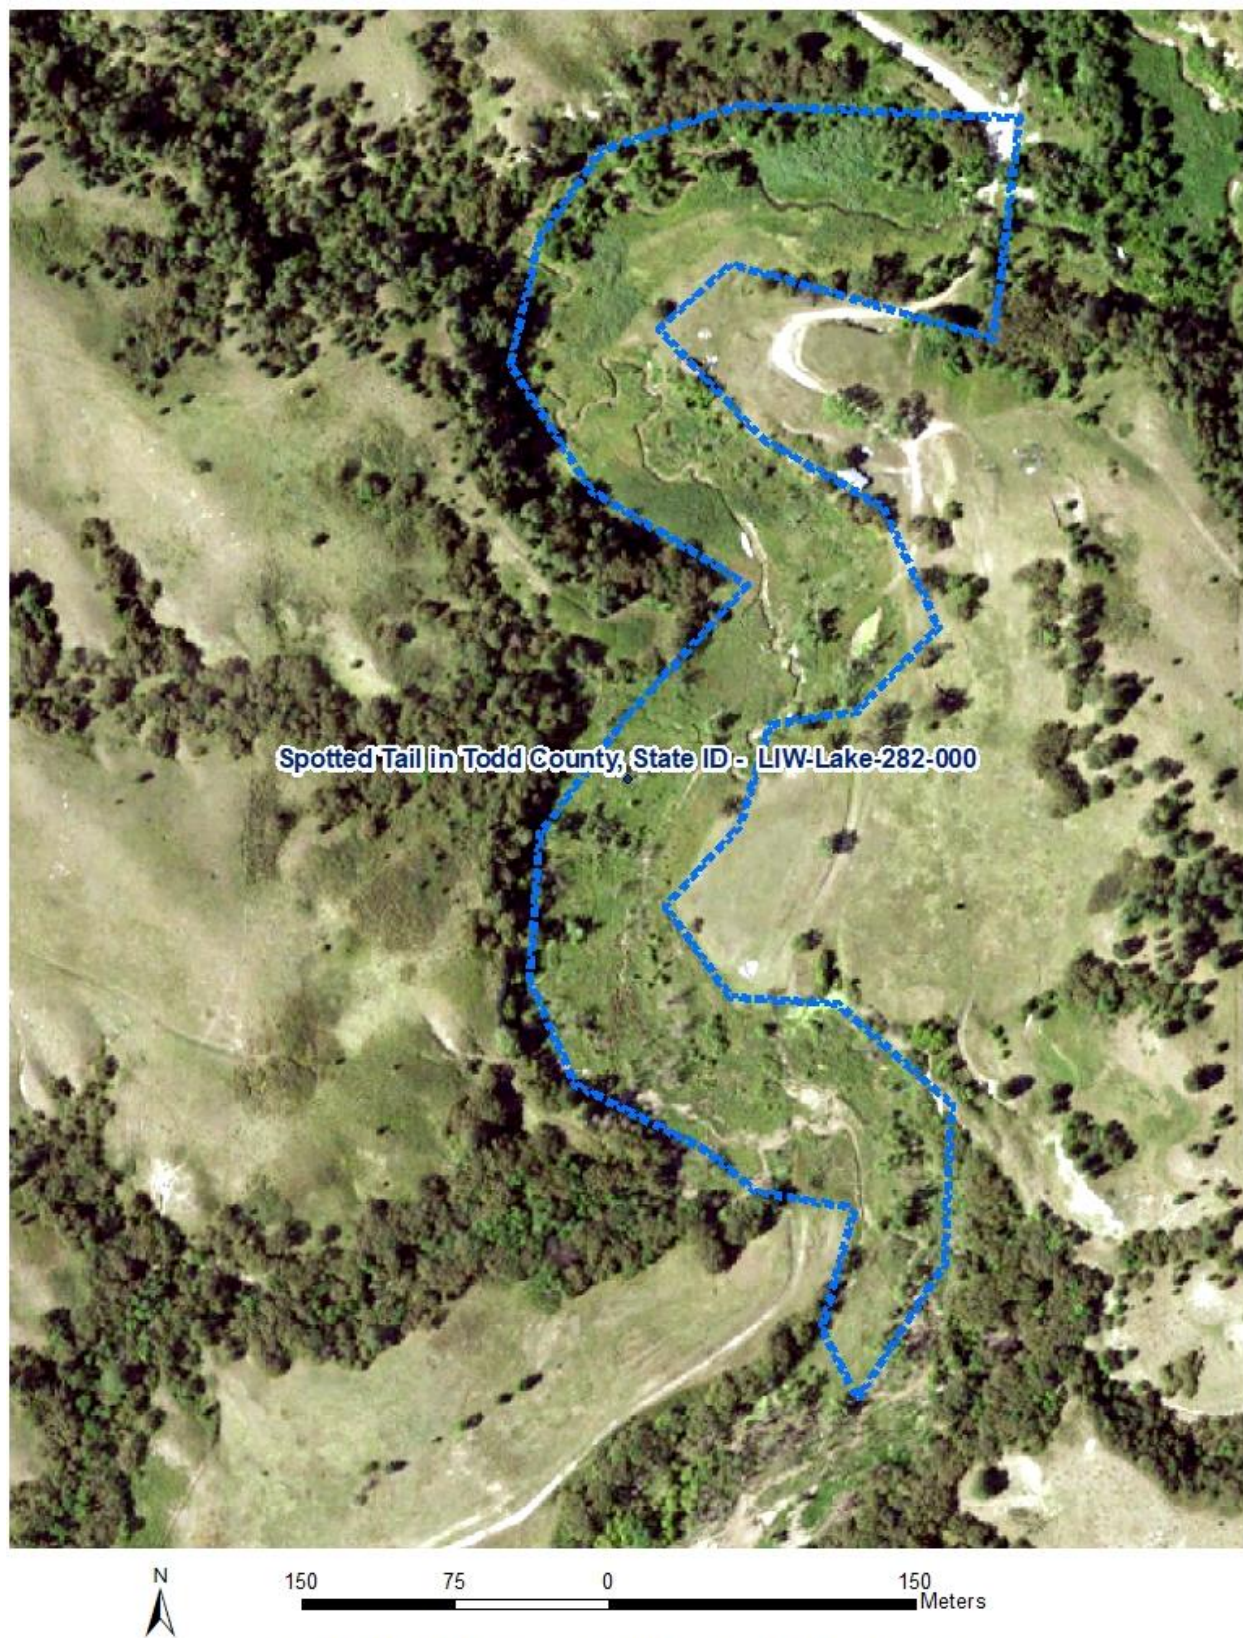
Figure 94. 2016 NAIP image of Spotted Tail Dam in Todd County

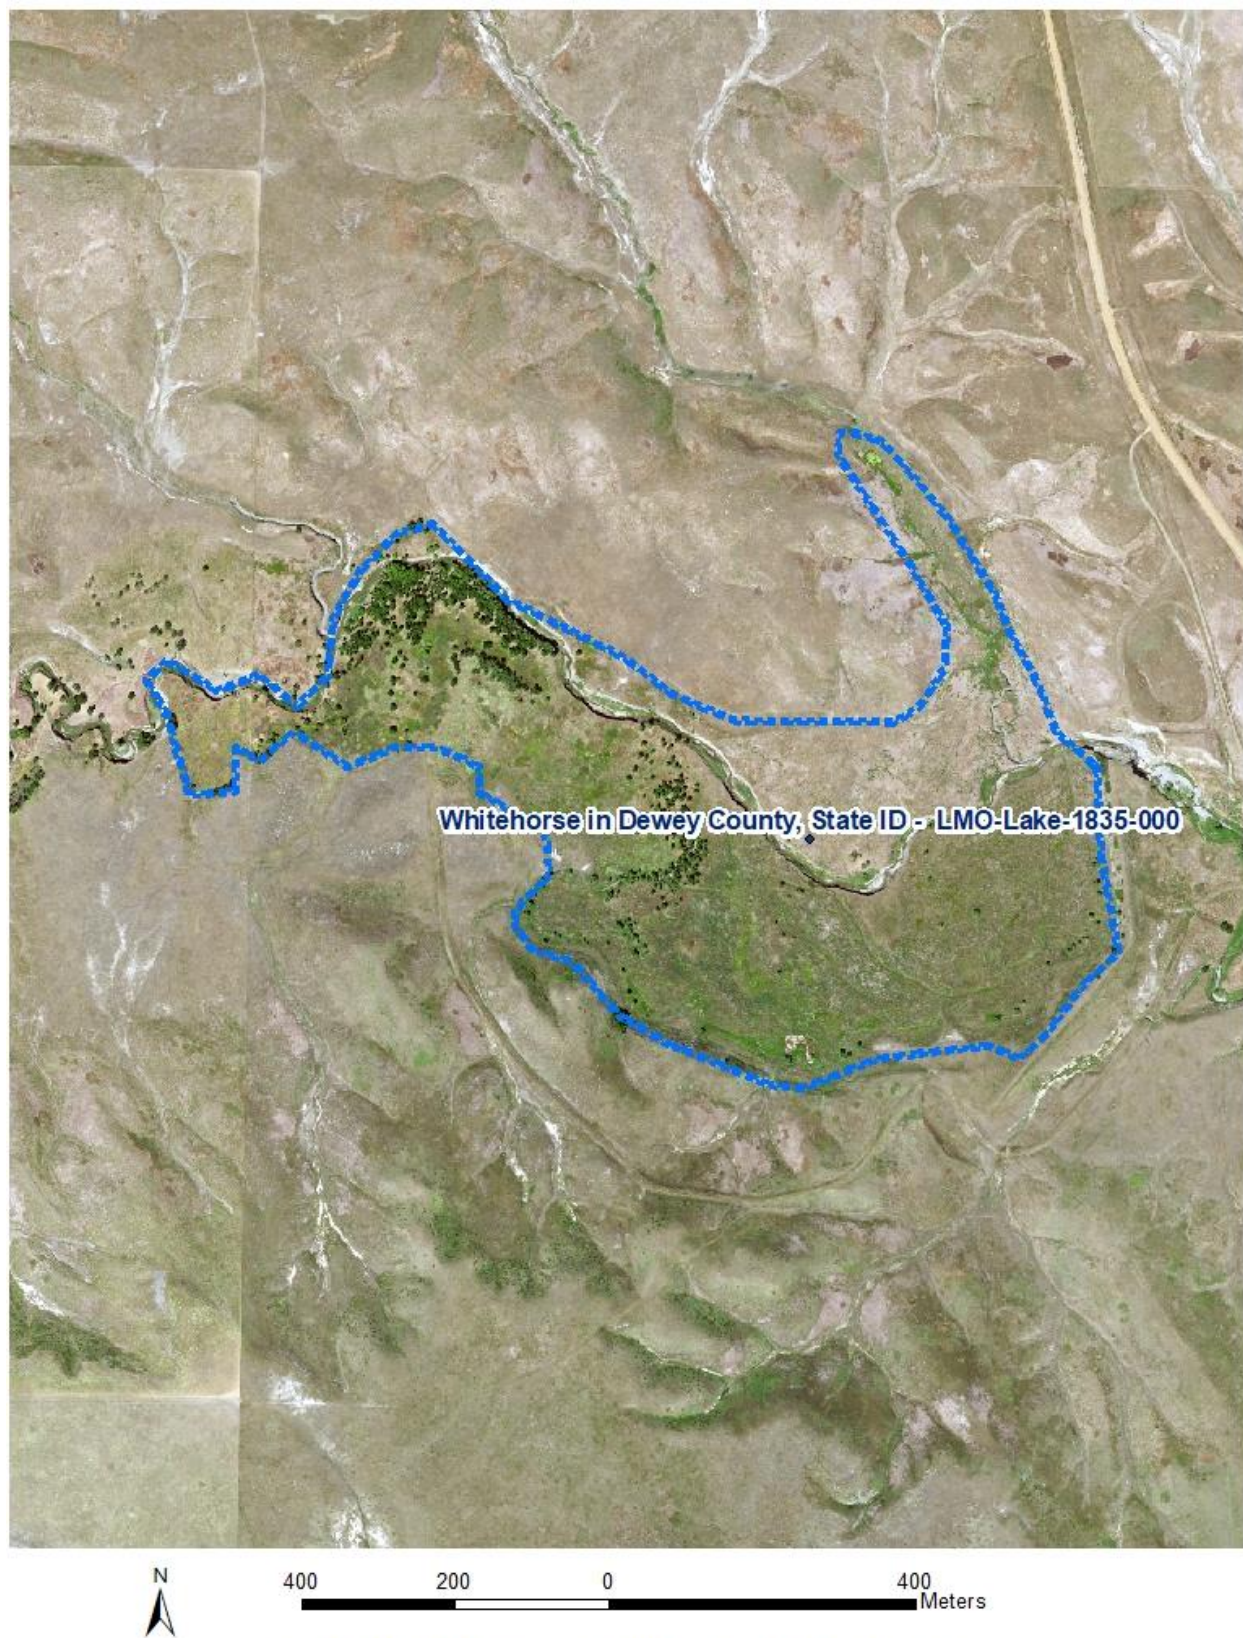
Figure 98. 2016 NAIP Image of Whitehorse Dam in Dewey County

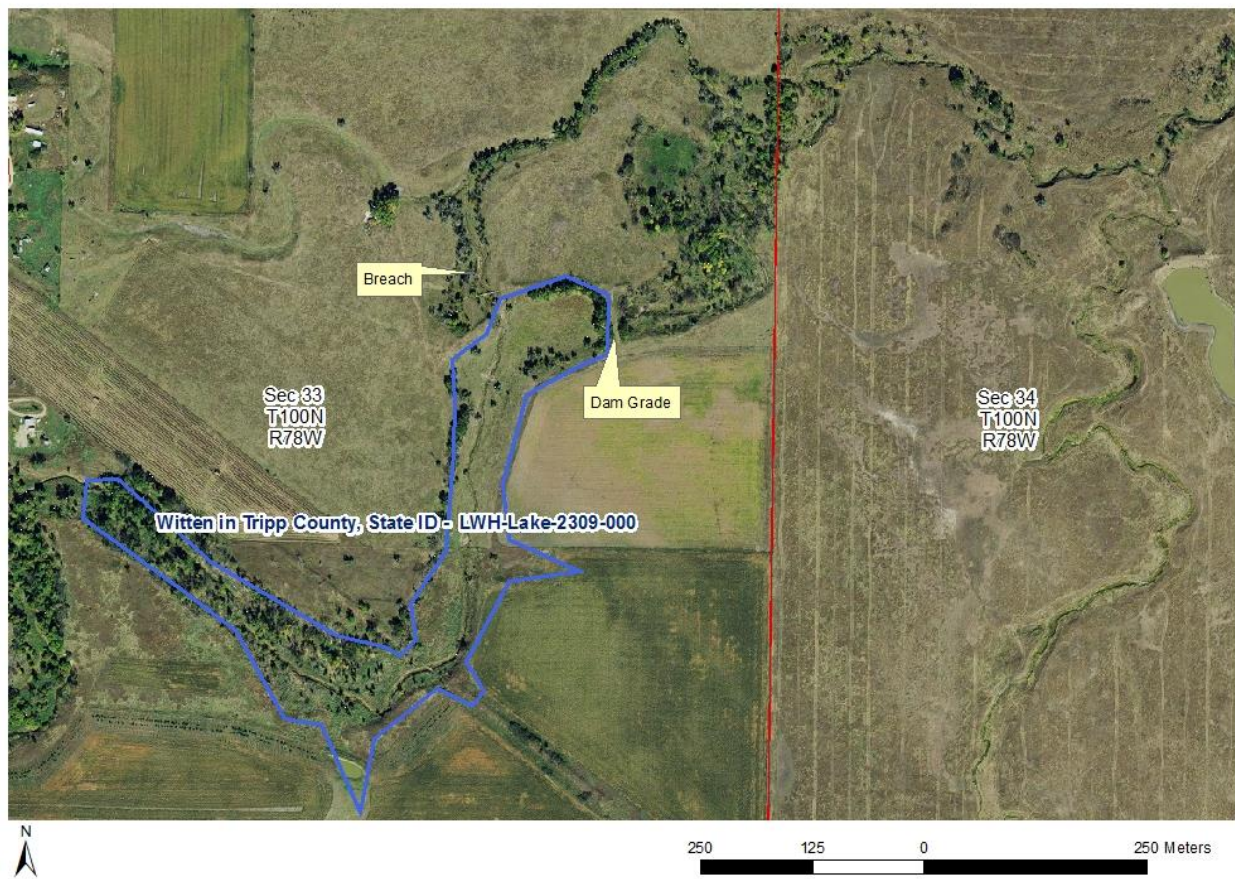
Witten Lake was created by damming an unnamed tributary to the White River at S33 T100N R78W in Tripp County. The breached dam and dry lakebed are located on private property and no public access exists. The lake was assigned the use (5) warmwater semipermanent fish life propagation and was last stocked with fish in 1964 (SDGFP, 2018). Recreation uses assigned to the lake include both (7) immersion and (8) limited contact. The oldest available aerial imagery from 1997 shows a dry lakebed with a well-developed drainage network and mature trees similar to what is visible in the 2016 image Figure 102. The breach visible in Figure 103 does not go through the dam grade. Instead, it cut a new channel which connects to the drainage north of the dam. Due to the long duration since the failure, it is not expected that the dam will be repaired.

Figure 101. Google image of the breach at Witten Dam. The breach formed overland to the north and rerouted the stream through the drainage to the north. (Google, 2014)

Witten is unable to attain the current assigned uses due to the factors identified in 40 CFR 131.10(g) 2) Natural, ephemeral, intermittent or low flow conditions or water levels prevent the attainment of the use; 4) dams, diversions or other types of hydrologic modifications preclude the attainment of the use, and it is not feasible to restore the water body to its original condition or to operate such modification in a way that would result in the attainment of the use; and 5) physical conditions related to the natural features of the water body, such as the lack of a proper substrate, cover, flow, depth, pools, riffles, and the like, unrelated to water quality, preclude attainment of aquatic life protection uses. The dam has been breached, the reservoir is no longer able to hold water, and there are no plans to rebuild the dam and restore the reservoir. Because of these factors, SD DANR recommends removing the designated uses assigned in ARSD 74:51:02.
