**Removal of Certain
Classified Impoundments
From
Administrative Rules of South Dakota
Chapter 74:51:02**

October 2022

**South Dakota
Department of Agriculture and Natural Resources
Office of Water
Pierre, South Dakota**

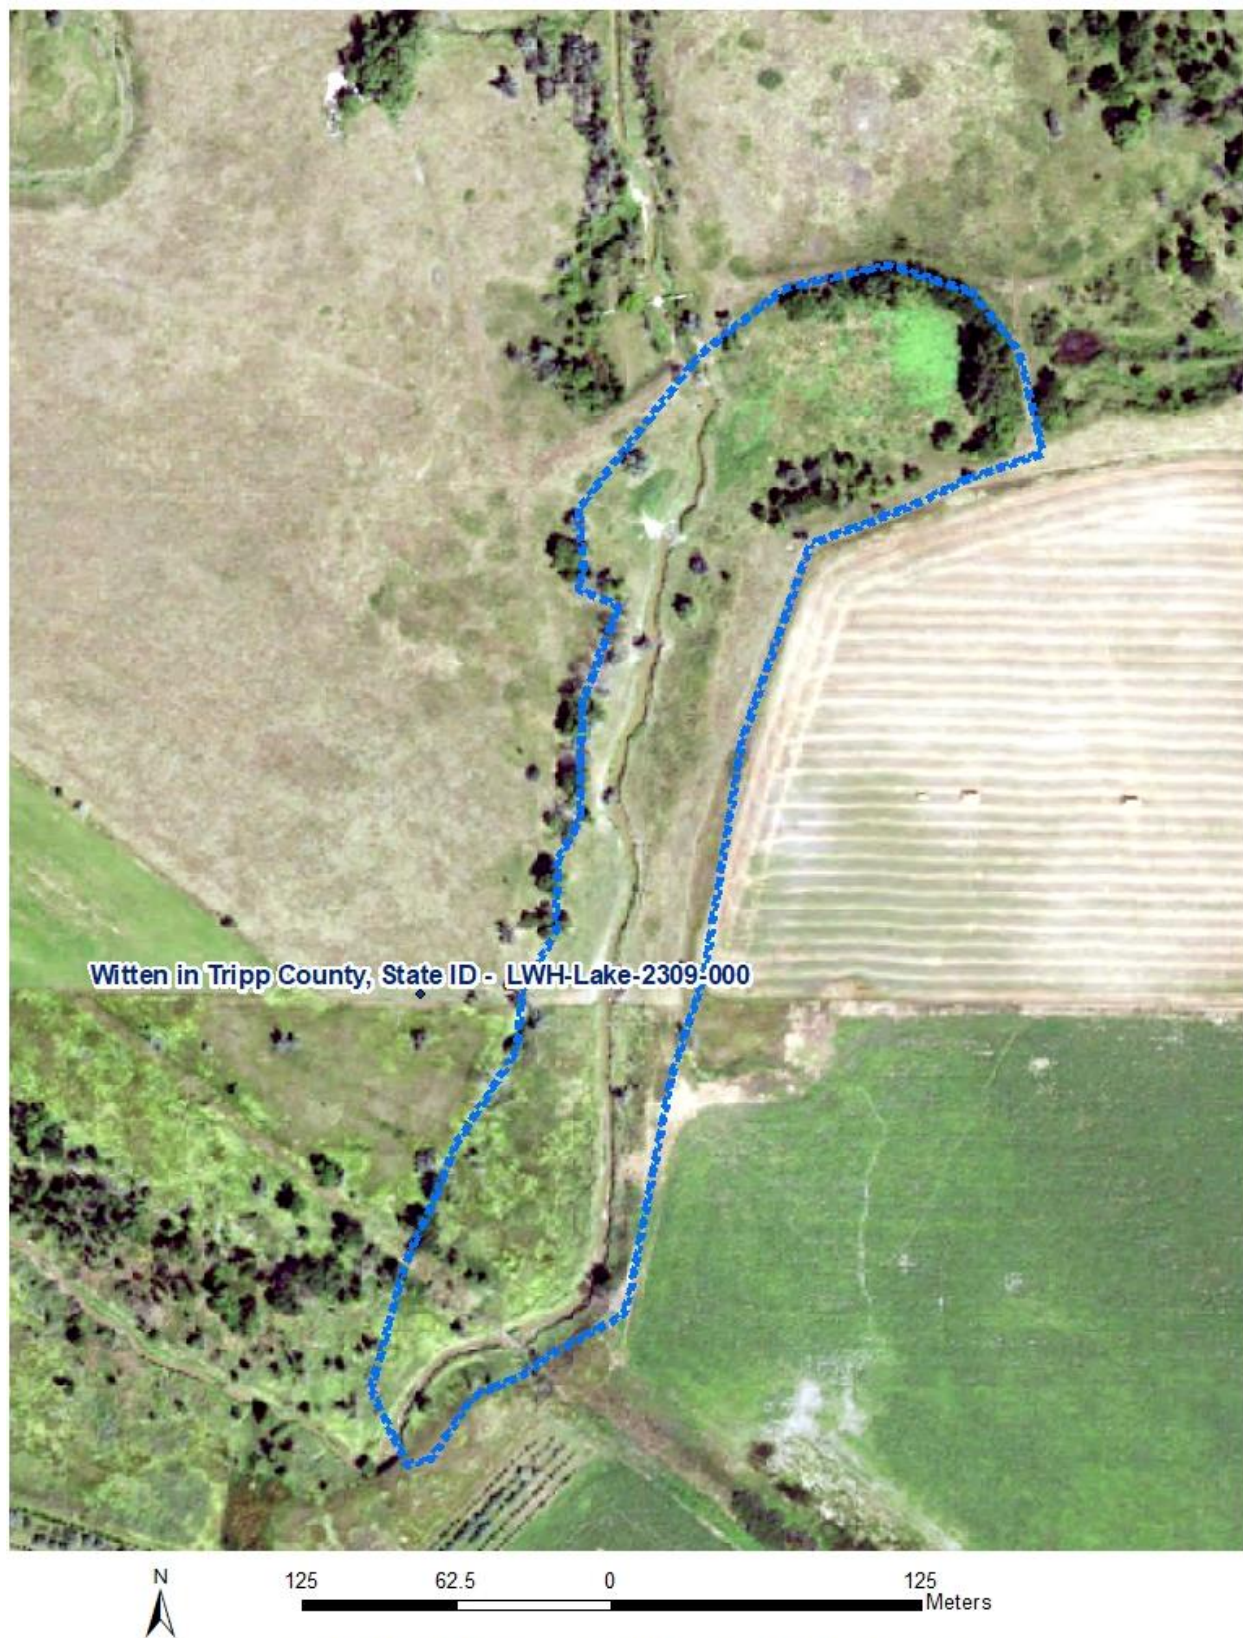
Figure 102. 2016 NAIP Image of Witten Dam in Tripp County

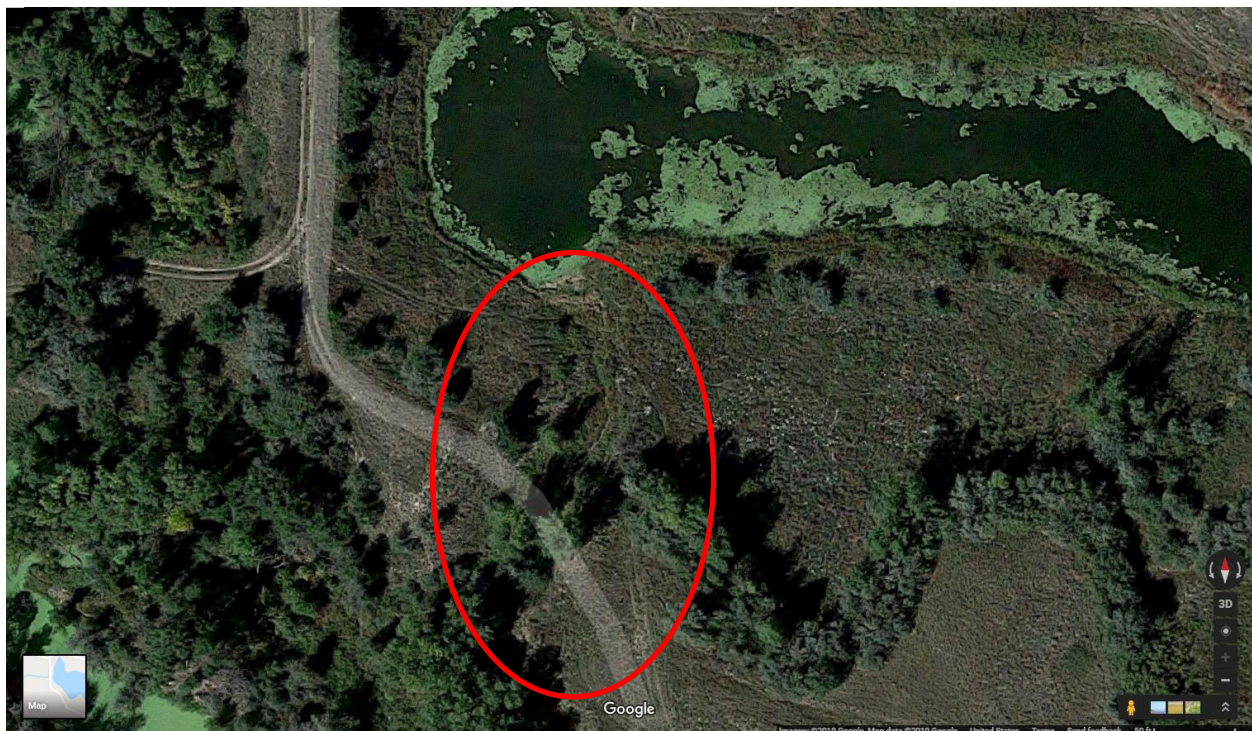
Figure 104. DOQ of Wolf Creek Lake prior to breach in 1991, well used roadway across dam is visible.

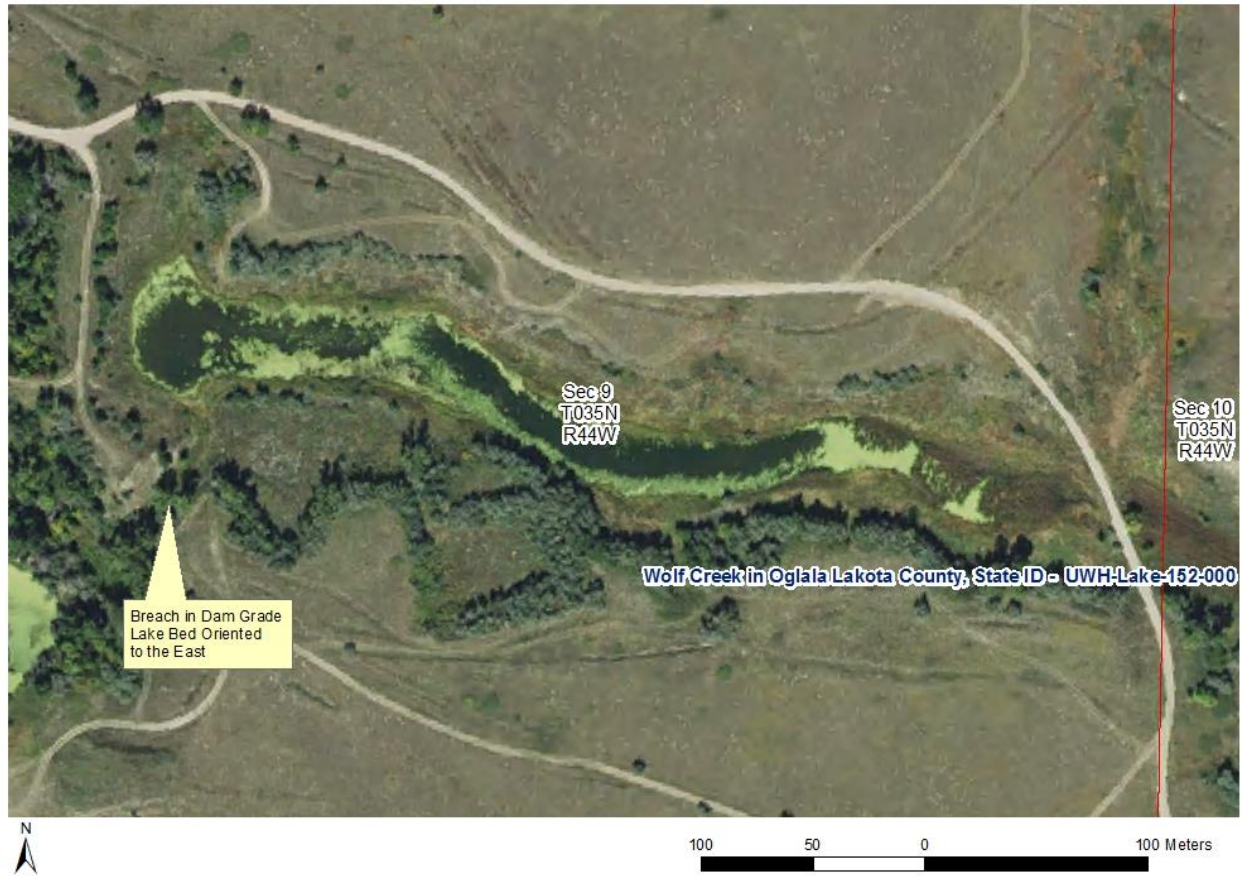
Wolf Creek Lake was created by damming Wolf Creek at S9 T35N R44W in Oglala Lakota County. The breached dam and lakebed are located within the Pine Ridge Indian Reservation boundary and no public access exists. The lake was assigned the use (2) coldwater permanent fish life propagation and state stocking records indicate it was last stocked in 1983 (SDGFP, 2018). Recreation uses assigned to the lake include both (7) immersion and (8) limited contact. Review of aerial photography indicates that the dam began to fail sometime in the 1990's. Due to the relatively recent nature of the breach, there remains capacity to hold small amounts of ponded water in the former lakebed. Prior to the breach, the dam grade served as a roadway (see Figure 104) to reach residences south of the lake. Subsequent to the breach, a culvert was installed in the lakebed near the boundary of sections 9 and 10 and a new road across the lake was established while the dam grade road appears to have been entirely abandoned which is further evidence that there is no intent to rebuild the dam.

Figure 105. Google image of the dam breach at WolfCreek. The breach (red circle) is not fully developed and partially obscured by trees. (Google, 2016)

Wolf Creek Lake is unable to attain the current assigned uses due to the factors identified in 40 CFR 131.10(g) 2) Natural, ephemeral, intermittent or low flow conditions or water levels prevent the attainment of the use; 4) dams, diversions or other types of hydrologic modifications preclude the attainment of the use, and it is not feasible to restore the water body to its original condition or to operate such modification in a way that would result in the attainment of the use; and 5) physical conditions related to the natural features of the water body, such as the lack of a proper substrate, cover, flow, depth, pools, riffles, and the like, unrelated to water quality, preclude attainment of aquatic life protection uses. The dam has been breached, the reservoir is no longer able to hold water, and there are no plans to rebuild the dam and restore the reservoir. Because of these factors, SD DANR recommends removing the designated uses assigned in ARSD 74:51:02.

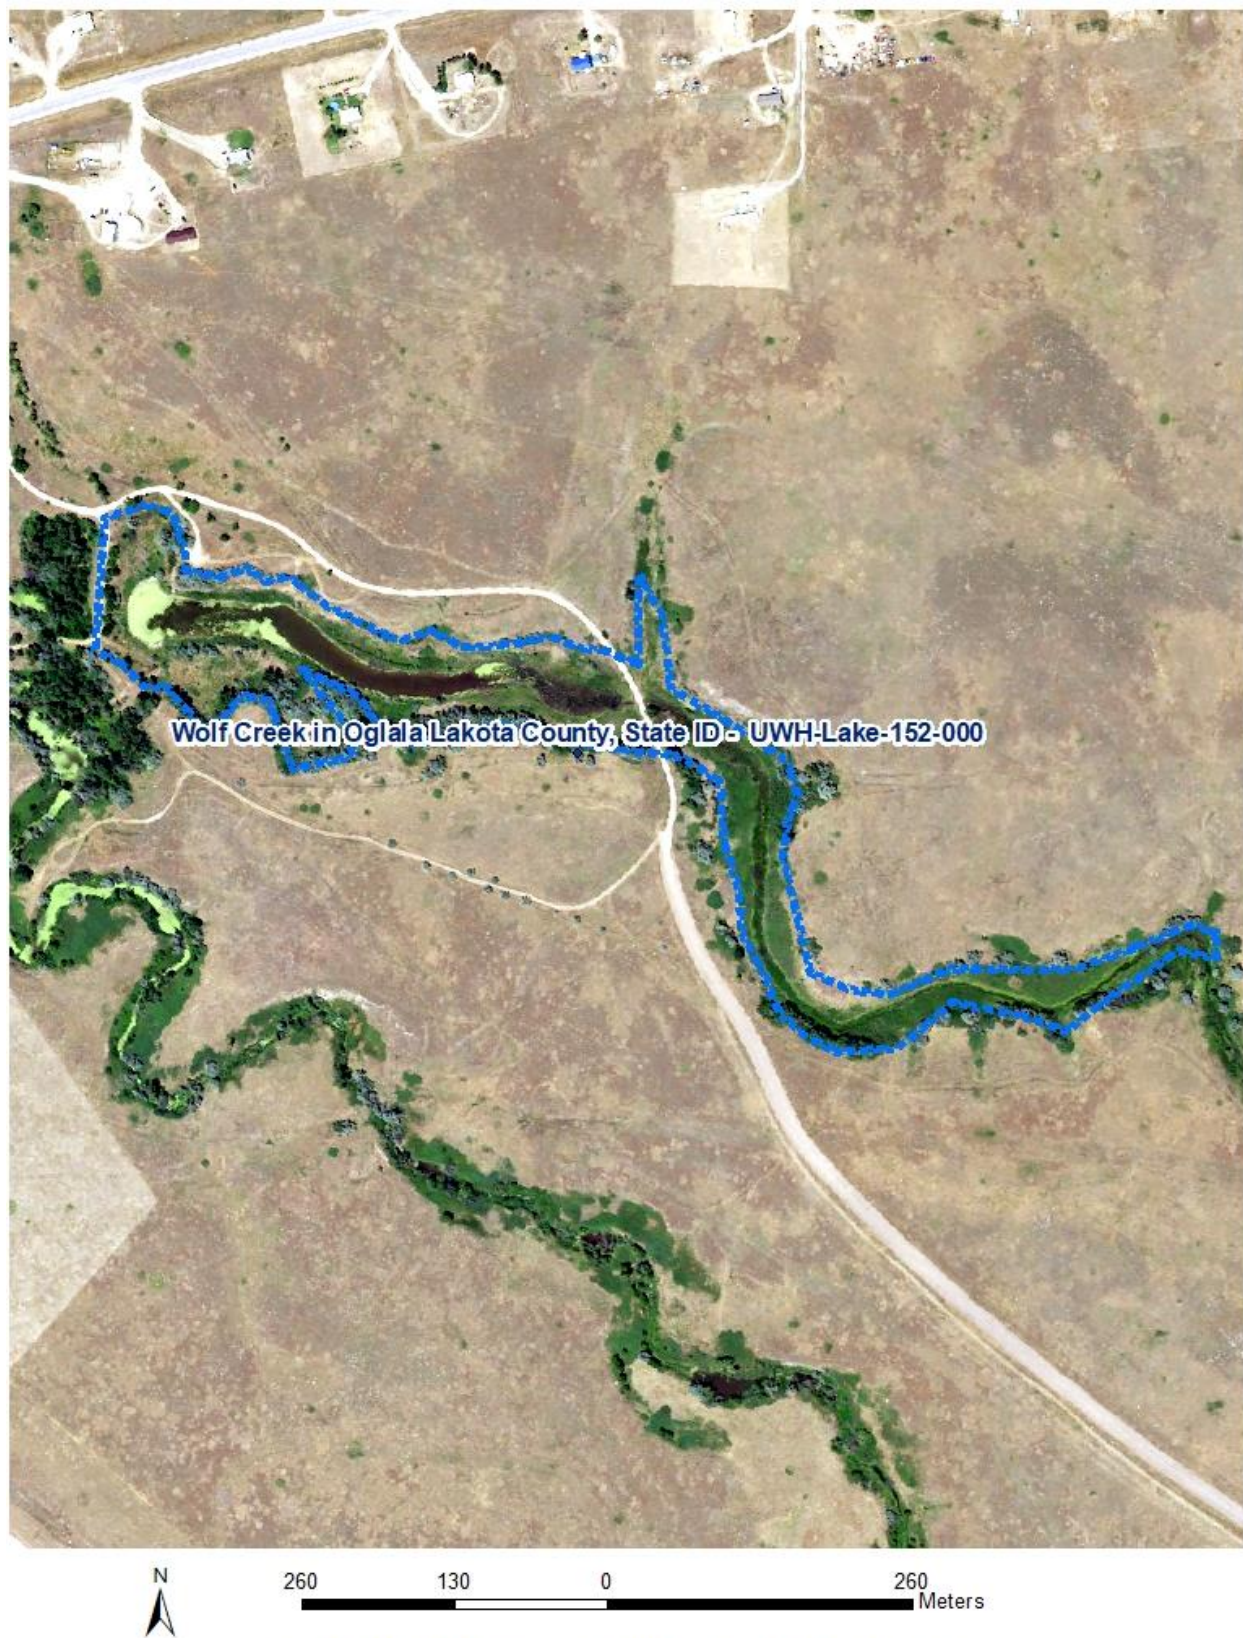
Figure 106. 2016 NAIP Image of Wolf Creek in Oglala Lakota County
