Notice of Hearing on Request for Variance from
South Dakota Safety of Dams Rules Requested by City of Mitchell

Lake Mitchell Dam Variance Request

Houston Engineering, Inc.

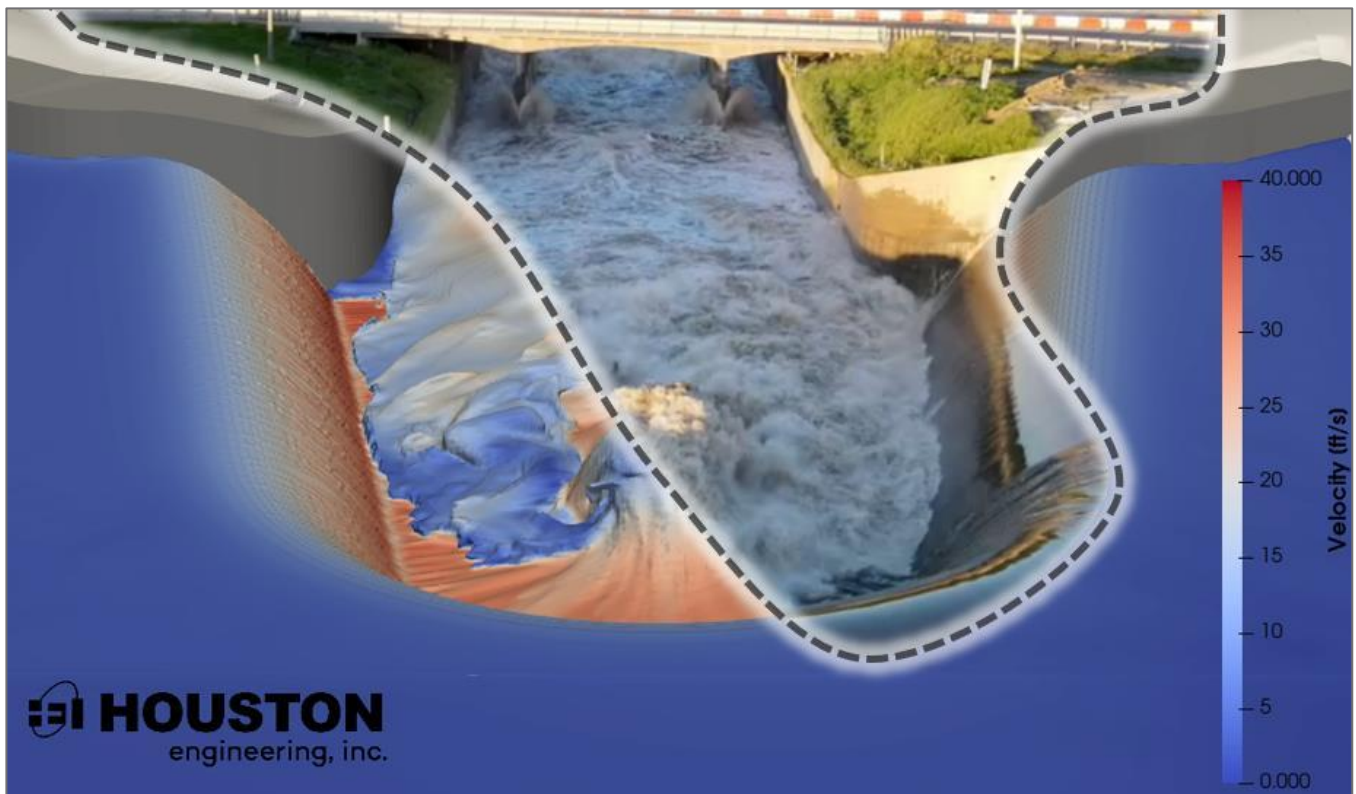
Figure 1 – CFD Modeling matches observed flow patterns within the Lake Mitchell Horseshoe Ogee-weir Spillway

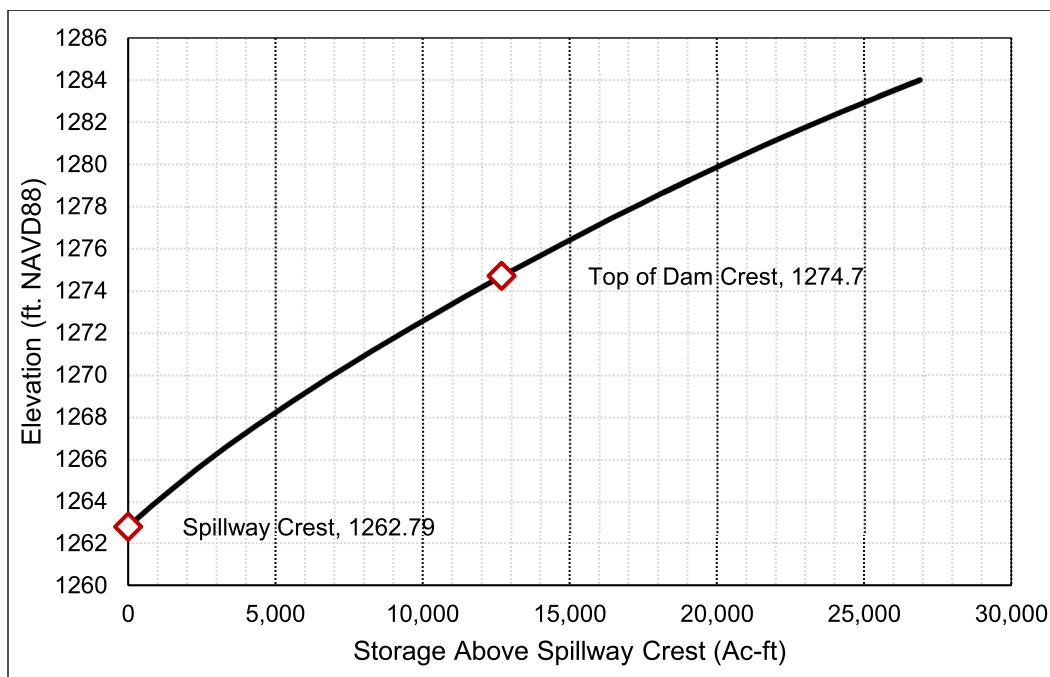
The current elevation-storage relationship was developed using Light Detection and Ranging (LiDAR) data. An elevation-storage table could not be located from the as-built drawings. Therefore, storage below the spillway crest elevation could not be determined. Figure 2 shows the current capacity curve for the reservoir with the zero (0) value of flood storage set at the spillway crest elevation. Within the analyses explained below, the normal storage below the spillway crest elevation was not required to perform the reservoir routings.

Figure 2 - Lake Mitchell Elevation-Storage Relationship

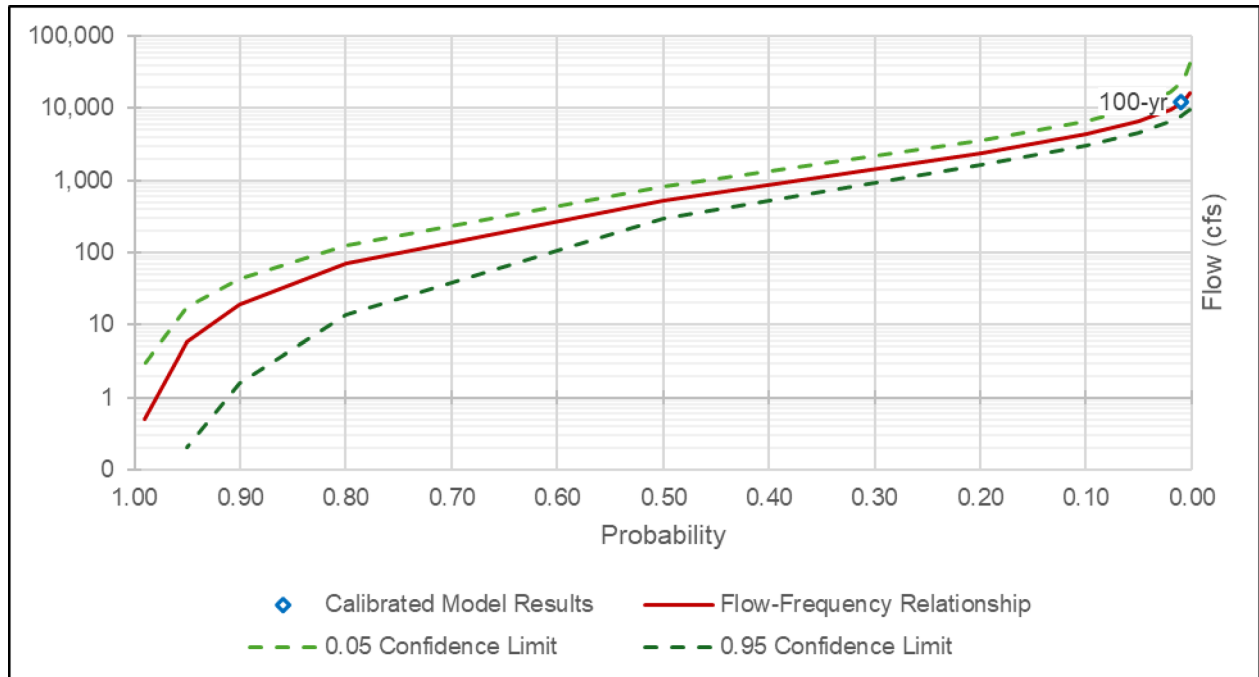
For the USGS gage Bulletin 17C analysis, the 100-year peak Q was determined to be 11,912 cfs. For the calibrated model, the 100-year peak Q was determined to be 12,388 cfs. Figure 9 shows the flow-frequency relationship for the USGS gage graphically with the calibrated model 100-year result shown.

Figure 9 - Bulletin 17C and Calibrated Model Peak Q

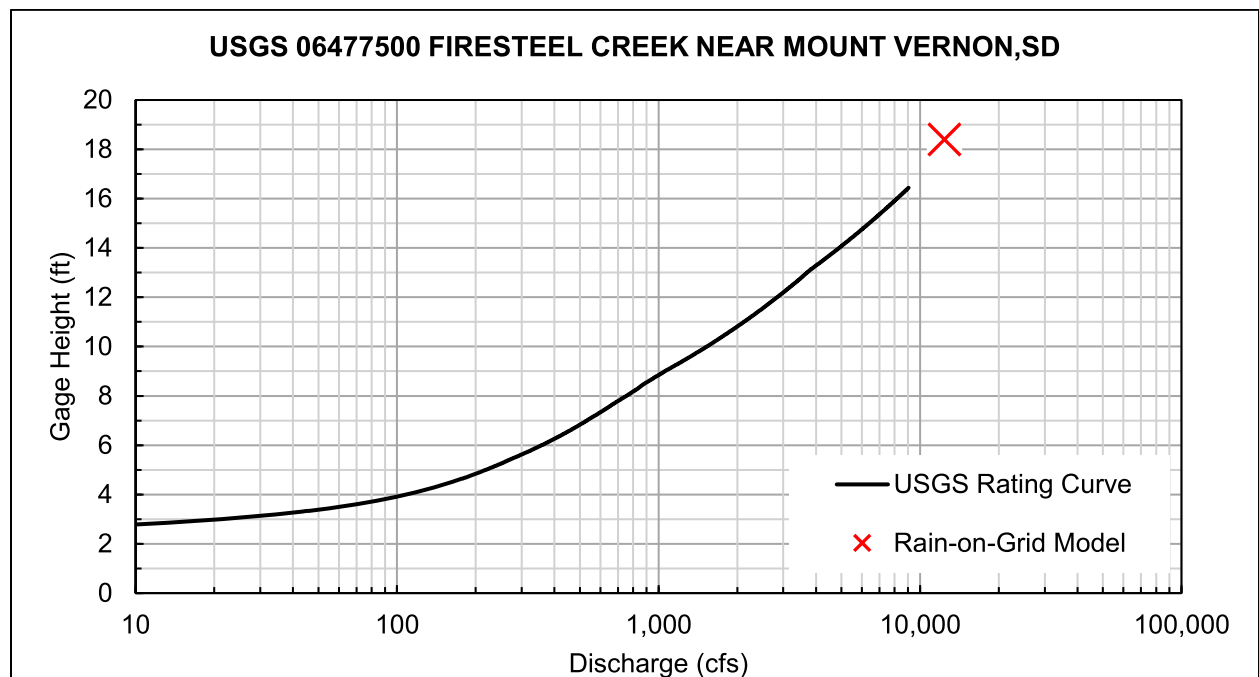
The modeled stage and peak flow at the USGS gage location within the rain-on-grid model was plotted against the USGS rating curve. Figure 10 shows this plot.

Figure 10 - USGS Rating Curve and Rain-on-Grid Model

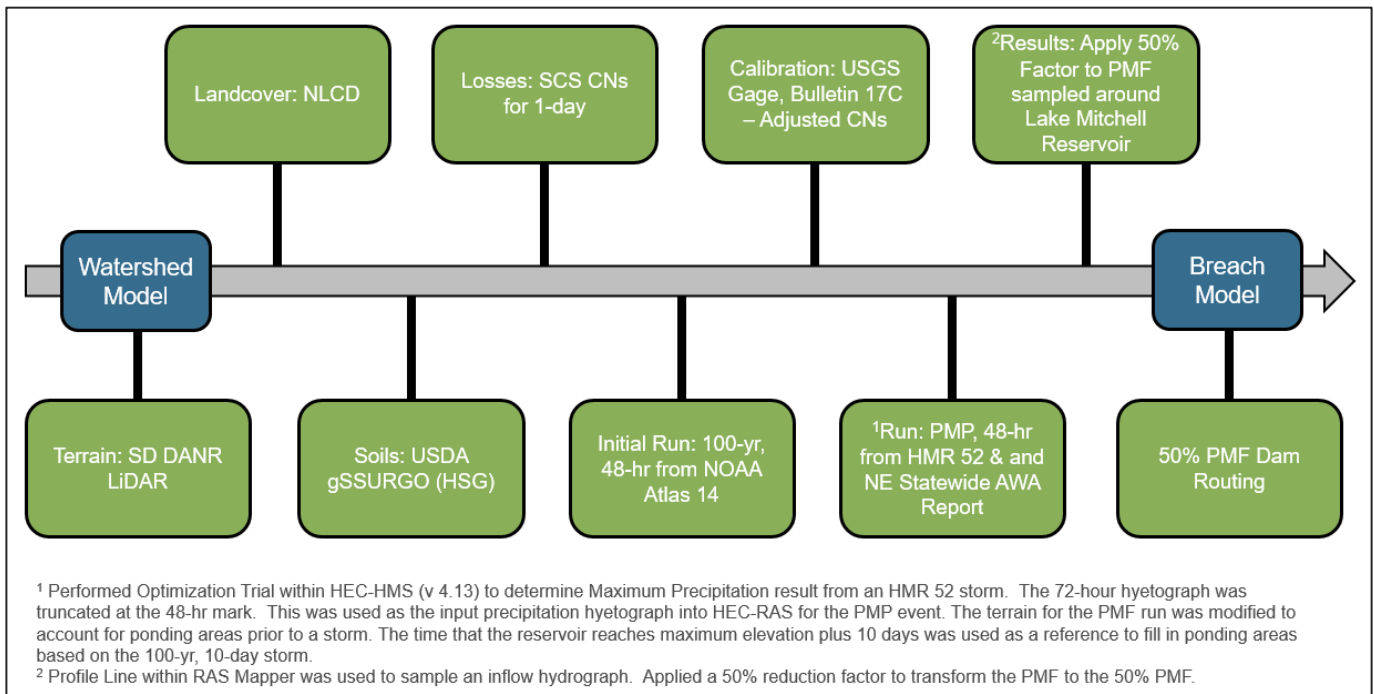
To summarize the analyses performed prior to performing the breach modeling, Figure 19 shows this visually below. A HEC-RAS 2D unsteady state model was developed to assess breach hazards downstream of the Lake Mitchell Dam. The 2D model was set up using the same approach as the ROG watershed model; however, no losses were computed in the model. Flow was introduced into the model using a boundary condition line at the downstream toe of the dam representing the breach hydrographs.

Figure 19 – Summary of Watershed Model prior to Breach Model

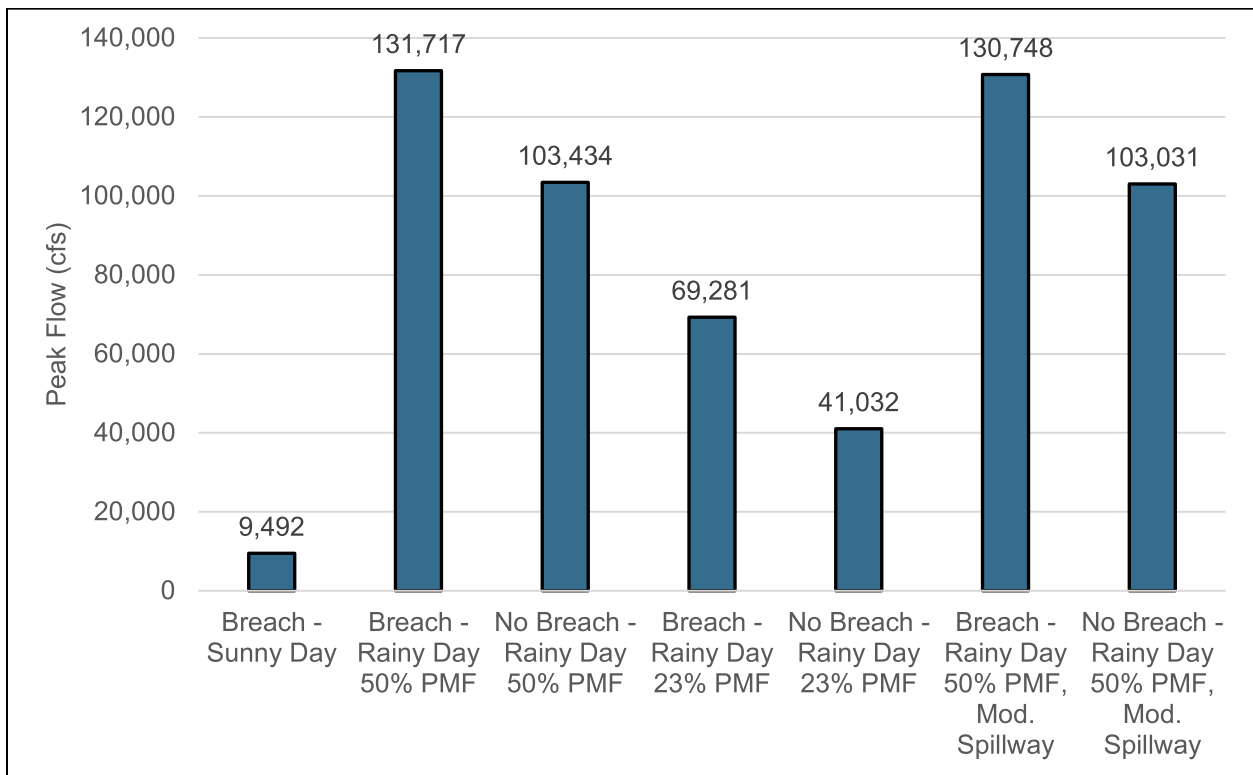
Coincidental downstream flooding was not taken into consideration during the breach analysis. Flow into the outlet channel prior to the breach occurring only consists of spillway outflow. Figure 20 includes peak flow values for each breach scenario modeled.

Figure 20 – Peak Breach Discharges

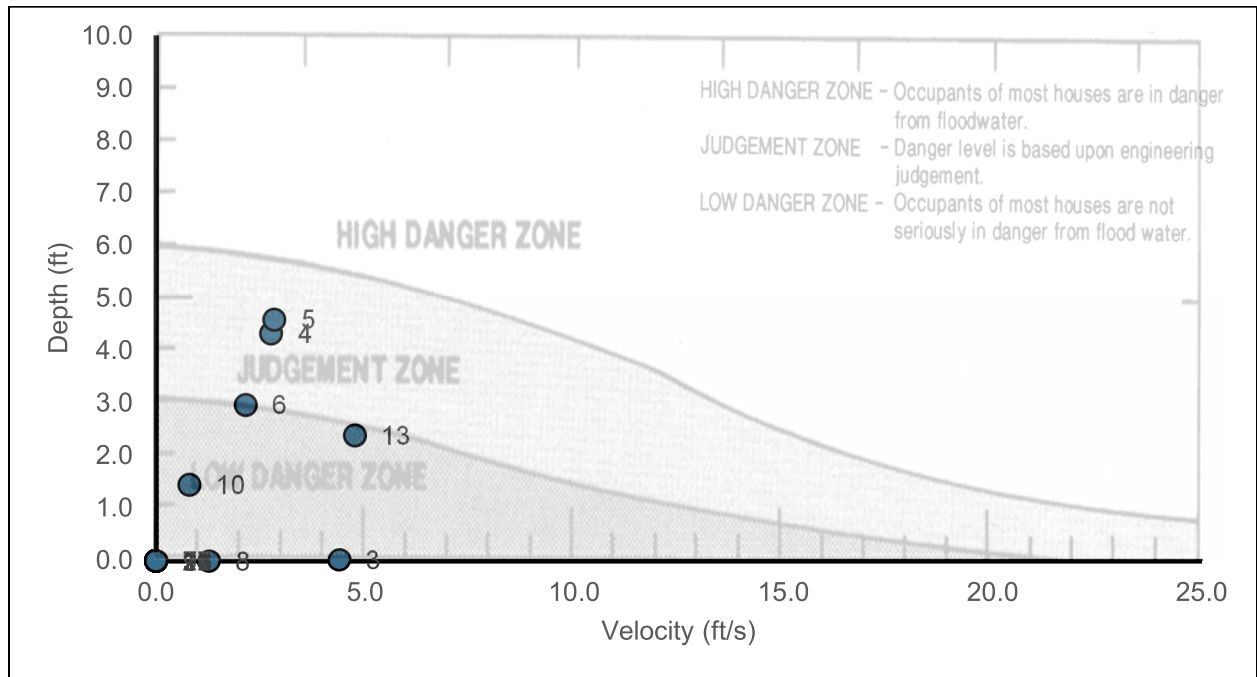
Figure 25 – 23% PMF No Dam Failure Dangers

Danger Zones and comparisons for the 23% PMF are shown in Figure 25, Figure 26, and Figure 27 below.

For the 23% PMF dam failure scenario, structures 3, 4, 5, and 13 are elevated in Danger Zones with respect to depths and velocities; however, as discussed above, these structures are already at a high risk based on warning times, delay times, and egress routes. Therefore, the risk to these structures for a no dam failure scenario at the 23% PMF is inherently high due to their proximity to the dam and egress routes. Based upon this, there is a negligible increase in consequences due to failure of the dam when compared to the same flood (23% PMF) without dam failure.

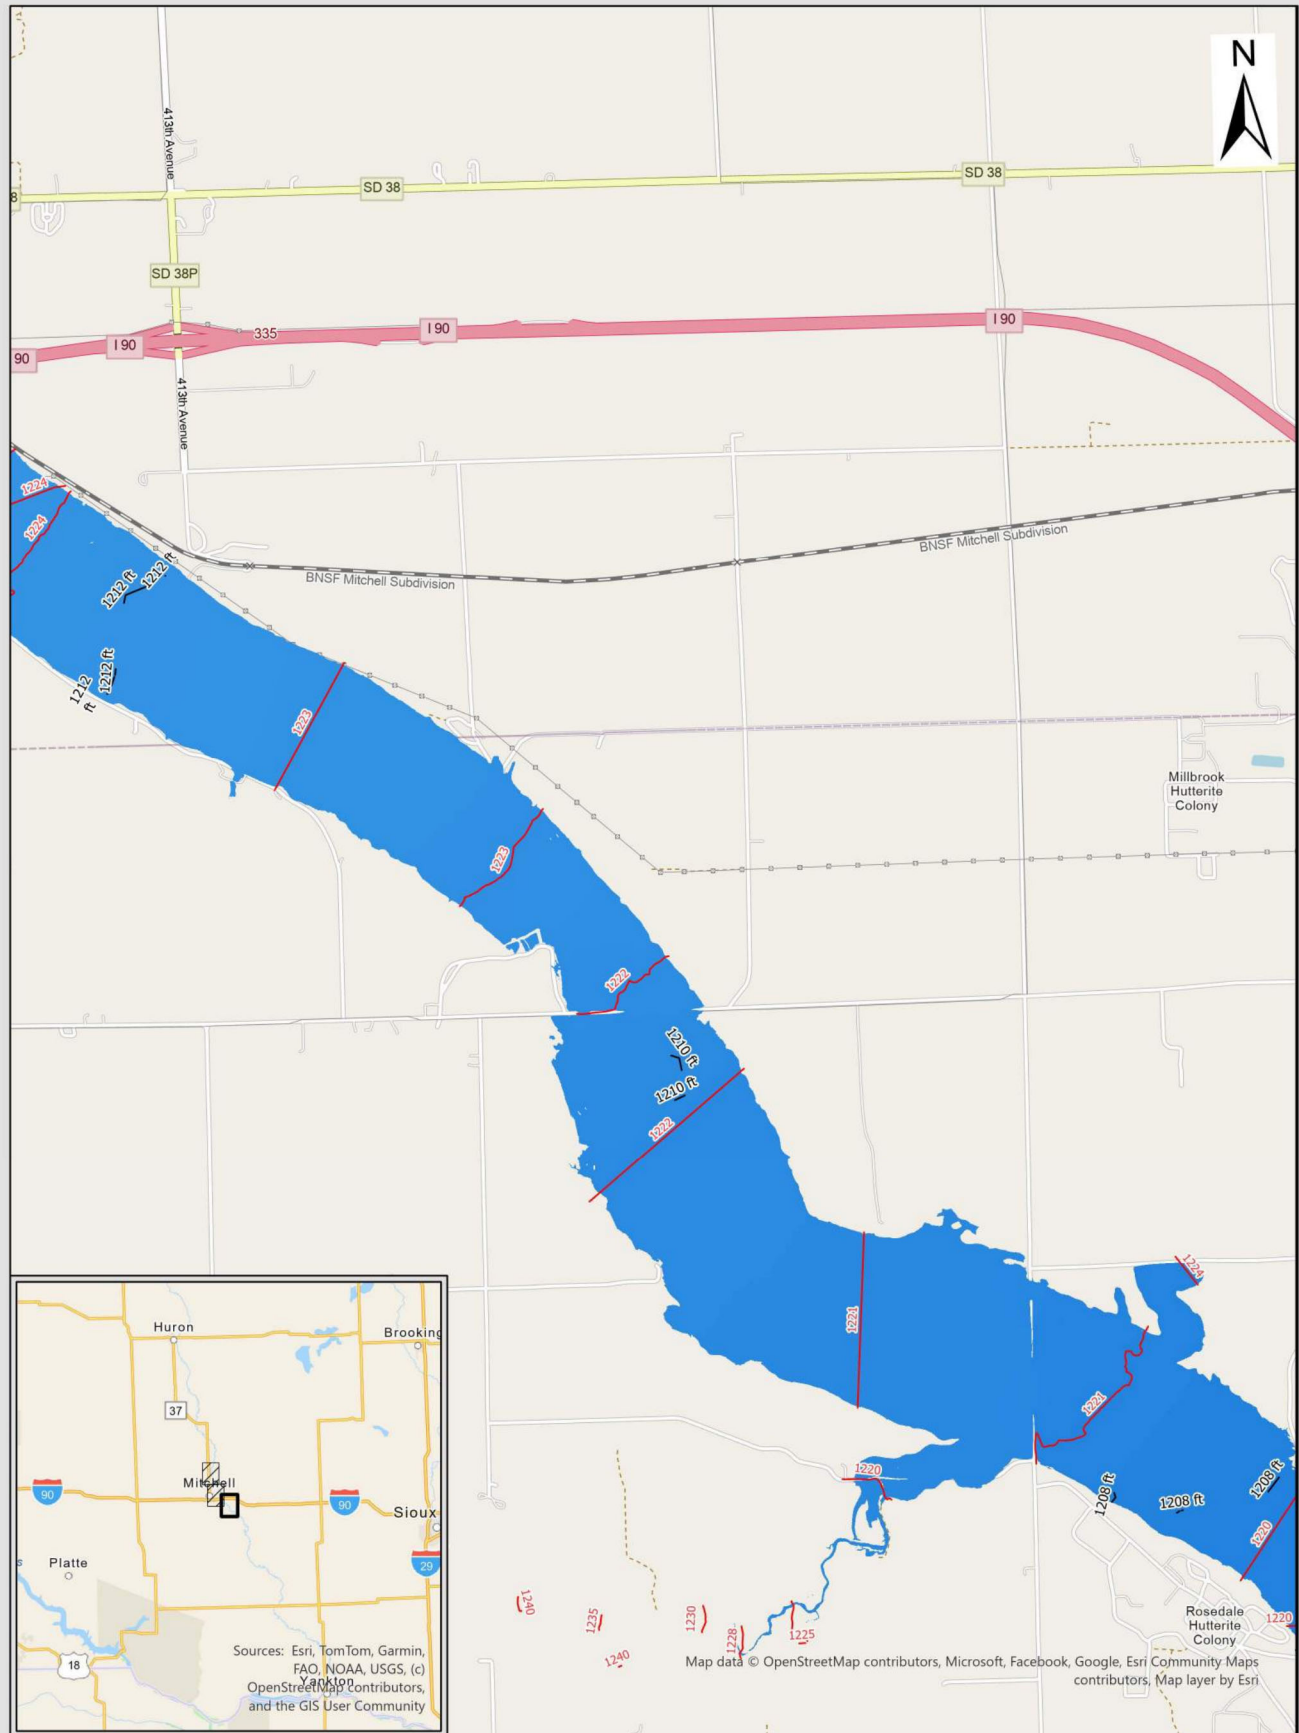
— WSE Contours (2-ft)
Water Surface Elevations (ft NAVD 88)
 Value
 1260.85
 1204.33
 — Base Flood Elevations

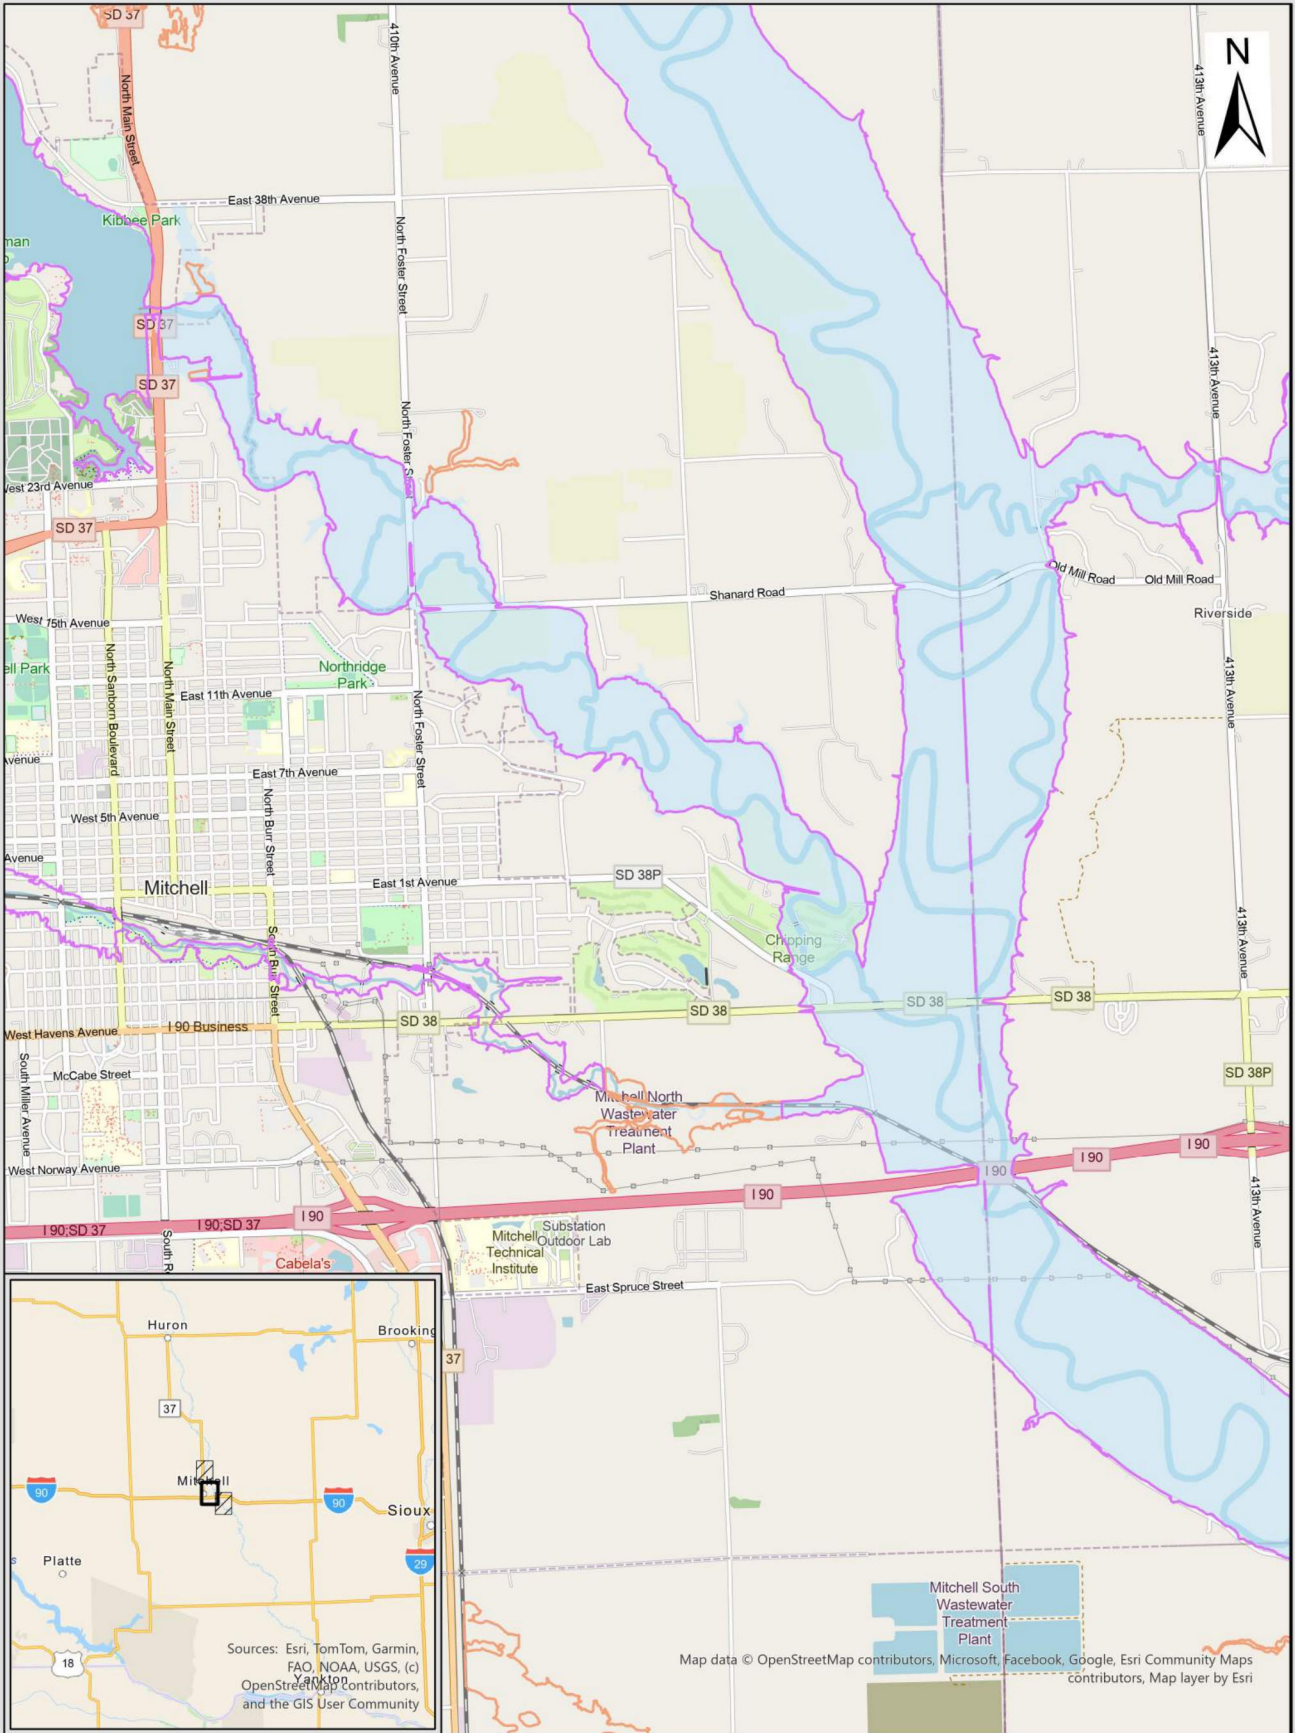
Breach Inundation Extents

- FEMA Flood Zone A
- FEMA Flood Zone AE

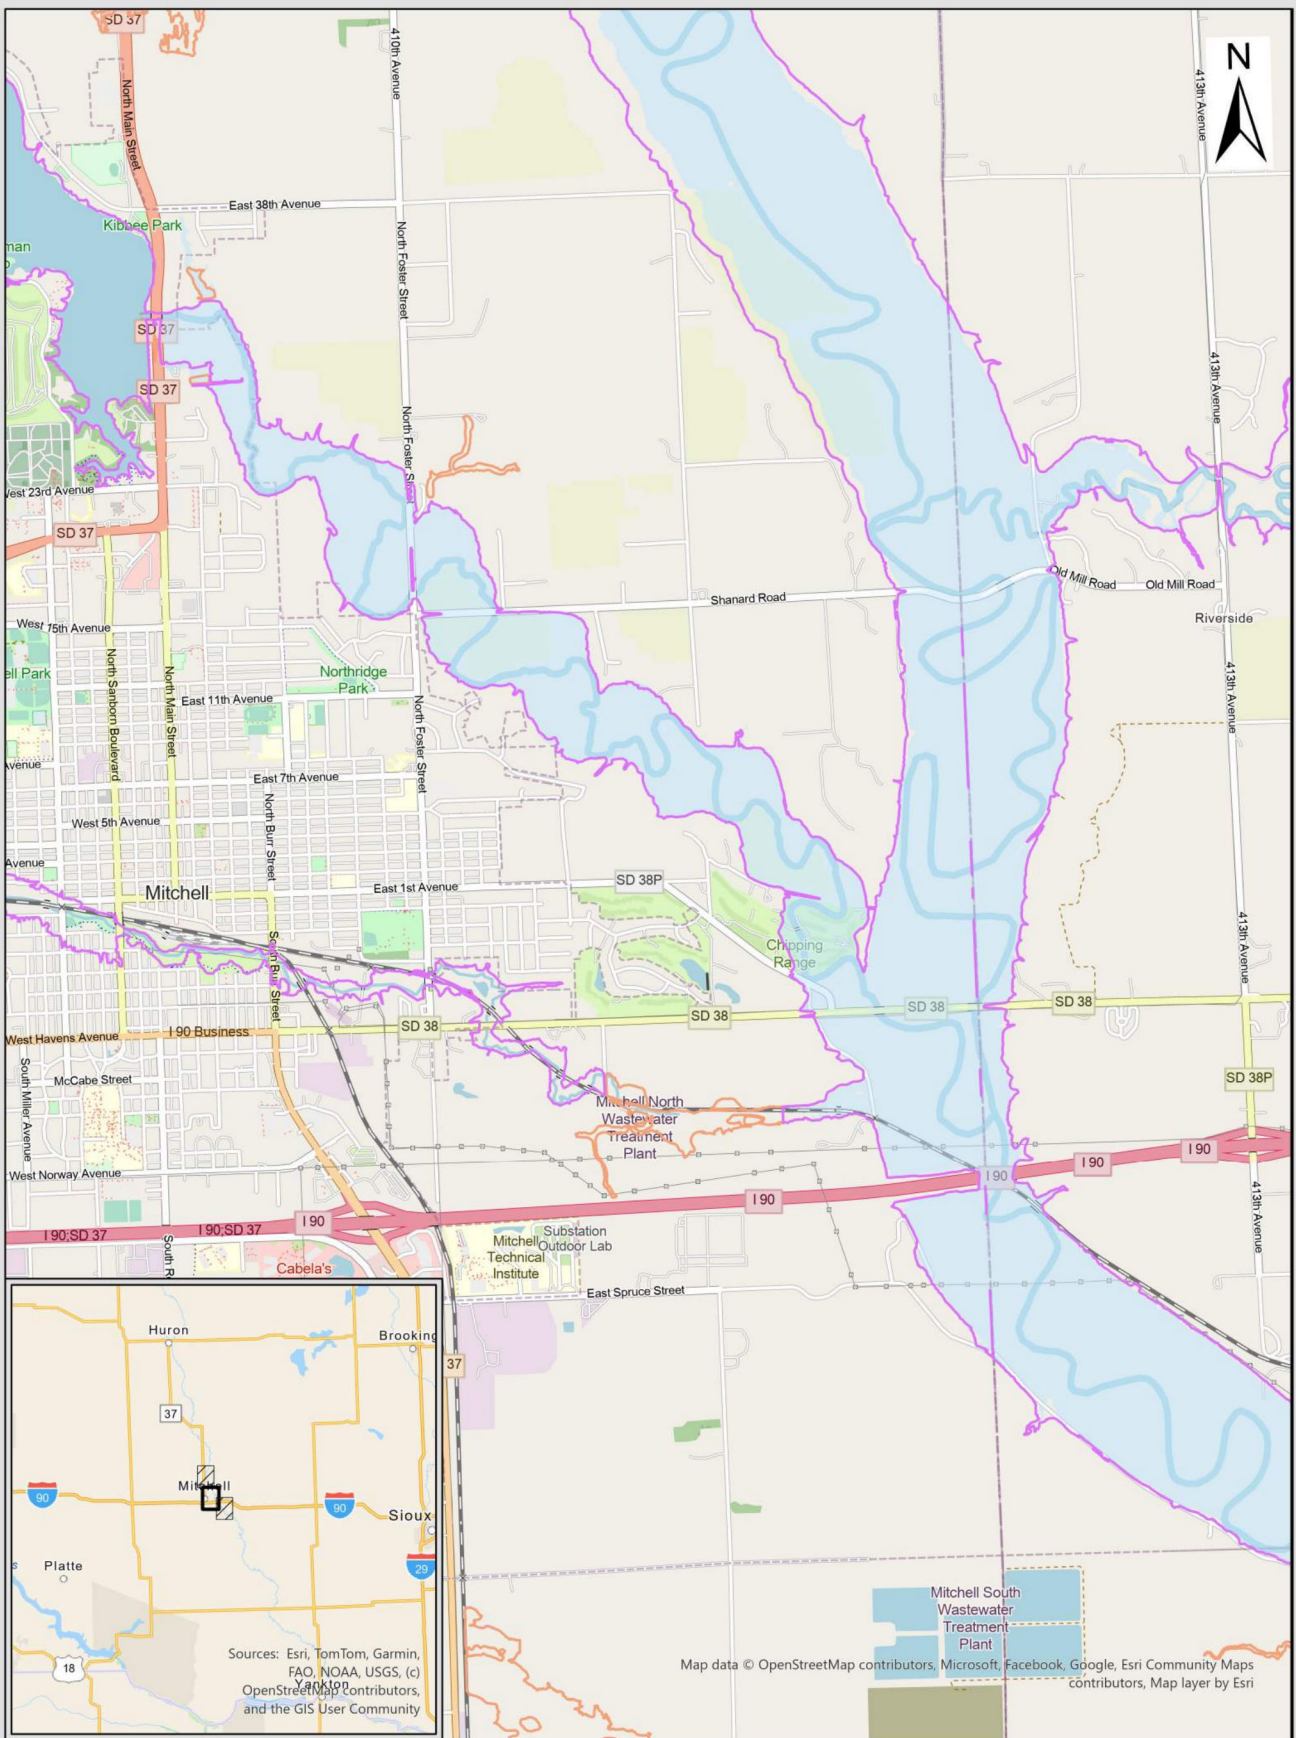
Breach Inundation Extents

- FEMA Flood Zone A
- FEMA Flood Zone AE

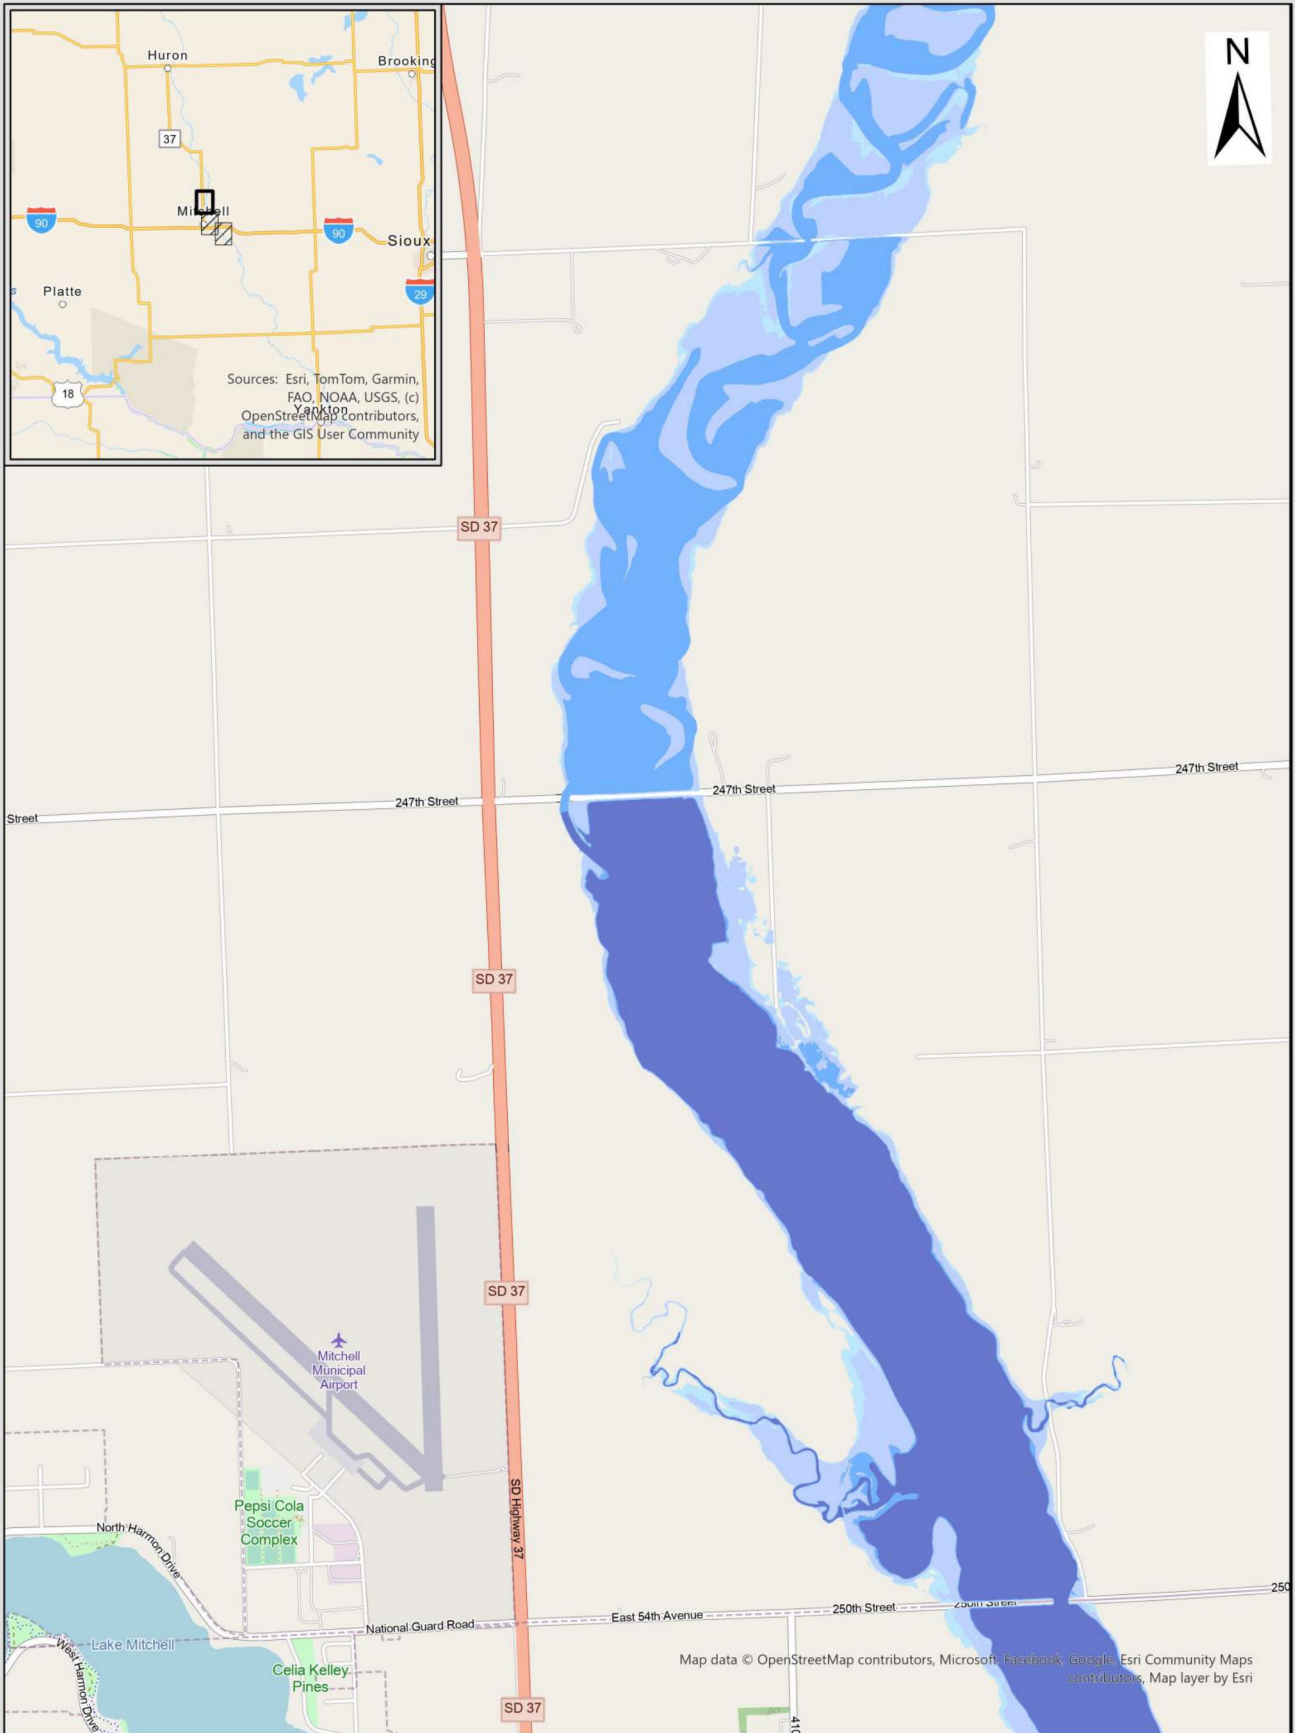
Depths (ft)

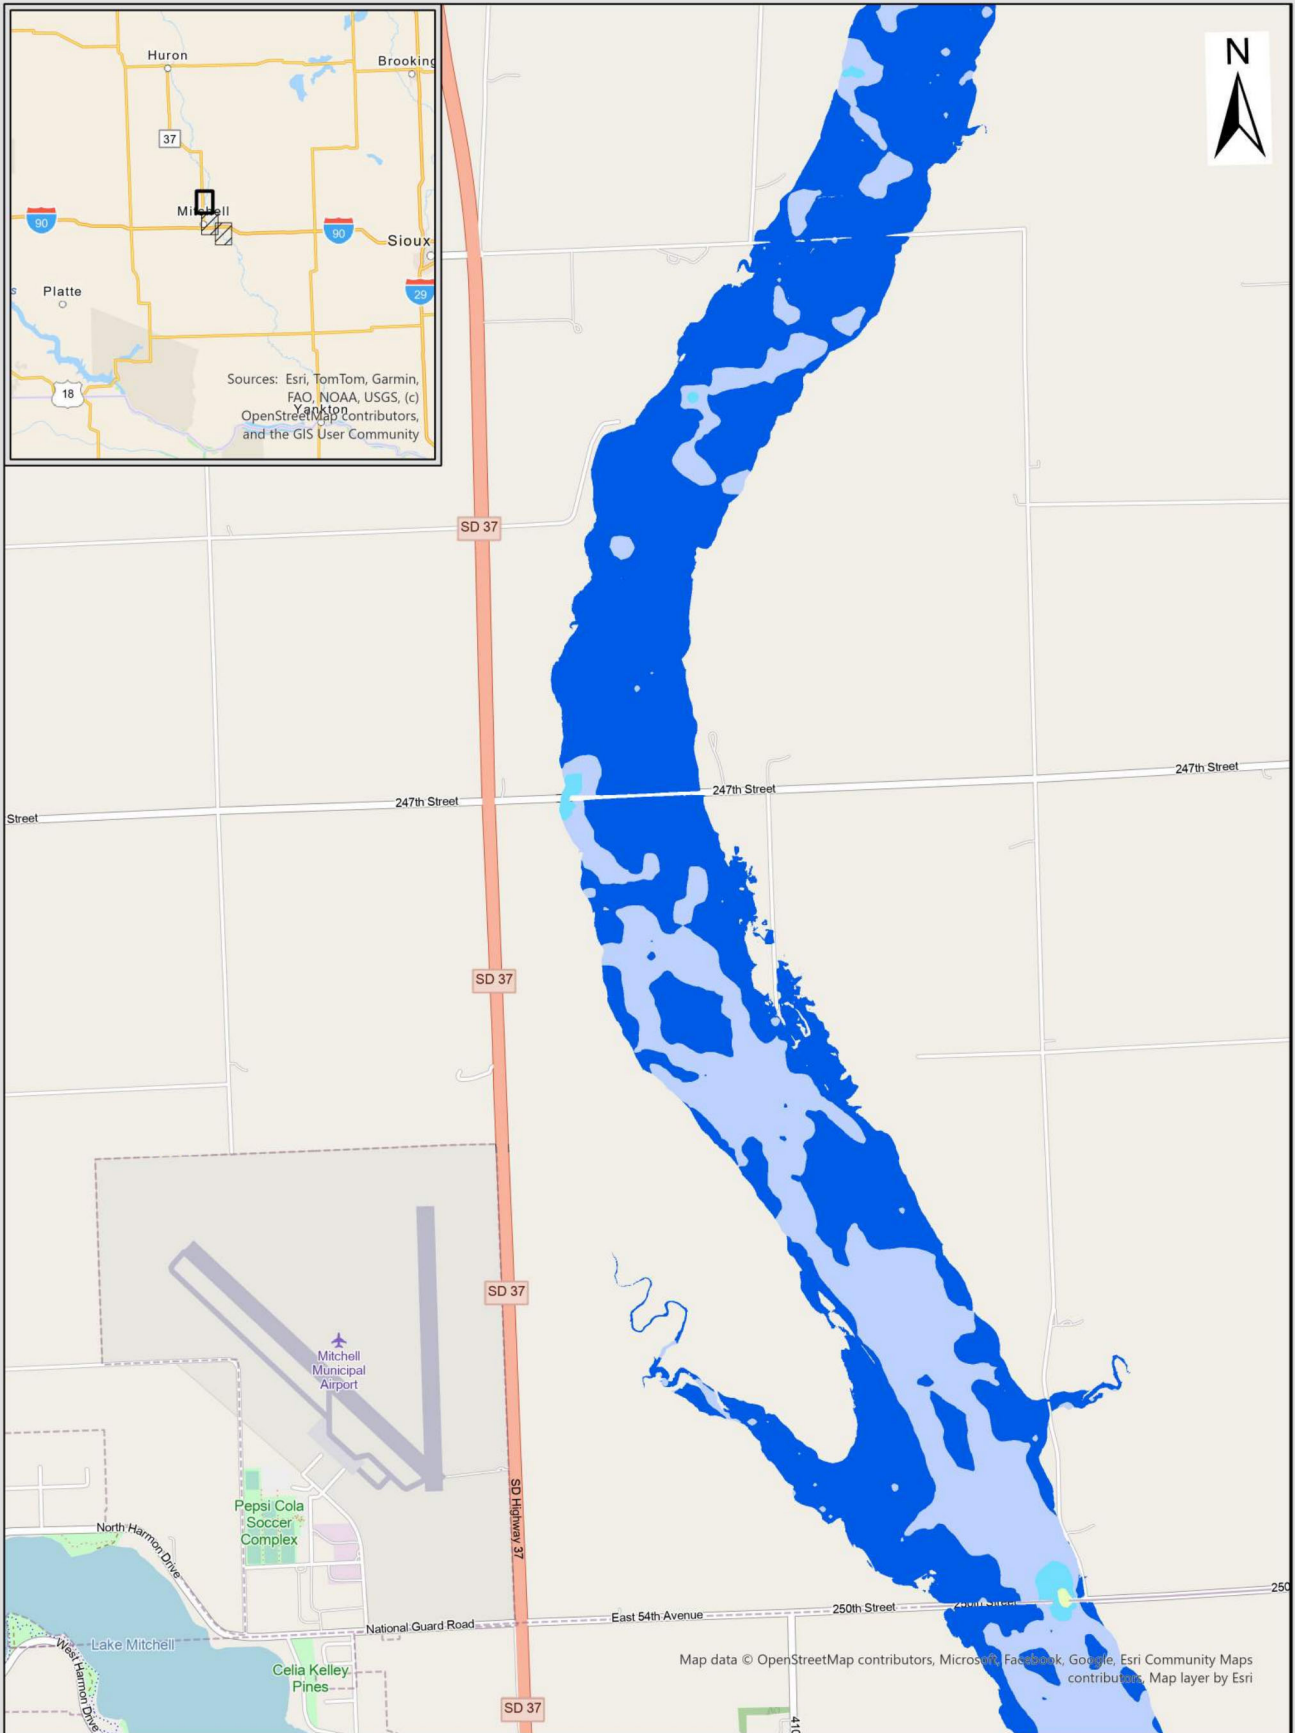
Breach Velocities (ft/s)

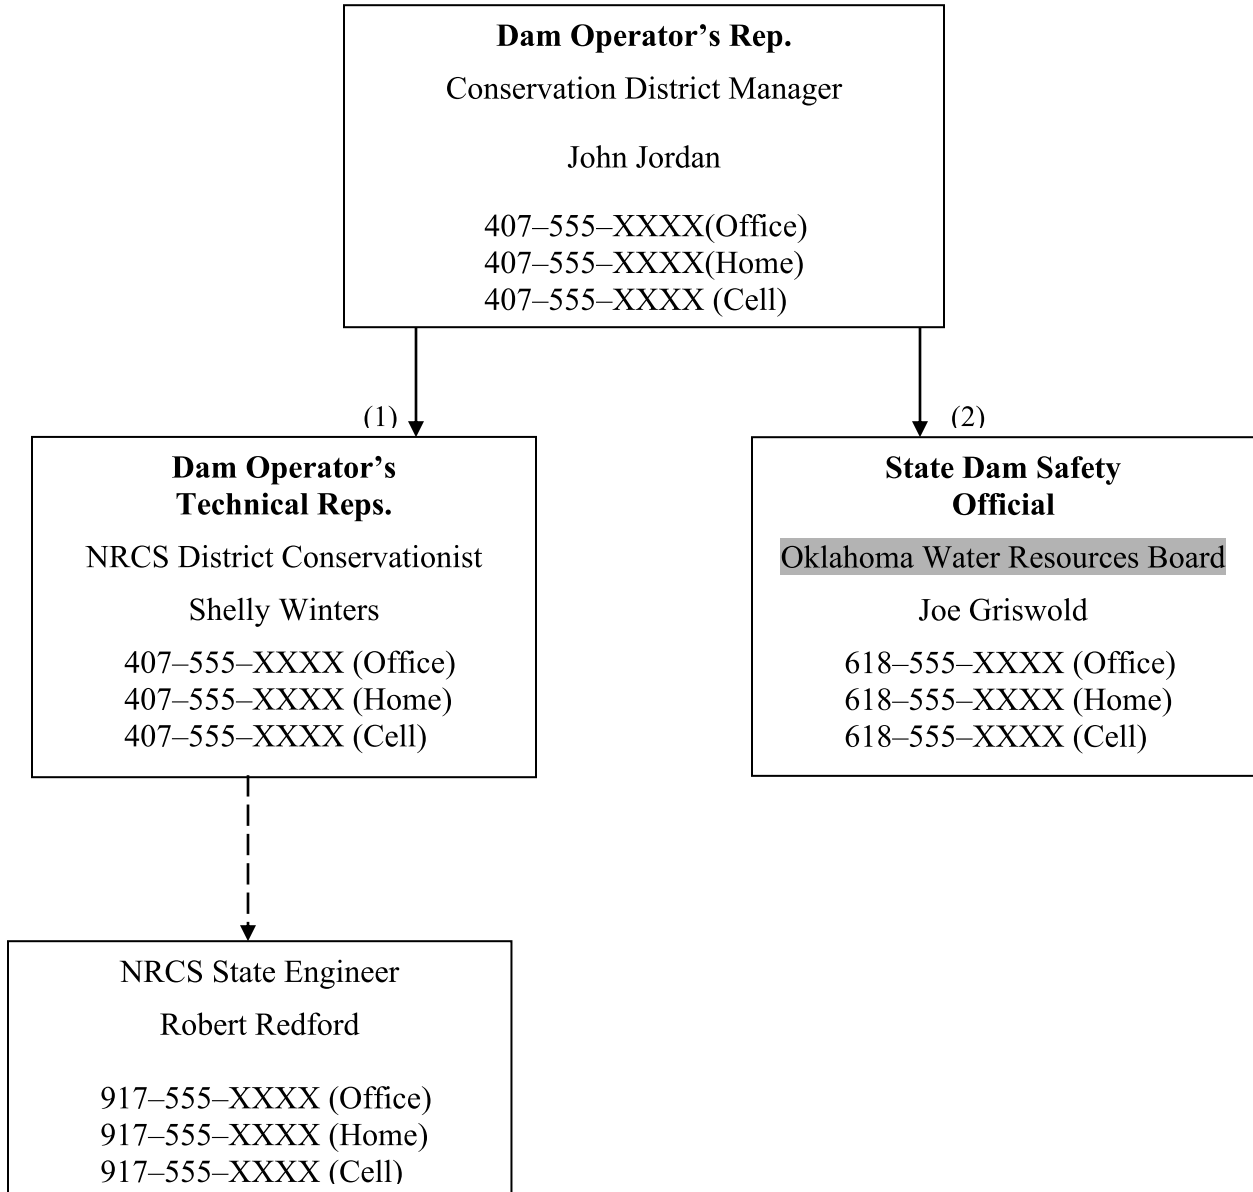
Emergency Level 1 Notifications

Nonemergency unusual event; slowly developing

Note:
1, 2, etc., denotes call sequence

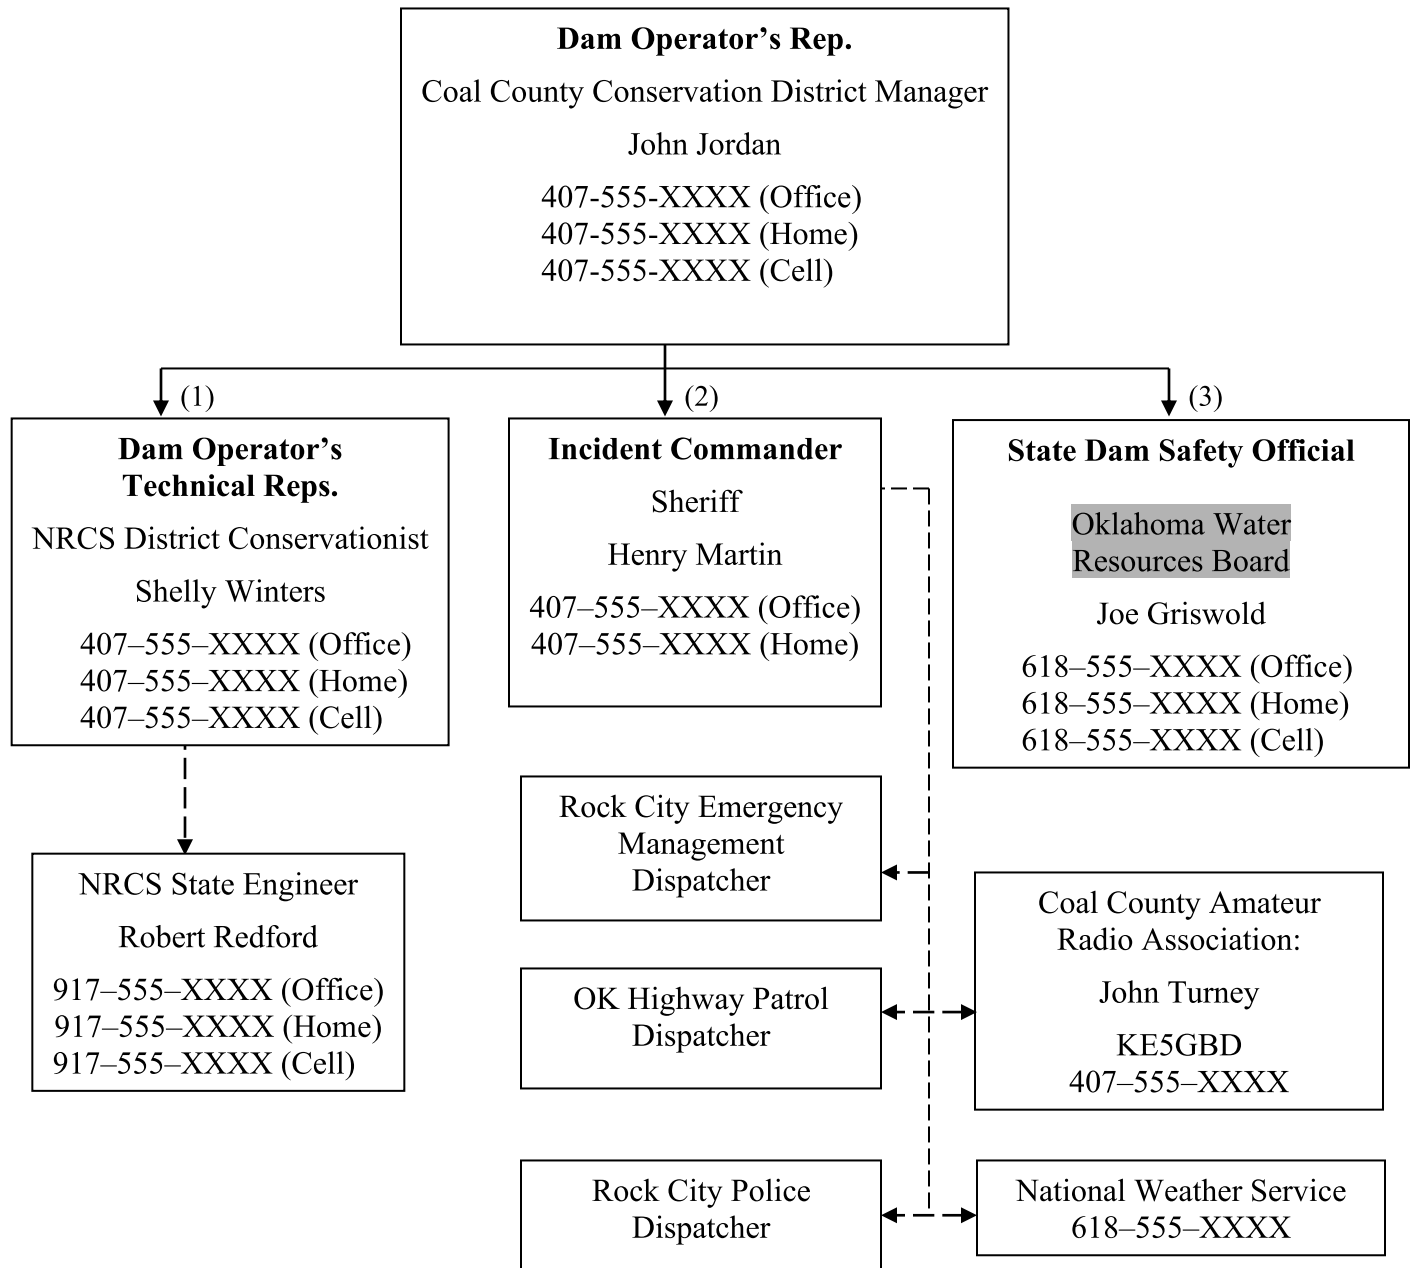
Emergency Level 2 Notifications

Emergency event, potential dam failure situation; rapidly developing

Note:
1, 2, etc., denotes call sequence
