Notice of Hearing on Request for Variance from
South Dakota Safety of Dams Rules Requested by City of Mitchell

Lake Mitchell Dam Variance Request

Houston Engineering, Inc.

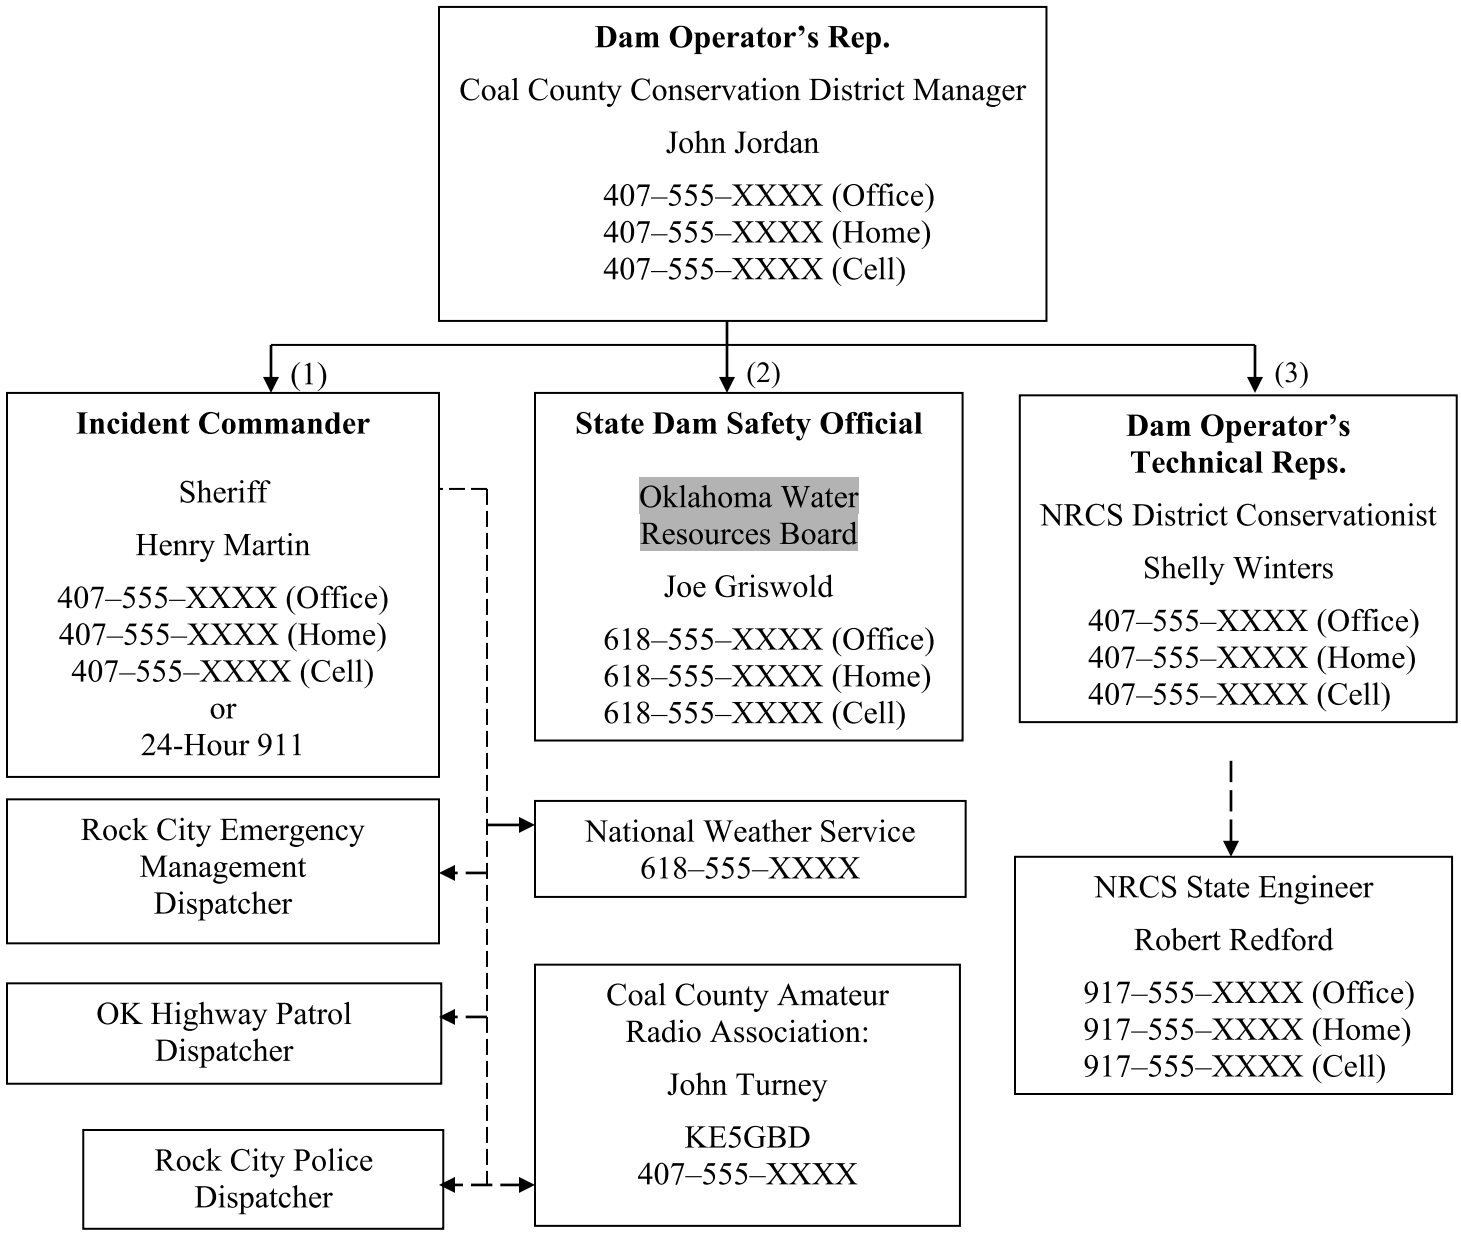
Emergency Level 3 Notifications

Urgent event, dam failure appears imminent or is in progress

Note:
1, 2, etc., denotes call sequence
