THICKNESS AND VOLUME OF SEDIMENT IN PELICAN LAKE, SOUTH DAKOTA, JUNE 1994

U.S. GEOLOGICAL SURVEY

Water-Resources Investigations Report 96-4247

Prepared in cooperation with the PELICAN LAKE WATER PROJECT DISTRICT

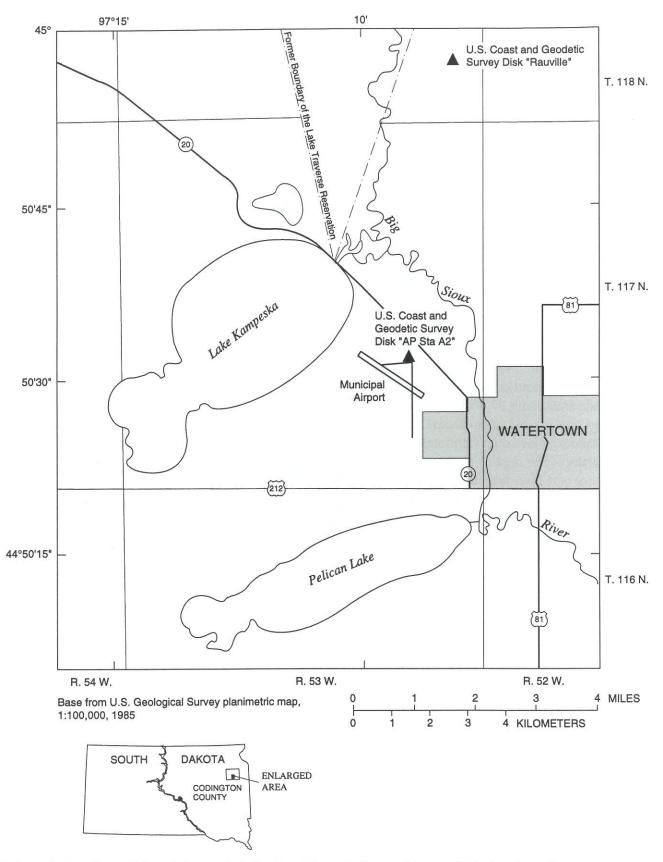
Figure 1. Location of Pelican Lake and U.S. Coast and Geodetic Survey disks near Watertown in northeastern South Dakota.

Pelican Lake is a natural lake with partial artificial regulation in Codington County, South Dakota (fig. 1). It serves as an important recreational resource

Mean annual precipitation (1961-90) at the Watertown airport, located about 2.5 miles north of Pelican Lake (fig. 1) is 22.23 inches (U.S. Department of Commerce, 1994). Mean annual free-water surface evaporation for the Pelican Lake area is about 41 inches (Farnsworth and others, 1982). Although long-term systematic records of lake stage are not available for Pelican Lake, water-level fluctuations prior to the construction of the control structure probably were large due to variable surface-water inflow and ground-water discharge, and because annual evaporation generally exceeds annual precipitation. Pelican Lake was known to have been completely dry during the 1930's prior to the construction of the control structure.

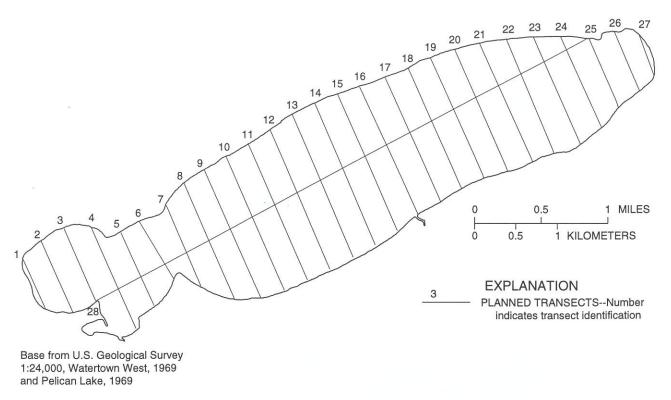
Figure 2. Planned locations of transects for sediment survey of Pelican Lake.

The general approach for the survey was to traverse 27 approximately evenly spaced northwest-southeast transects and one southwest-northeast longitudinal transect (fig. 2) by boat while simultaneously and continuously operating: (1) a standard water depth fathometer; (2) a seismic system to determine the thickness of fine-grained sediment; and (3) a global positioning system (GPS) to determine the horizontal position of the seismic and water depth measurements.

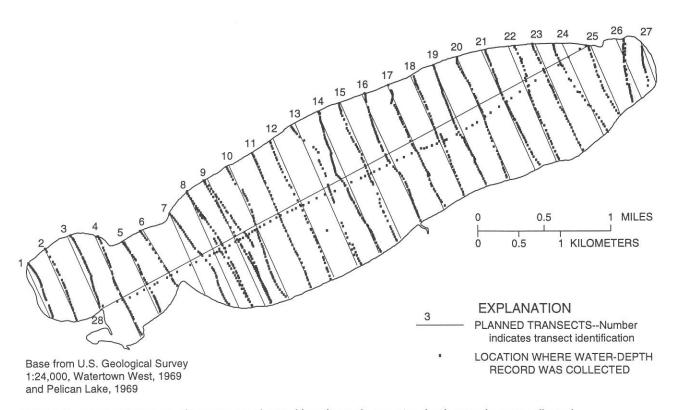
Figure 3. Planned locations of transects and actual locations where water-depth records were collected.

Comparison of the strip-chart fathometer record with the simultaneously operated digital fathometer generally indicated agreement within 0.3 foot for the water-depth measurement. Locations where water-depth records were collected are shown in figure 3. Locations where sediment thickness was determined using the seismic system are shown in figure 4.

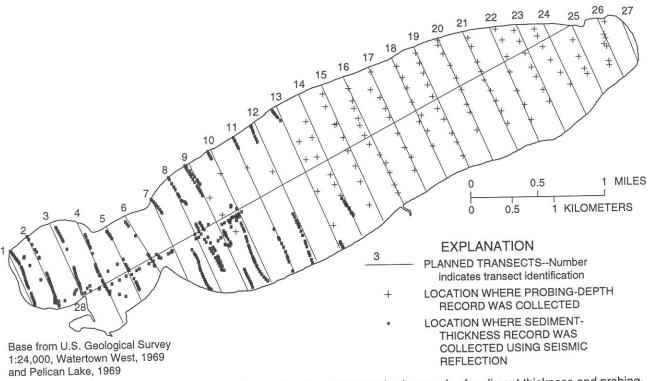
Figure 4. Planned locations of transects and actual locations where seismic records of sediment thickness and probing-depth records were collected.

The seismic system was not everywhere effective in distinguishing the interface between finegrained lake sediment and glacial drift, especially in the eastern half of Pelican Lake. Deeper reflectors were not always apparent in the seismic record because, at places, they were obscured by an interference near the top of the sediment. An example of seismic record with associated interpreted profile that shows such an interference is presented in figure 6. Efforts were made during the survey to reduce the interference in the seismic record by adjusting the transducer frequency, transmitter power, and chart and receiver gains, but these procedures were ineffective. The ineffectiveness of the seismic system in some areas probably was due to the presence of gas from the decomposition of organic material in the sediments. Accumulated gas within the sediments can act as a strong scatterer or reflector of the acoustic energy and result in interference patterns (typically multiple signals¹) that obscure deeper reflectors in the seismic record. Observations of gas bubbles released from the sediments during probing indicated that gas tended to be more prevalent in the sediments in the eastern half of the lake. Locations where sediment thickness was estimated using manual probing are shown in figure 4.

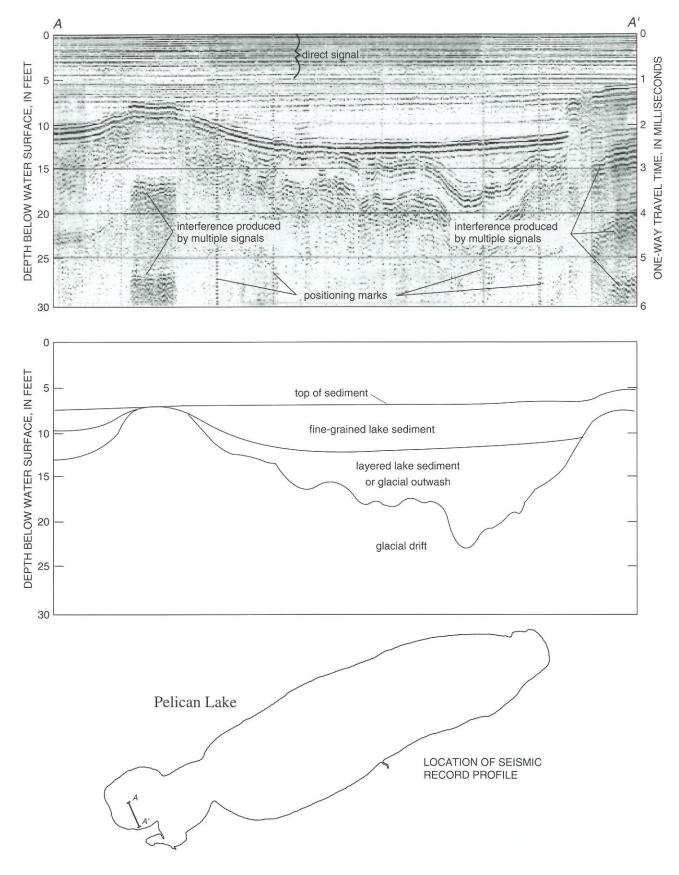
Figure 5. Example seismic record and corresponding interpreted profile.

A strong, undulating sub-sediment reflector was apparent beneath much of the western part of the lake and was interpreted to be the interface between the fine-grained lake sediment and underlying glacial drift. At some locations, several reflectors below the top of the sediment were apparent in the seismic record (fig. 5). These reflectors could represent: (1) layers of coarser grained lake sediment; (2) compacted layers that resulted from drying and oxidizing of the sediment during periods when the lake was dewatered; or (3) layers within the glacial drift (for example, layers of outwash on top of glacial till). Where more than one reflector was present below the top of the sediment, the deepest strong reflector was assumed to be the top of the glacial till, and the depth from the top of the sediment to the deepest reflector was used to estimate the lake-sediment thickness. This procedural choice has the effect of possibly including any glacial outwash or coarse-grained lake sediment together with the overlying fine-grained lake sediment in subsequent sediment-thickness estimates at locations where the geologic composition of the material producing the reflectors in the seismic record was uncertain. The seismic system produced easily interpretable records for about 65 percent of the western half of the lake.

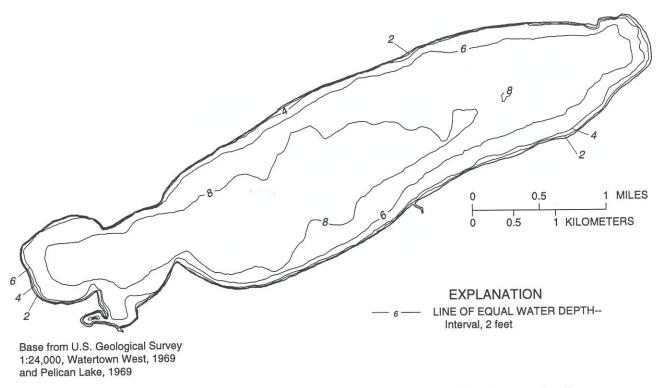
Figure 7. Water depth in Pelican Lake, June 1994 (water-surface elevation 1,710.6 feet above sea level).

Water depth in Pelican Lake is presented in figure 7. Elevation/area/capacity data are presented in table 1. The mean water surface elevation of Pelican Lake was about 1,710.6 feet above sea level during the survey. The volume of water in Pelican Lake at the time of the survey was calculated to be about 19,600 acre-feet, and the surface area was 2,809 acres. The maximum water depth was 8.8 feet, and the average water depth was 7.0 feet.

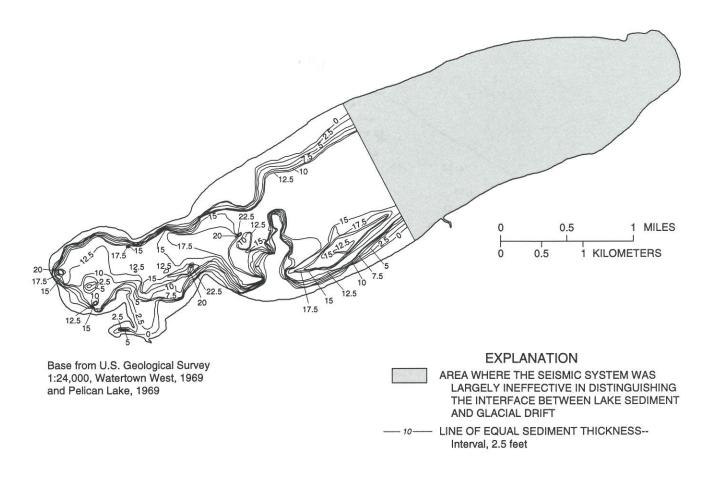
Figure 8. Thickness of sediment in Pelican Lake, June 1994.

Thickness of fine-grained lake sediment in the bed of the western half of Pelican Lake is presented in figure 8. In the western half of Pelican Lake, the maximum fine-grained lake-sediment thickness evident from the seismic record was about 23 feet, and the volume-weighted mean sediment thickness was about 9 feet.

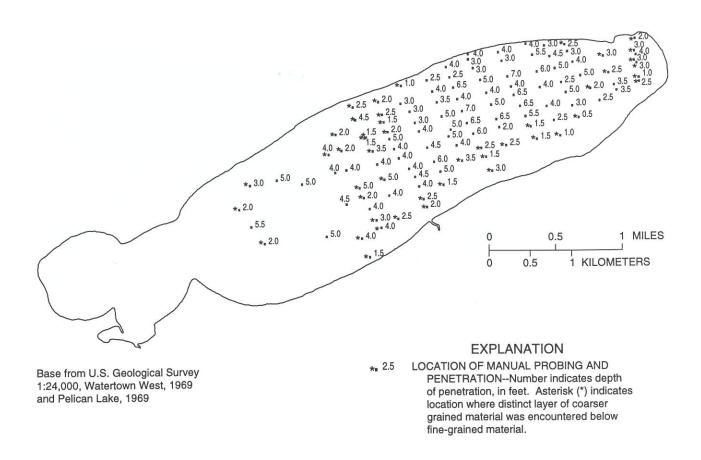
Figure 9. Locations and depth of penetration where manual probing was performed.

Penetration depths for manual probing in the eastern half of Pelican Lake are shown in figure 9. Manual probing was not very effective because the lake sediments typically were sufficiently compacted about 1 foot below their top so that they resisted penetration. Also, instability of the boat, even when anchored, made it difficult to force the steel rod directly downward into the sediment. As a result, the probing penetration depth generally does not represent the total thickness of fine-grained lake sediment on top of the glacial drift. While probing in some locations, a distinct coarser grained layer that generally could not be penetrated more than about 1 foot was detected below the finegrained material at the top of the sediment. Whether this coarser grained material was coarser lake sediment or glacial outwash is unknown. Points where coarser grained material was encountered below the finegrained surficial material are indicated with an asterisk (*) in figure 9. Because probing penetration probably

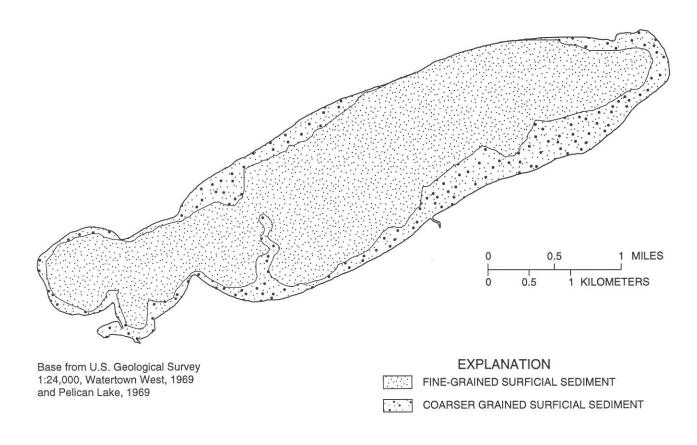
Figure 10. Distribution of coarser grained and fine-grained surficial sediment in Pelican Lake.

volume of fine-grained lake sediment in the lake was, thus, estimated to be about 41 million cubic yards. The lateral distribution of coarser material (that is, material containing substantial amounts of sand and/or gravel) versus fine-grained material occurring at the upper surface of the lake sediments is presented in figure 10. Interpreted cross-sectional profiles for selected transects are presented in figure 11.

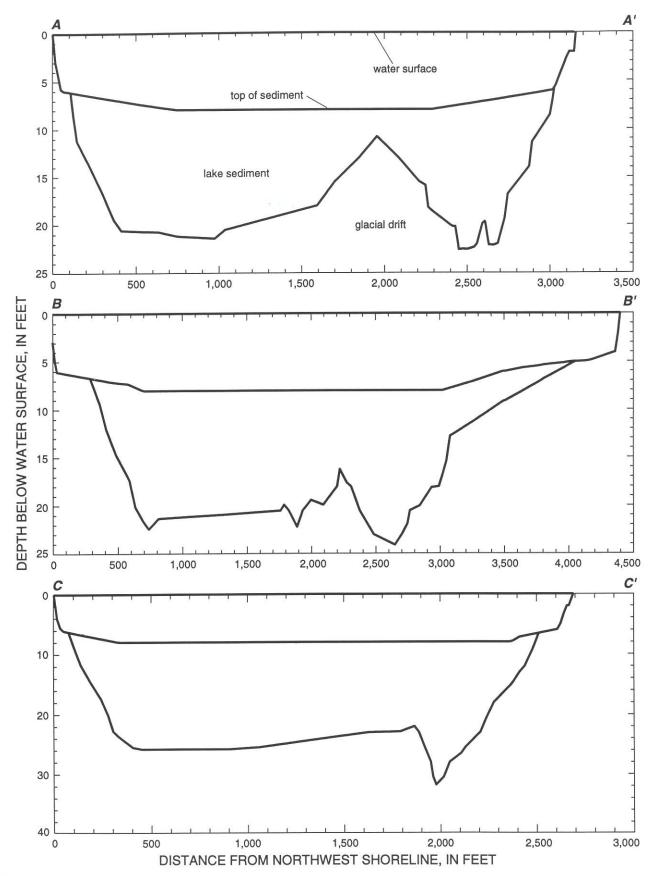
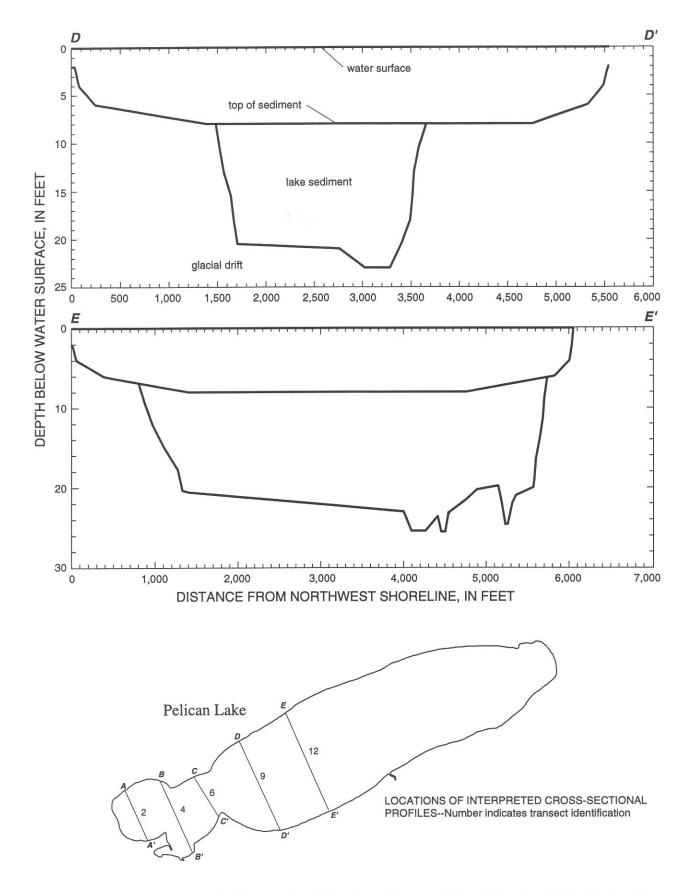
Figure 11. Interpreted cross-sectional profiles for selected transects across Pelican Lake, June 1994.
