PROJECT SUMMARY SHEET

PROJECT TITLE: **South Central Watershed Implementation Project Segment 2 Amendment 1**

NAME: James River Water Development District

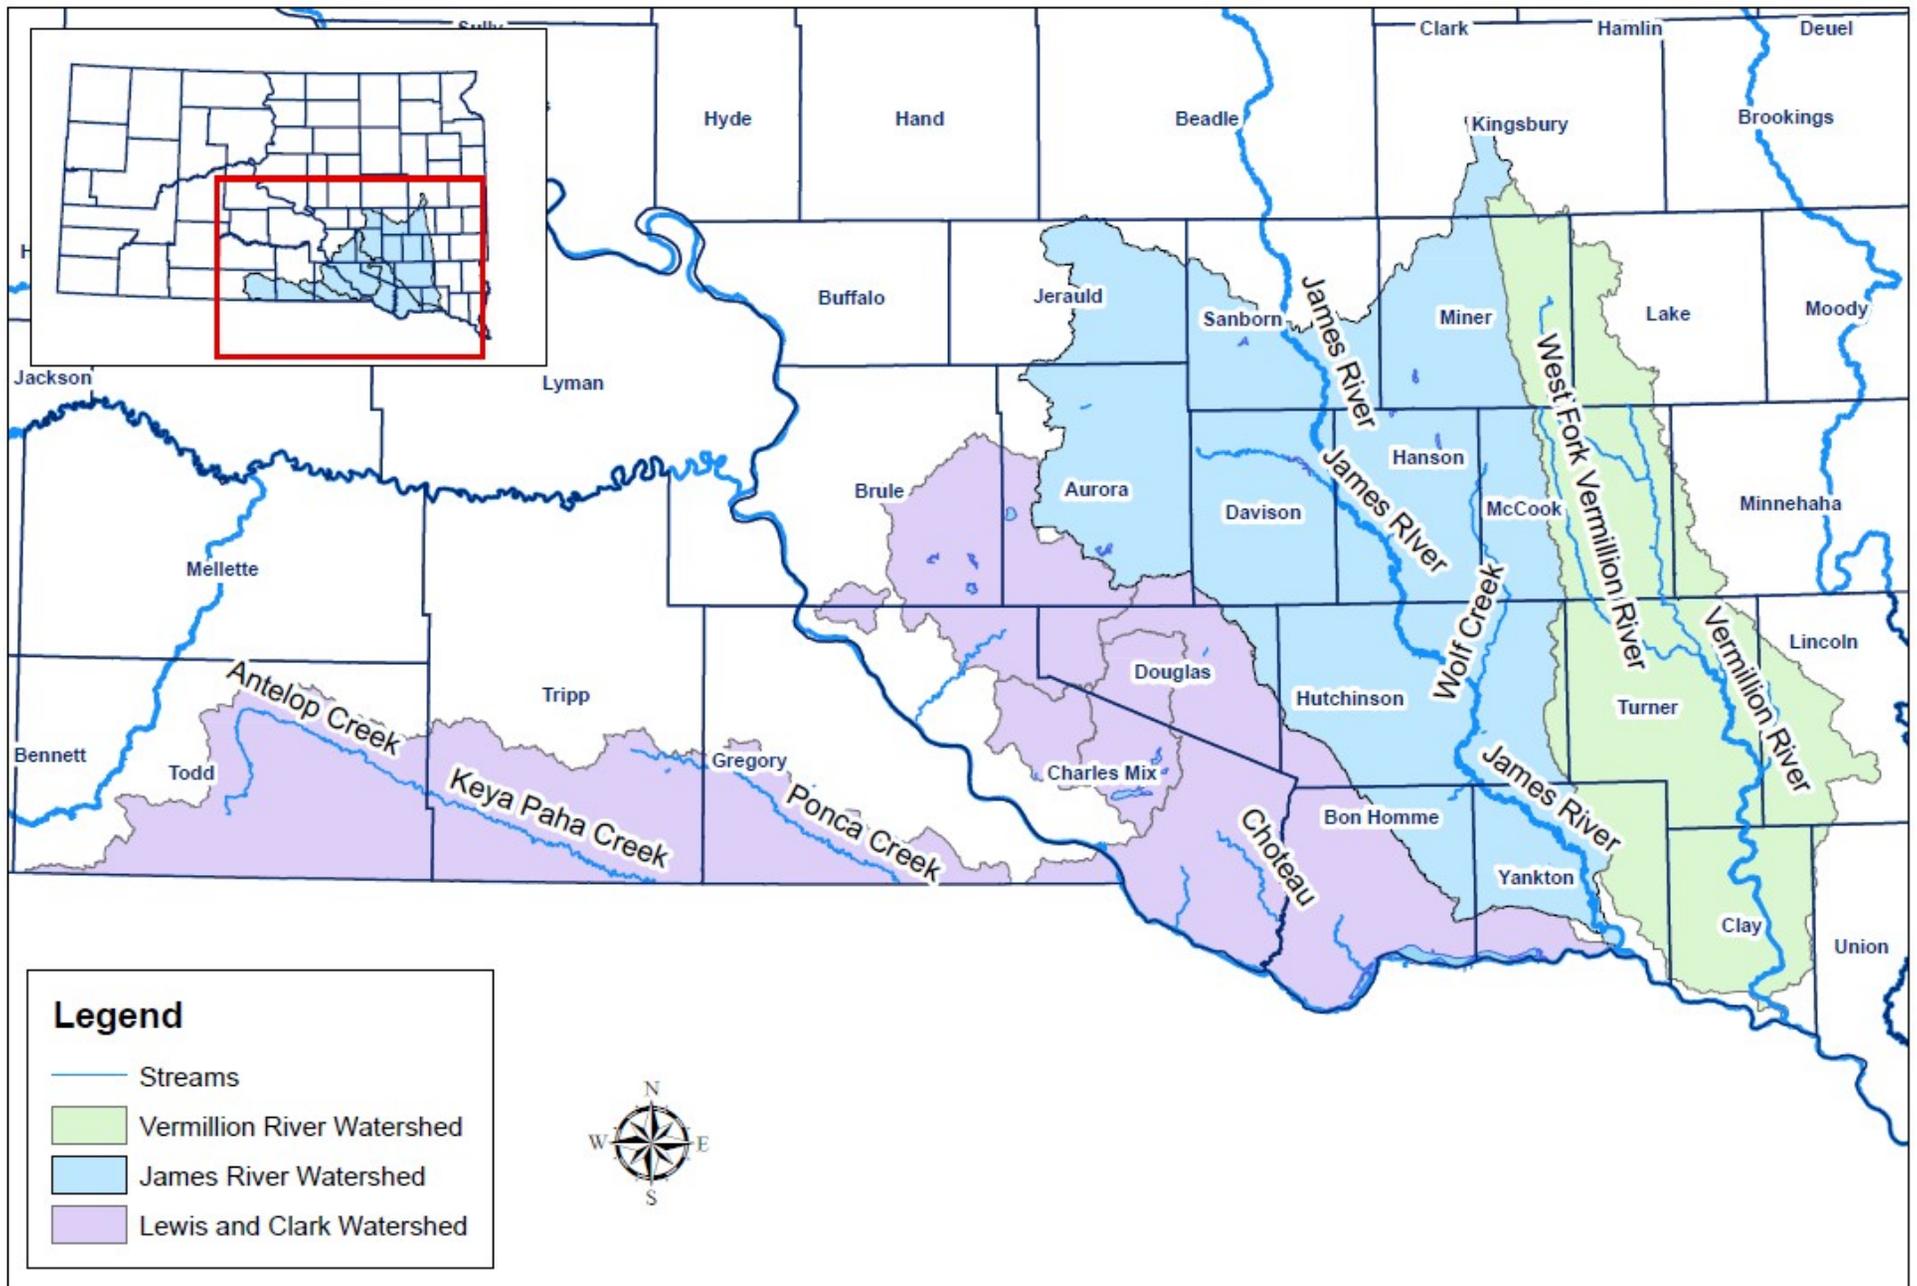
Figure 1: South Central Watersheds.

The Lower Missouri River Basin portion of the watershed has a drainage area of approximately 1,700,000 acres, the Niobrara River Basin has approximately 280,000 ac, the Lower James River Basin is approximately 2,300,000 ac (seen in Figure 1), and the Vermillion River Basin is 1,430,000 ac. This project's area includes the South Dakota portion of the Watershed, HUC8# 10170101, 10150001, 10150006, 10160010 and most of 10140101.

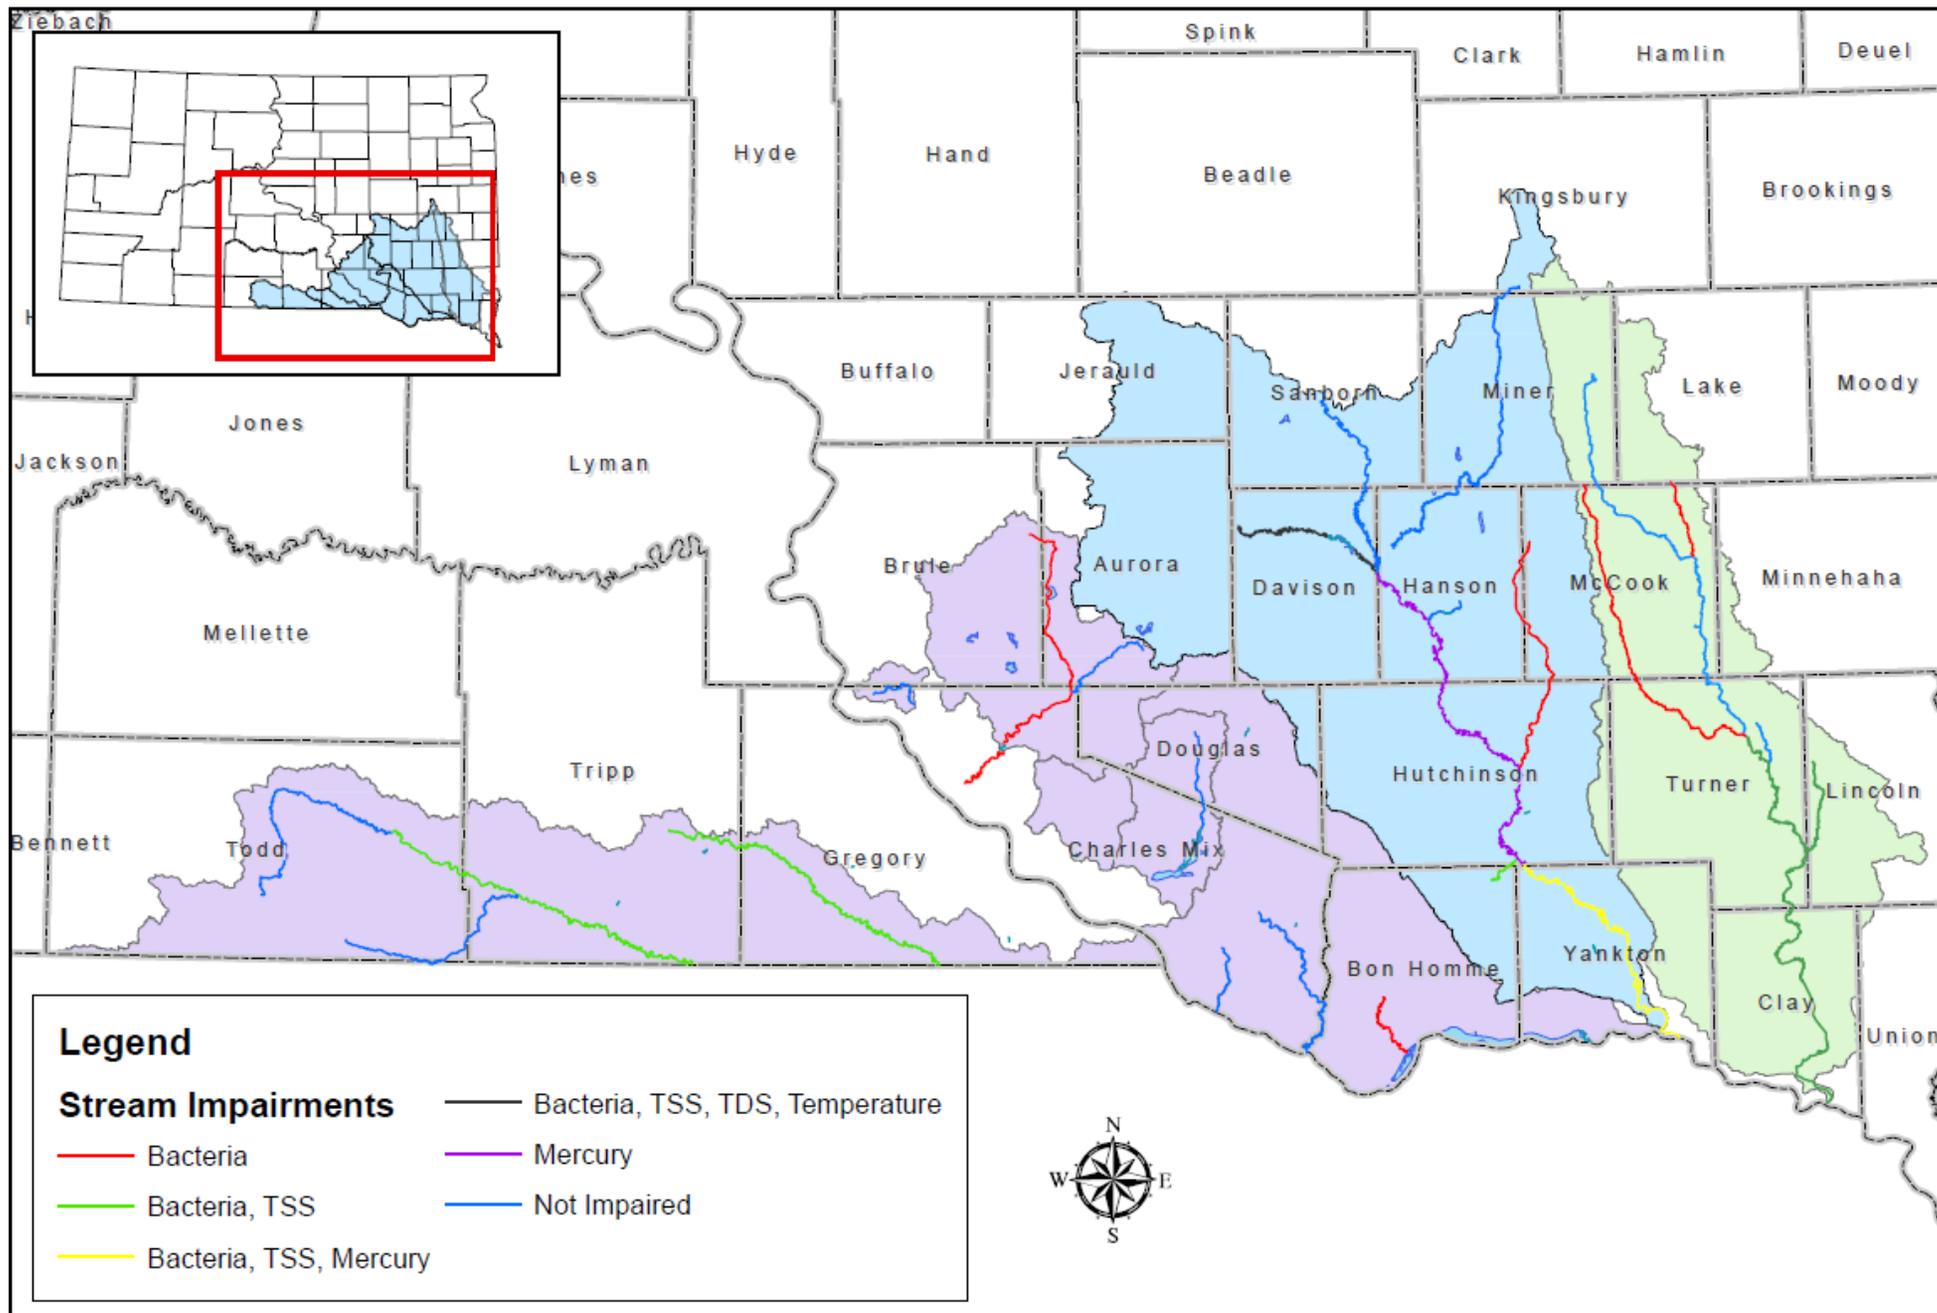
Figure 2: South Central Watershed Impaired Waterbodies.

Table 2 below identifies water bodies in the Project Area listed in the “2020 South Dakota Integrated Report for Surface Water Quality Assessment” as not meeting their designated beneficial use(s).

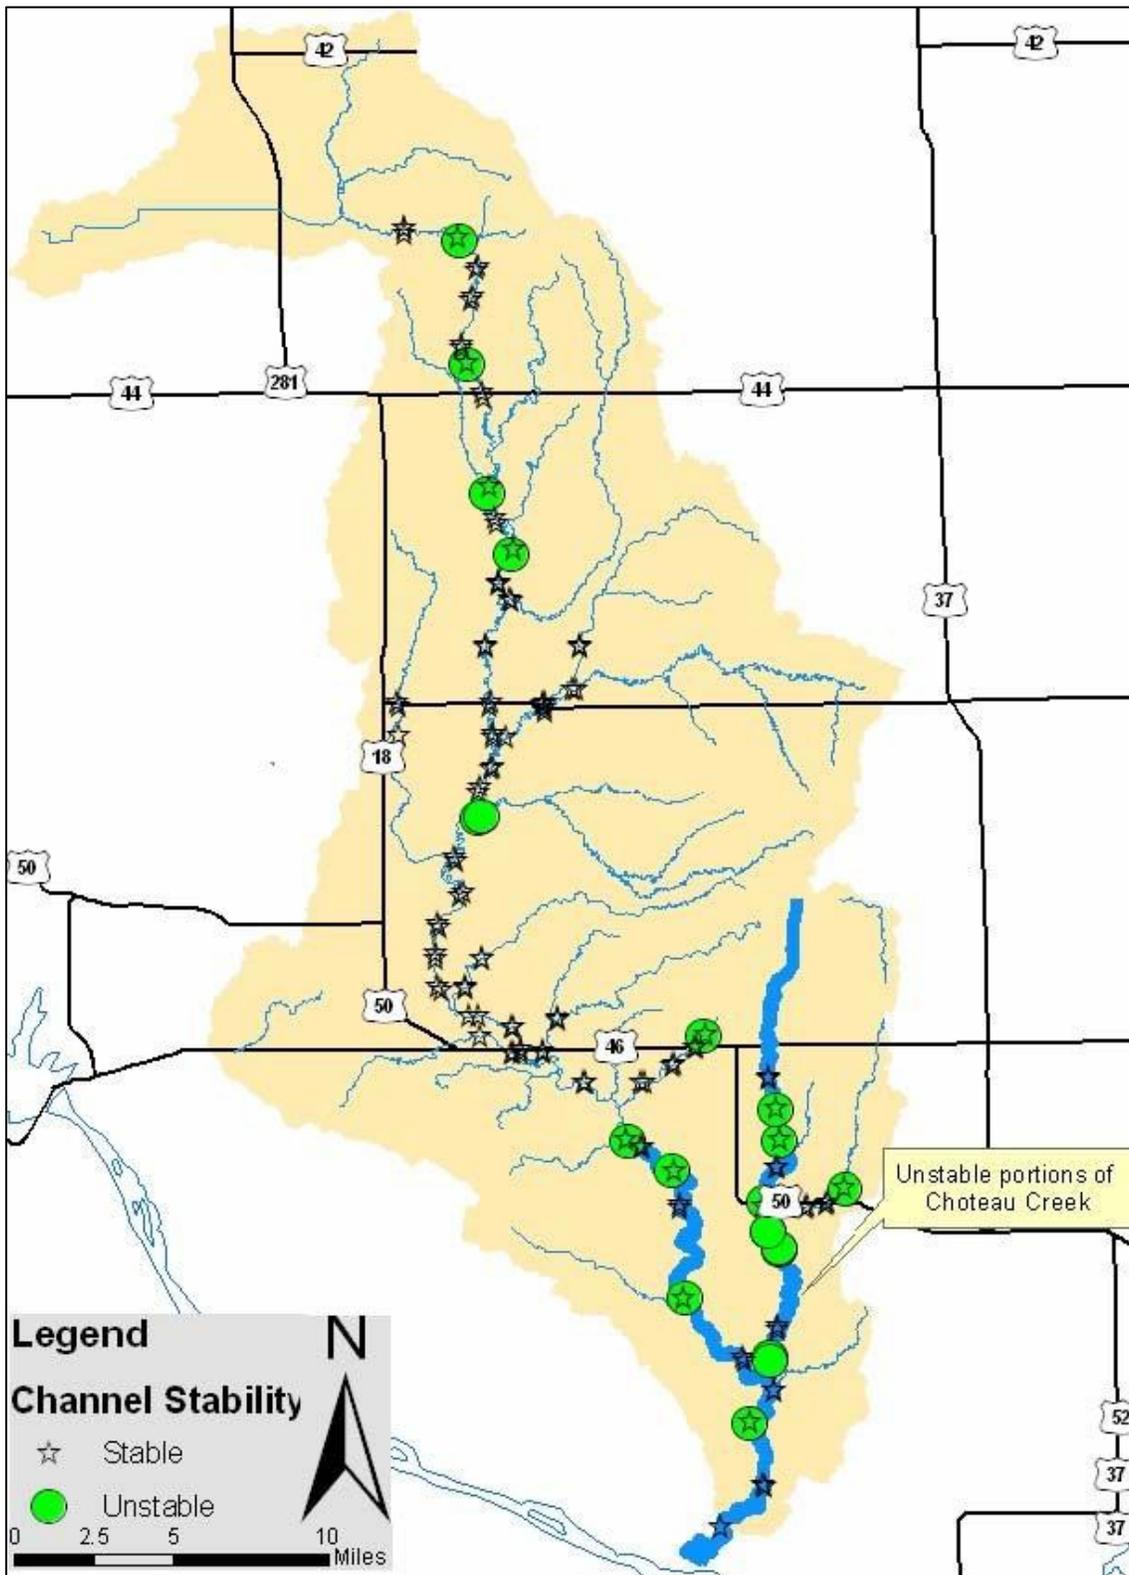
Figure 3. Choteau Creek RGA Locations.

There were 262 individual Rapid Geomorphic Assessments (RGAs) completed in the Choteau Creek drainage. Figure 3 depicts the locations of each of the RGAs and also represents their relative stability scores. Each RGA was completed on both the upstream and downstream portions of a road crossing, resulting in what appears to be some sites receiving both a stable and unstable score. These are treated as two separate scores for each crossing, one upstream and the other downstream. This was done to determine potential impacts of culverts and bridges under the assumption that a stable score upstream and an unstable score downstream may be a localized effect of the road crossing.

Using a gross score of 20 as the dividing line between stable and unstable channels, it appears that the lower reaches of Choteau Creek are more unstable than the rest of the watershed. Based on a combination of the RGA scores and the best professional judgment of the local coordinators, approximately 50 miles of the 420 stream miles (12%) were identified as having intermittent segments of degraded channel stability (see the bolded stream segments in Figure 4). It is interesting to note that the portions of the stream that appear to be most unstable include nearly the entire segment of Choteau Creek that is impaired and is assigned the fisheries and recreation classifications.

RGA scores throughout the remainder of the basin indicated a range of conditions. Unstable sites found upstream of the highlighted section in Figure 3 appear to be localized in nature. Remediation success is more likely on localized area such as these, however many of them are located a significant distance upstream of the listed segment. Due to this distance, best management practices applied to these areas are unlikely to result in measurable improvements in the listed segment.

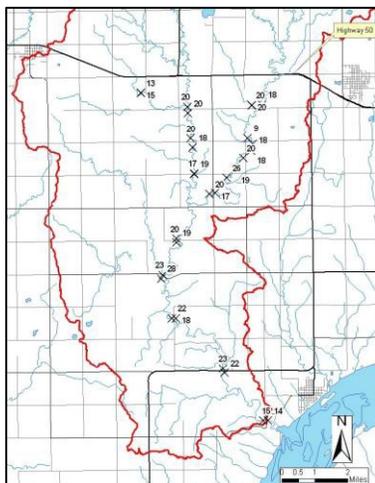
Figure 4. Emmanuel Creek RGA Locations with score.

A number of rapid geomorphic assessments (RGAs) were conducted on portions of Emanuel Creek located downstream of Highway 50 (Figure 4). Scores from the RGAs indicate an unstable channel. Since the AnnAGNPS model does not address channel stability or erosion, the high RGA scores help to explain the source of sediments in Emanuel Creek. The scoring technique used during this assessment places any channel with a score of 20 or greater into the unstable category. Using this as the basis to target stream miles, 50 % or approximately 30 km of the stream located downstream of Highway 50 are unstable and contributing to increased sediment loading

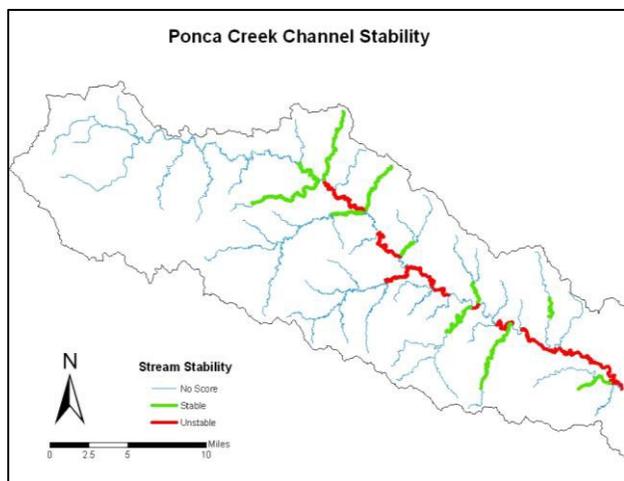
Figure 5: Ponca Creek Channel Stability.

The average RGA score for each stream segment was evaluated. For the purposes of this study, it was determined that a score less than 18.5 would be considered a stable channel while scores exceeding 18.5 would be considered unstable, and they were only completed within Gregory County for the Ponca Creek portion of the assessment.

The main stem of Ponca Creek consistently received scores indicating an unstable channel. Small tributaries to the main channel consistently received scores indicating that they were stable. During the assessment, some local concern was expressed regarding stream crossing structures (bridges and culverts) and their impact on channel stability. Reviewing the upstream and downstream scores suggests that there are localized areas of bank erosion that may be linked to the stream crossing structure.

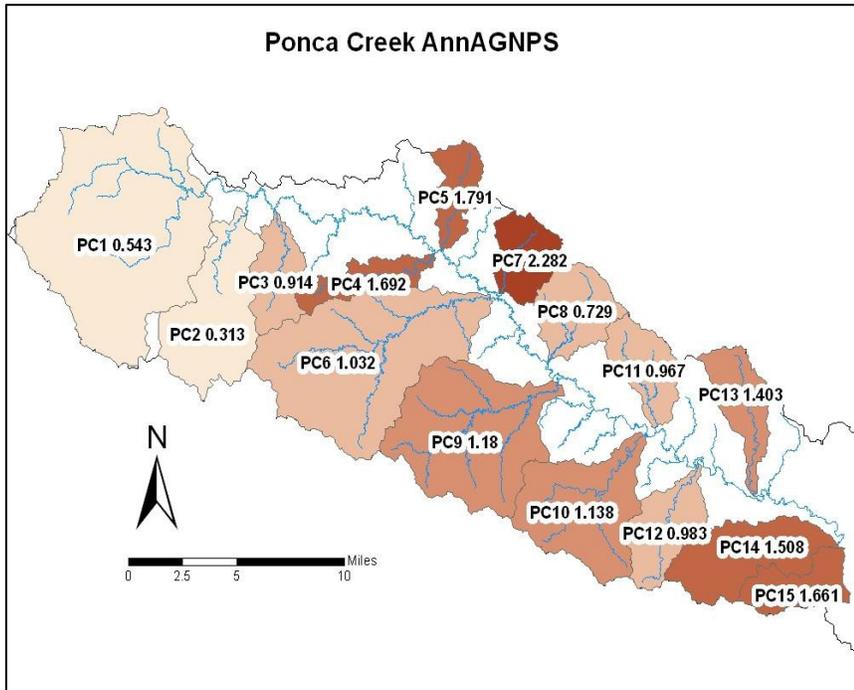
Figure 6: Sediment Production for Ponca Creek.

Five tributaries produced sediment yield estimates of greater than 2 tons/acre. One of these (PC7, 2.3 tons/acre) is located in South Dakota. PC7 originates ½ way between Burke and Gregory and drains south into Ponca Creek, see Figure 6.

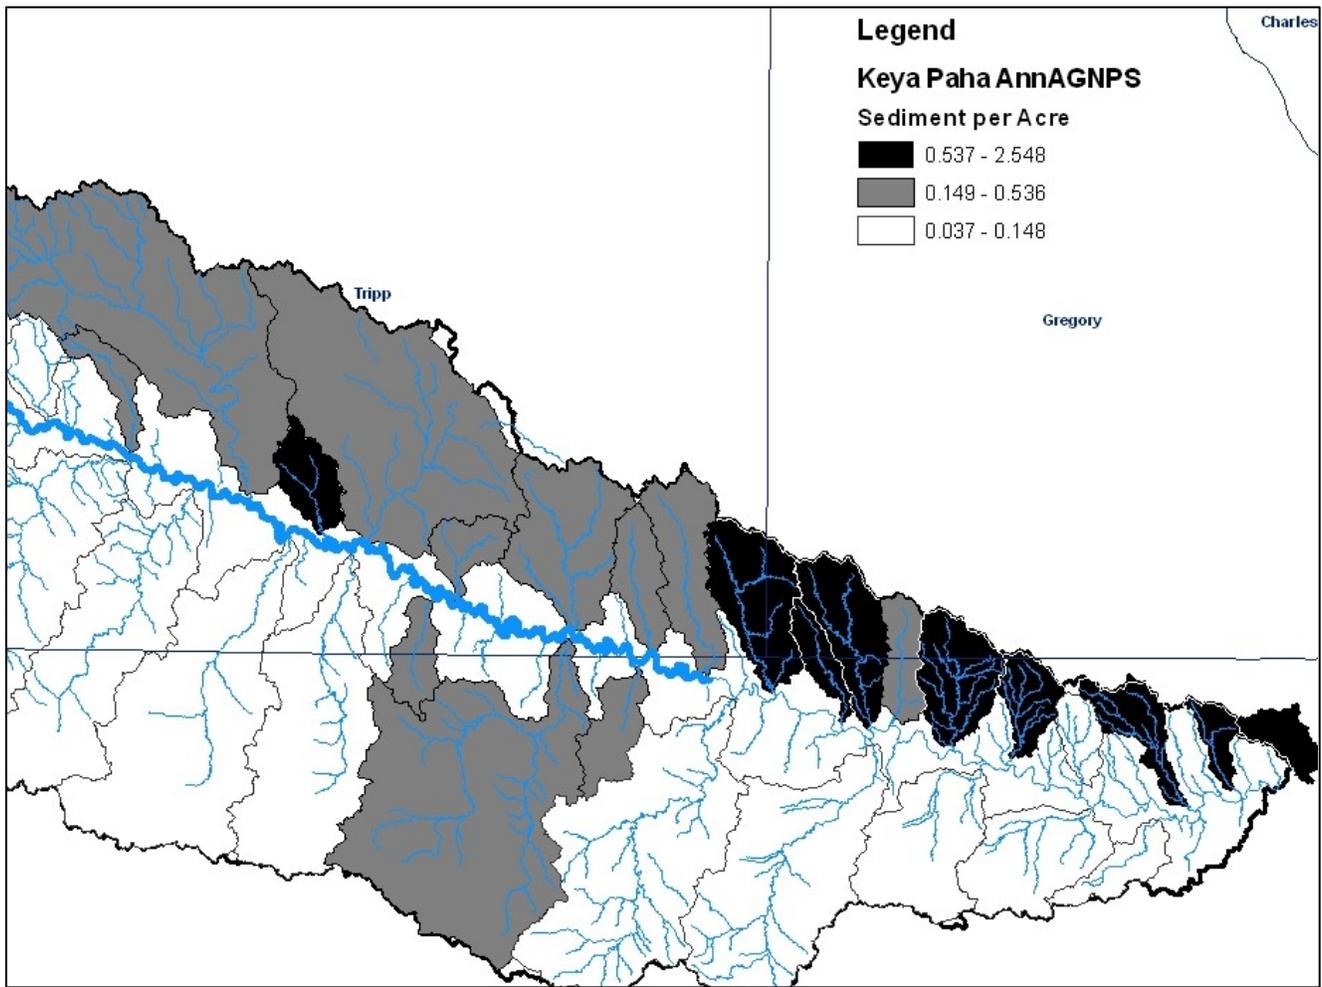
Figure 7: Keya Paha AnnAGNPs

AnnAGNPs analysis of the subwatersheds in the Keya Paha basin indicates low rates of sediment production for a majority of the basin when compared to the greater Lewis and Clark drainage. Figure 7 depicts a relative ranking with the subwatersheds that the model suggested were producing higher erosion rates (as compared against other drainages within the Keya Paha drainage and not against the greater Lewis and Clark basin) represented by darker shading.

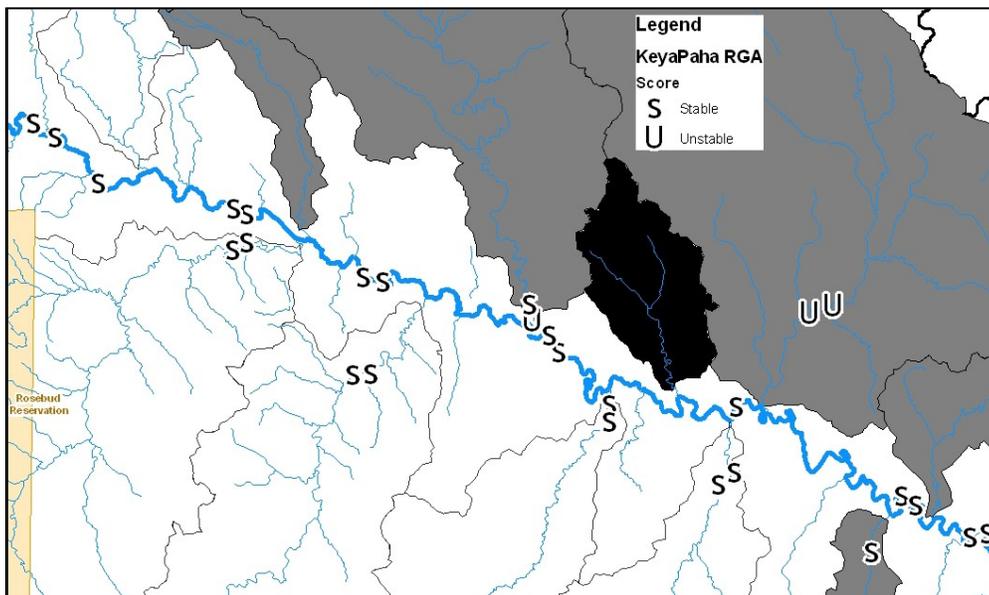
Figure 8: Keya Paha RGA Locations

Rapid Geomorphic Assessments (RGAs) were completed at 23 sites within the Keya Paha basin. Figure 8 depicts the areas where RGAs were completed with the AnnAGNPs results shaded. The results were broken into stable and unstable stream channels with approximately 12% of the sites ranking as unstable. The three unstable sites were located on tributaries.
