Coeur Wharf  
Wharf Boston Visual Simulation

WHARF BOSTON  
EXPANSION

## Wharf Fence-Line and Lost Camp Subdivision Photographs December 30, 2021 and January 20, 2022

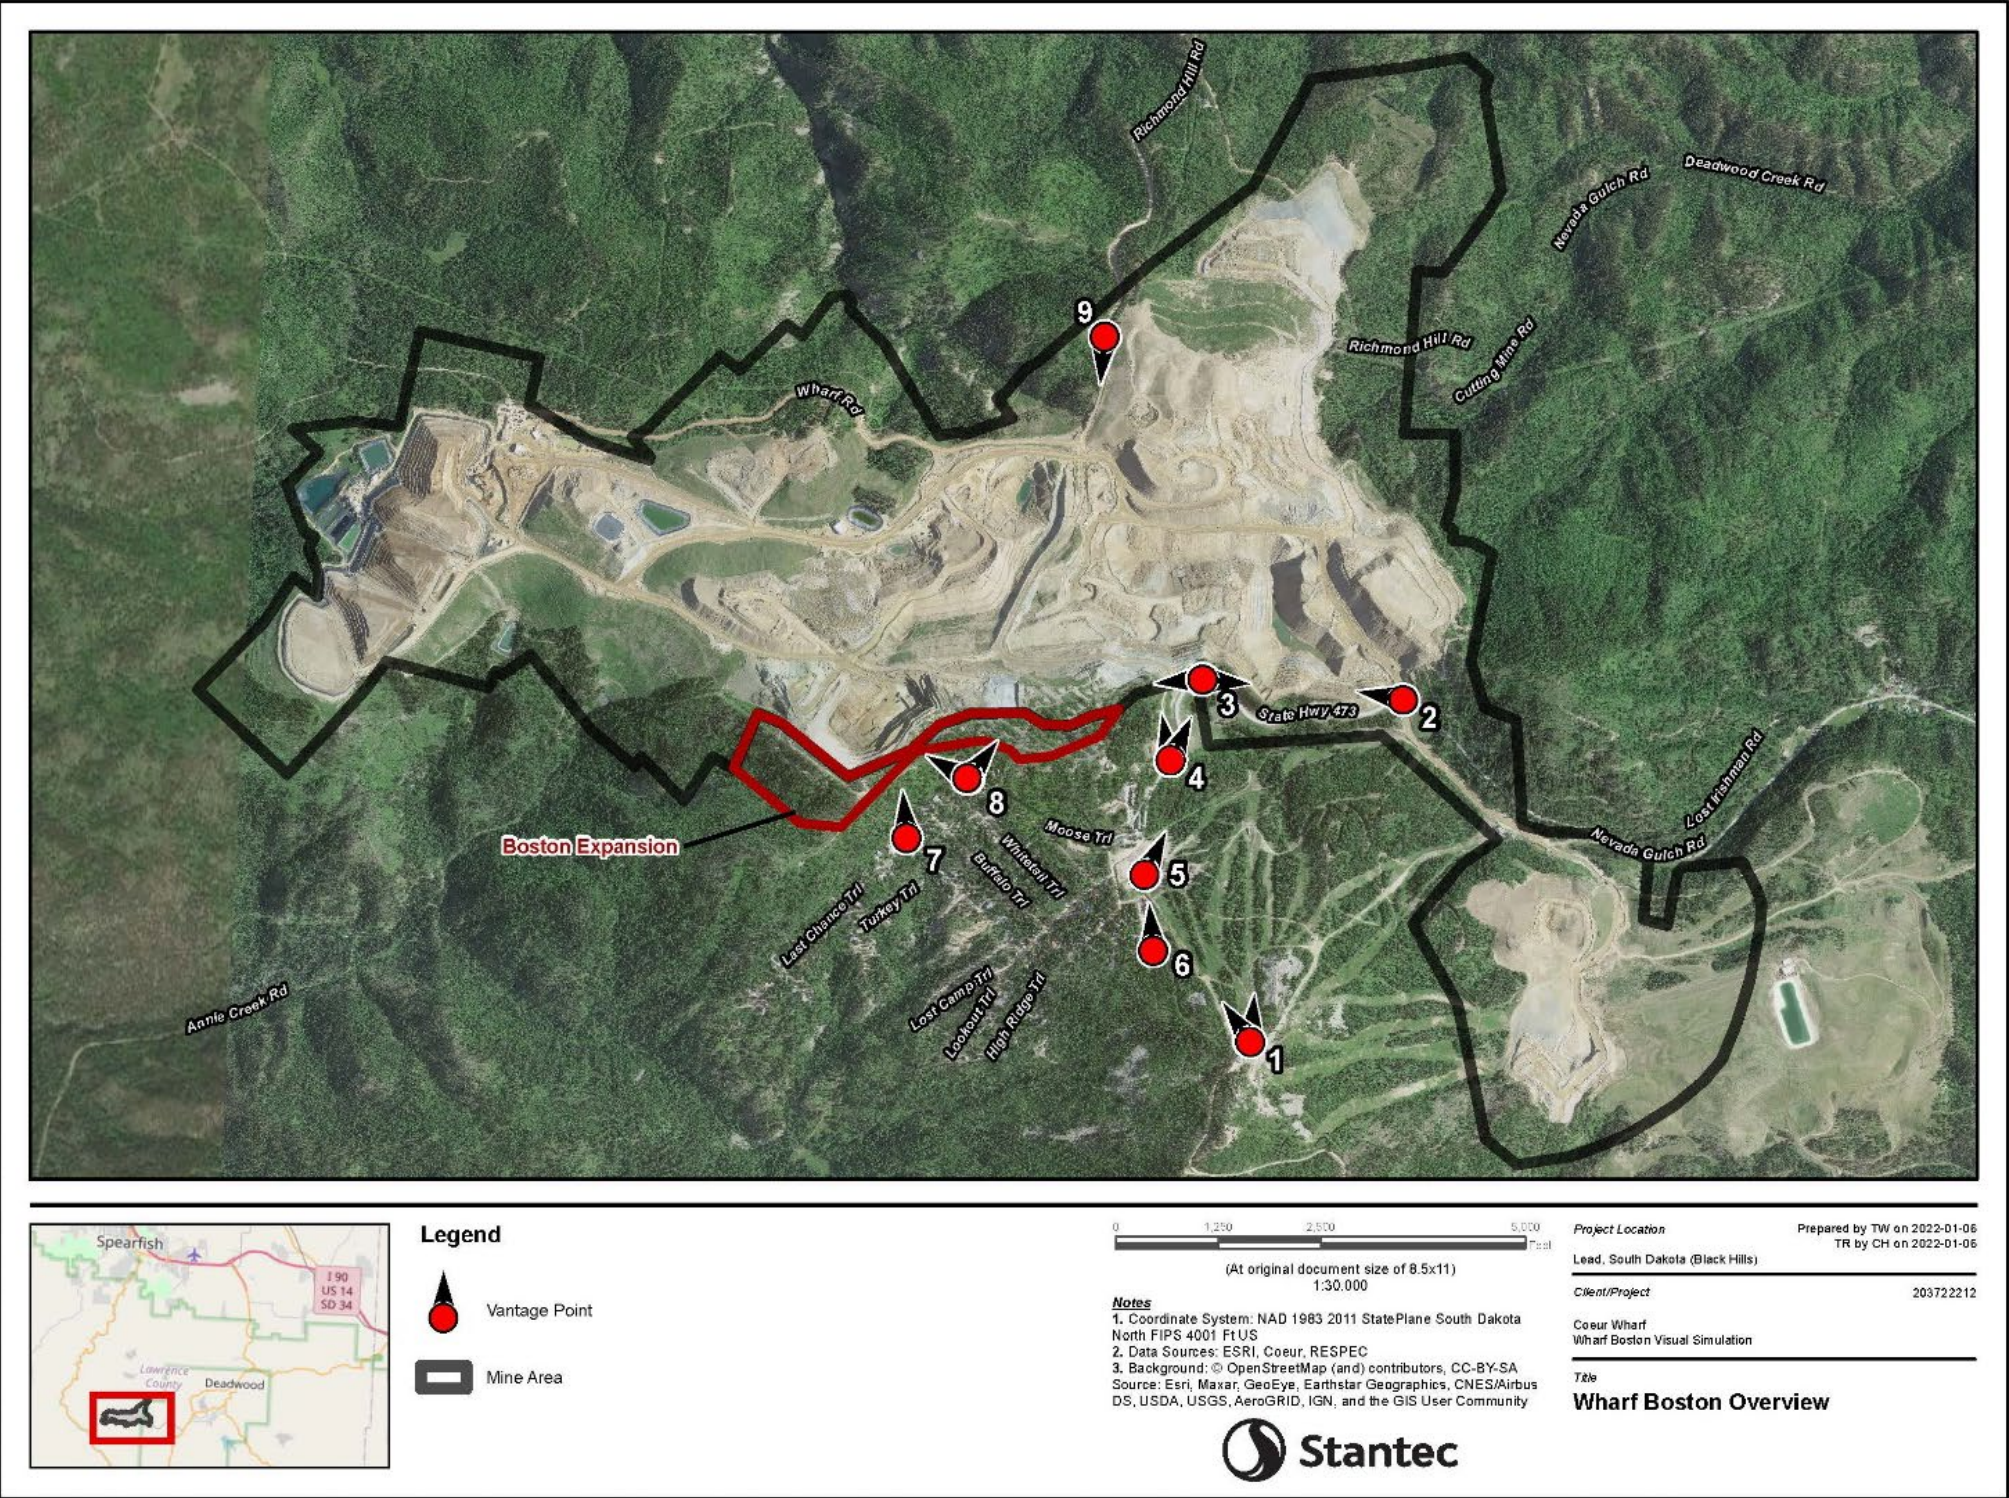
Figure 1. Vantage Point Locations

Because of the exact location of the expansion and local topography, most vantage points evaluated do not show public views of the expansion but more so show views of the general Wharf Mine and views seen by residents and visitors as they approach the mine. Locations of VPs are shown in Figure 1 below and include the following sites:

- VP 1 NW - Terry Peak Summit overlooking Wharf
- VP 4 NNW - Top of Nevada Gulch Road and intersection of Stewart Road
- VP 7 N - Antelope and Last Chance intersection
- VP 8 NW - Toward Wharf/Thaler house
- VP 8 NE - Moose Trail and Last Chance intersection
- VP 9 S – Perkins Road

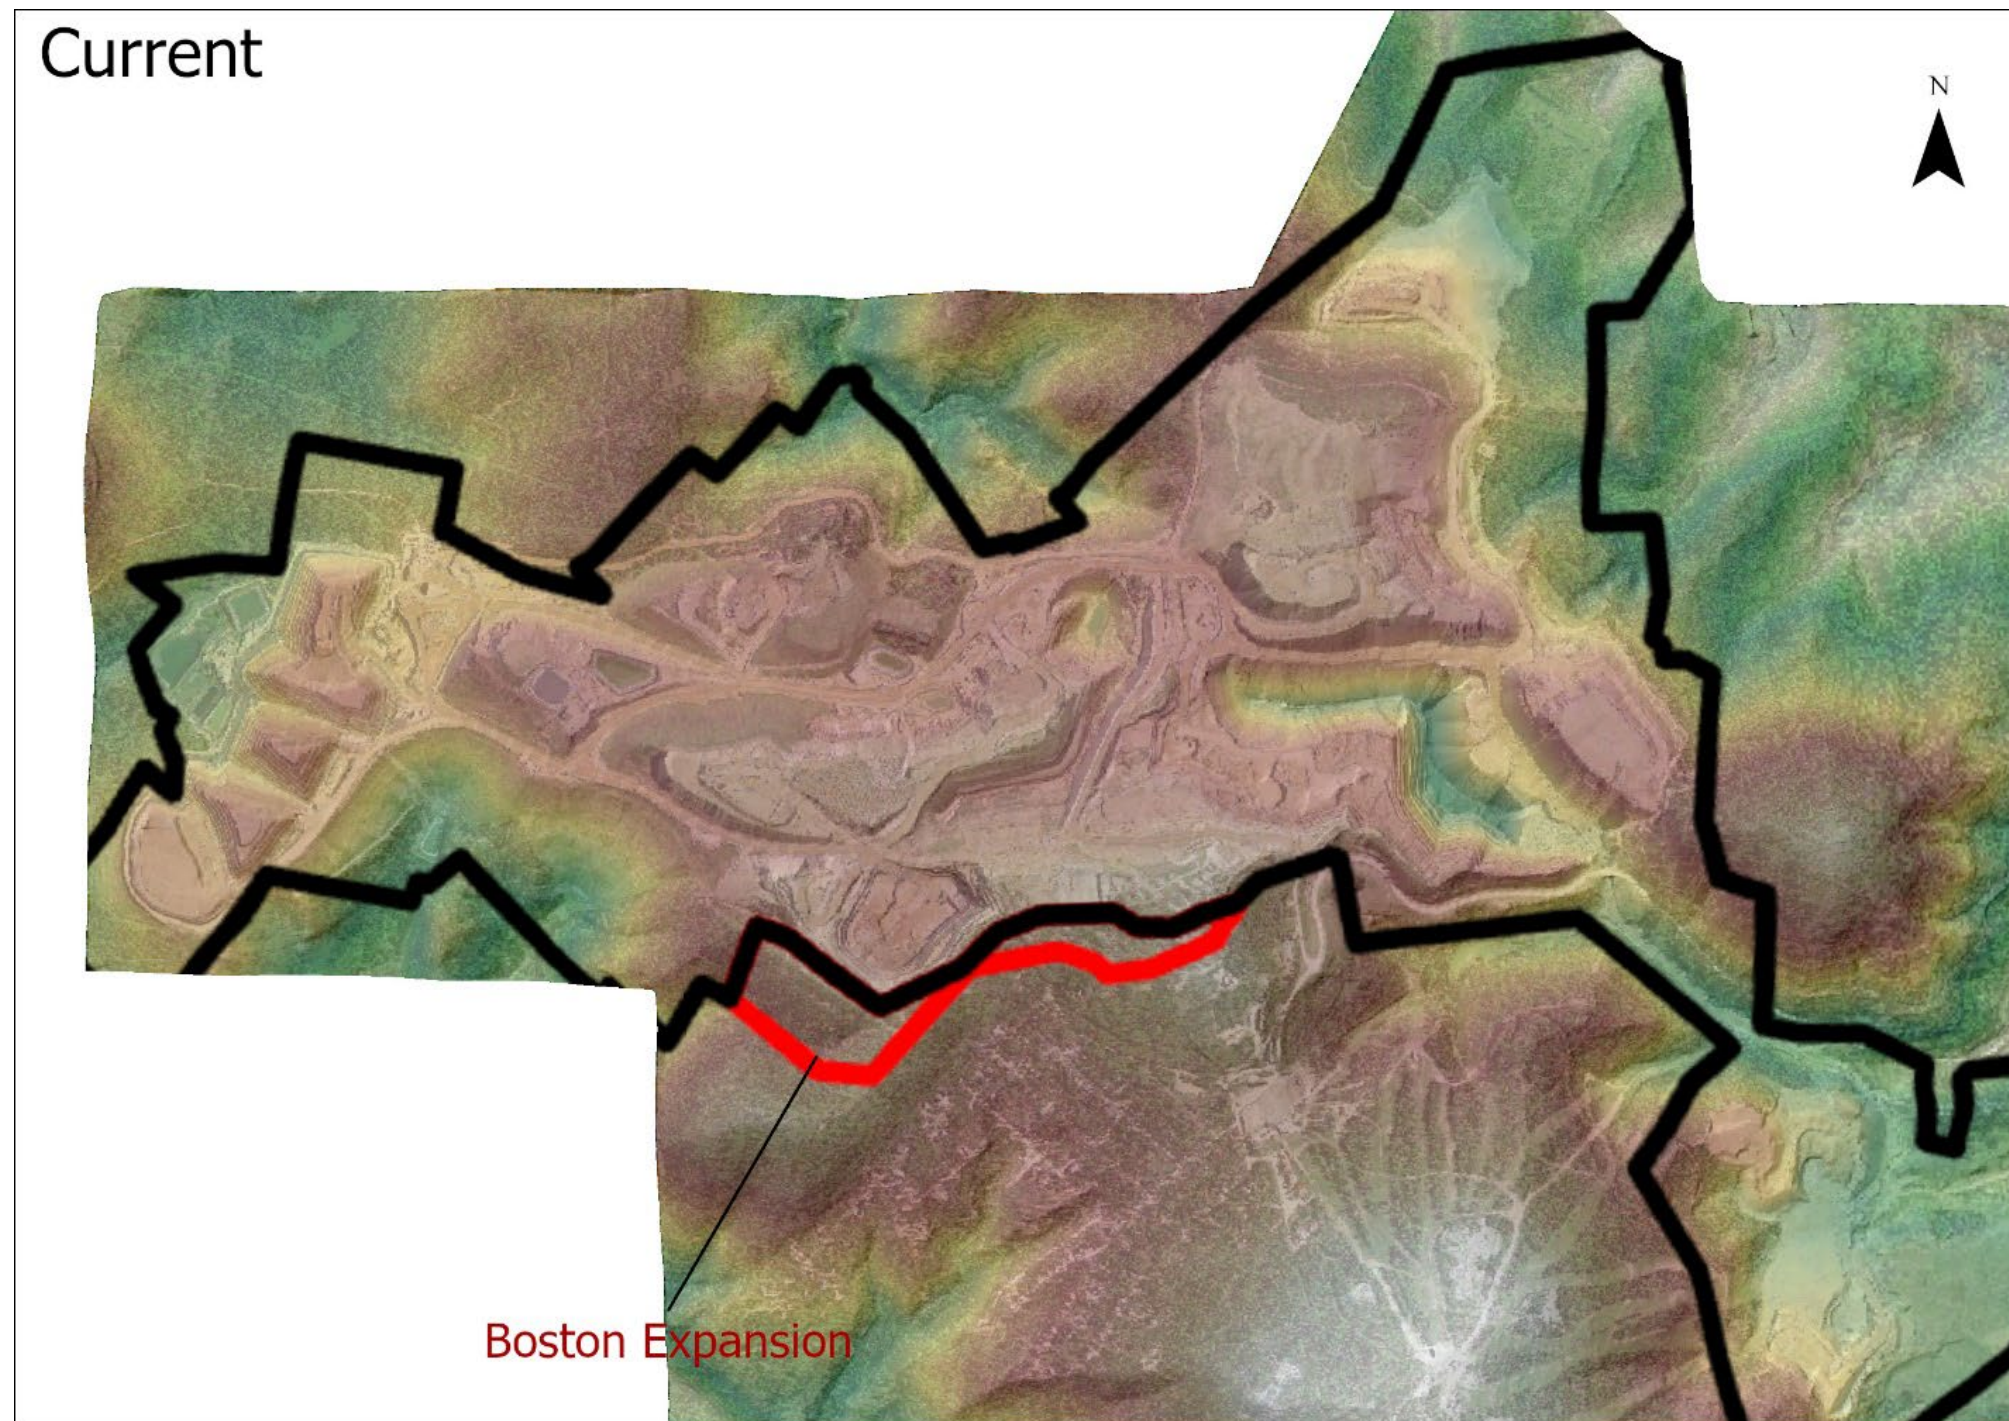
**Figure 2.** Current Contours Plan View

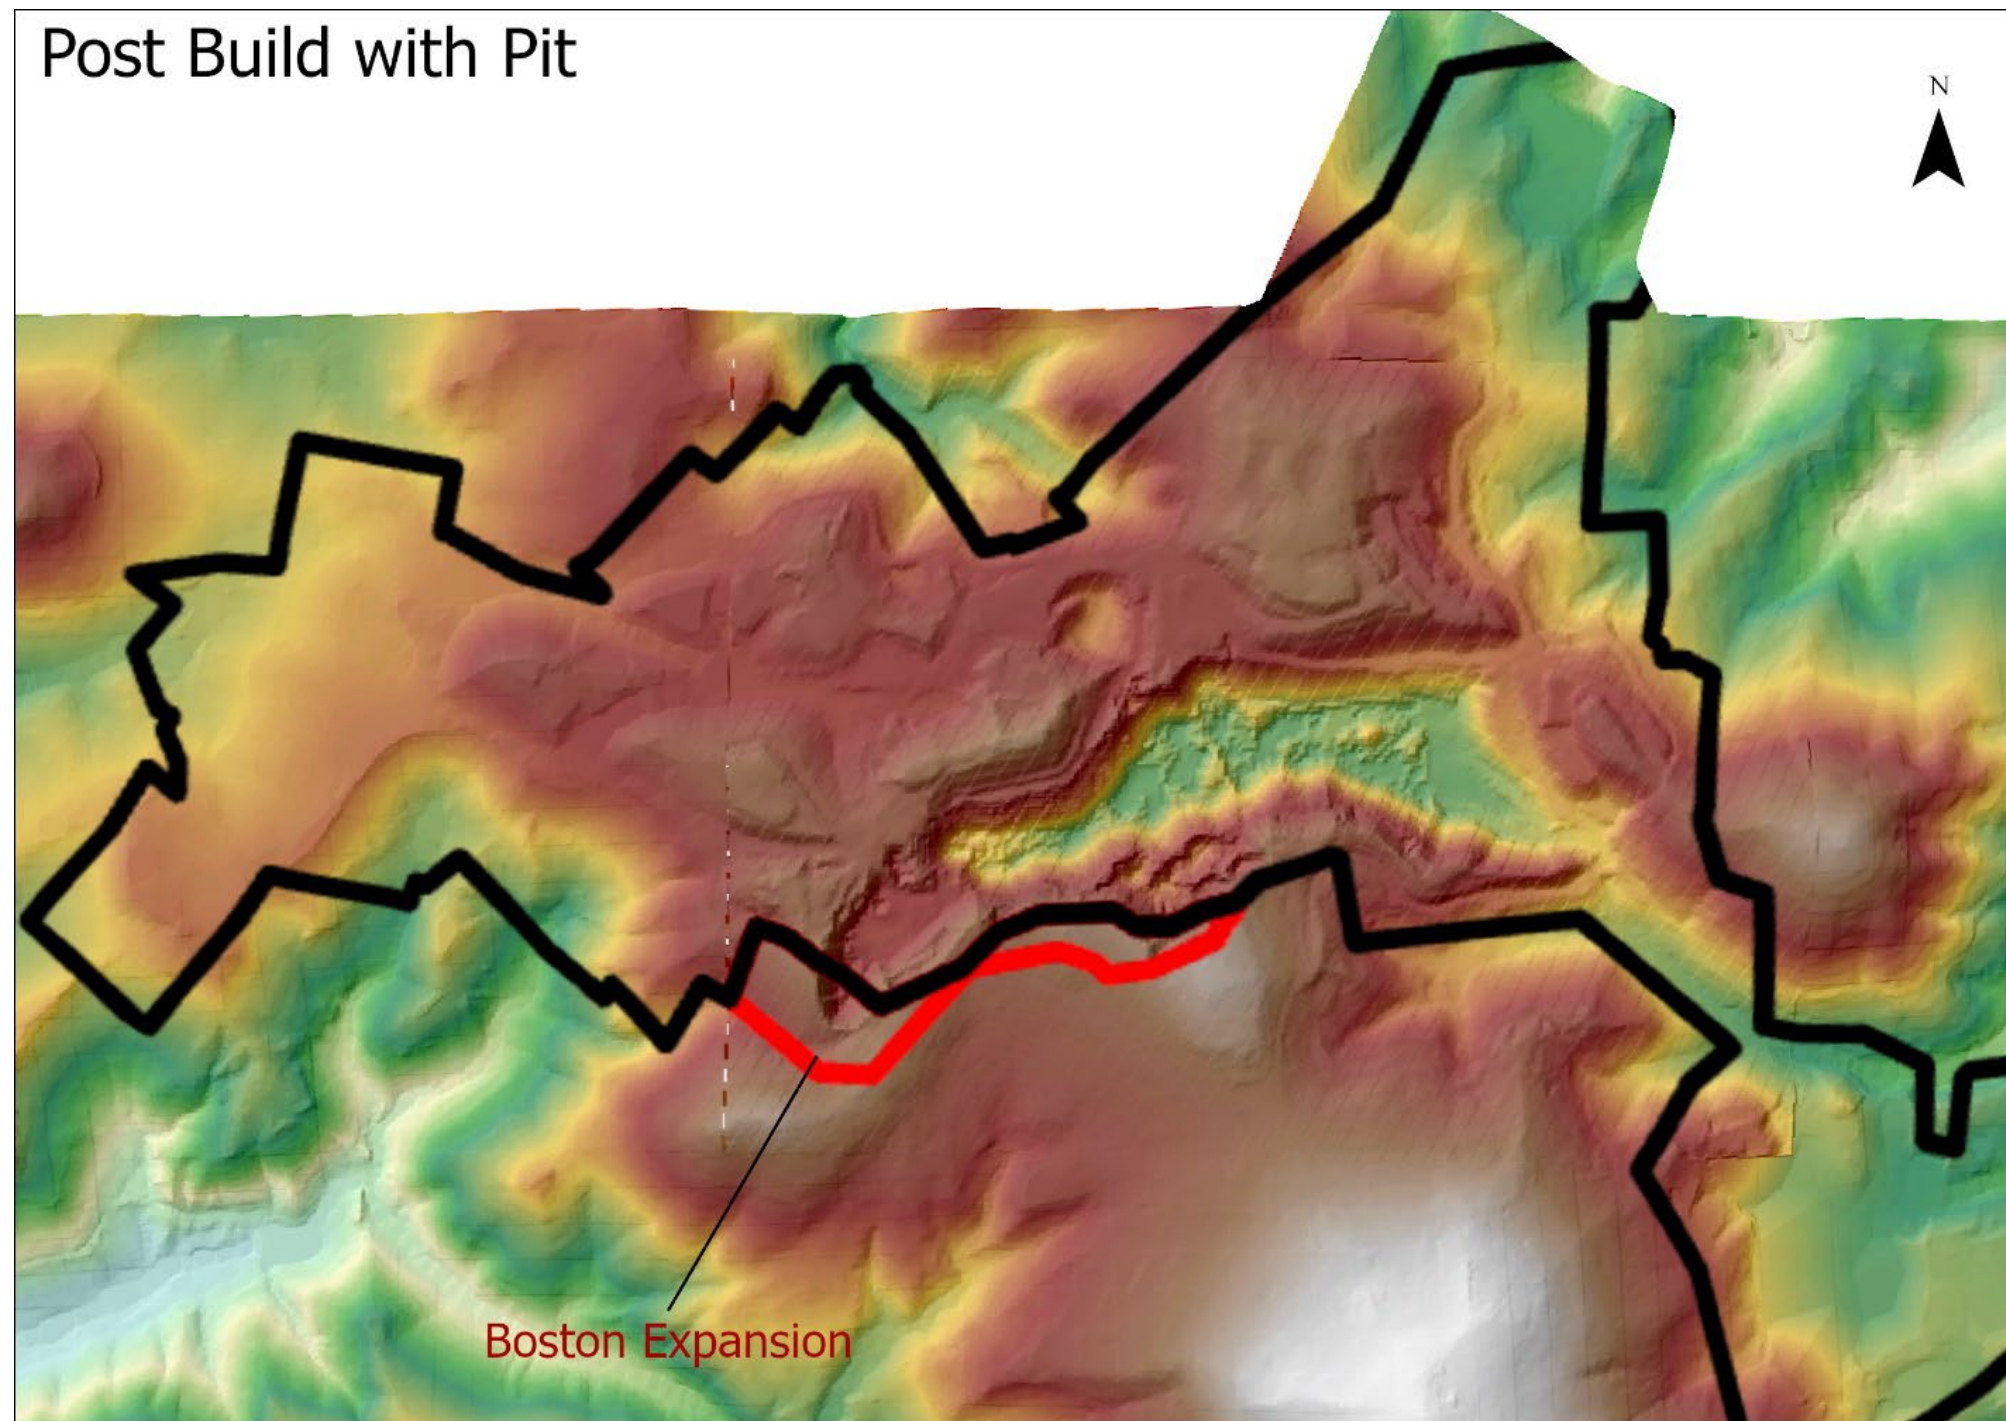
**Figure 3.** Maximum Pit / Post-Build Construction Contours Plan View

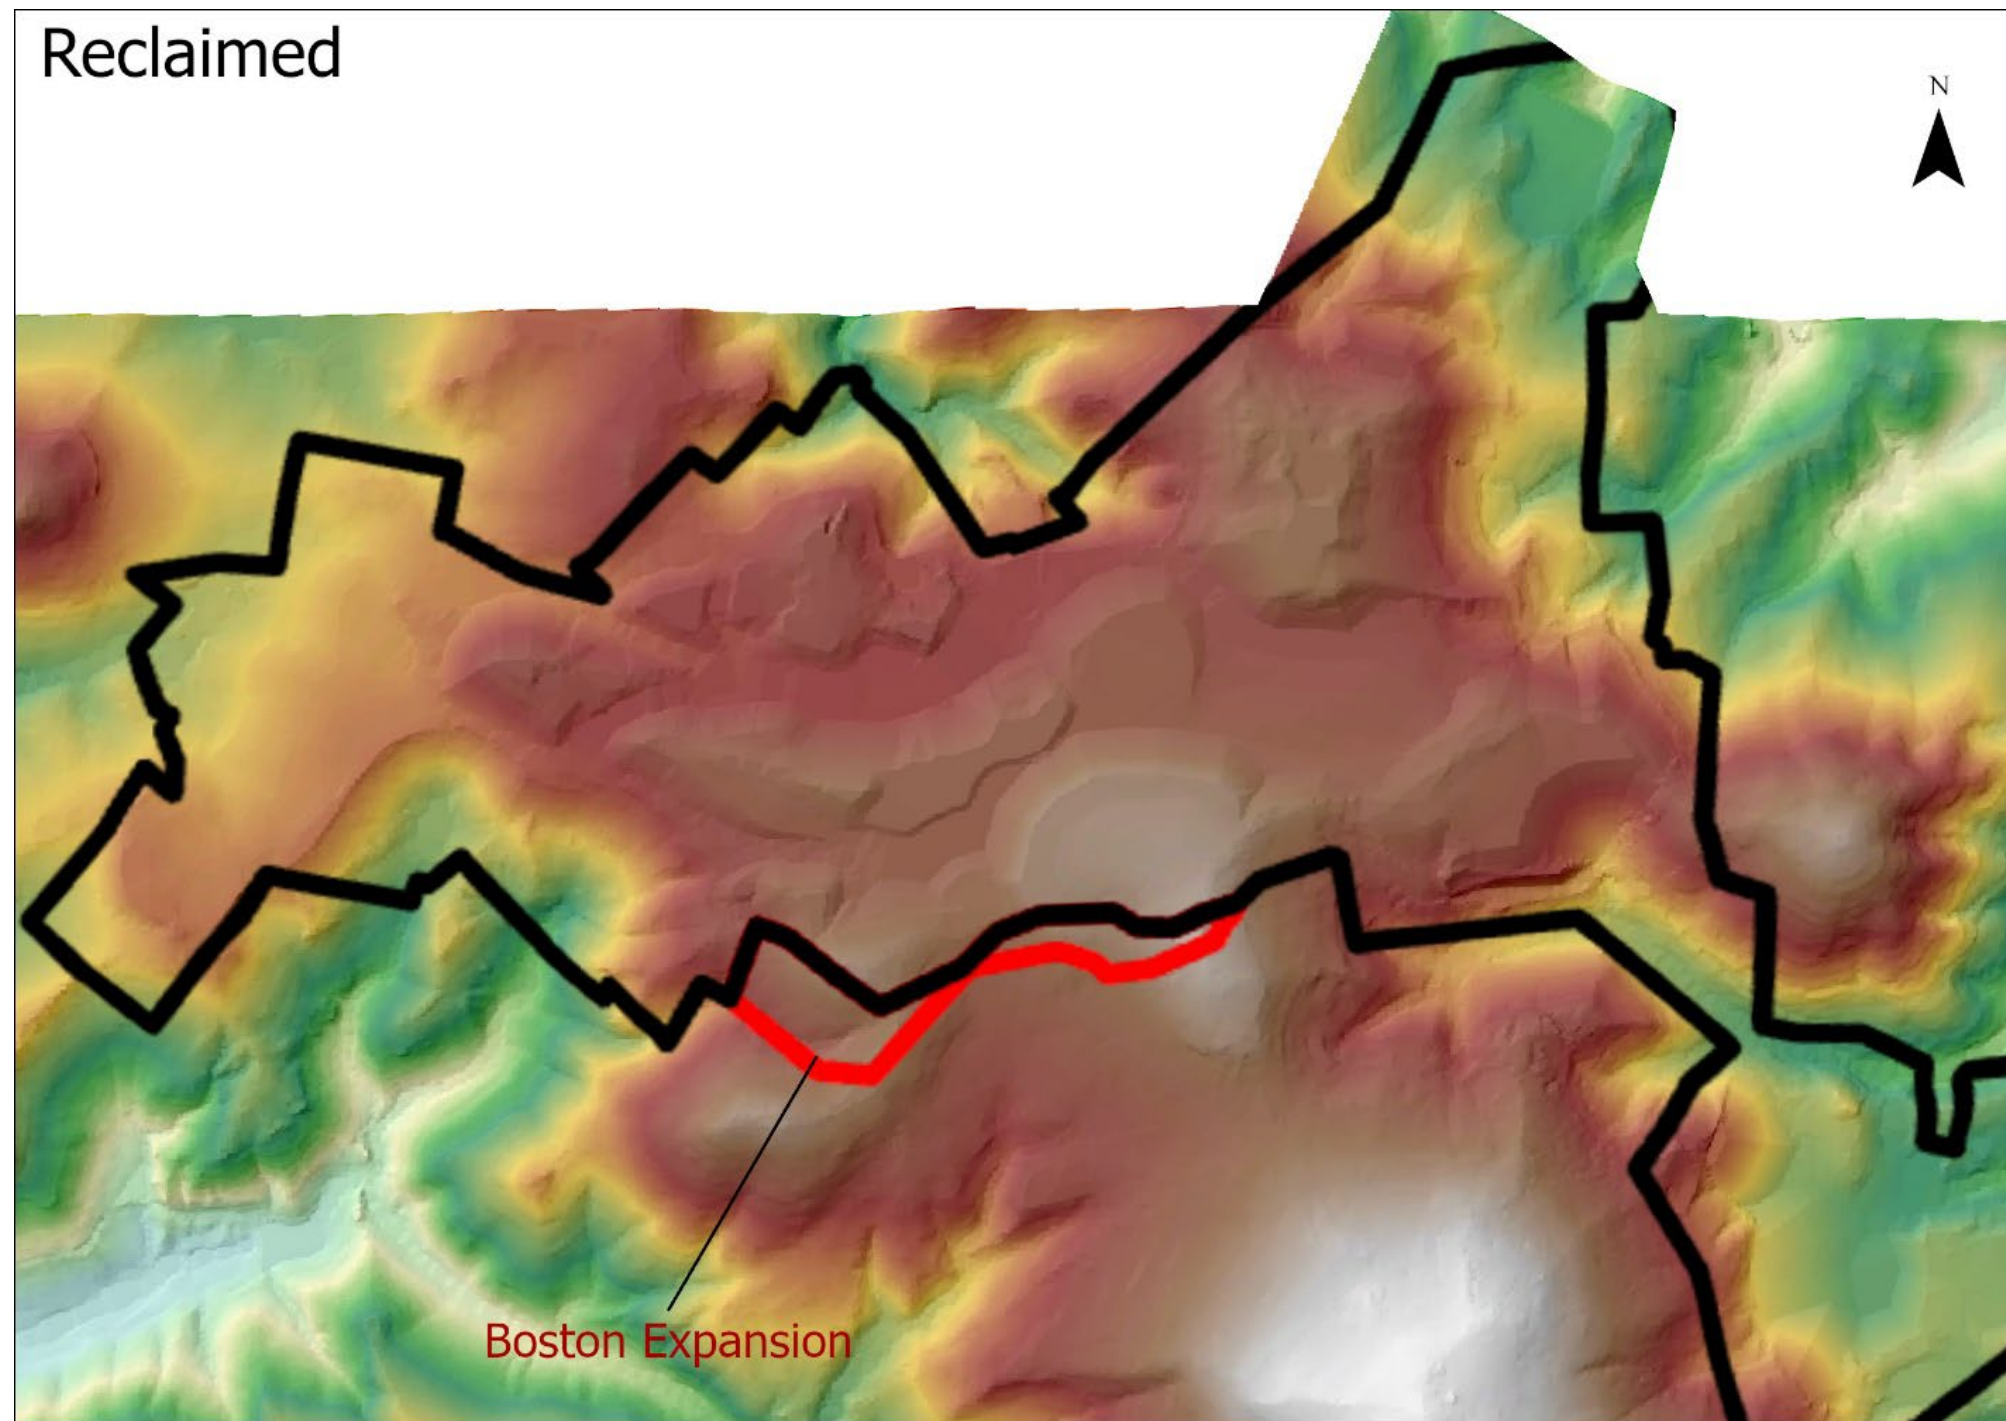
**Figure 4.** Reclaimed Contours Plan View

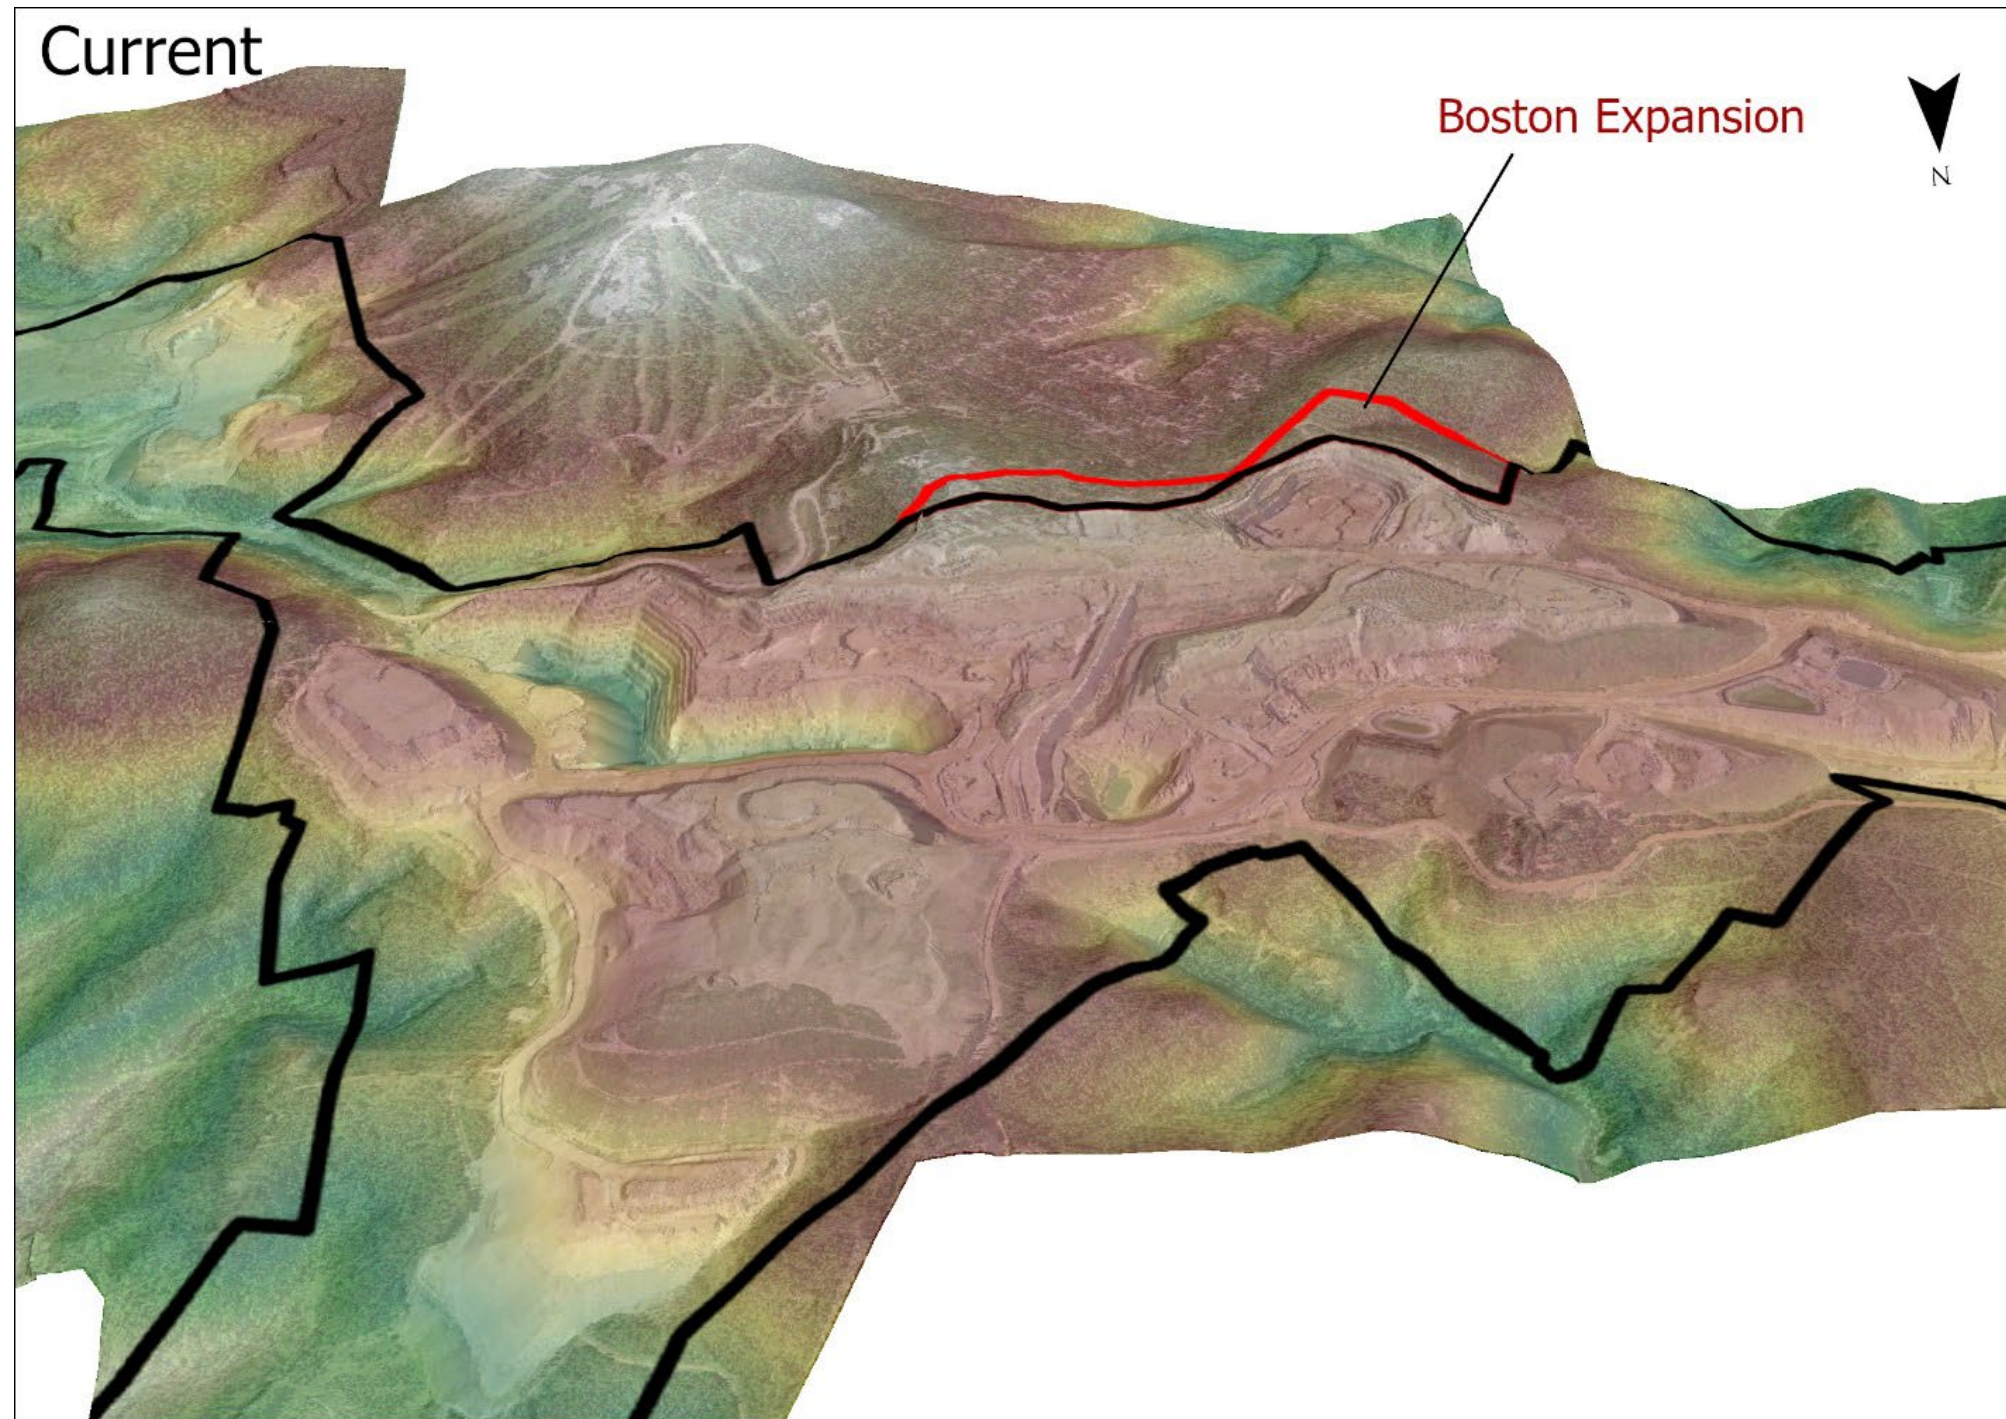
**Figure 5.** Current Contours Oblique View from North

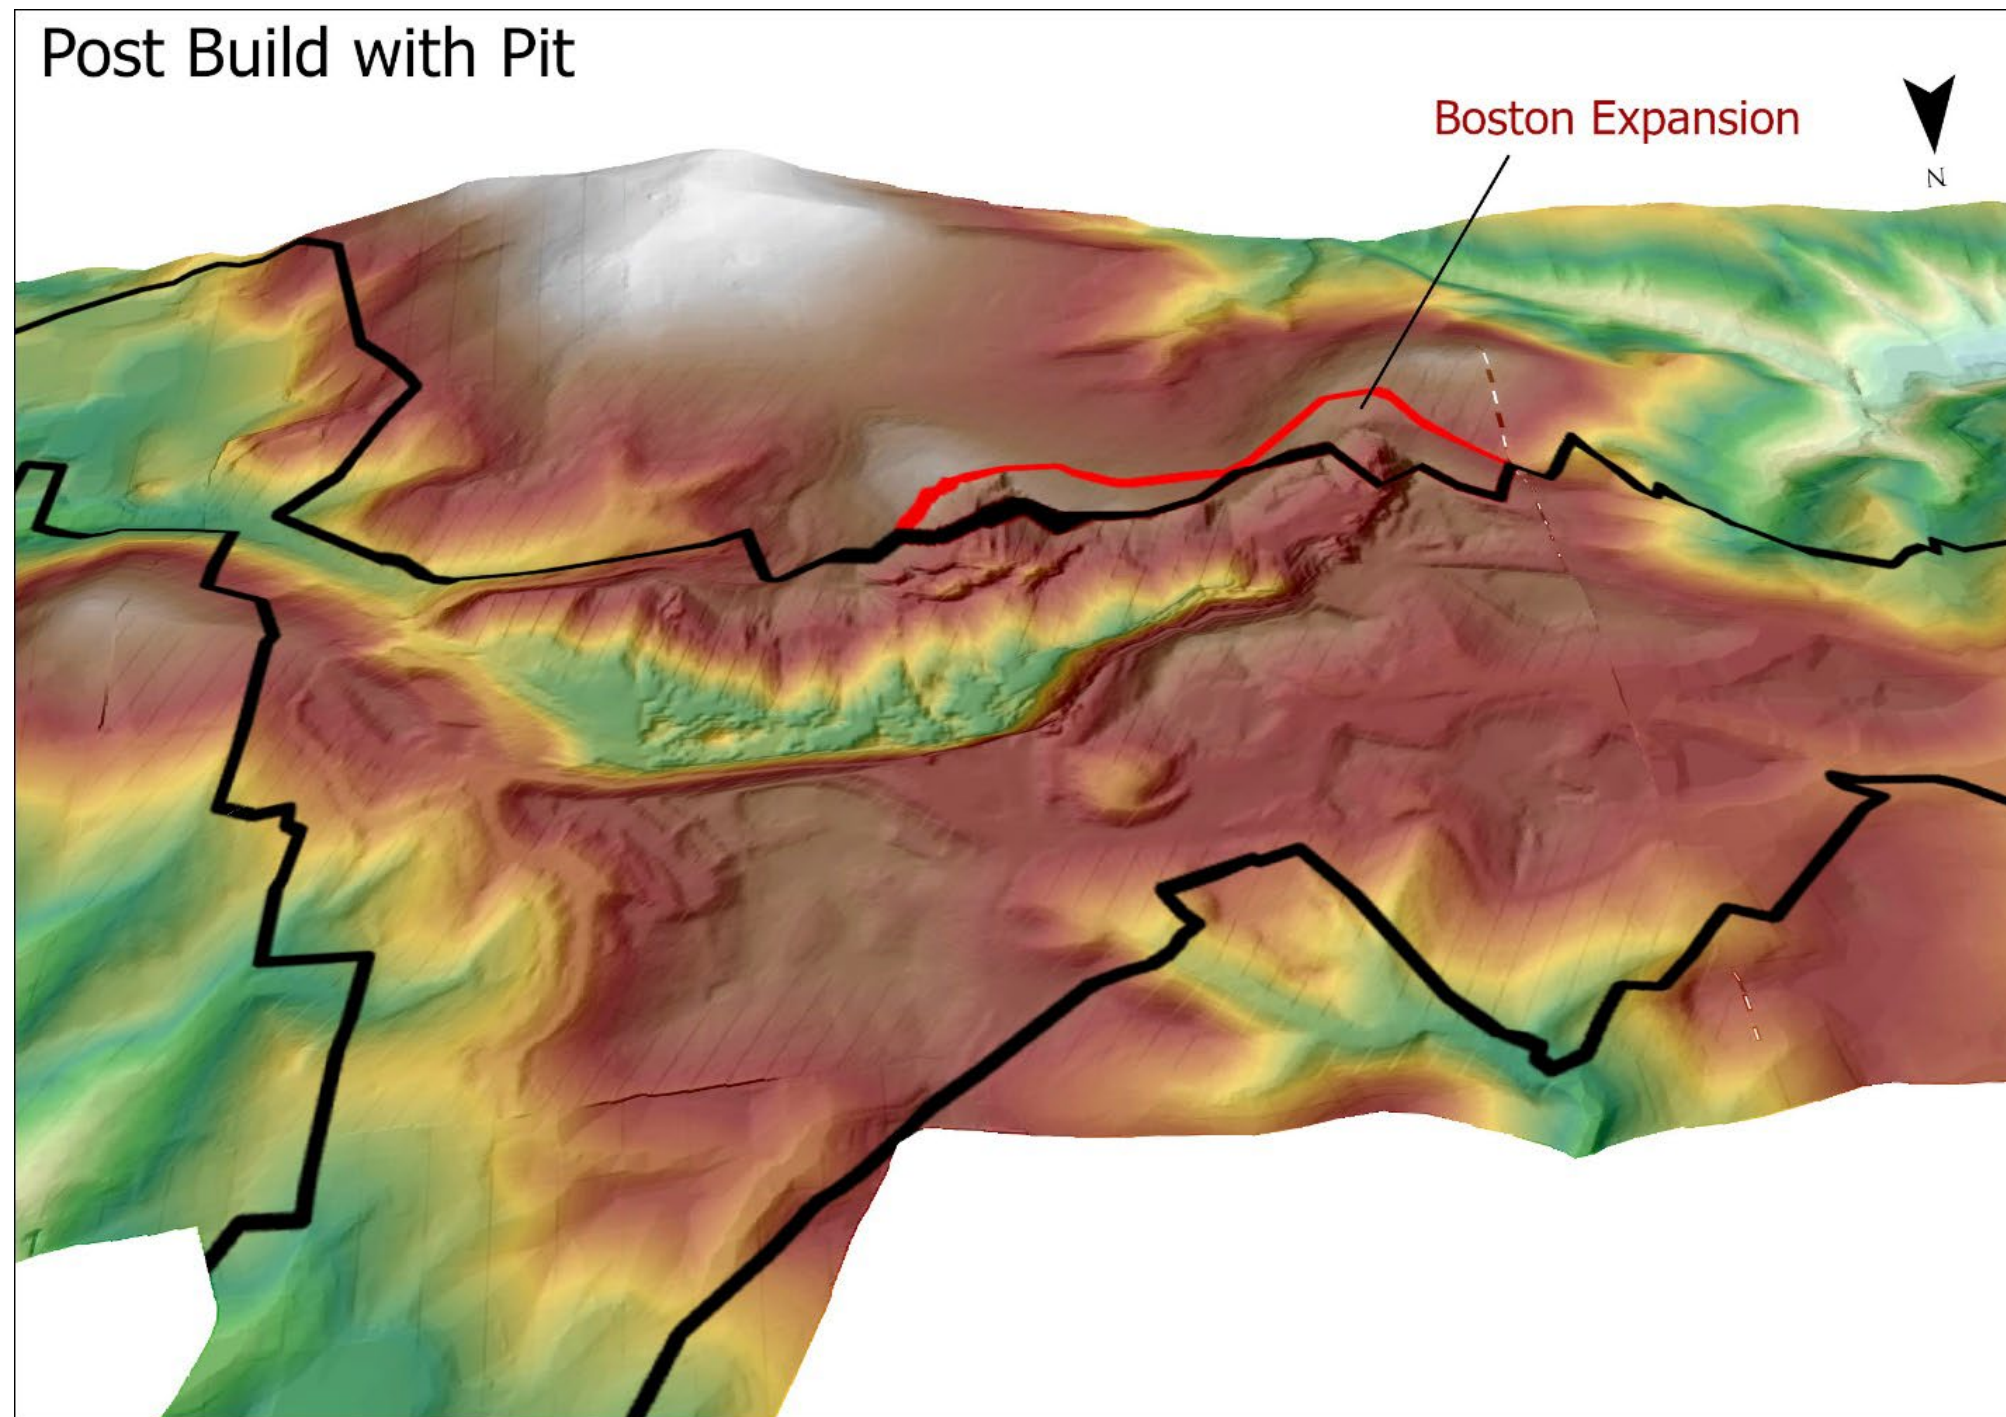
**Figure 6a.** Maximum Pit / Post-Build Construction Contours Oblique View from North

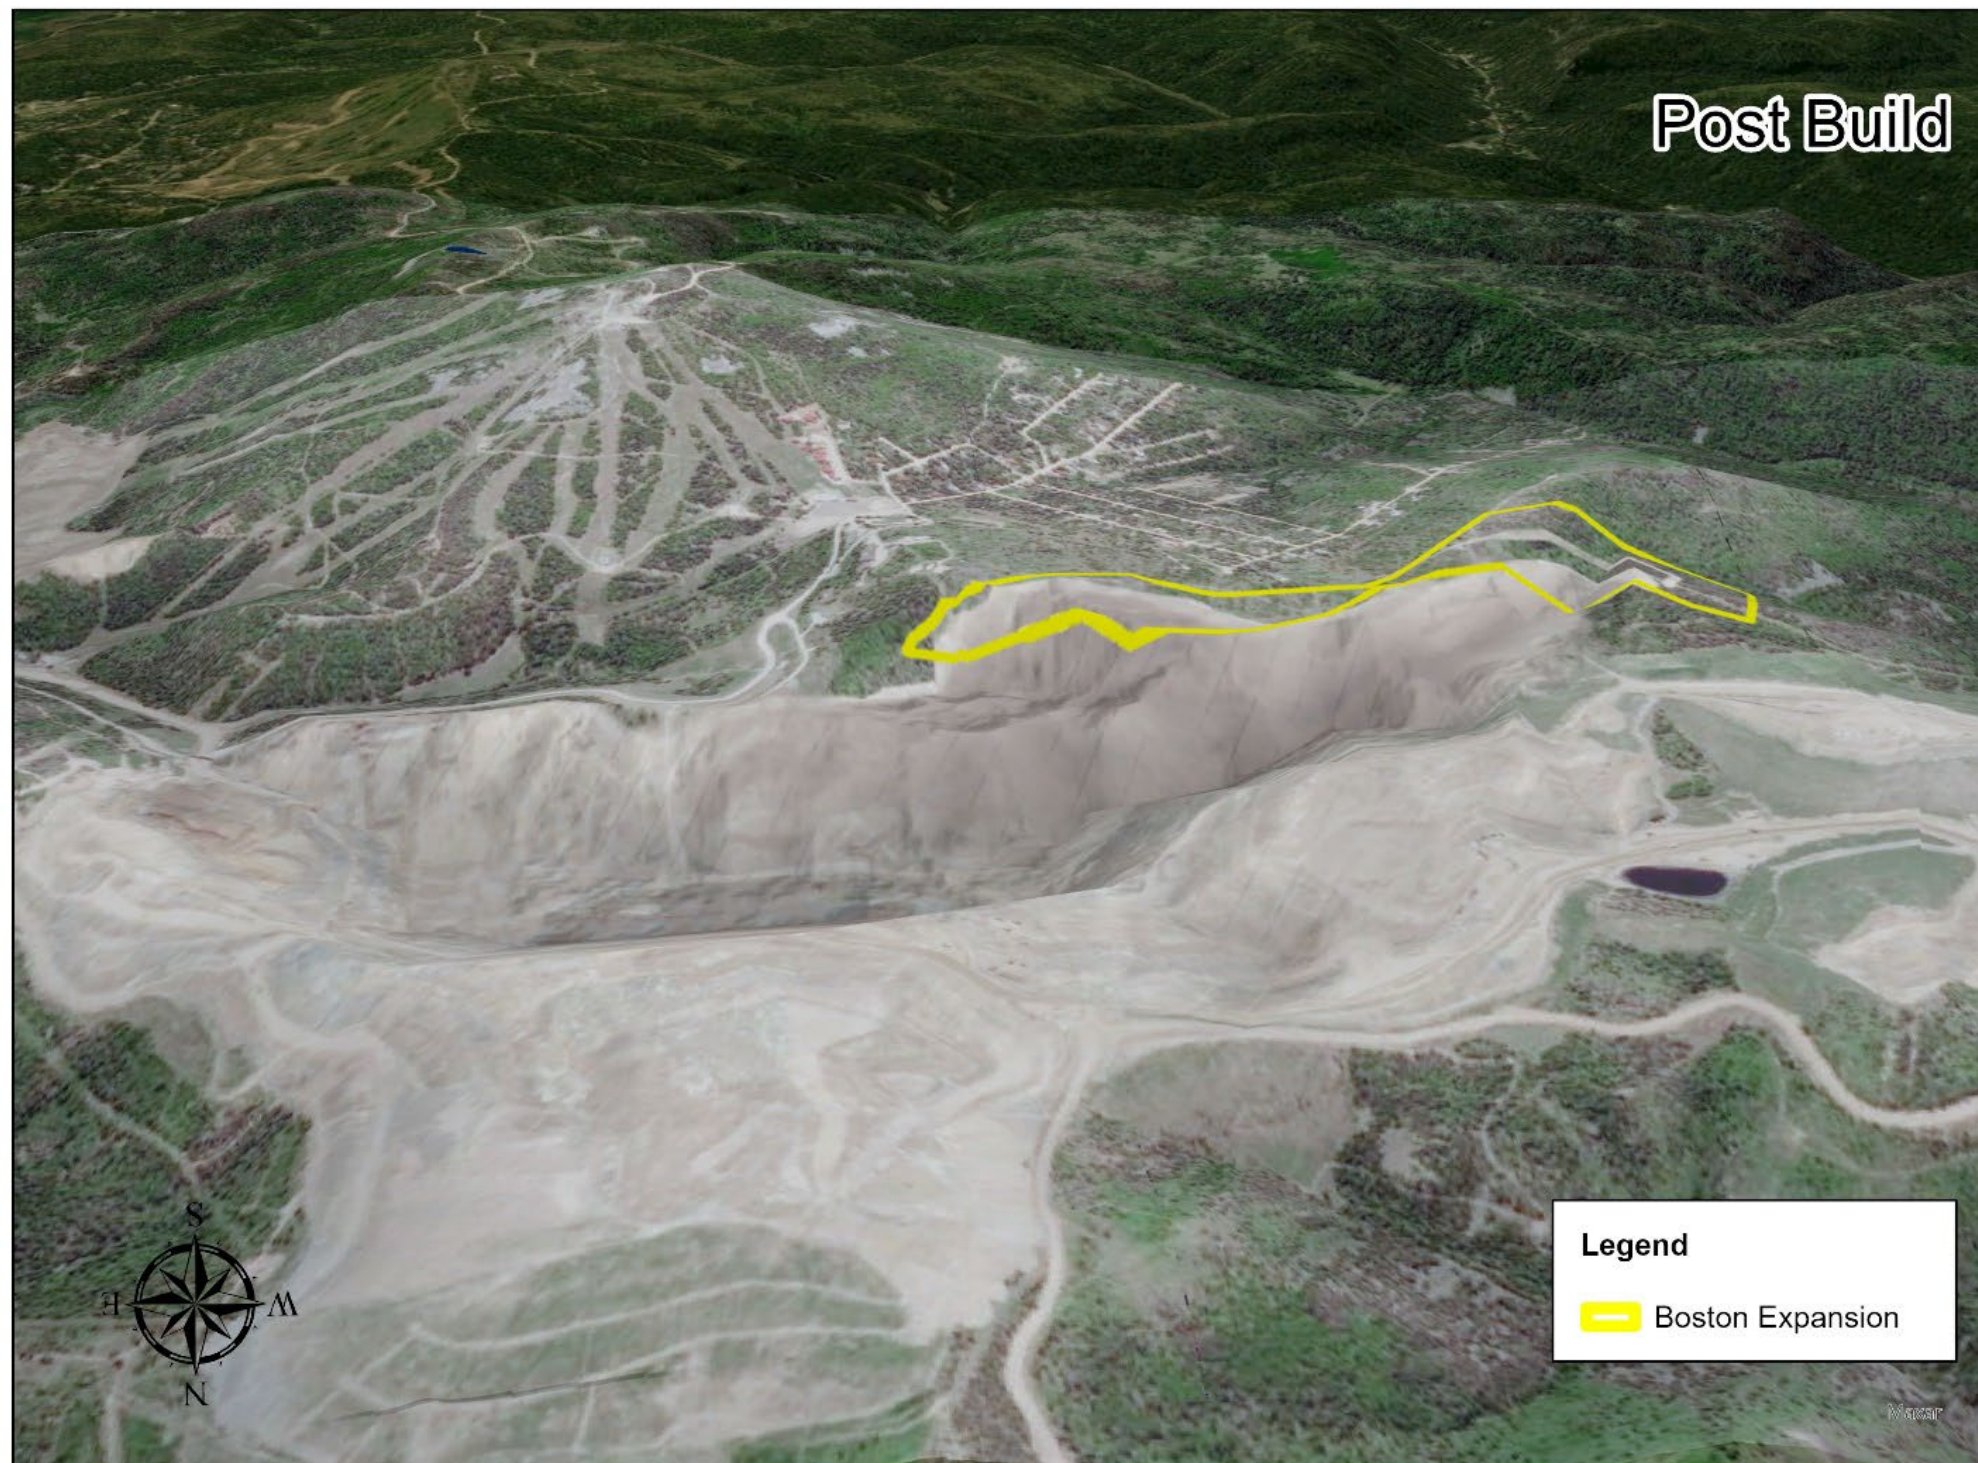
**Figure 6b.** Maximum Pit / Post-Build Construction Contours Oblique View from North Draped with Conceptual Imagery

To supplement the visual assessment conducted by Stantec and assist in understanding the visual changes that may occur as a result of the proposed Boston Expansion, Stantec expanded our visual assessment to include oblique aerial views of the Boston Expansion and Wharf took photographs from their property fence line looking toward the residences as well as toward the mine. Because of the limited public views of the Boston Expansion, topographic surfaces, including an oblique view looking from the north to south, were developed (see Figures 2 through 11). These surfaces show current, post-build, and post-reclamation topography. The topographic impact of the Boston Expansion is most notably visible as a pushback to the current mining operations as shown in Figures 6b, 8, and 10.
