Coeur Wharf  
Wharf Boston Visual Simulation

WHARF BOSTON  
EXPANSION

## Wharf Fence-Line and Lost Camp Subdivision Photographs December 30, 2021 and January 20, 2022

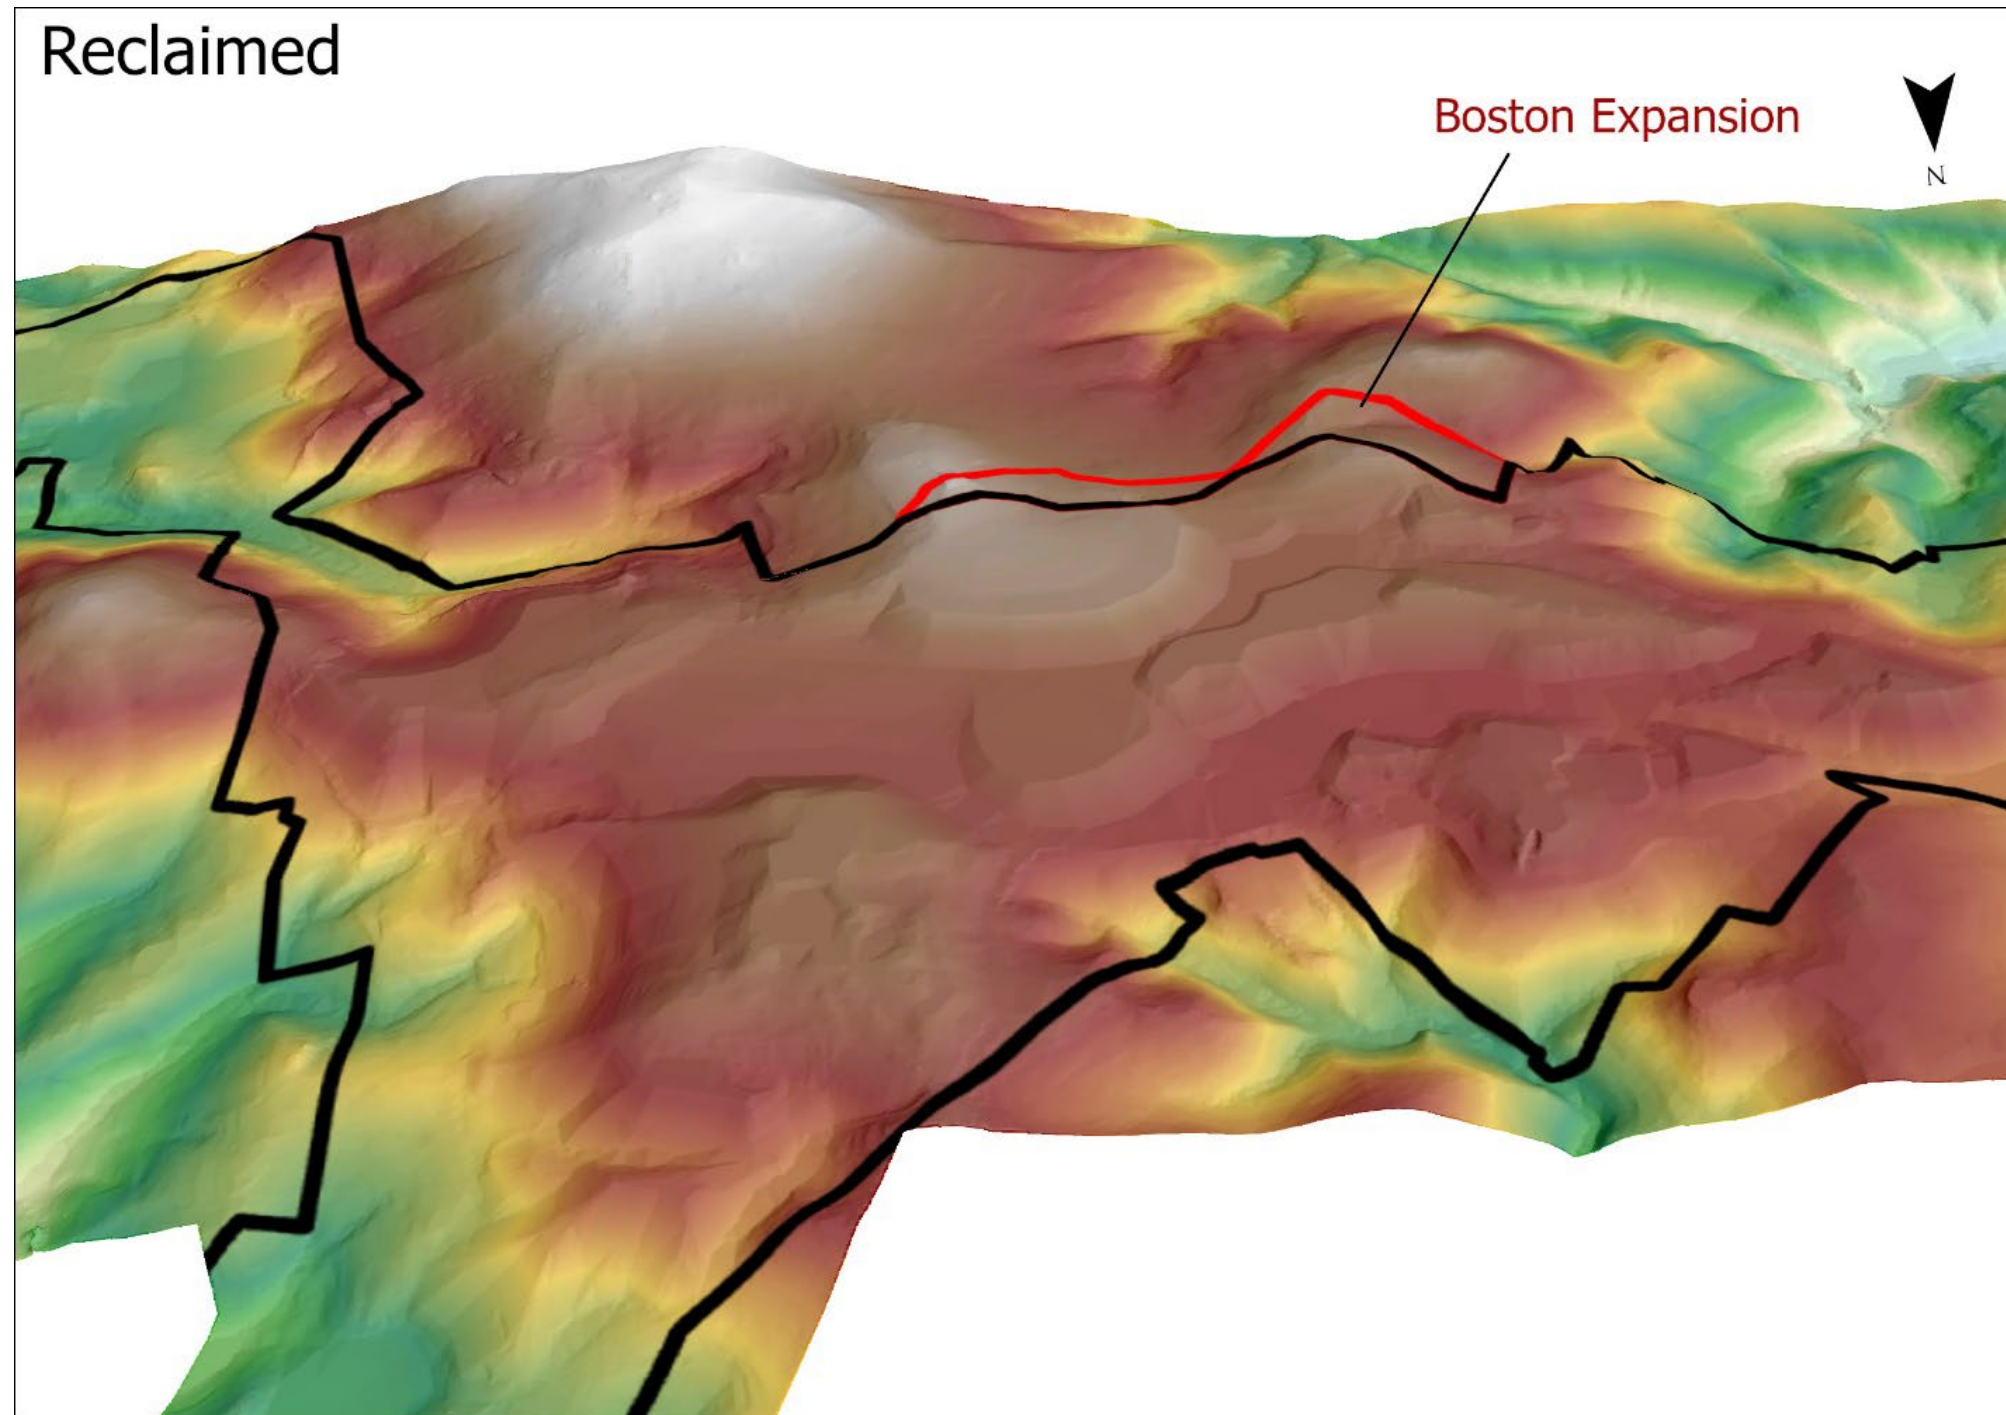
**Figure 7a.** Reclaimed Contours Oblique View from North

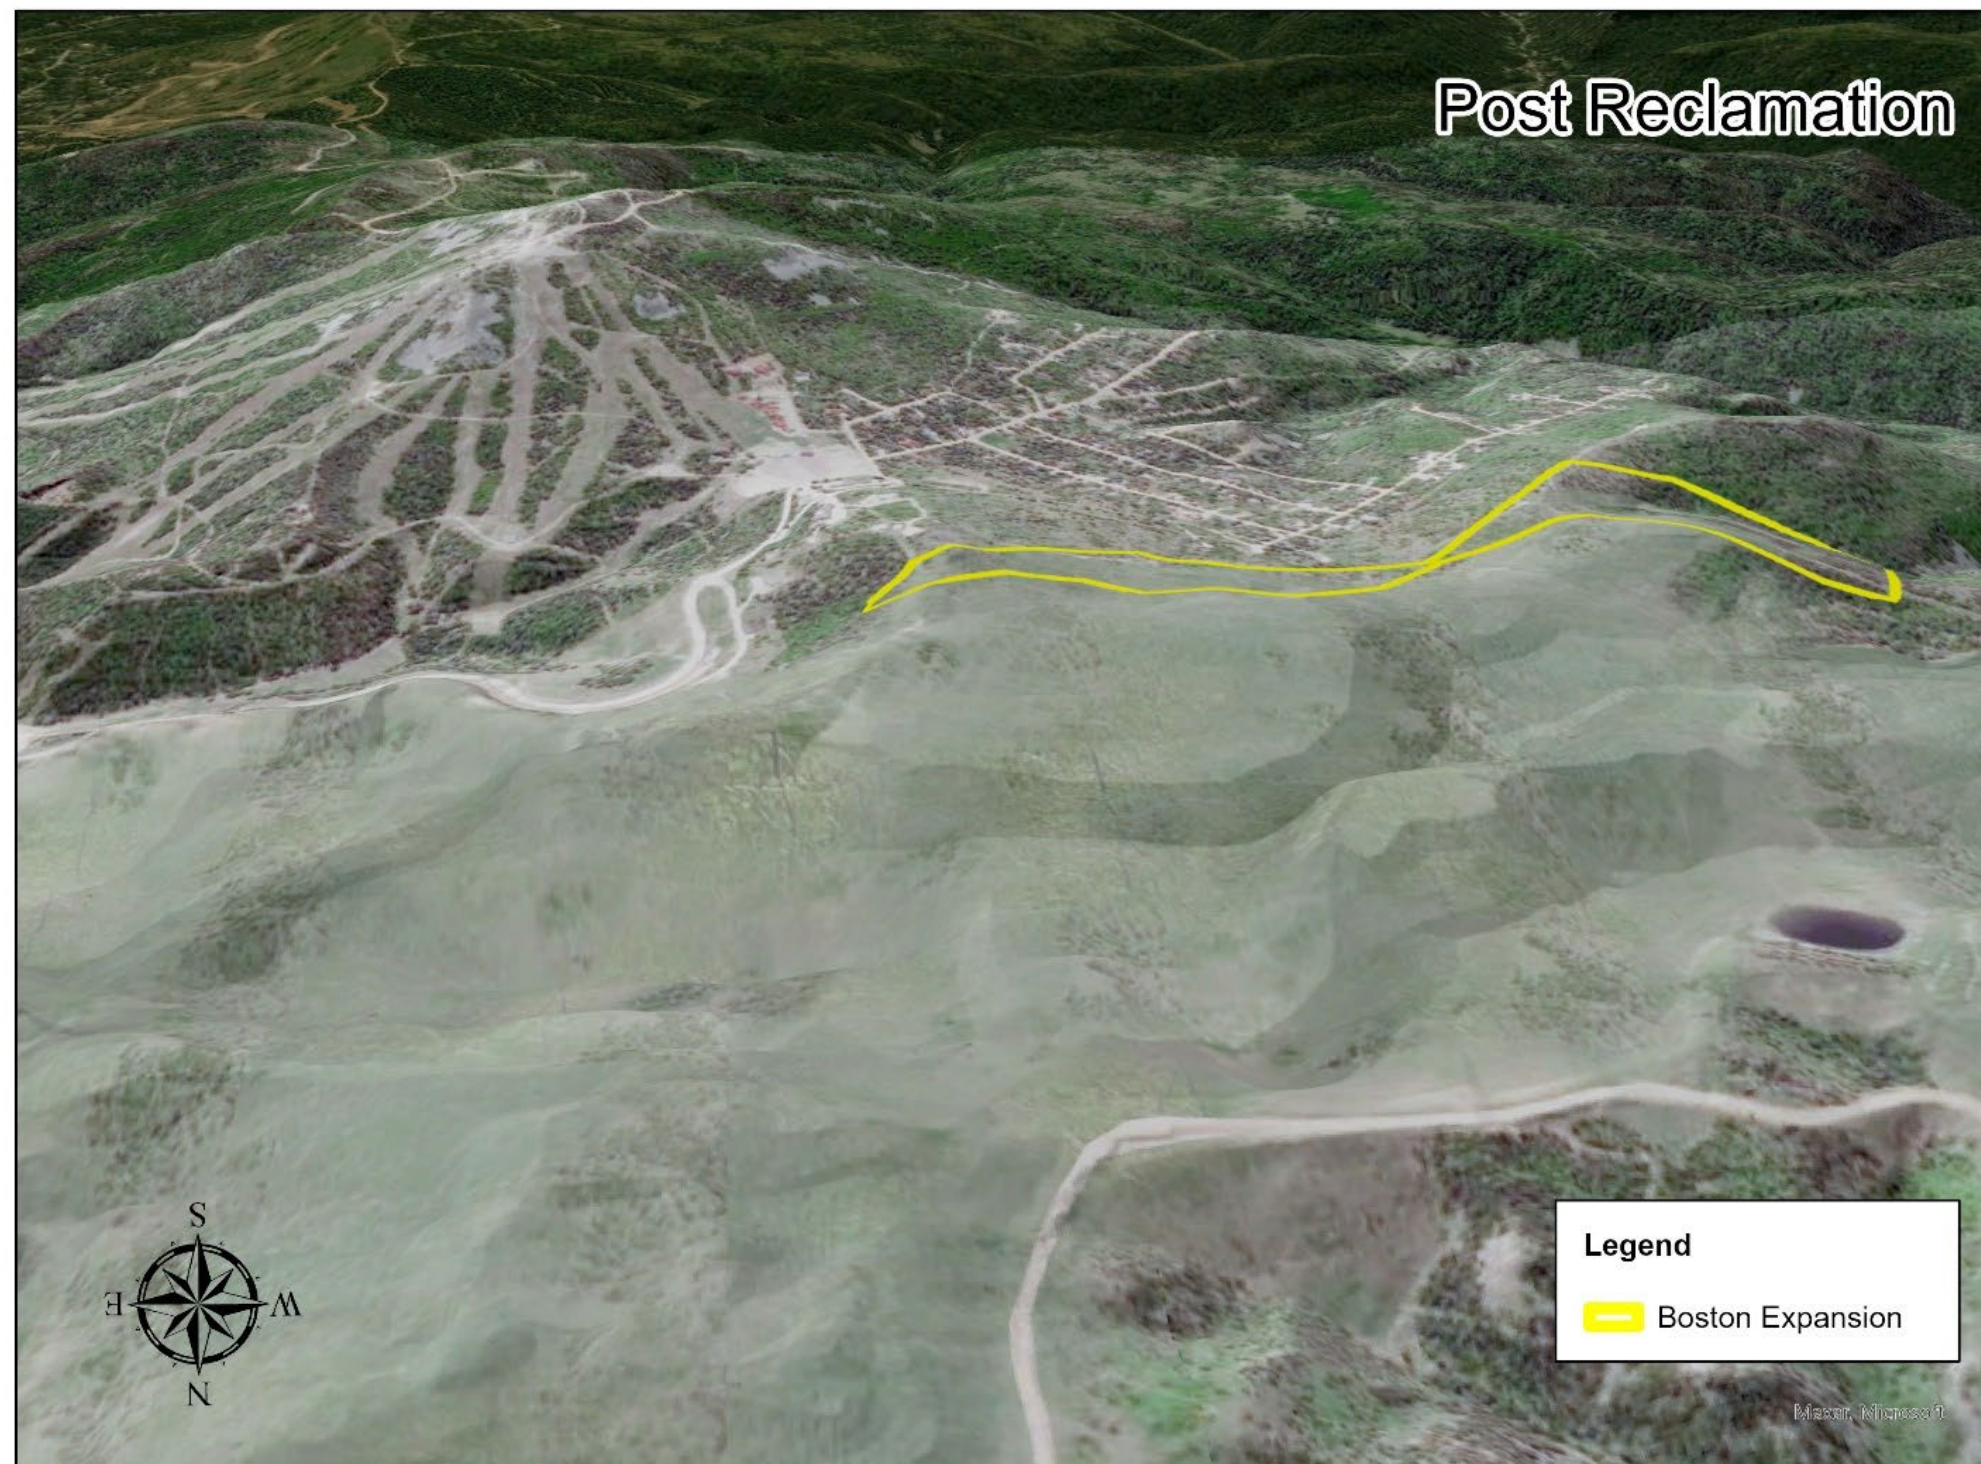
**Figure 7b.** Reclaimed Contours Oblique View from North Draped with Conceptual Imagery

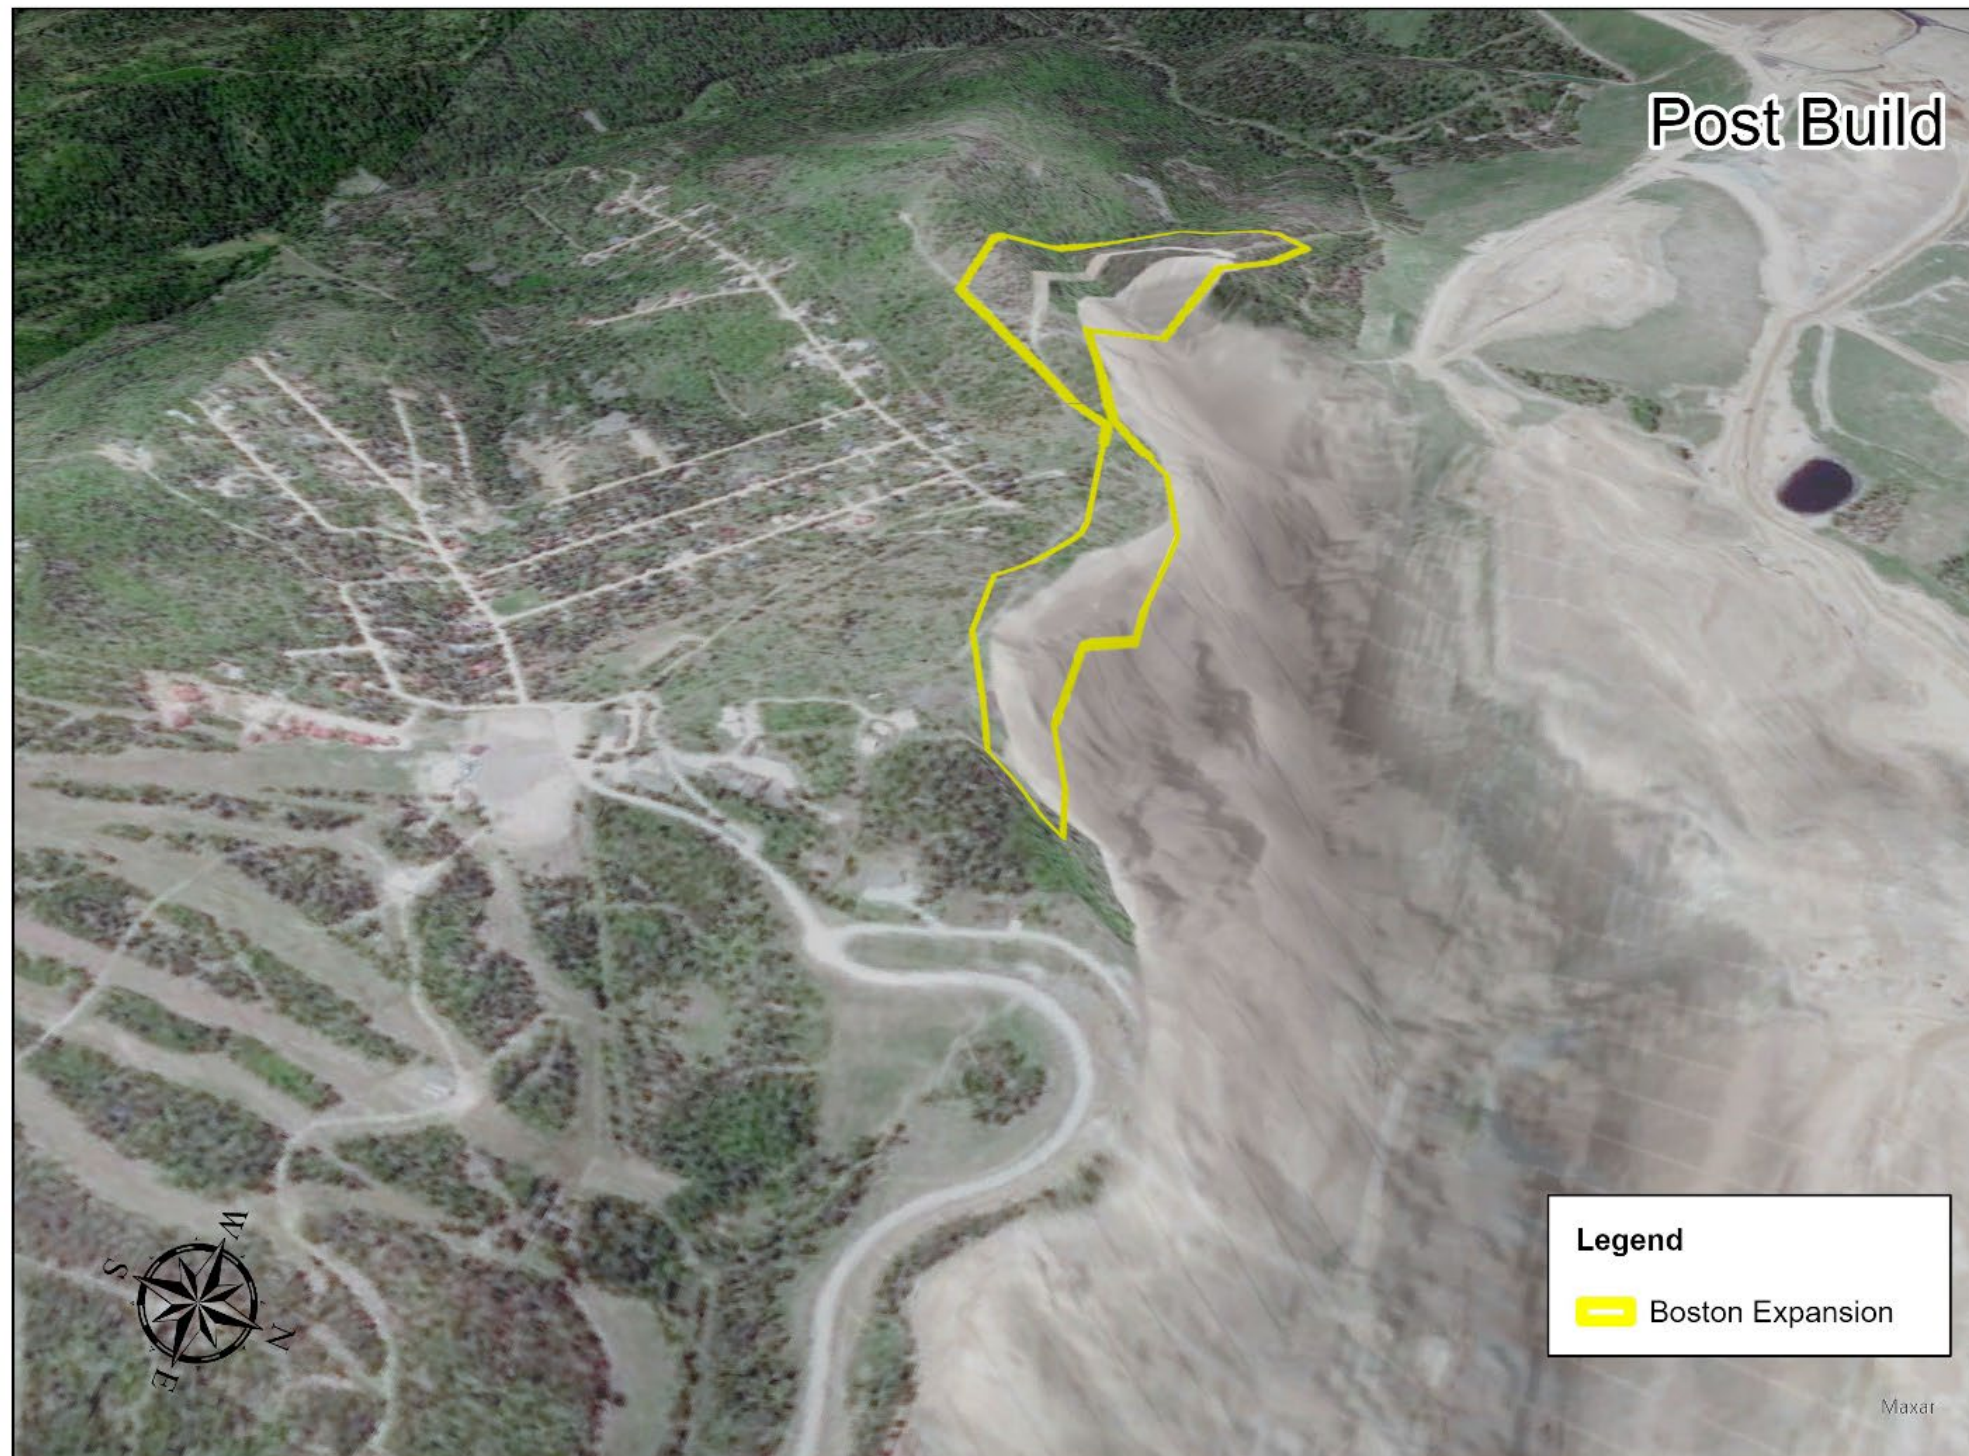
**Figure 8.** Maximum Pit / Post-Build Construction Contours Oblique View from East Draped with Conceptual Imagery

To supplement the visual assessment conducted by Stantec and assist in understanding the visual changes that may occur as a result of the proposed Boston Expansion, Stantec expanded our visual assessment to include oblique aerial views of the Boston Expansion and Wharf took photographs from their property fence line looking toward the residences as well as toward the mine. Because of the limited public views of the Boston Expansion, topographic surfaces, including an oblique view looking from the north to south, were developed (see Figures 2 through 11). These surfaces show current, post-build, and post-reclamation topography. The topographic impact of the Boston Expansion is most notably visible as a pushback to the current mining operations as shown in Figures 6b, 8, and 10.

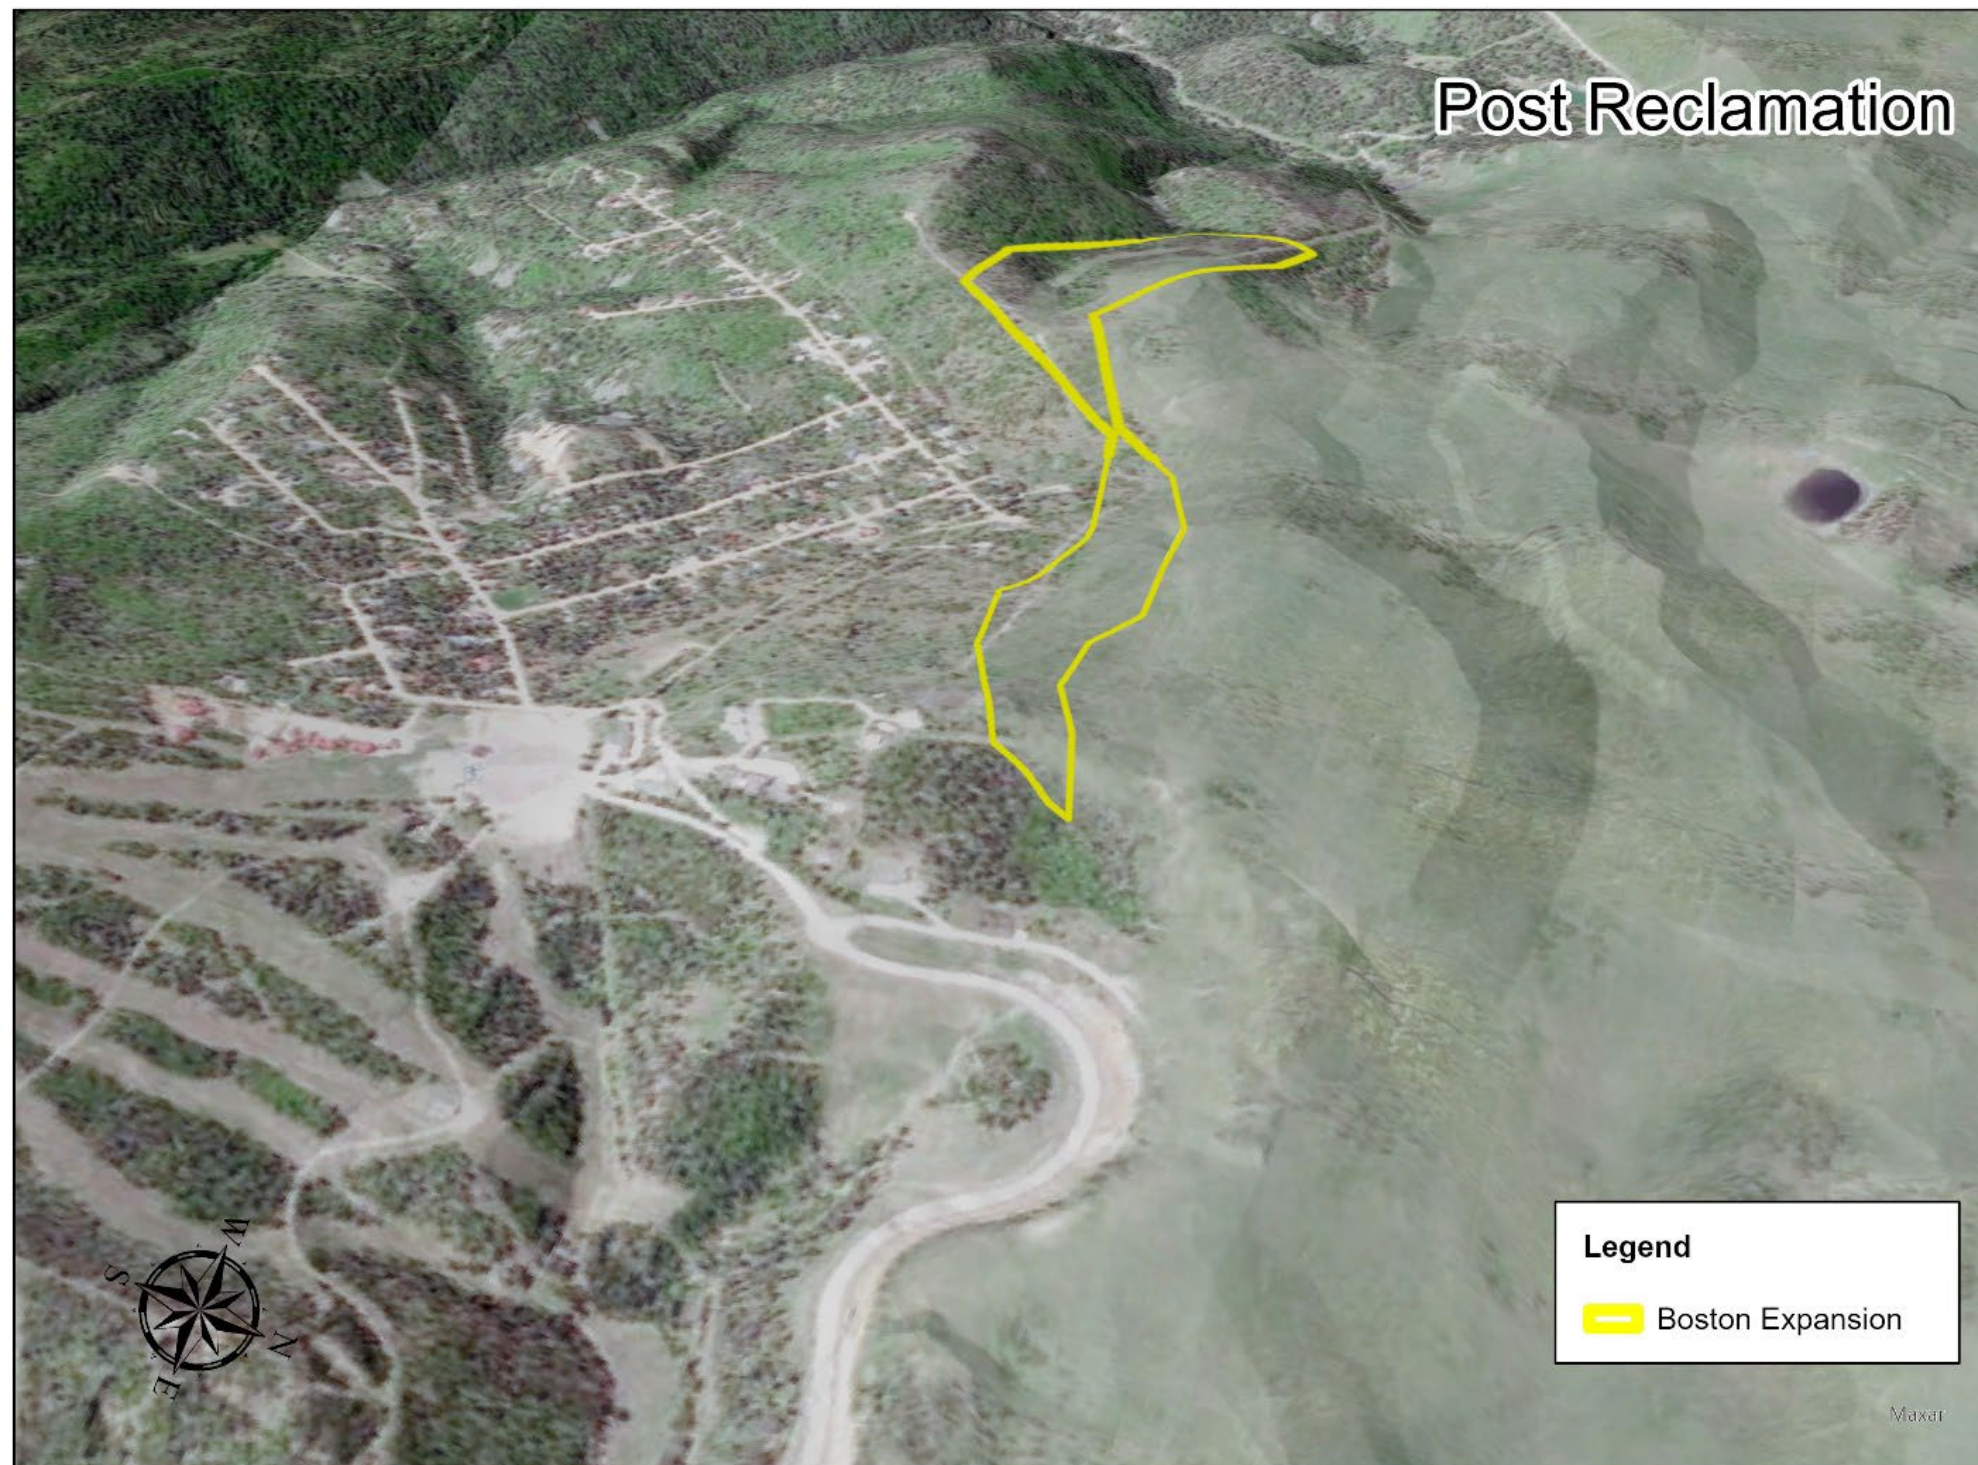
**Figure 9.** Maximum Pit / Post-Build Construction Contours Oblique View from East Draped with Conceptual Imagery

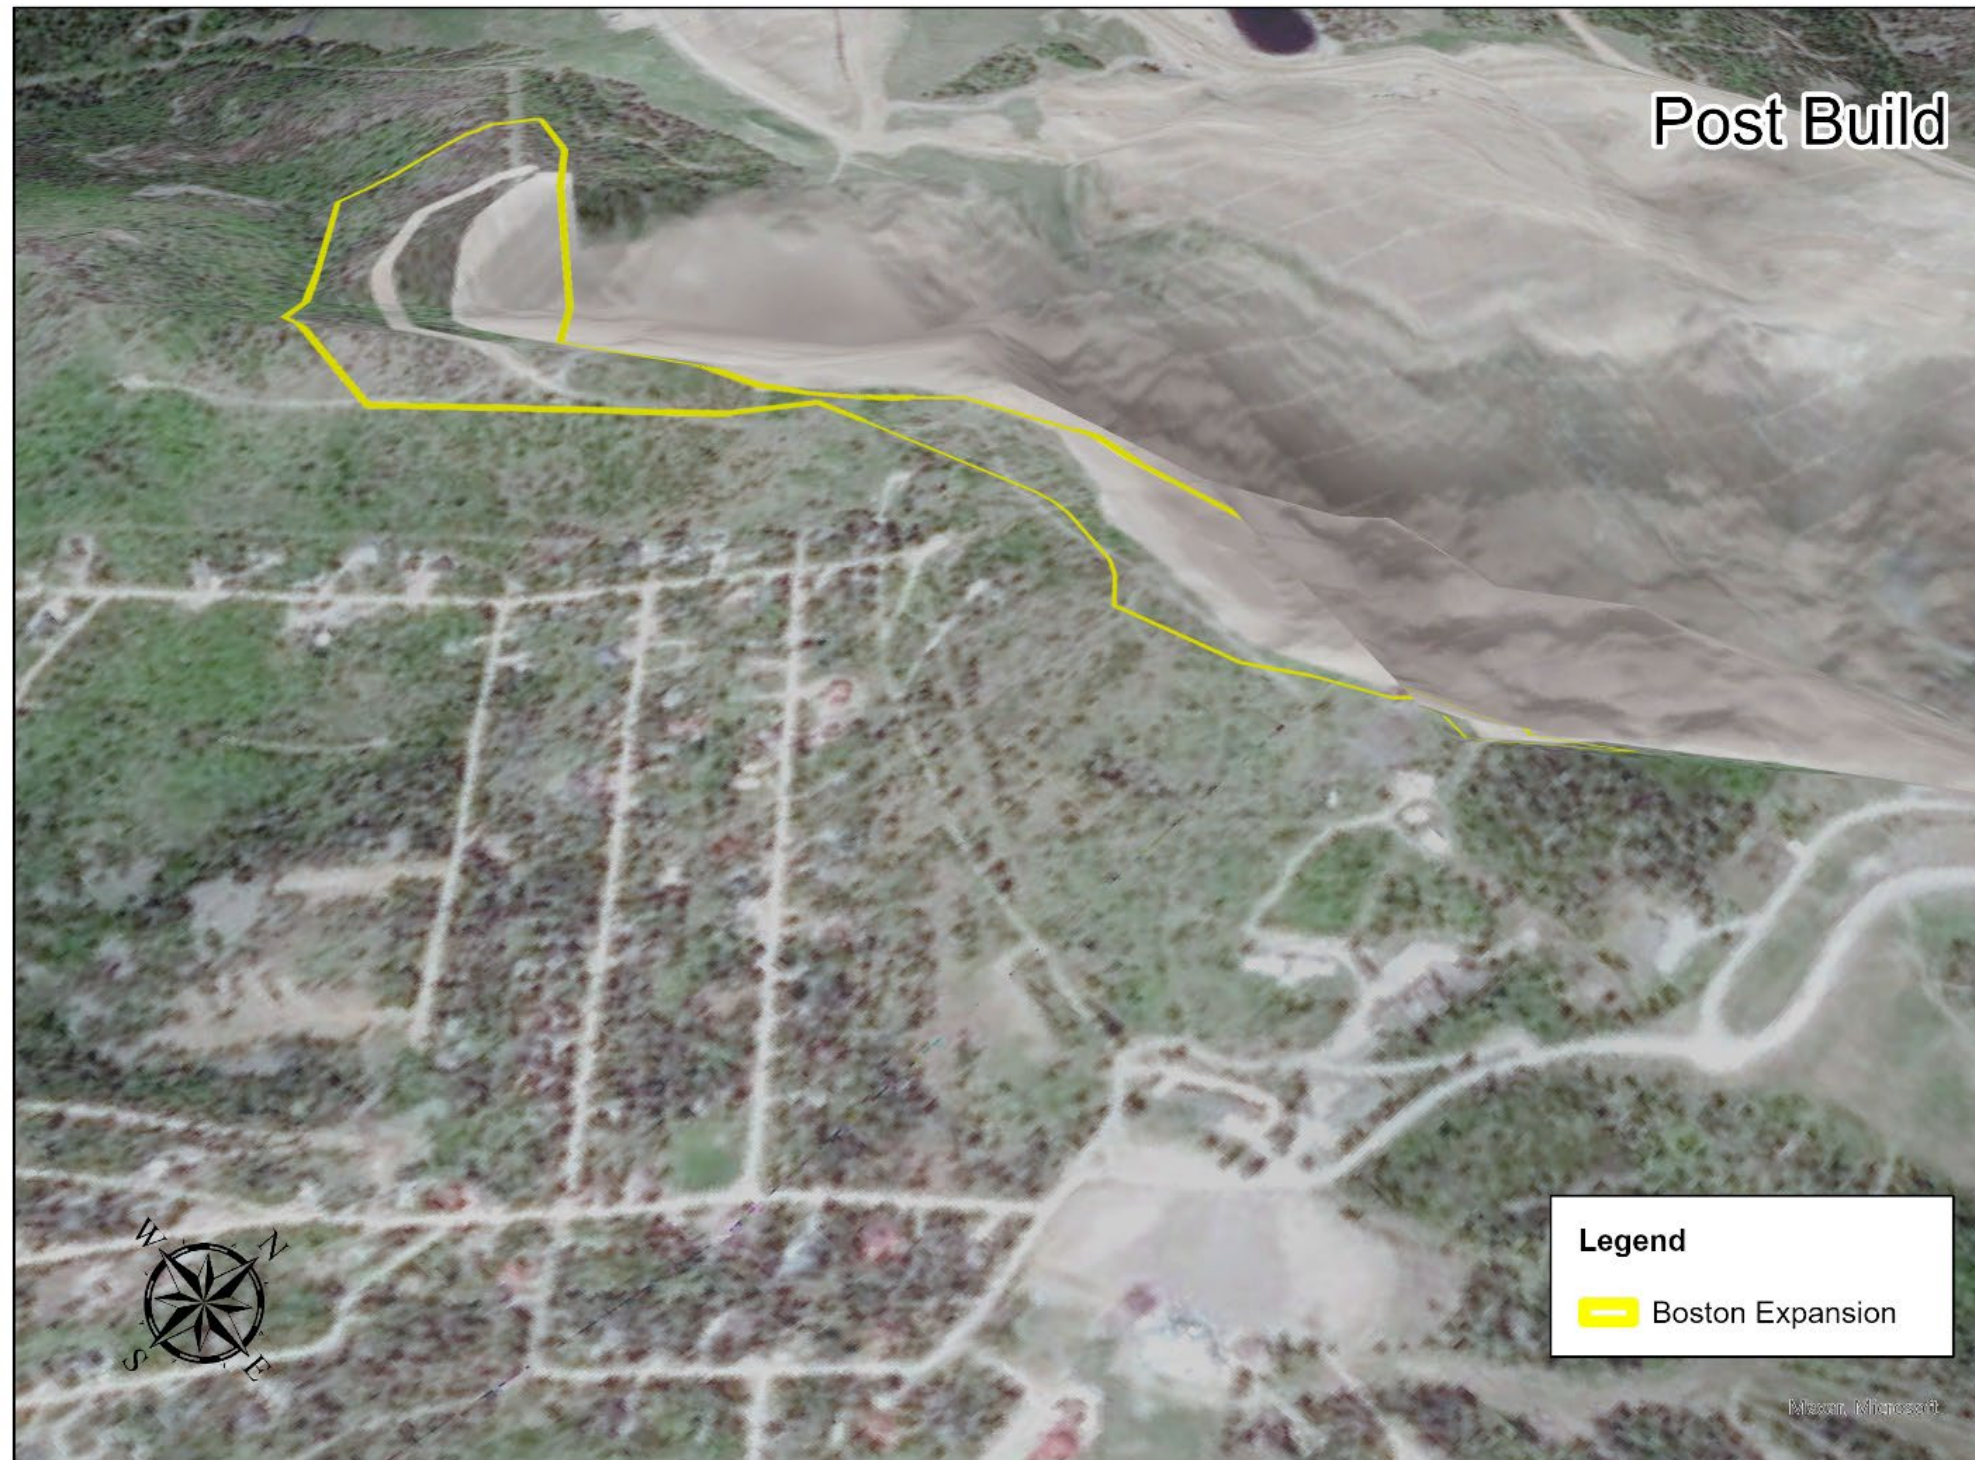
**Figure 10.** Maximum Pit / Post-Build Construction Contours Oblique View from SouthEast Draped with Conceptual Imagery

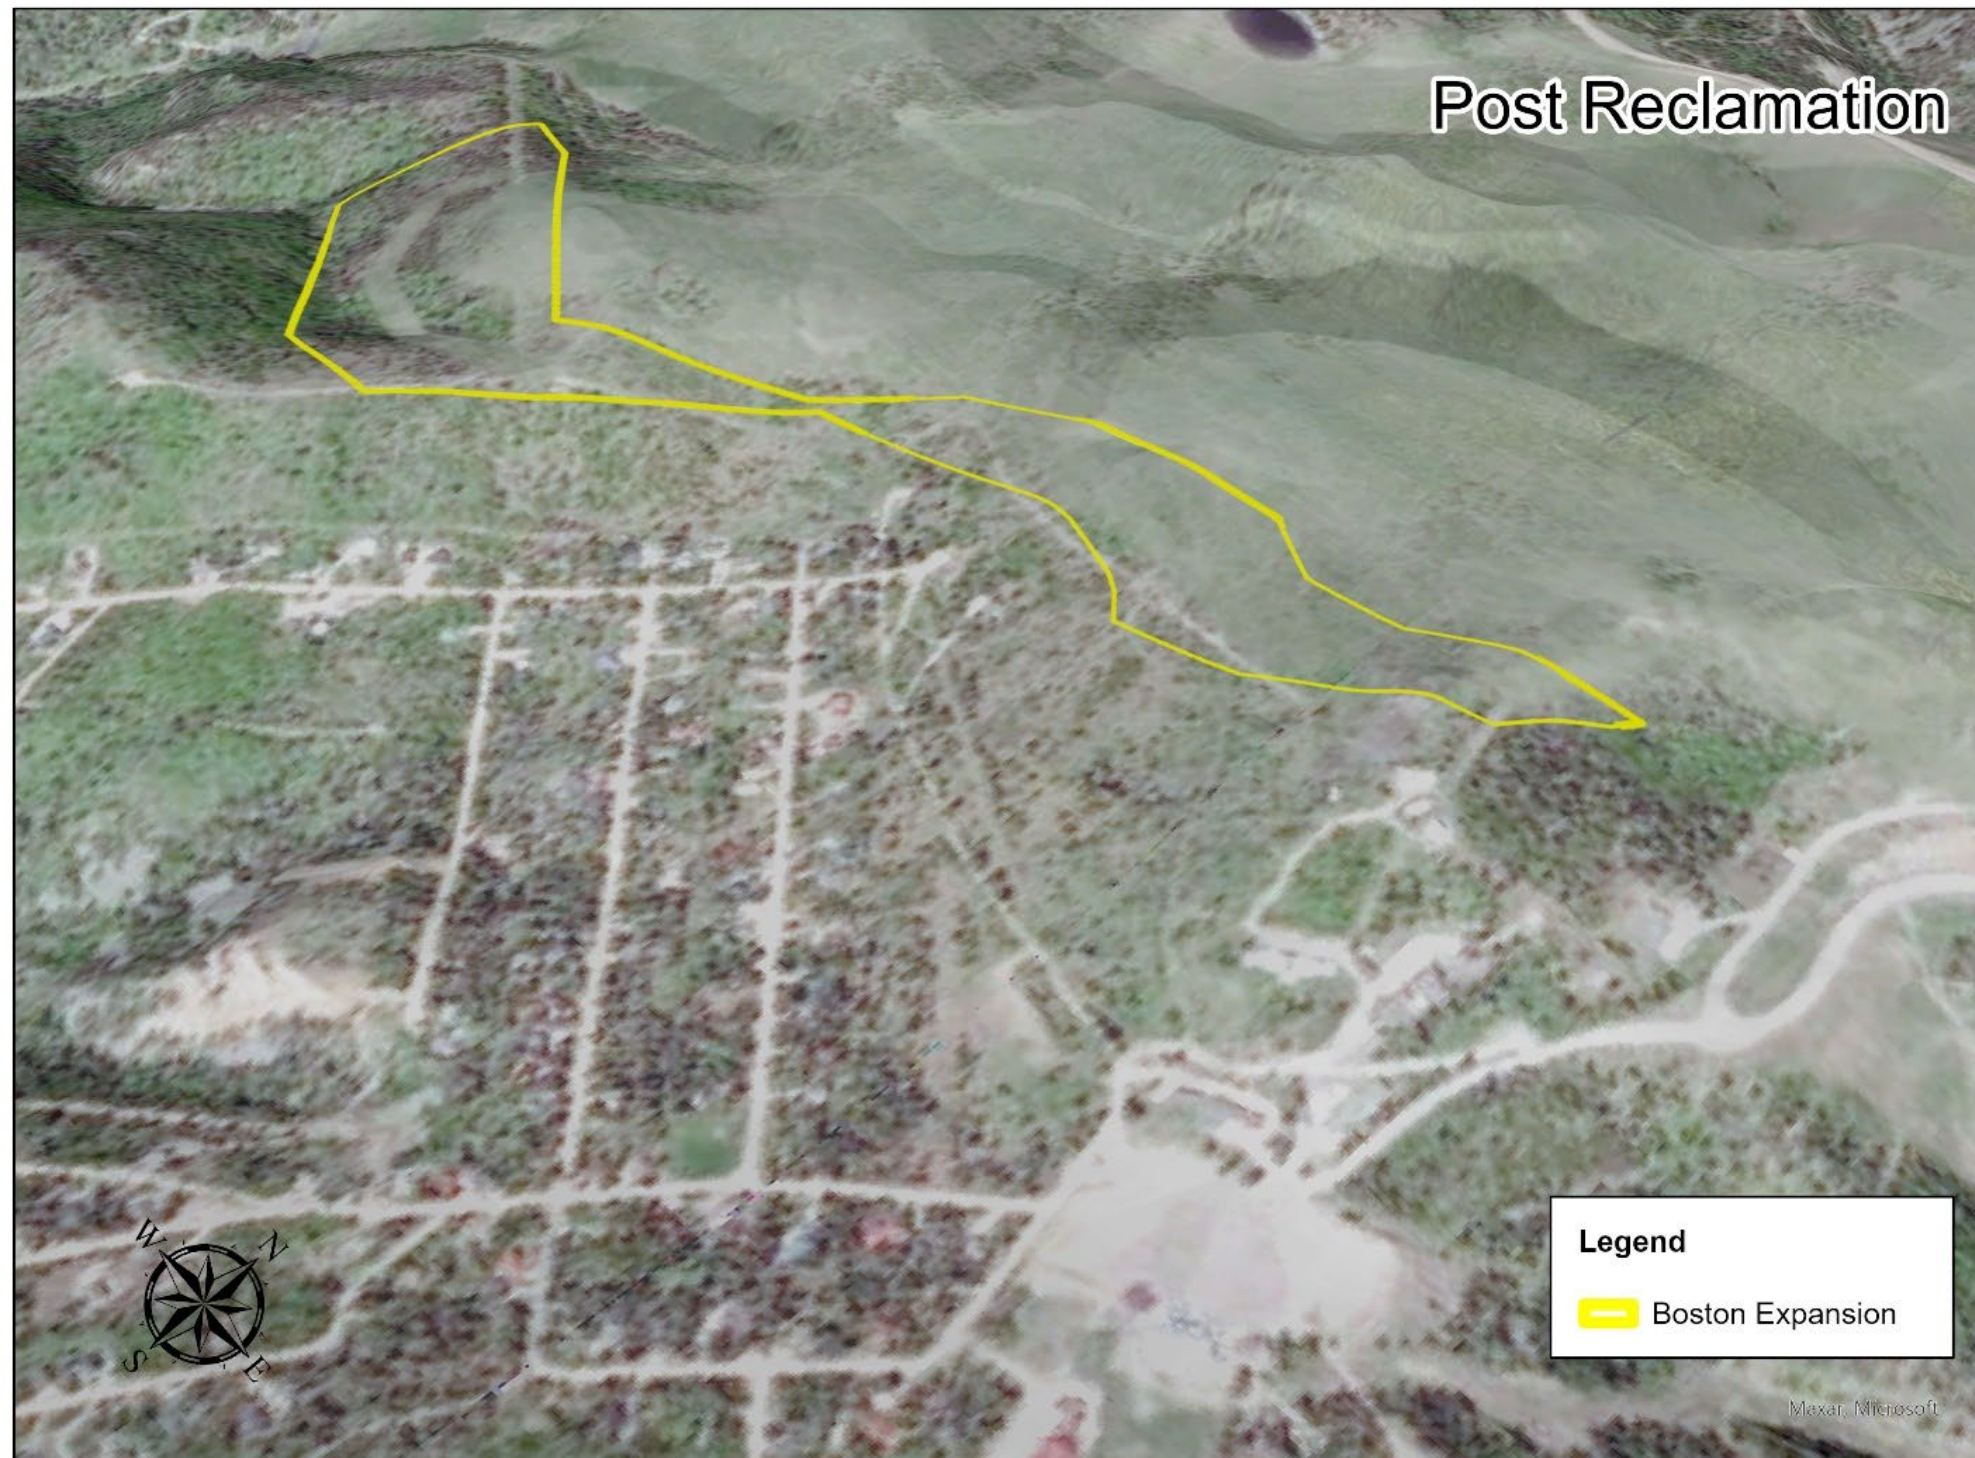
**Figure 11.** Reclaimed Contours Oblique View from SouthEast Draped with Conceptual Imagery

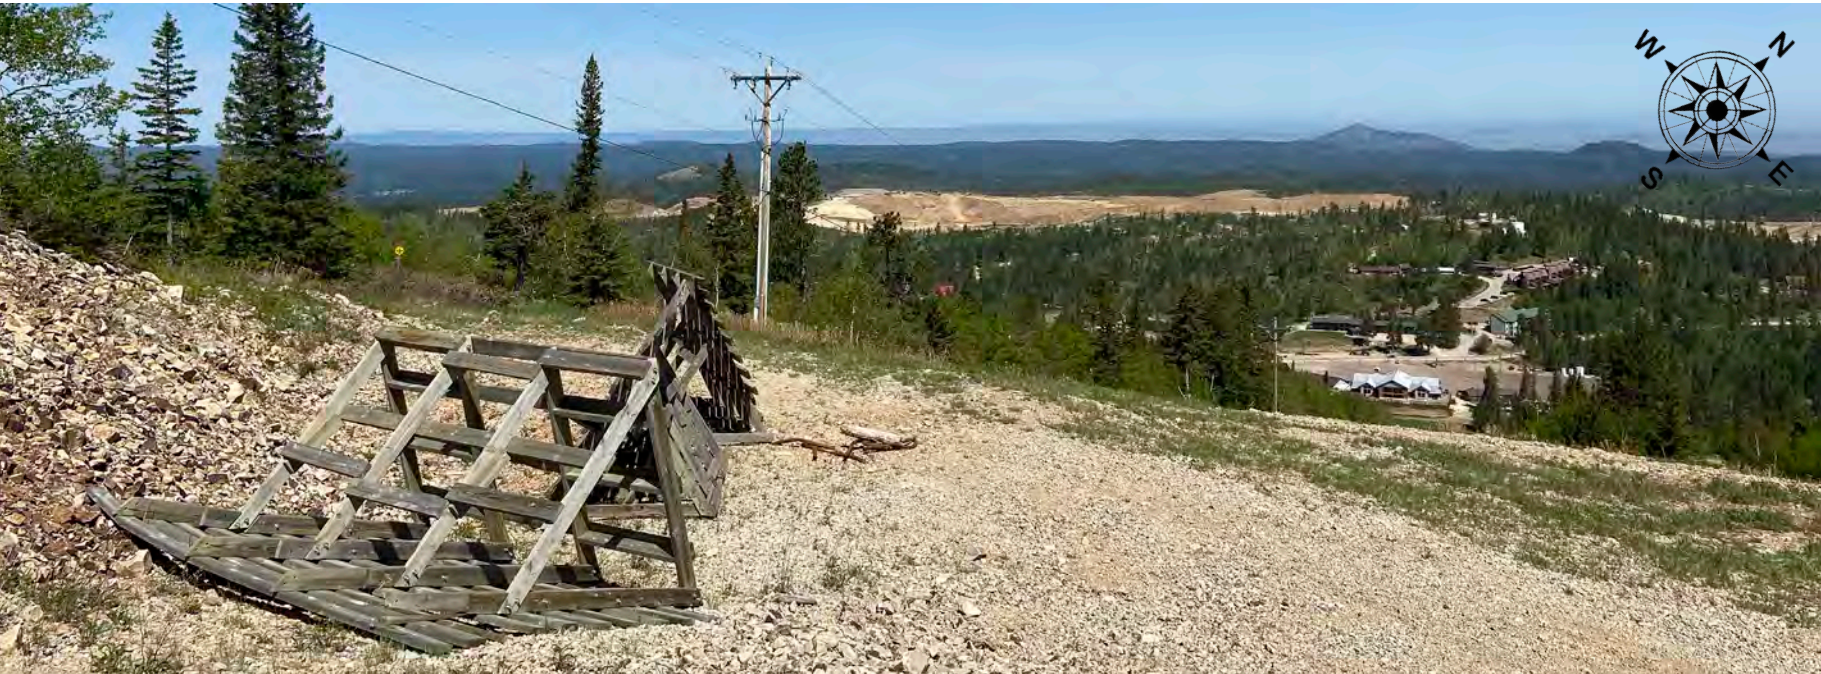
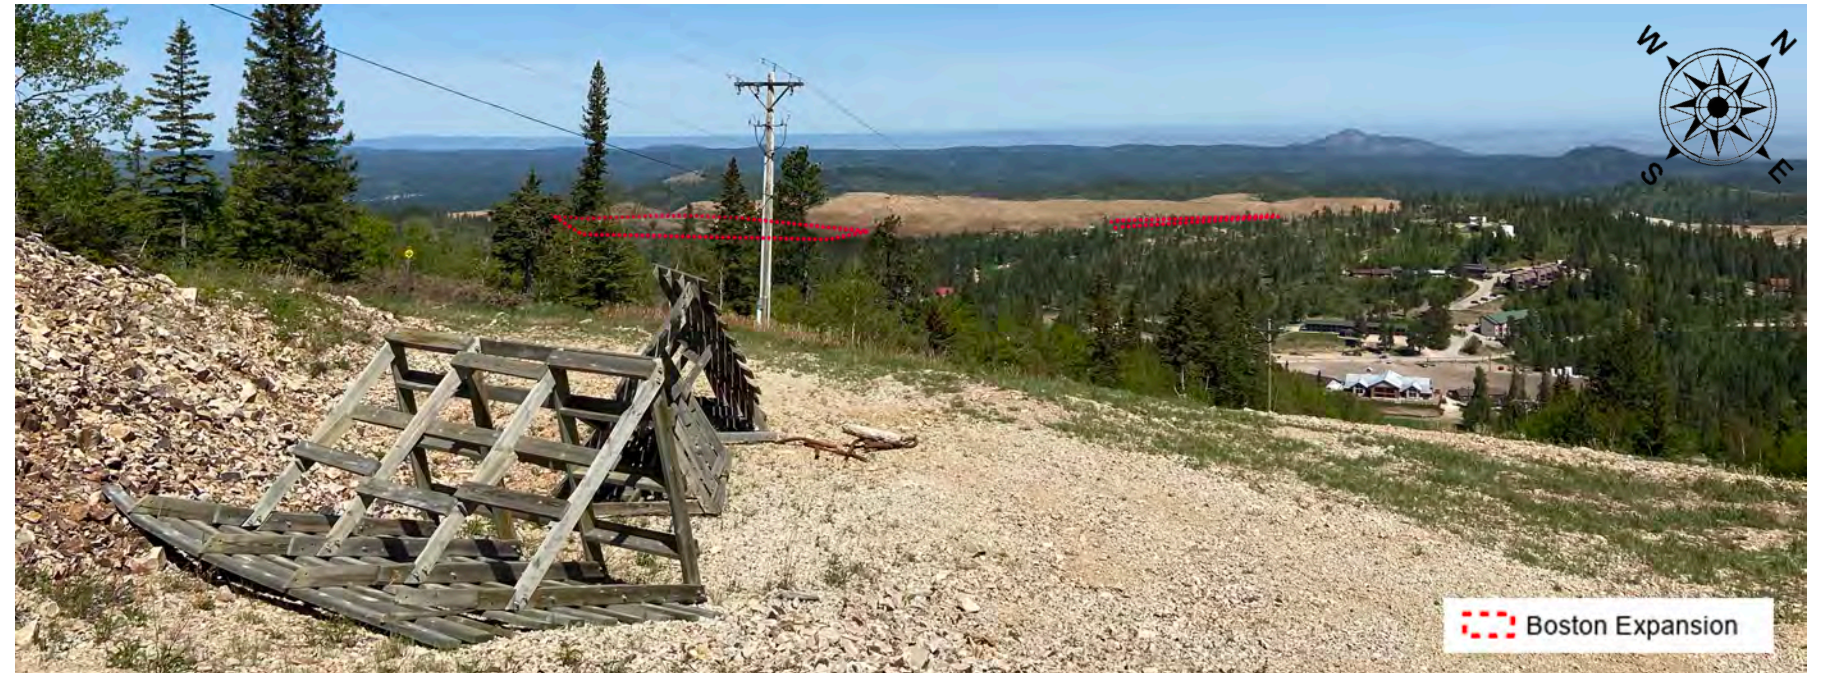
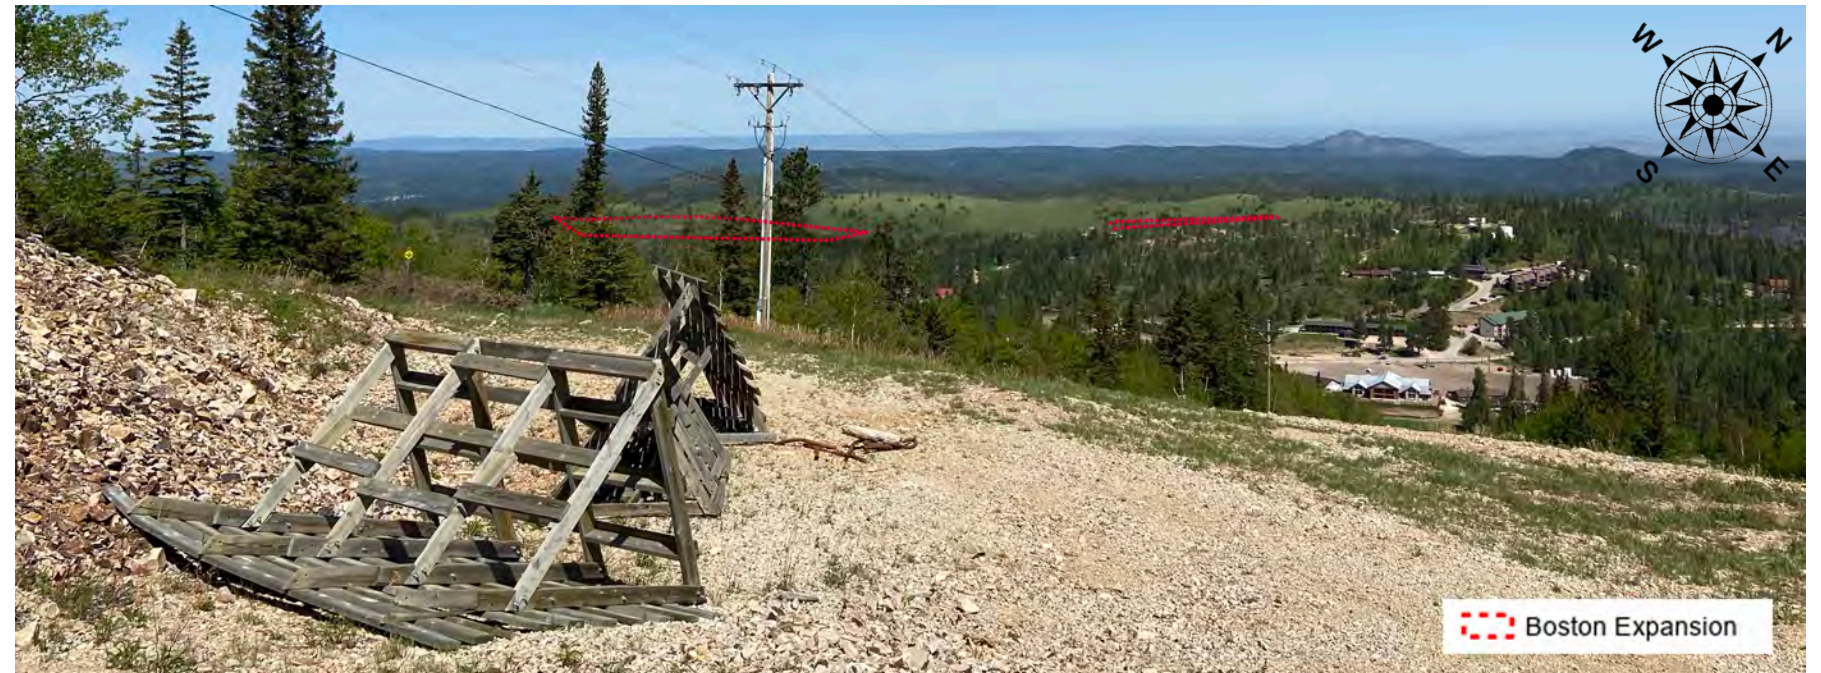
VISUAL SIMULATION  
VANTAGE POINT 1 NW  
(Terry Peak Summit overlooking  
Wharf)

Existing Conditions - VP 1 NW (Terry Peak Summit overlooking Wharf)

Post Build Computer Simulation - VP 1 NW (Terry Peak Summit overlooking Wharf)

Reclaimed Computer Simulation - VP 1 NW (Terry Peak Summit overlooking Wharf)

Latitude (WGS 84): 44.329289  
Longitude (WGS 84): -103.835139  
Elevation (NAD 83/ft): 6,952.84  
Camera Height (ft): 5.5  
Orientation of View: NW  
Distance to Project (mi): 1.20  
Date of Photography: 2021-06-08

VP 1 is located at the top of the Terry Peak ski resort and has a large field of view. The biggest visual change at VP 1 is the change in land cover between post-build and post-reclamation of existing permitted disturbance. The majority of the Boston Expansion is not visible, though small areas may be visible depending upon exact viewing location and vegetation screening.
