Coeur Wharf  
Wharf Boston Visual Simulation

WHARF BOSTON  
EXPANSION

## Wharf Fence-Line and Lost Camp Subdivision Photographs December 30, 2021 and January 20, 2022

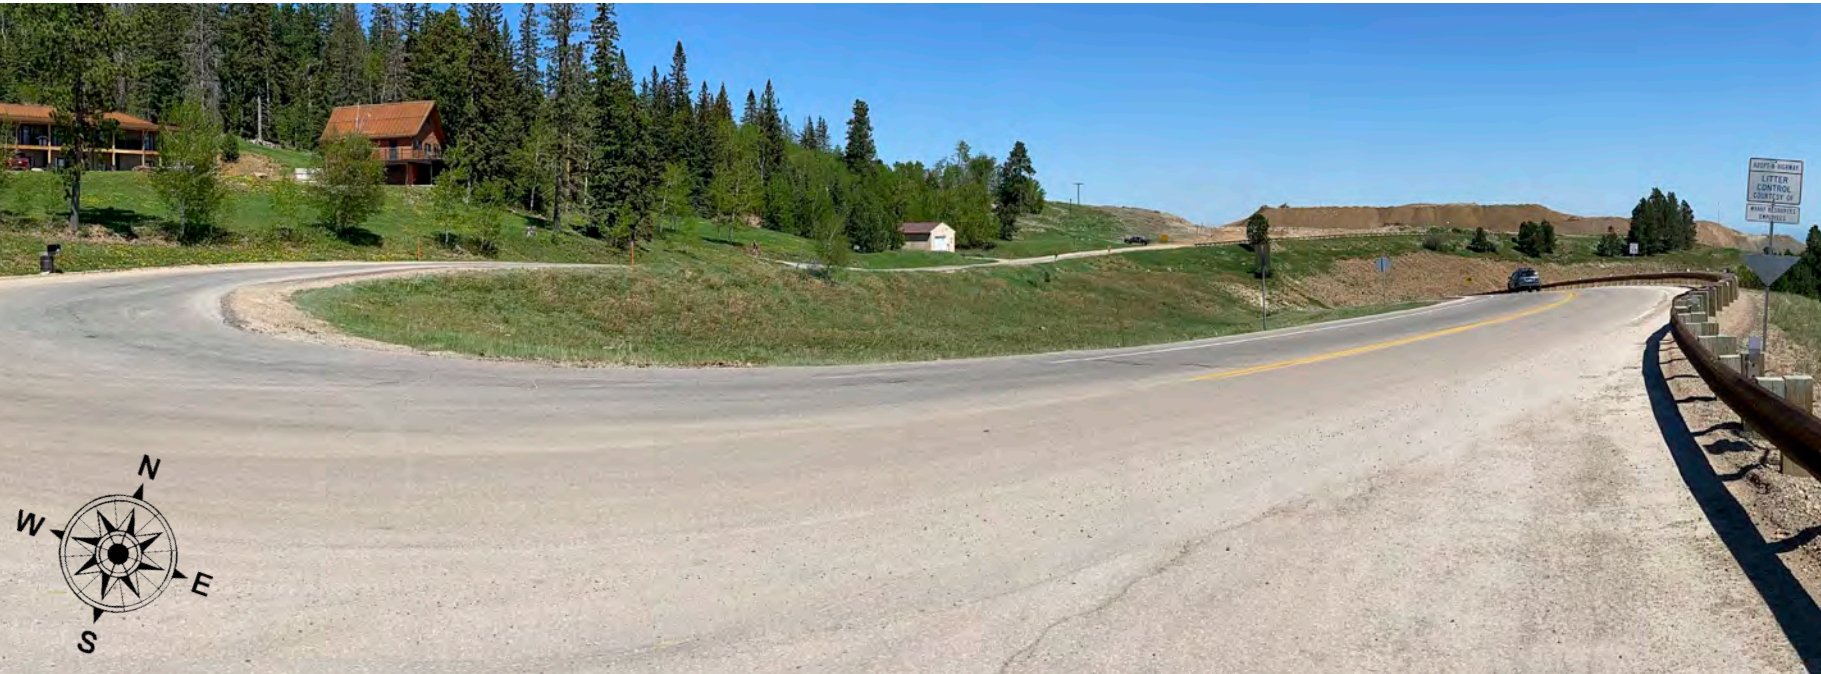
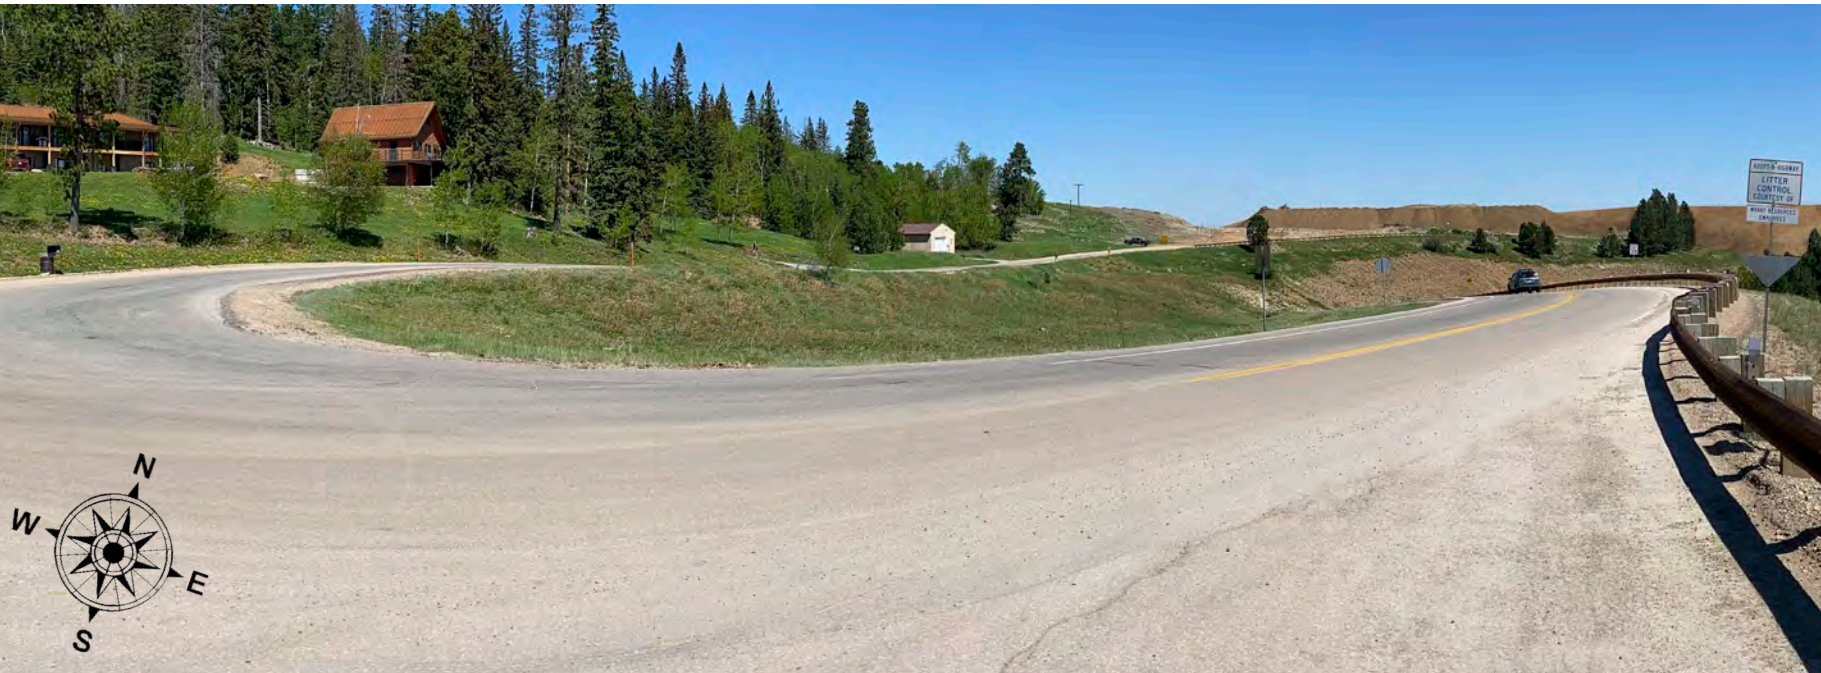
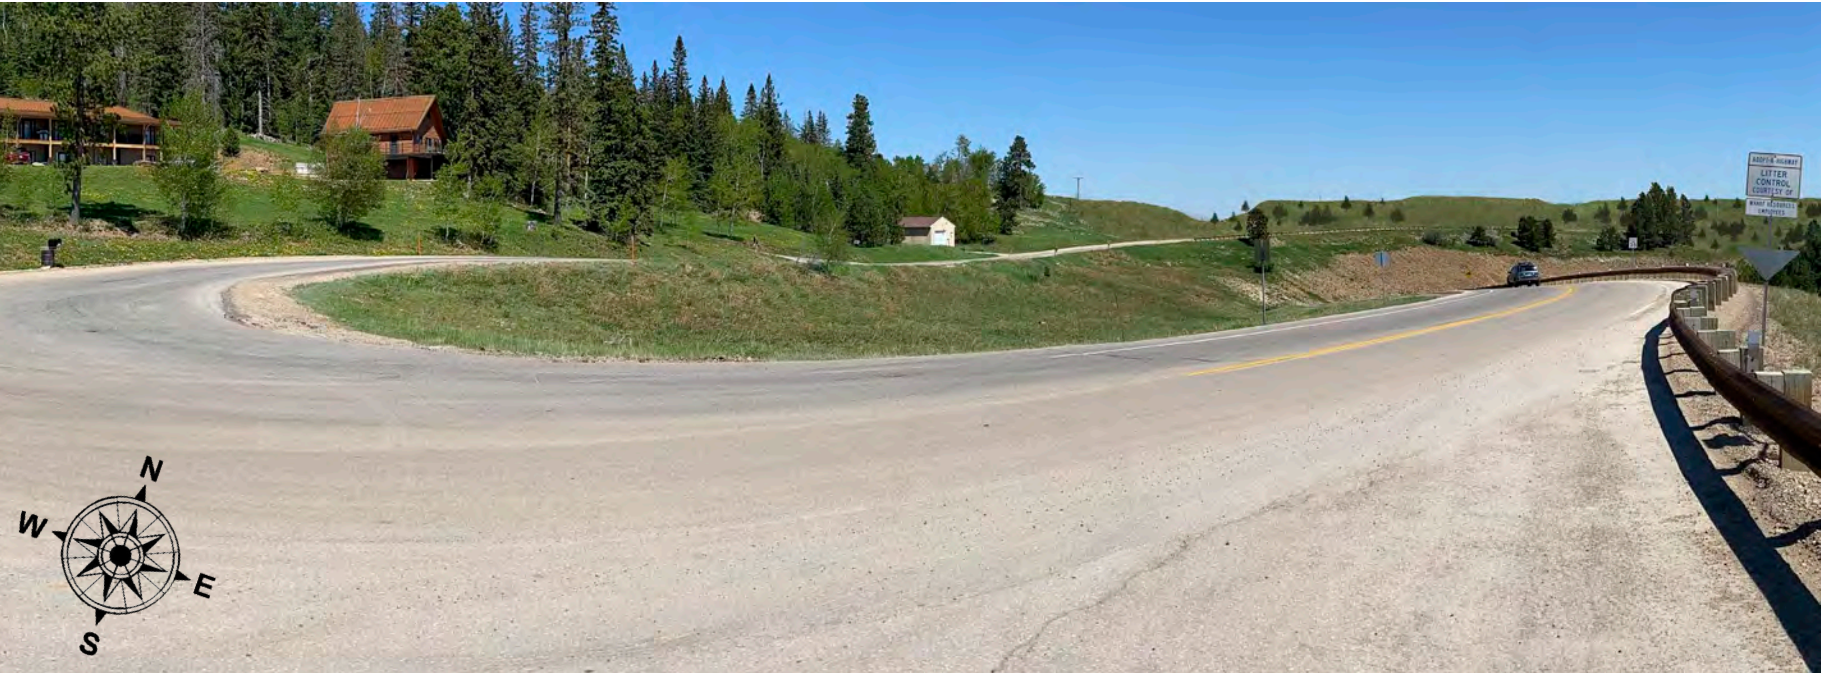
**VISUAL SIMULATION**  
VANTAGE POINT 4 NNW  
(Top of Nevada Gulch Road and  
intersection of Stewart Road)

Existing Conditions - VP 4 NNW (Top of Nevada Gulch Road and intersection of Stewart Road)

Post Build Computer Simulation - VP 4 NNW (Top of Nevada Gulch Road and intersection of Stewart Road)

Reclaimed Computer Simulation - VVP 4 NNW (Top of Nevada Gulch Road and intersection of Stewart Road)

Latitude (WGS 84): 44.338535  
Longitude (WGS 84): -103.839483  
Elevation (NAD 83/ft): 6,459.90  
Camera Height (ft): 5.5  
Orientation of View: NNW  
Distance to Project (mi): 0.29  
Date of Photography: 2021-06-08

VP 4 is located on Highway 473 (Nevada Gulch Road), higher in elevation, with a clear view of the Green Mountain Pit area and Deep Portland area. These areas also show a bigger change in land cover as opposed to topography. At VP 4 looking NNW, removal of a few trees along the ridgeline may be noticeable, but overall visual impacts from the Boston Expansion will be minimal.

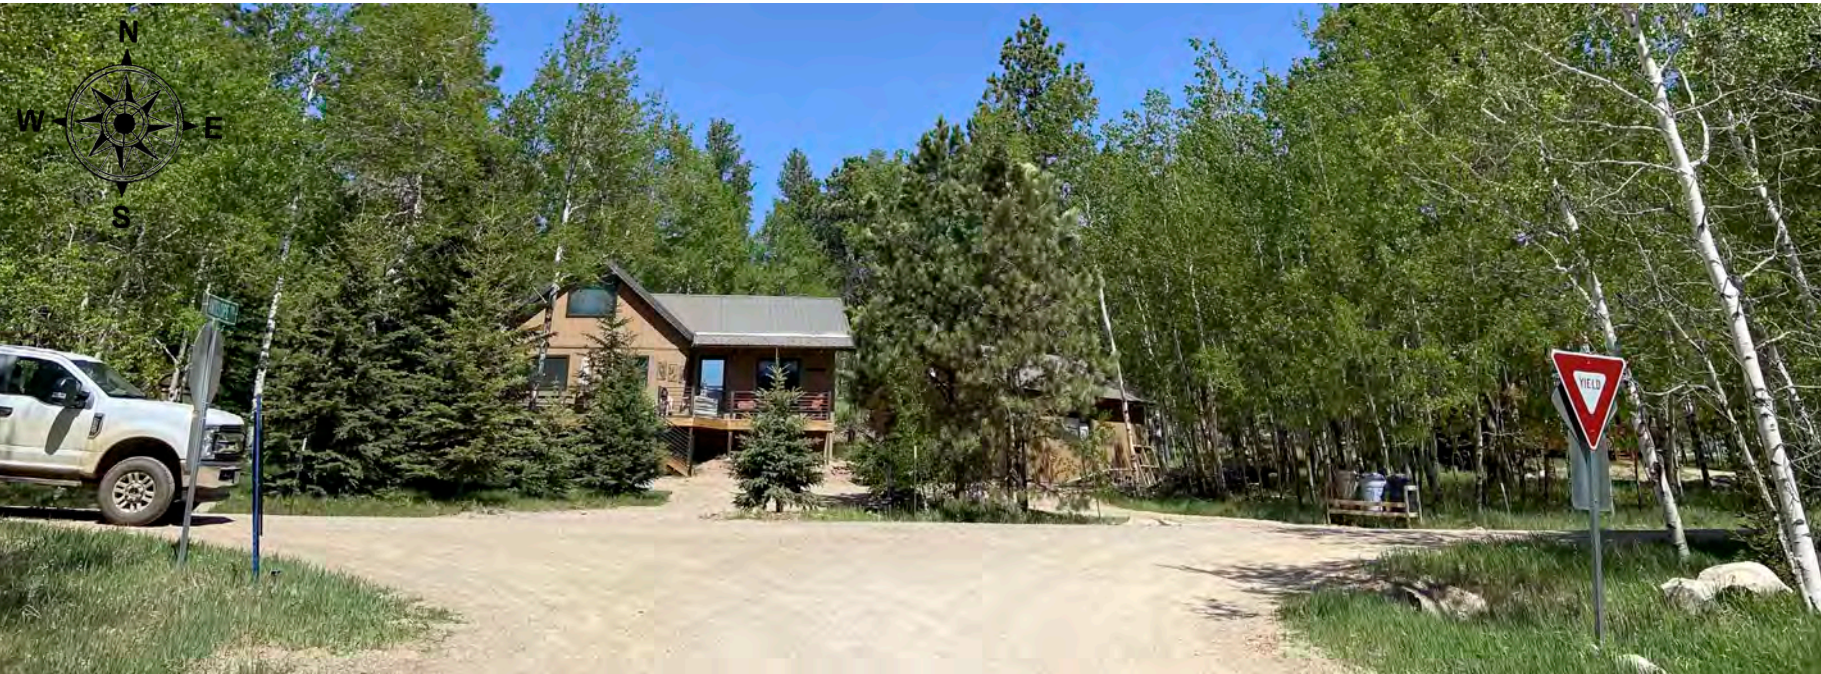
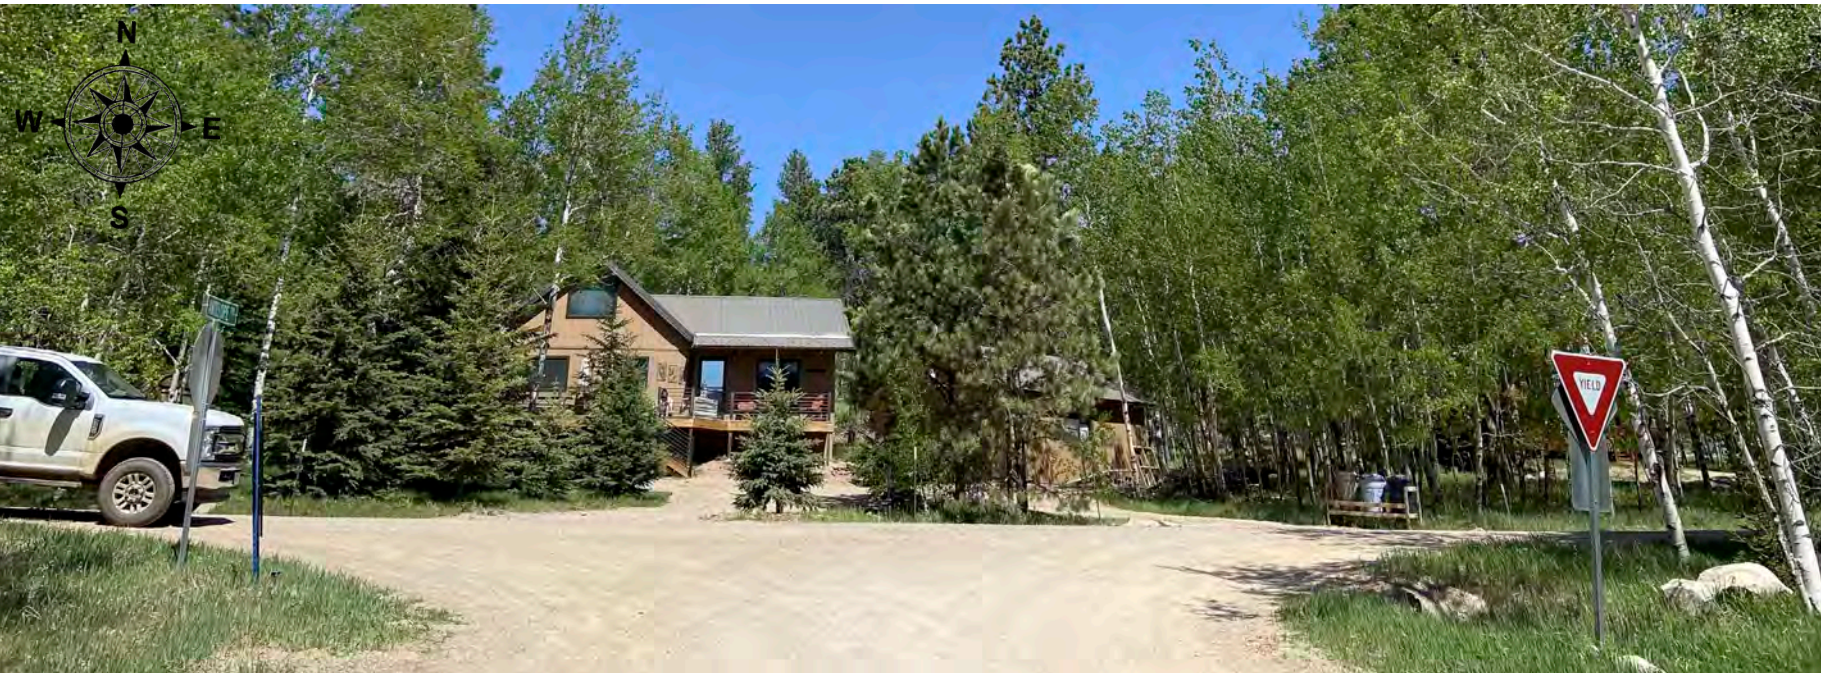
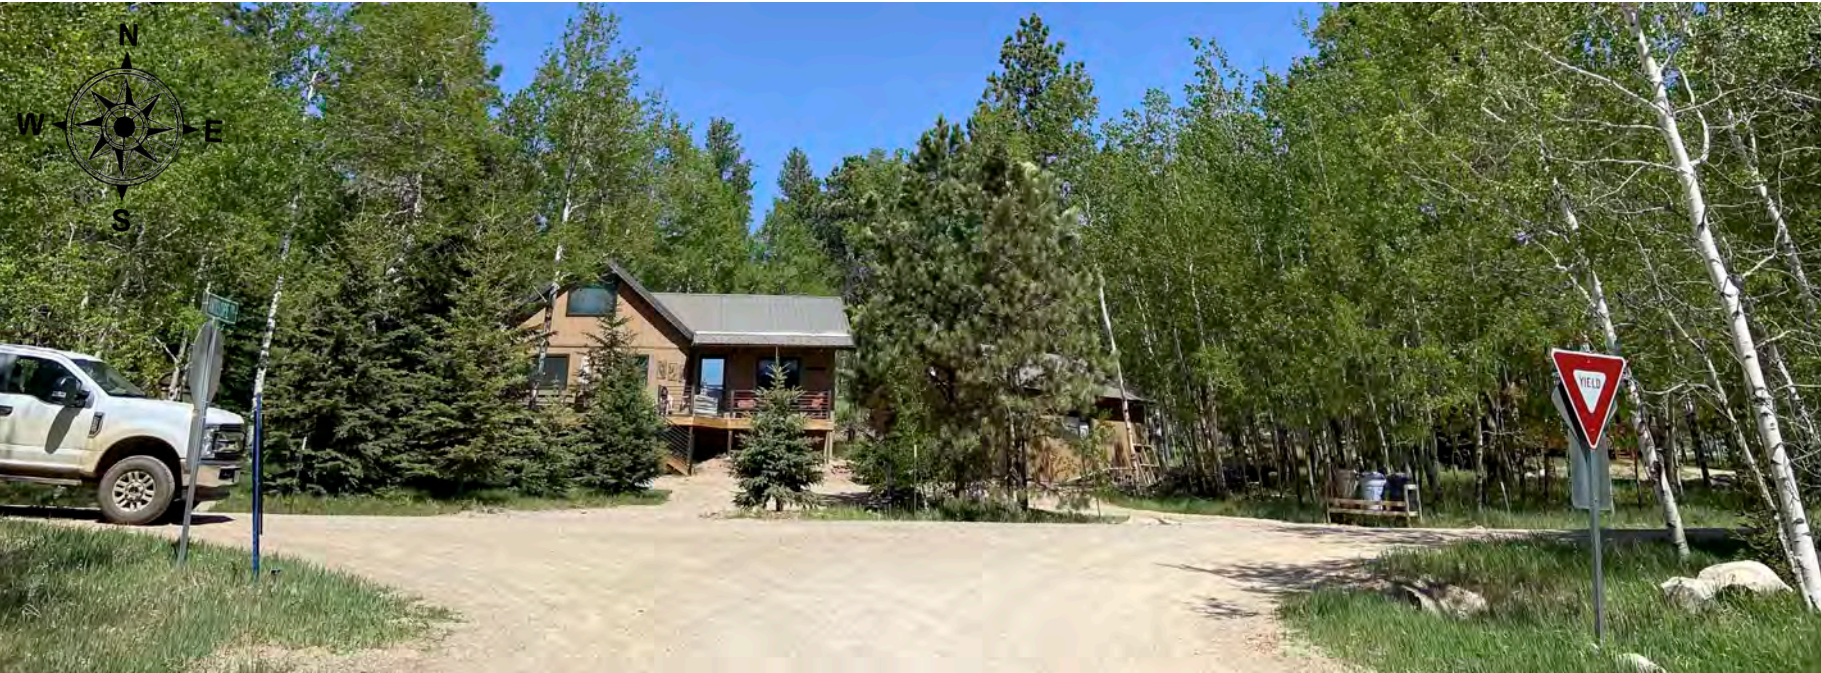
VISUAL SIMULATION  
VANTAGE POINT 7 N  
(Antelope and Last Chance intersection)

Existing Conditions - VP 7 N (Antelope and Last Chance intersection)

Post Build Computer Simulation - VP 7 N (Antelope and Last Chance intersection)

Reclaimed Computer Simulation - VP 7 N (Antelope and Last Chance intersection)

Latitude (WGS 84): 44.335548  
Longitude (WGS 84): -103.851599  
Elevation (NAD 83/ft): 6,357.64  
Camera Height (ft): 5.5  
Orientation of View: N  
Distance to Project (mi): 0.53  
Date of Photography: 2021-06-08

Views from within the Lost Camp subdivision (VP 7 and VP 8) were from public roads rather than private residences, as is industry standard. These VPs just happen to face residences and demonstrate the amount of current vegetation and topography blocking visibility in these areas. The difference in view and visual impacts from VP 8 and the nearest residences are not anticipated to greatly vary. VP 9 is located on Perkins Road, looking south towards the American Eagle Pit. Visual changes are most apparent associated with changes permitted under an existing mine permit, though depending on exact viewpoint on Perkins Road, the change along the Portland Ridgeline resulting from mining within the Boston Expansion may be visible to residents or all-terrain vehicles (ATV) users on the road.

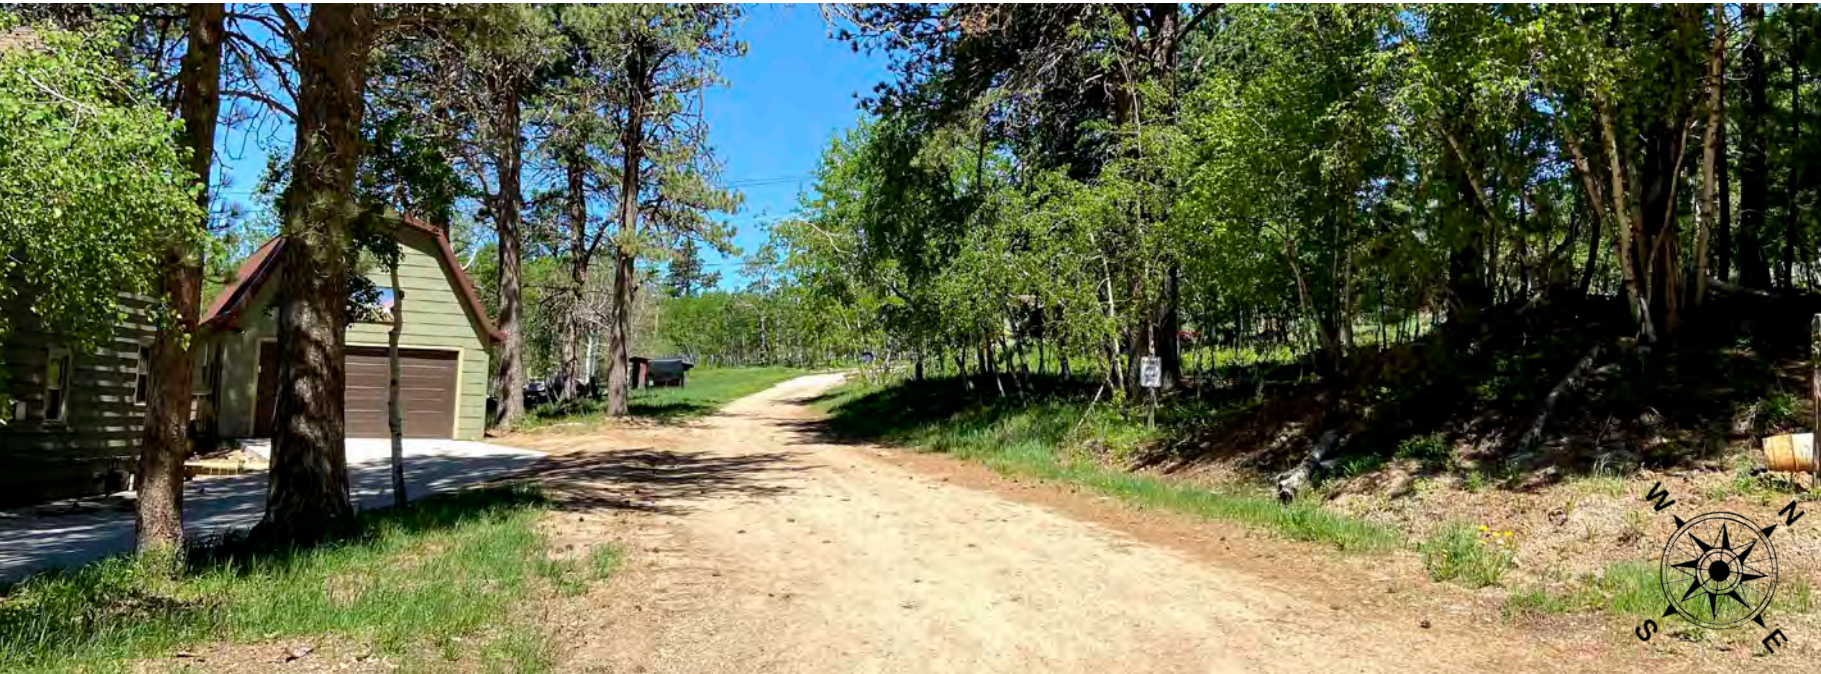
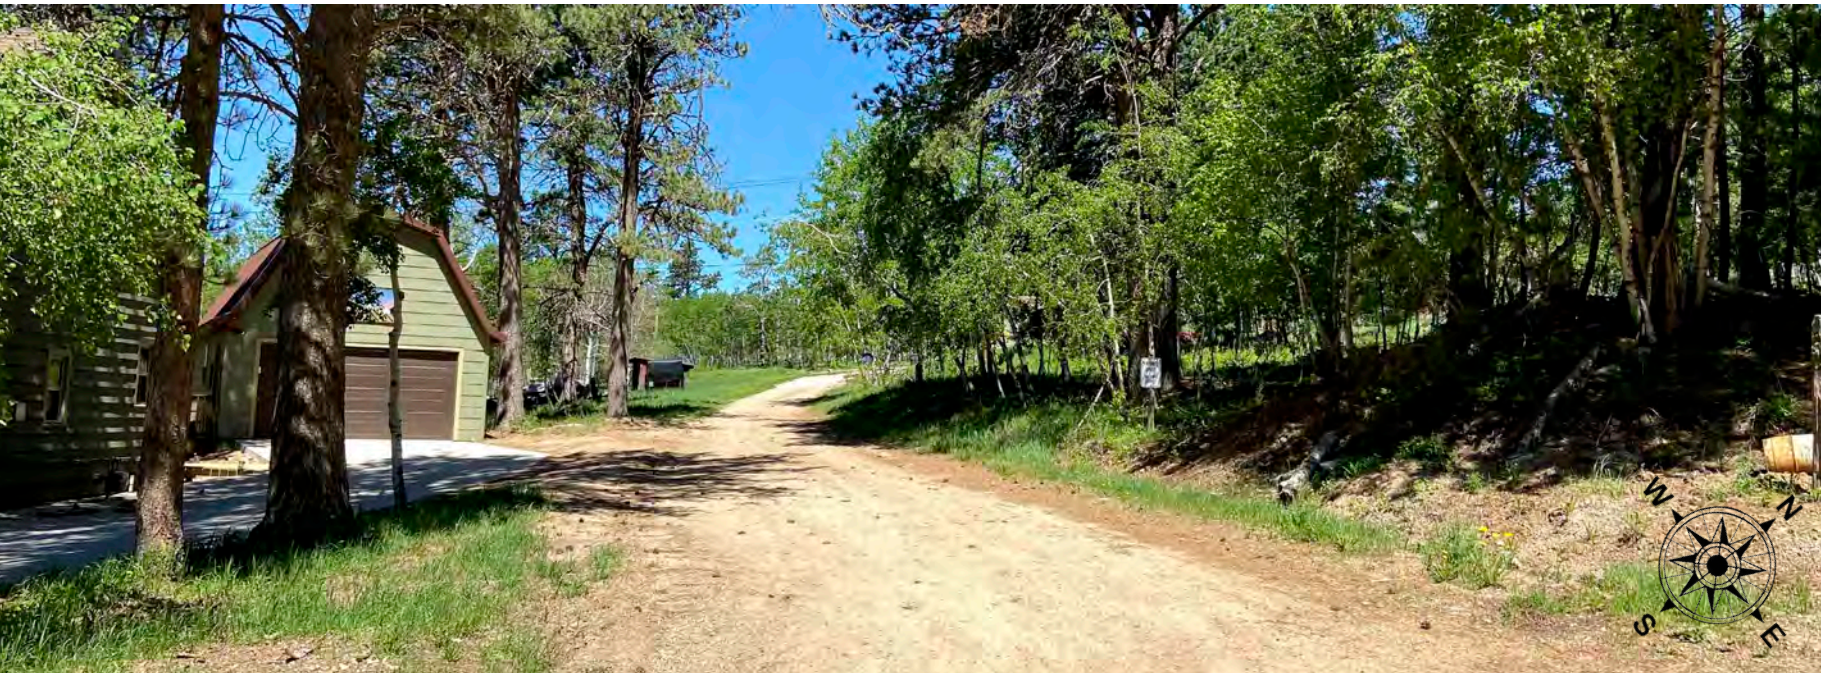
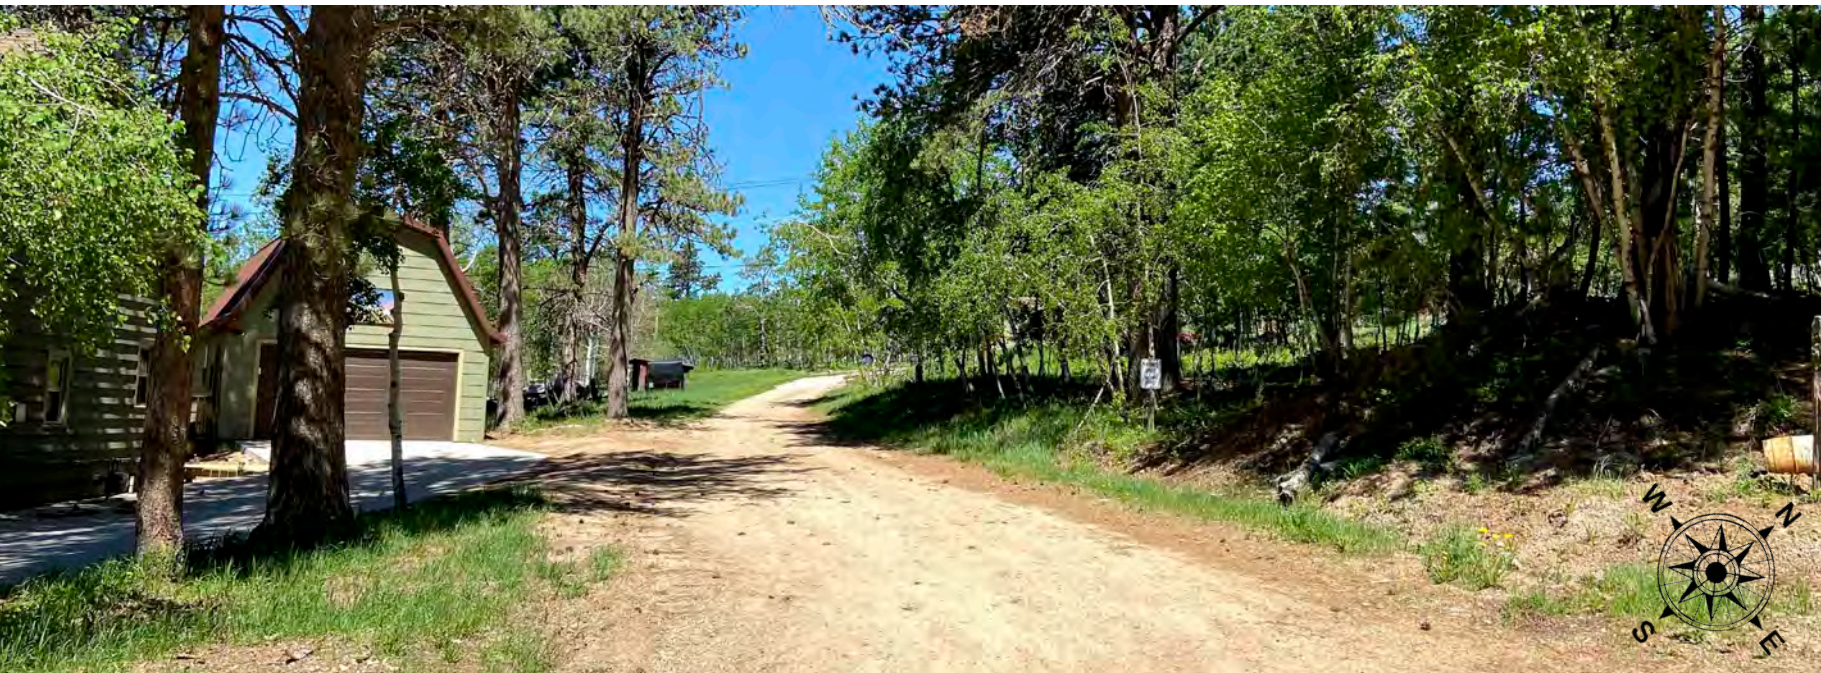
VISUAL SIMULATION  
VANTAGE POINT 8 NW  
(Toward Wharf/Thaler house)

Existing Conditions - VP 8 NW (Toward Wharf/Thaler house)

Post Build Computer Simulation - VP 8 NW (Toward Wharf/Thaler house)

Reclaimed Computer Simulation - VP 8 NW (Toward Wharf/Thaler house)

Latitude (WGS 84): 44.337615  
Longitude (WGS 84): -103.848877  
Elevation (NAD 83/ft): 6,419.77  
Camera Height (ft): 5.5  
Orientation of View: NW  
Distance to Project (mi): 0.40  
Date of Photography: 2021-06-10

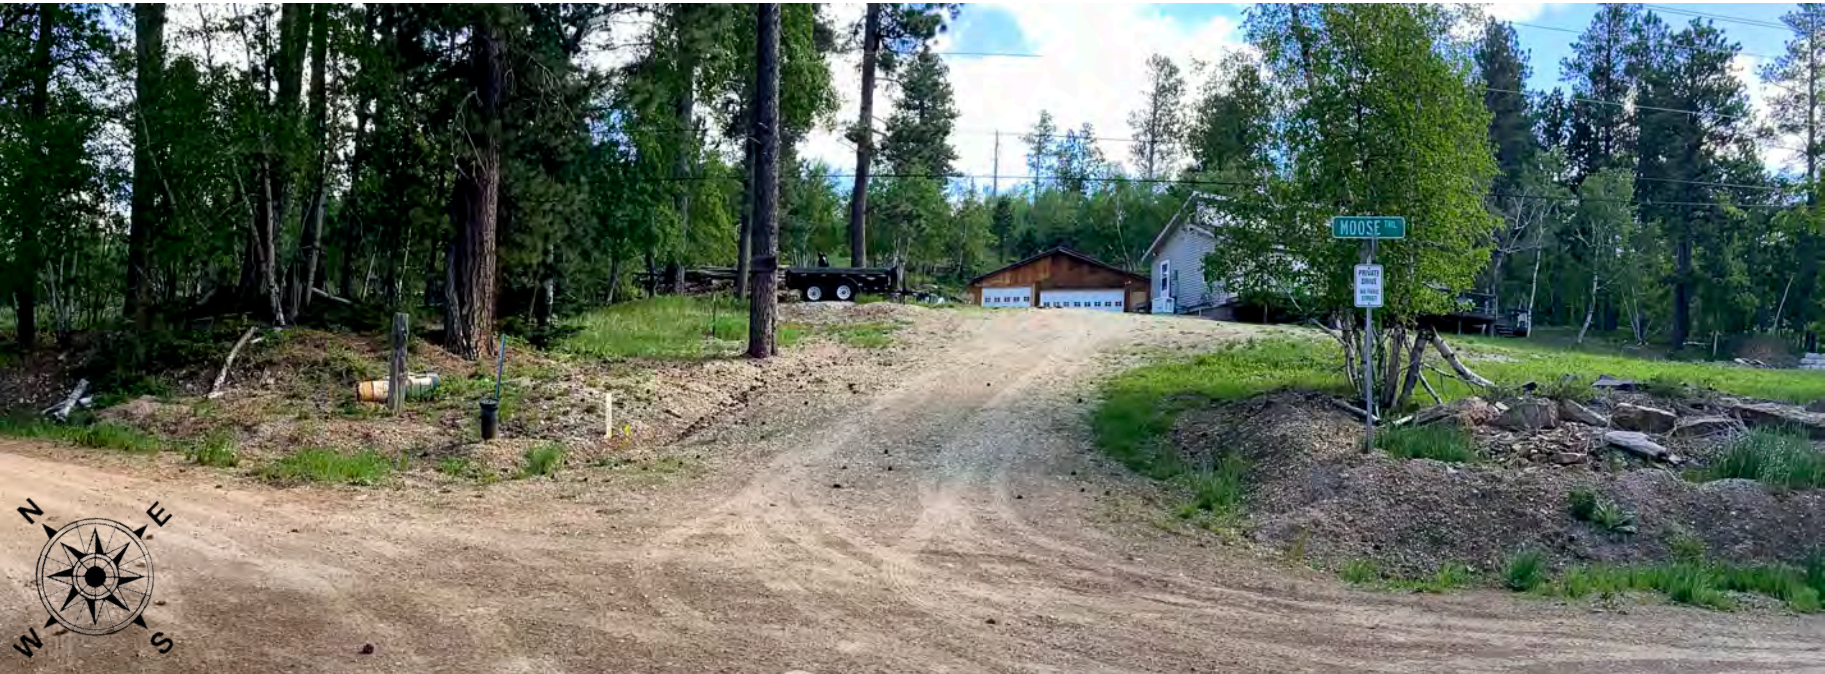
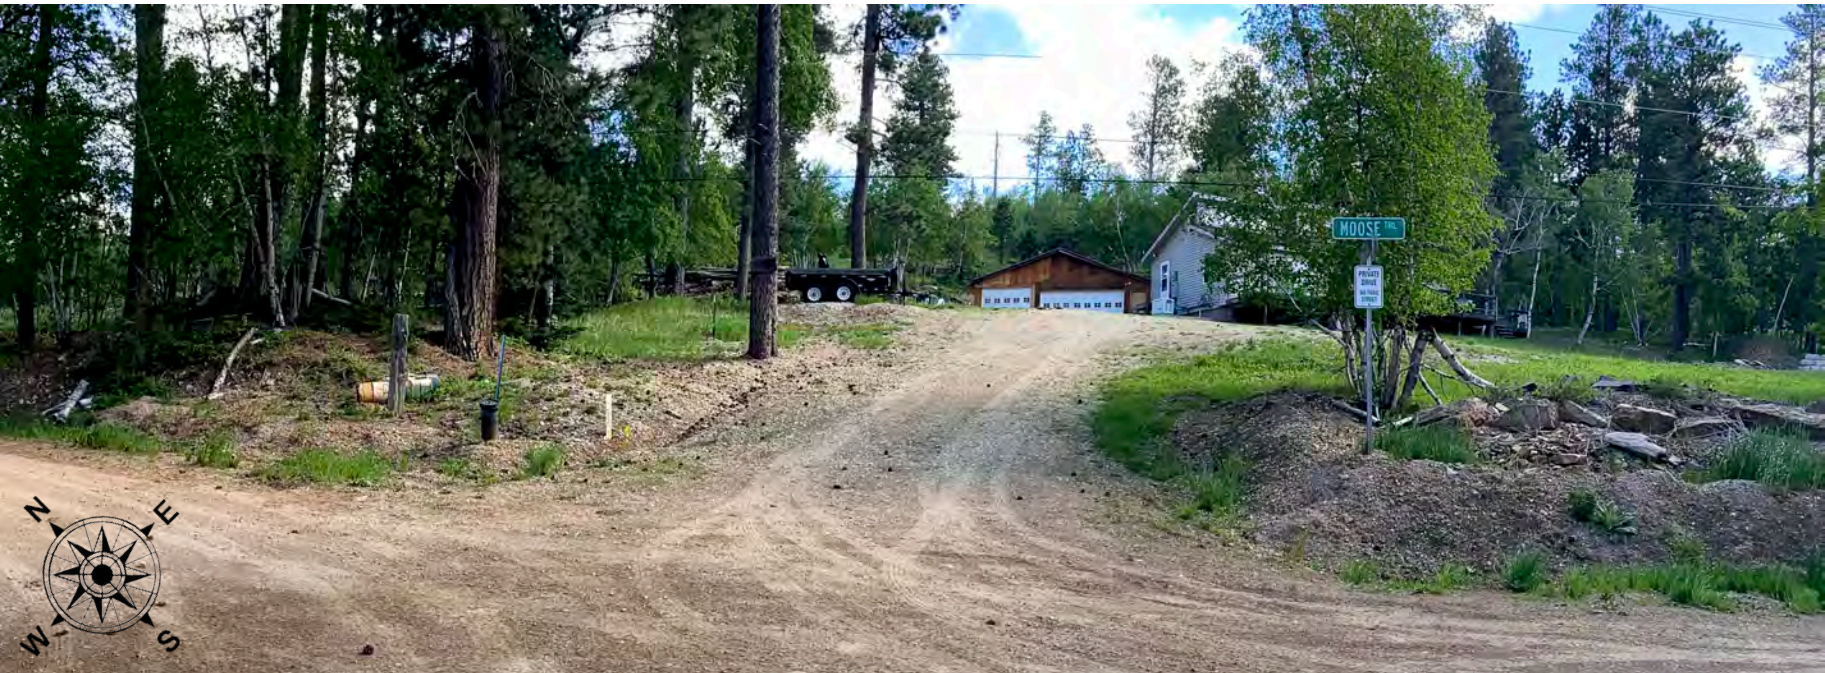
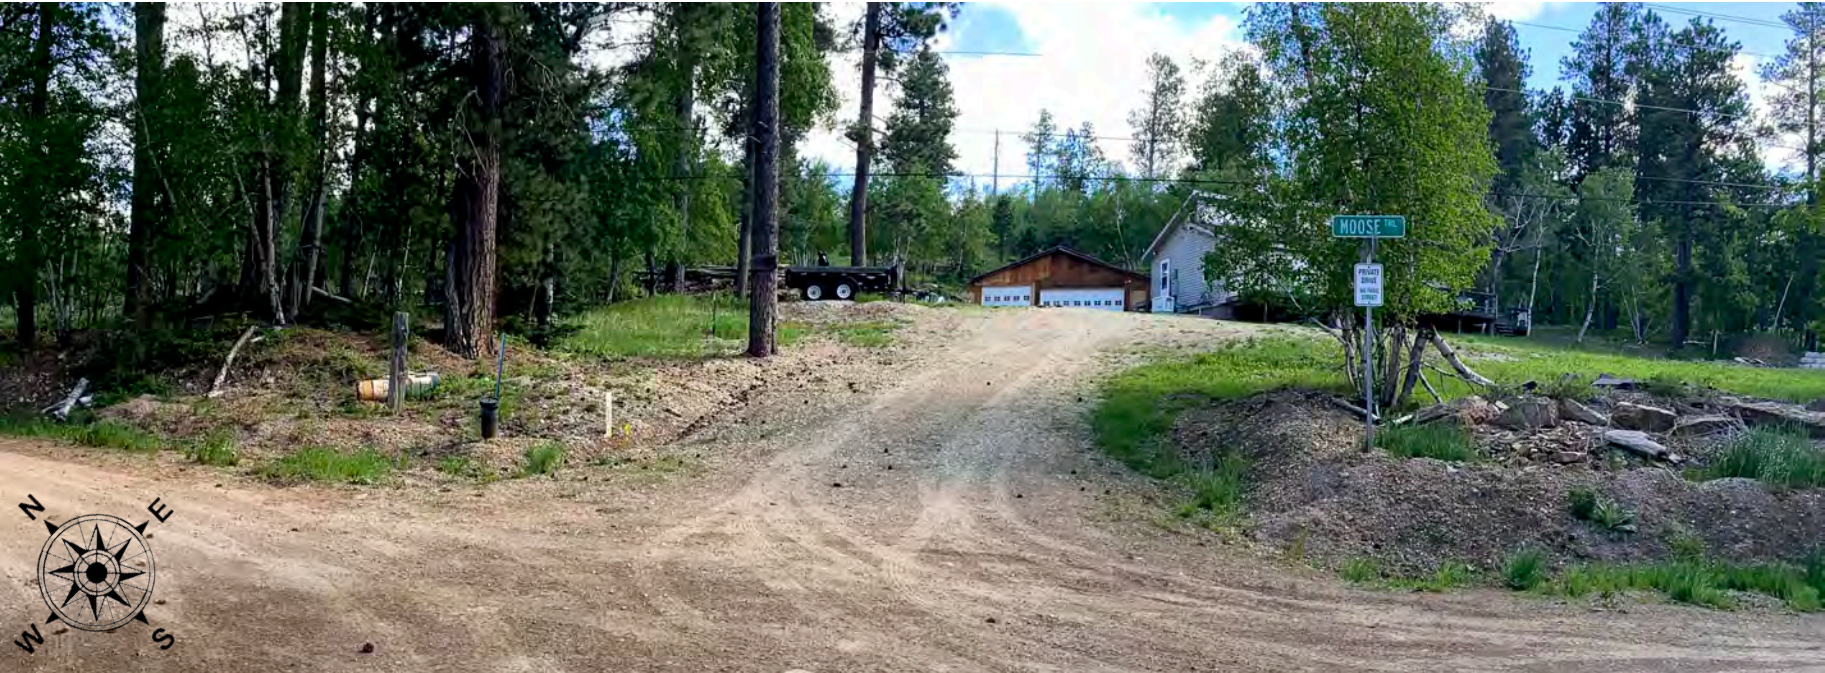
VISUAL SIMULATION  
VANTAGE POINT 8 NE  
(Moose Trial and Last Chance  
intersection)

Existing Conditions - VP 8 NE (Moose Trial and Last Chance intersection)

Post Build Computer Simulation - VP 8 NE (Moose Trial and Last Chance intersection)

Reclaimed Computer Simulation - VP 8 NE (Moose Trial and Last Chance intersection)

Latitude (WGS 84): 44.337615  
Longitude (WGS 84): -103.848877  
Elevation (NAD 83/ft): 6,419.77  
Camera Height (ft): 5.5  
Orientation of View: NE  
Distance to Project (mi): 0.60  
Date of Photography: 2021-06-11

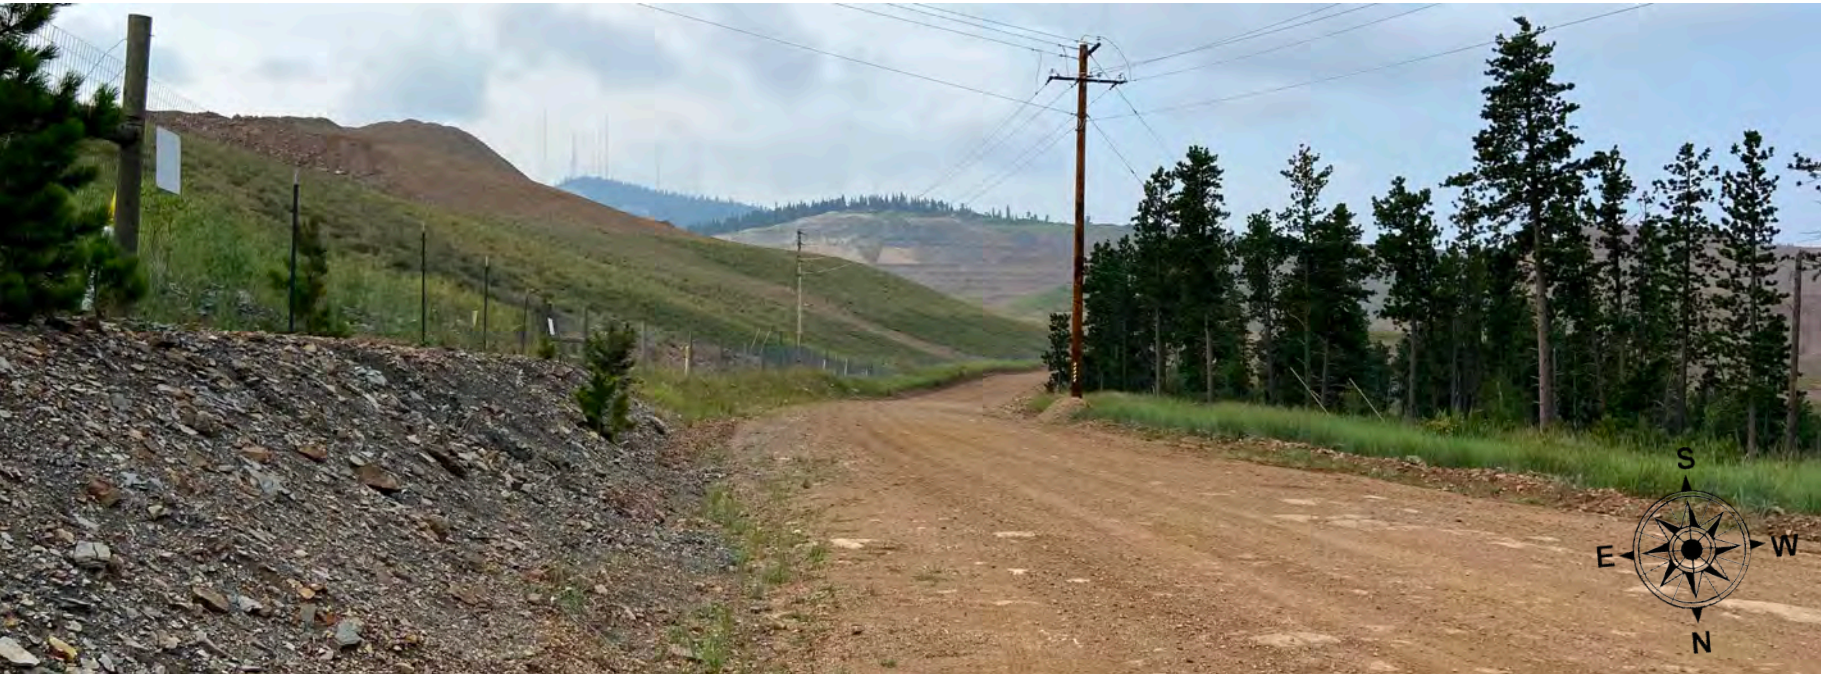
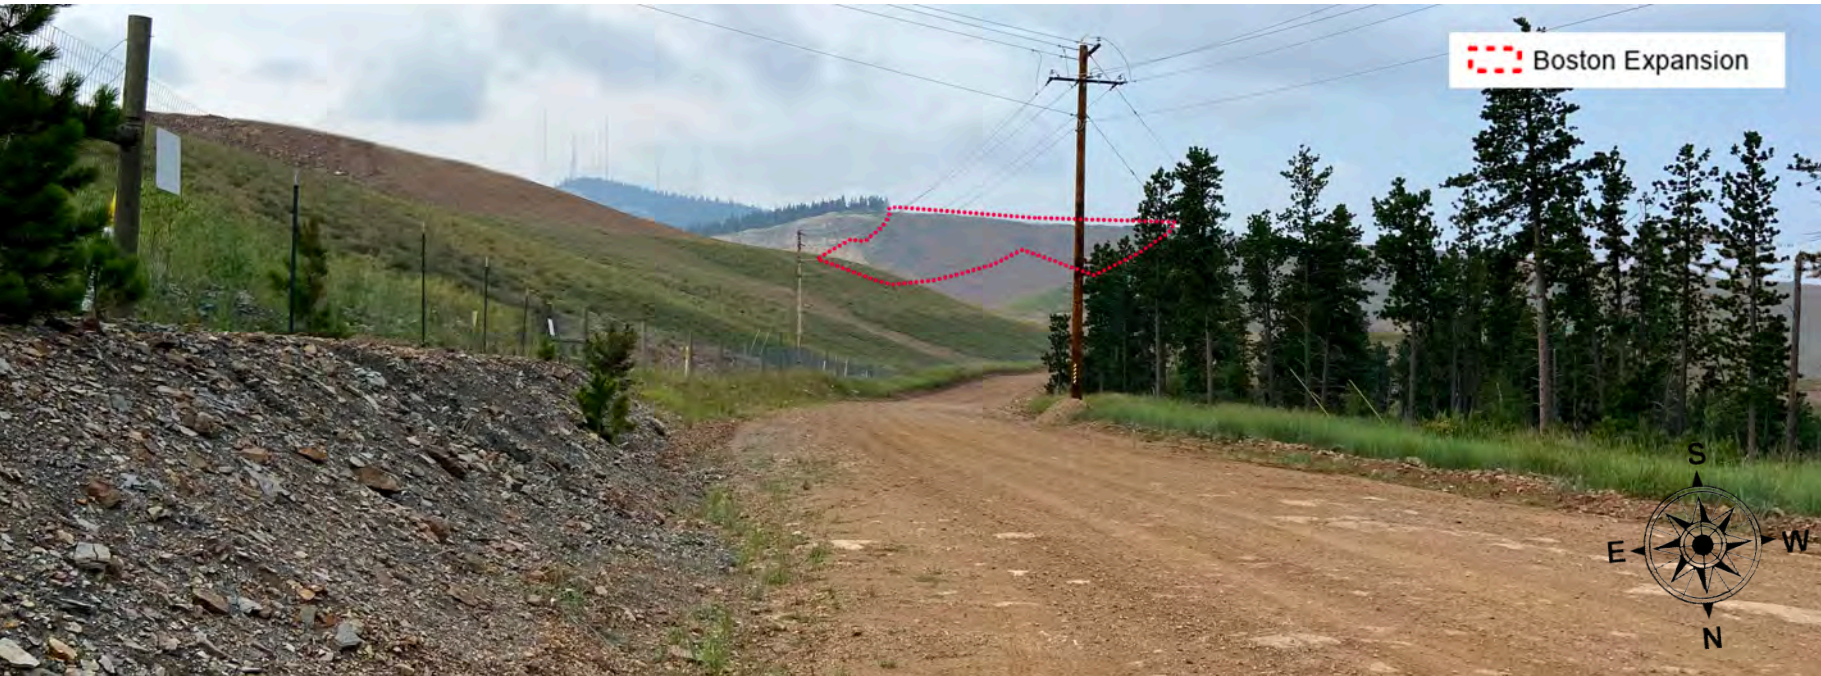
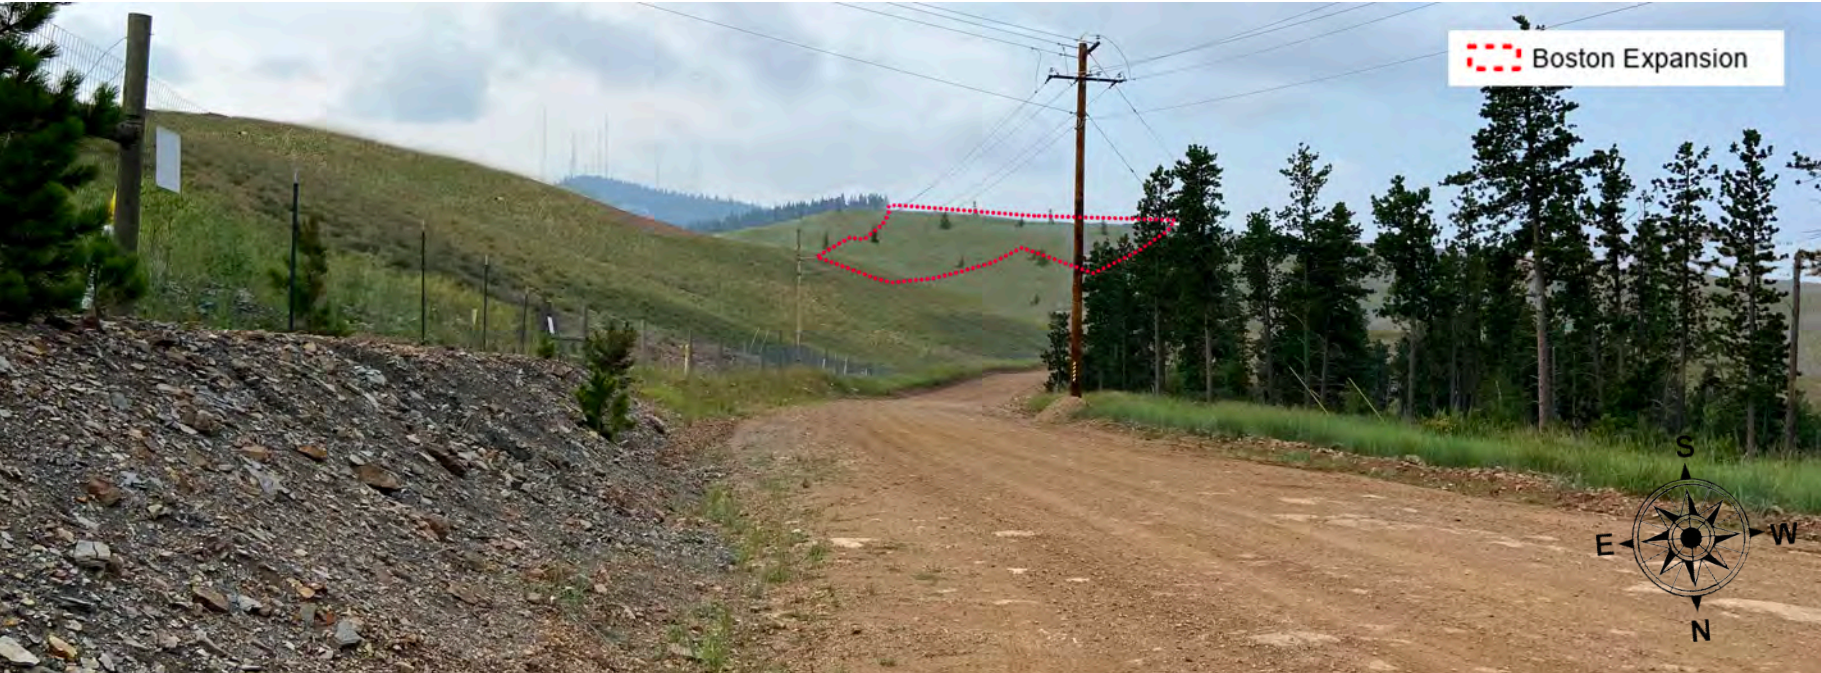
VISUAL SIMULATION  
VANTAGE POINT 9 S  
(Top of Perkins Road)

Existing Conditions - VP 9 S (Top of Perkins Road)

Post Build Computer Simulation - VP 9 S (Top of Perkins Road)

Reclaimed Computer Simulation - VP 9 S (Top of Perkins Road)

Latitude (WGS 84): 44.352618  
Longitude (WGS 84): -103.843496  
Elevation (NAD 83/ft): 6,368.15  
Camera Height (ft): 5.5  
Orientation of View: S  
Distance to Project (mi): 0.01  
Date of Photography: 2021-08-04

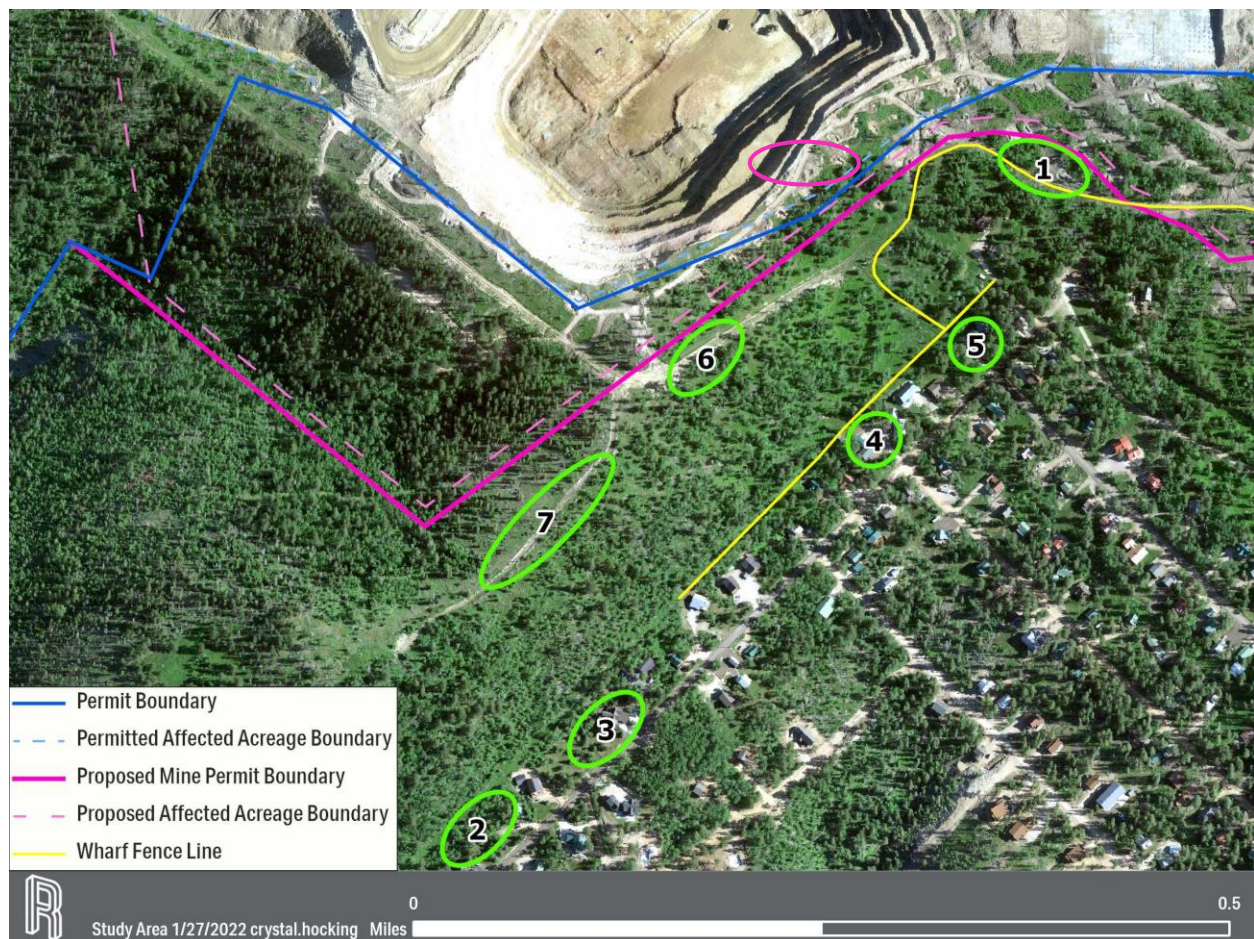
**Figure 1.** General Photograph Locations (green ovals) for photographs taken on December 30, 2021 and January 20, 2022.

The first set of photographs (Photo Location 1) were taken north of the closest residents to the Boston Expansion (Thaler, Akrop, and Determan) as shown on Figure 1. Photographs were taken on December 30, 2021 and show current conditions as of that date. The second set of photographs were taken along Last Chance Trail oriented toward Wharf as well as along Wharf's nearby fence line. The approximate locations of photographs are shown in Figure 1. Photographs presented in Figures 8 through 15 were taken on January 20, 2022 and show current conditions as of that date. Photograph orientation is noted as towards or away from the proposed Boston Expansion. Select photographs have been edited by Stantec to show conceptual images of what the view point may look like following removal of trees and vegetation as a result of the Boston Expansion.

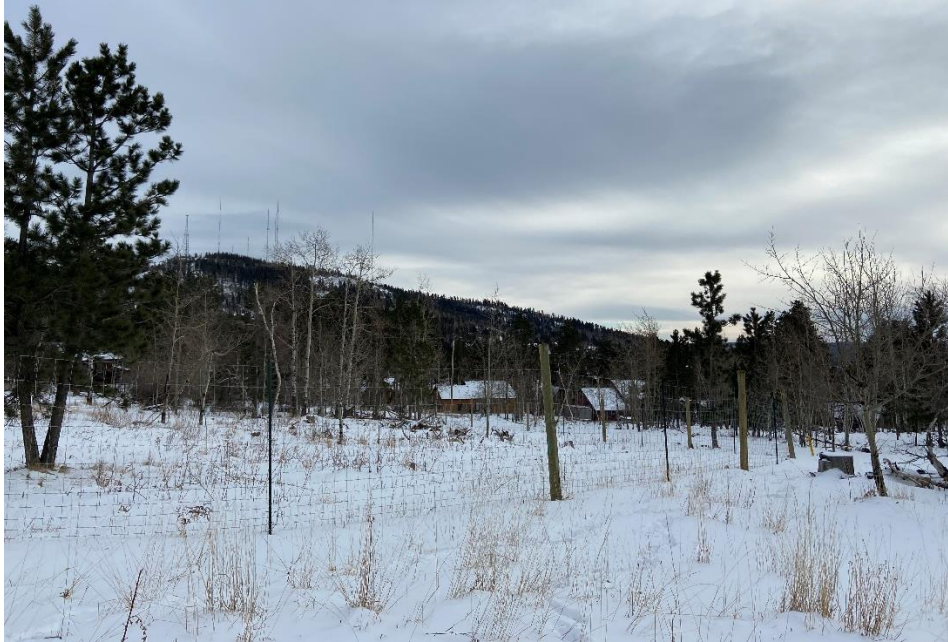
**Figure 2.** Photo Location 1 - View looking southeast from Wharf fence toward nearby residents located on the north side of Moose Trail Rd. The proposed Boston Expansion boundary is located approximately 100-150 ft north of the fence line at this location.

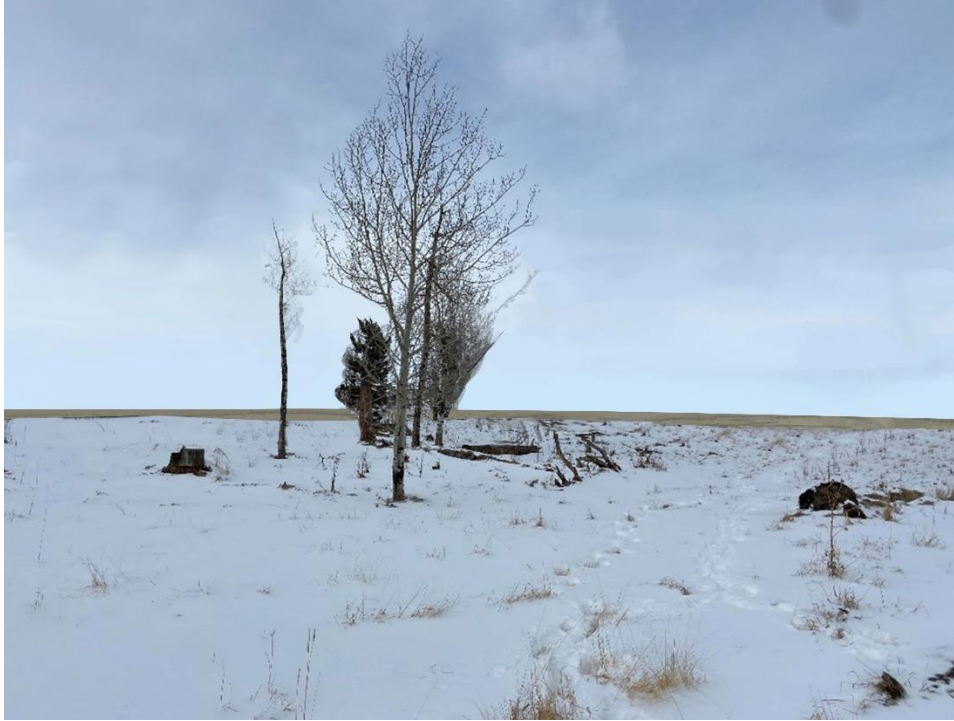
**Figure 3b.** Photo Location 1 – Conceptual Image Post-Vegetation Removal and Mining. At this location, several trees may be removed and the top elevation of the hillside will be decreased as part of the Boston Expansion. When standing at the fence line, residents will have early views of drilling and the berm along the ridgeline and that equipment will not be visible as mining progresses further.

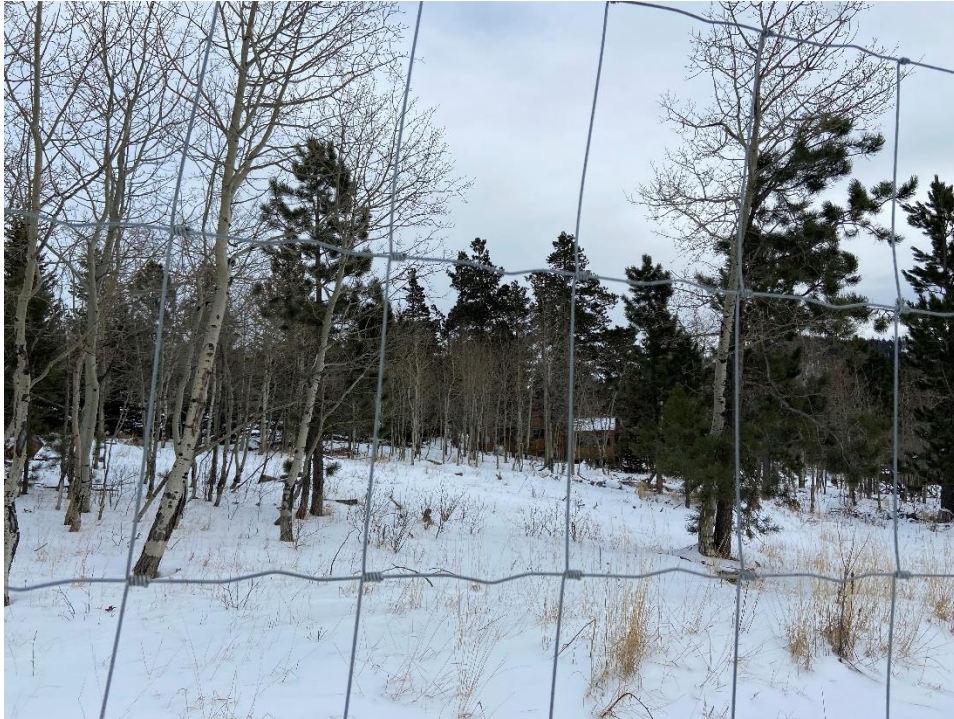
**Figure 5.** Photo Location 1 - View looking south-southeast toward residential area. View of residential structures is greater in the winter; deciduous trees and other vegetation provide additional visual screening in the growing seasons.
