Coeur Wharf  
Wharf Boston Visual Simulation

WHARF BOSTON  
EXPANSION

## Wharf Fence-Line and Lost Camp Subdivision Photographs December 30, 2021 and January 20, 2022

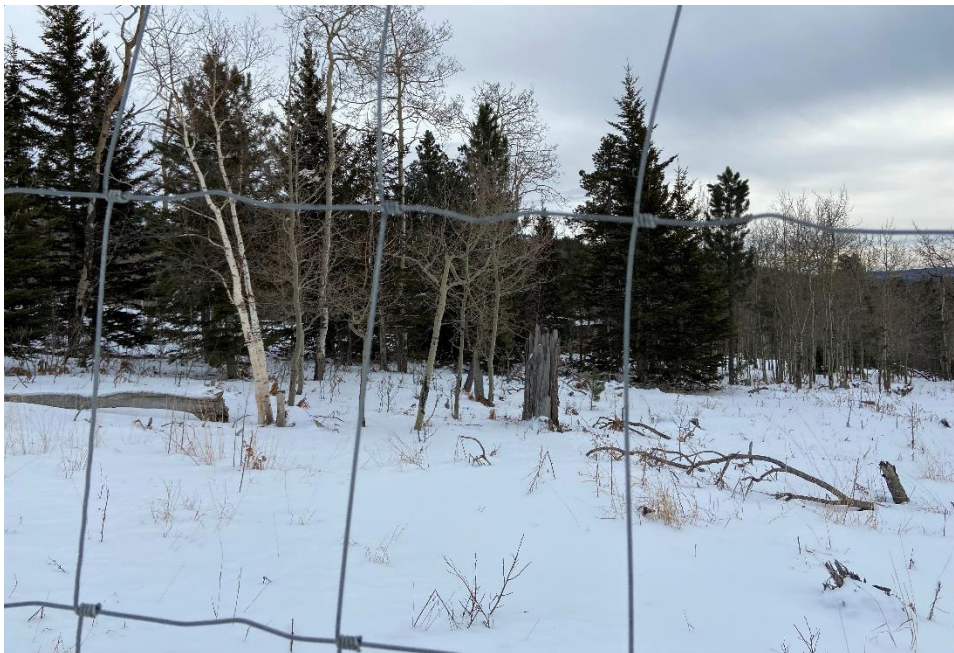
**Figure 6.** Photo Location 1 - View looking south. From this vantage point, trees provide notable visual screening between the mine and nearby properties.

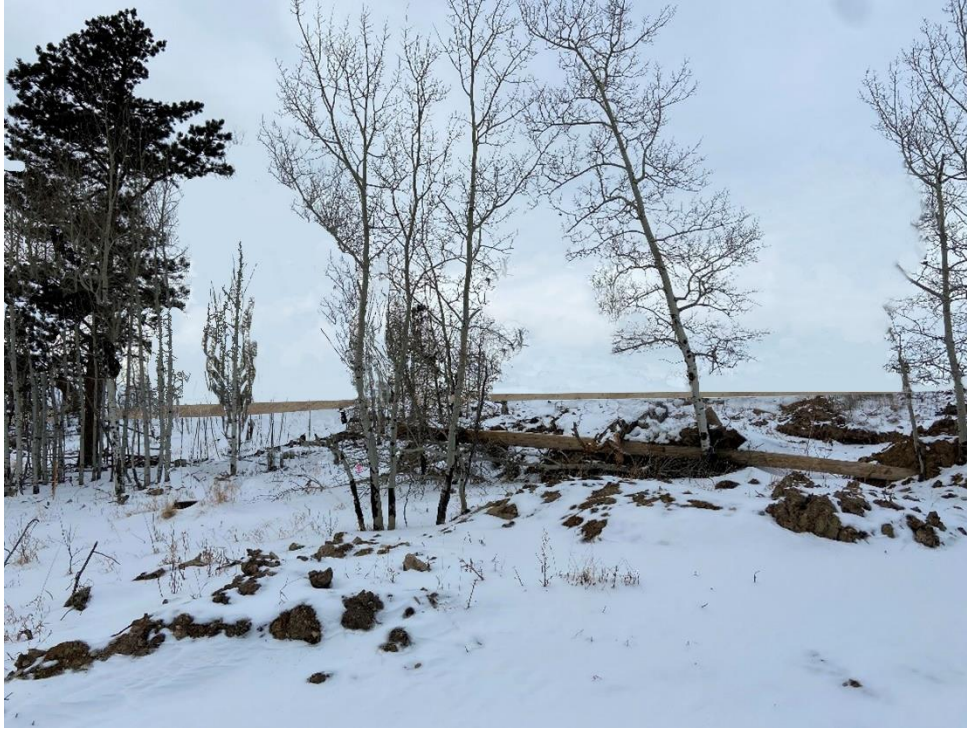
**Figure 7b.** Photo Location 1 - Conceptual Image Post-Vegetation Removal and Mining. Some vegetation in this area may be removed as part of the proposed Boston Expansion, and the elevation of the top of the hill will be reduced as the pit is pushed back to the south into the Boston area. Mine equipment and visual impacts will be greatest during construction of the uppermost one or two benches in this area, after which time view of the mine will be limited from this location. The new berm may be slightly visible.

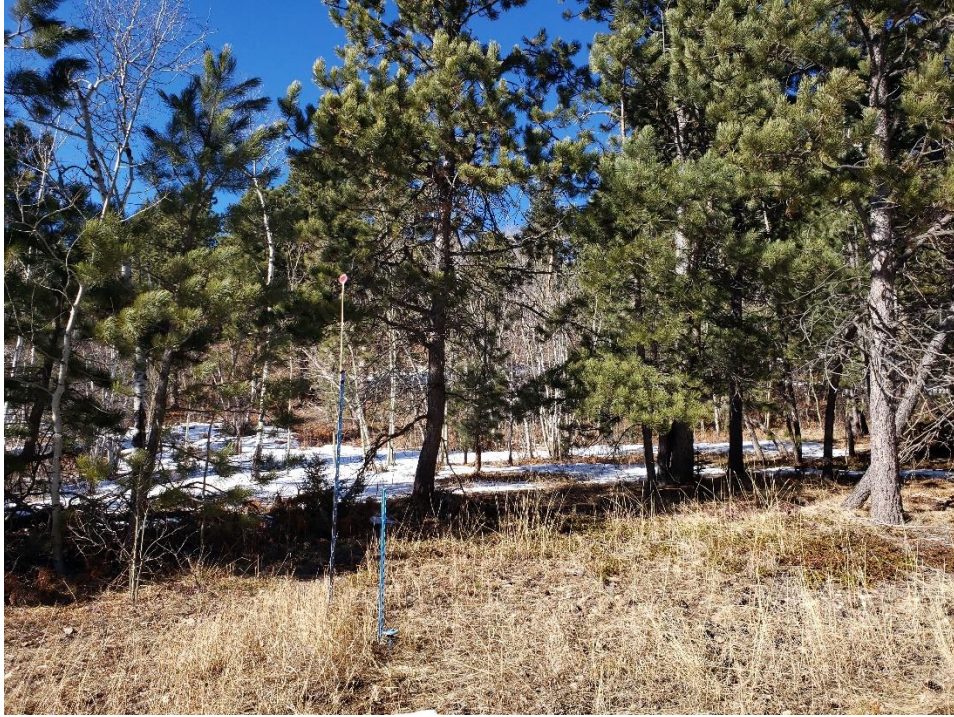
**Figure 8.** Photo Location 2 – This site is located toward on Last Chance Trail oriented north in the direction of the proposed Boston Expansion. The expansion permit boundary is over 1,000 ft from Last Chance Trail here.

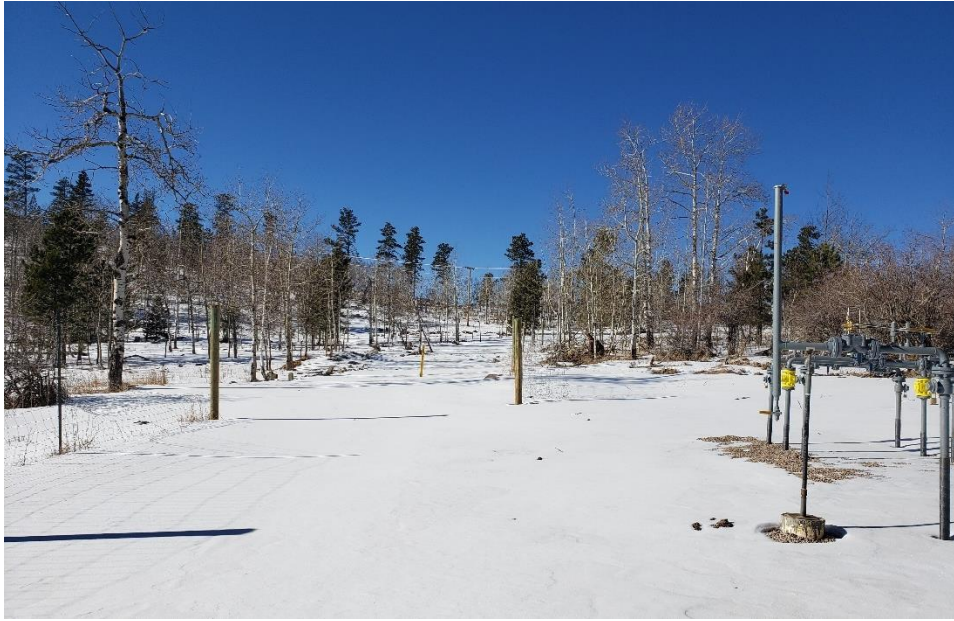
**Figure 11a.** Photo Location 5 – This photo is located at the end of Whitetail Trail looking toward the northwest. A MDU gas line is visible in the foreground and power line along the utility corridor is visible in the background.

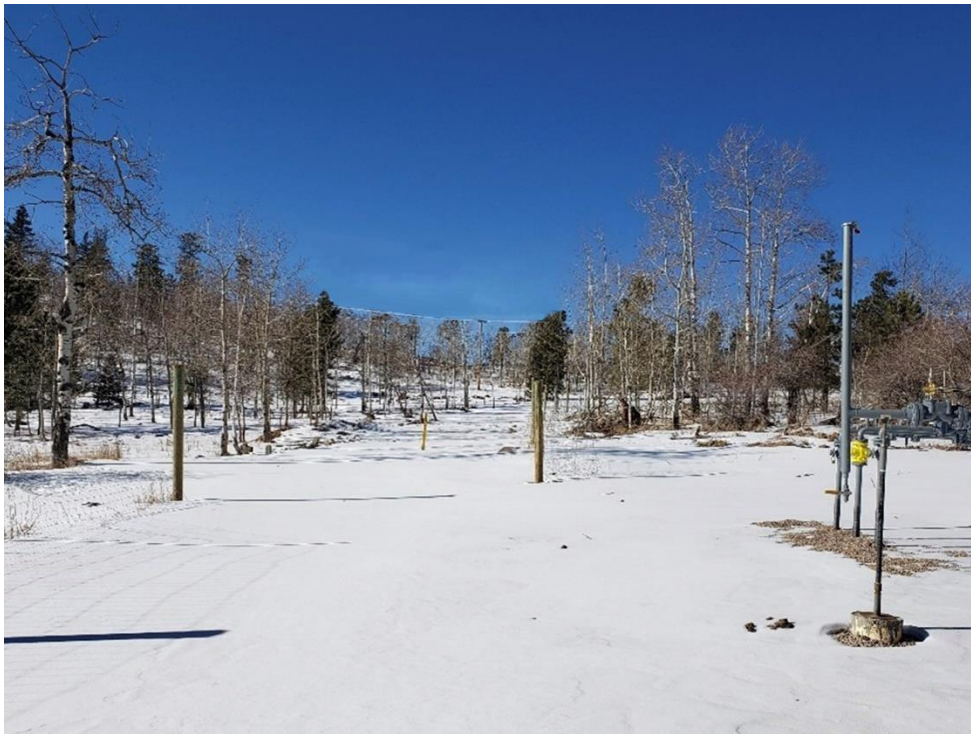
**Figure 11b.** Photo Location 5 – Conceptual Image Post-Vegetation Removal and Mining. Most vegetation between the fence and utility corridor will remain, though some vegetation may be altered based on utility relocation. At this location, mining should not be visible as the proposed Boston Expansion permit boundary is over 500 feet from this photo.

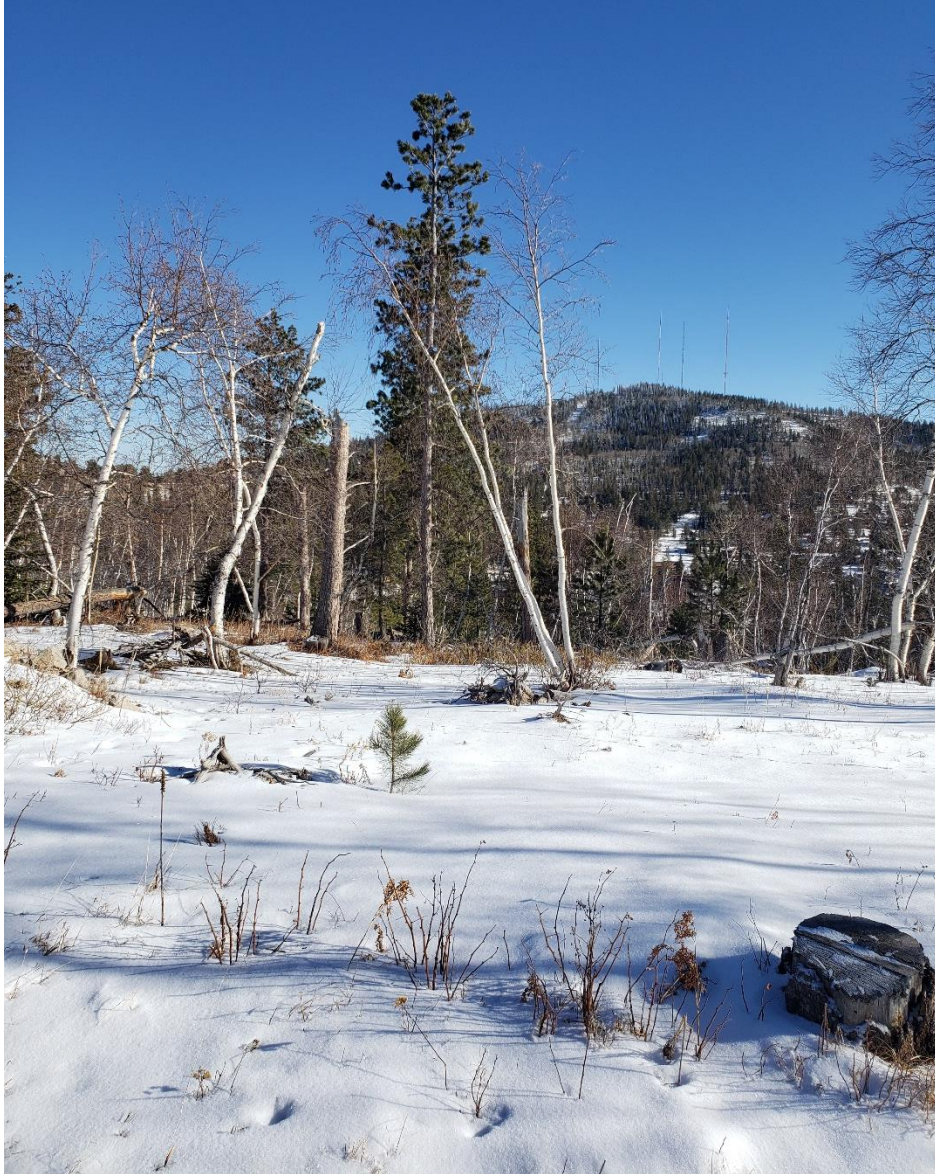
**Figure 13.** Photo Location 7 – This photo is located along the utility corridor (Wharf's fence line is located about 700 ft southeast of the proposed Boston Expansion permit boundary) northwest of Antelope Trail. The view is to the southeast toward the Lost Camp subdivision. Vegetation seen in this photograph will not be impacted as a result of mining.

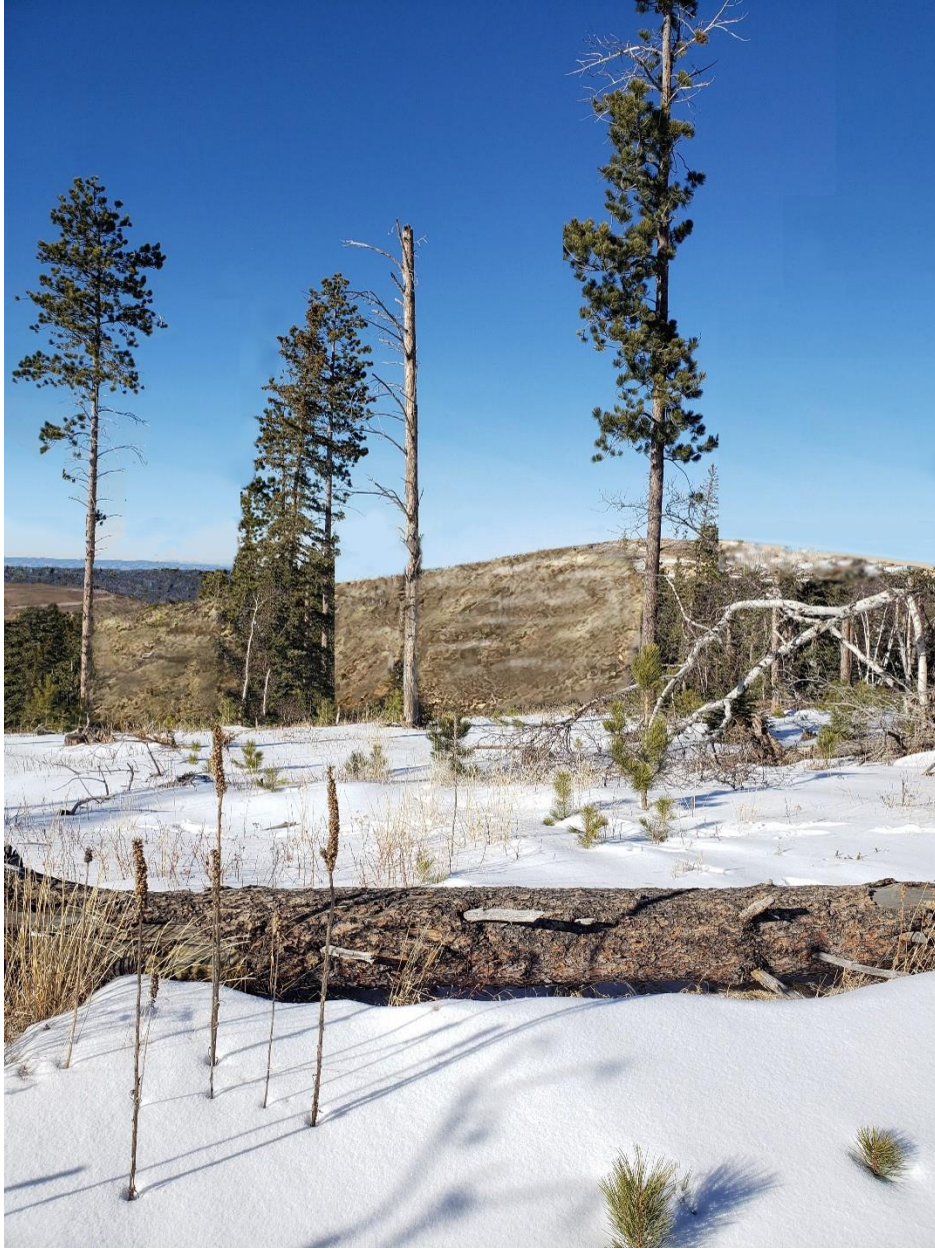
**Figure 14b.** Photo Location 7 – Conceptual Image Post-Vegetation Removal and Post-Reclamation. The downslope position of the expansion at this location serves as a topographic visual barrier, though many trees and vegetation will be removed.

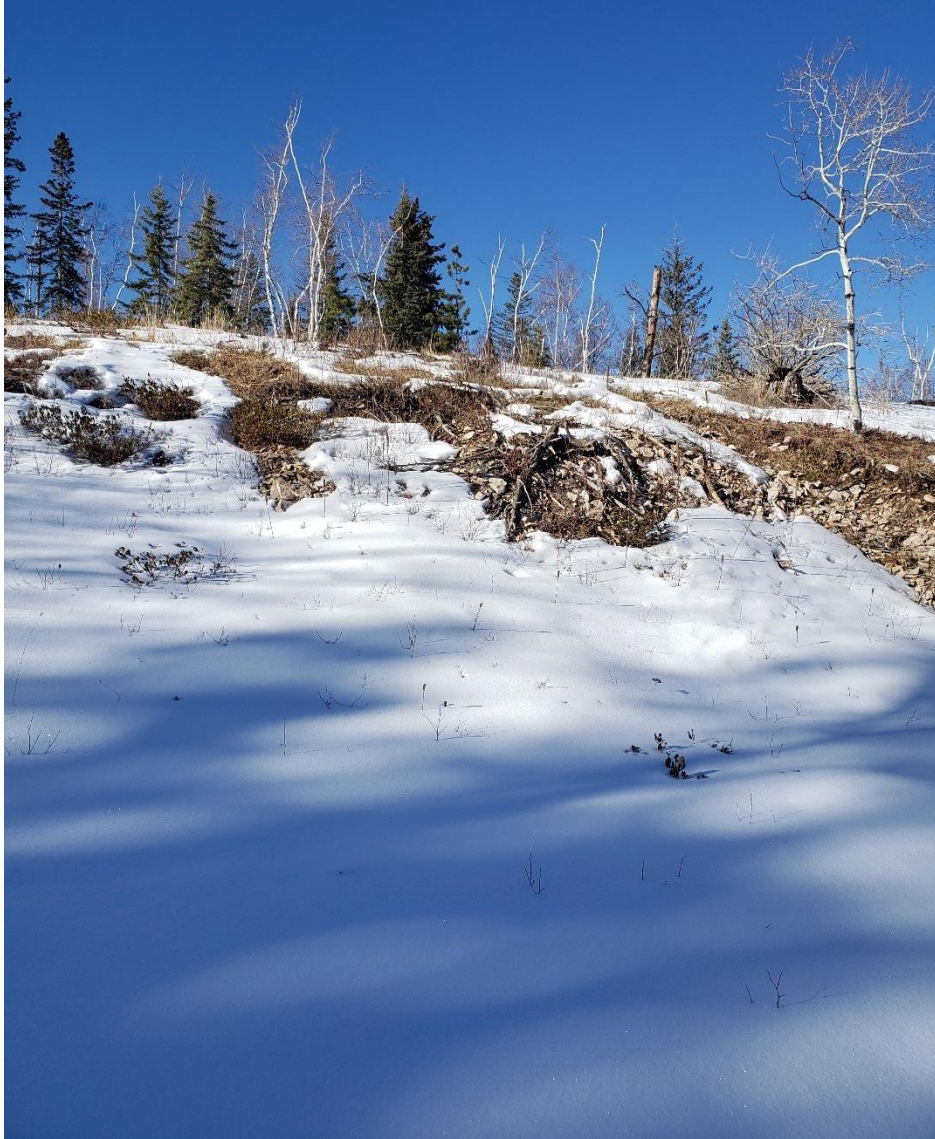
**Figure 15.** Photo Location 7 – This photo is located along Wharf’s fence line northwest of Eagle Trail. The view is to the northwest toward the proposed Boston Expansion. This slope would remain and serves as a topographic barrier to views of potential mining operations at this location.
